Effects of Long-Term Exposure on E-Glass Composite Material Subjected to Stress Corrosion in a Saline Medium.

ABSTRACT: This work provides an insight on very long-term degradation of polyester-fibre glass composites immersed more than 30000 hours in saline medium under service stresses. Samples were loaded under bending conditions with stresses both in the elastic and plastic fields. With the result that characteristics in a flexural mode were able to be determined and the ensuing decrease in characteristics was fitted to an exponential model. The degree of losses ranged from 25 to 31% for the bending modulus, from 28 to 35% for the flexural strength, and from 40 to 51% for the specific fracture energy. The most notable losses were for specimens immersed in artificial sea water under a continuous stress of 140 MPa, corresponding to the plastic behaviour of the material. Although the existence of matrix plasticization is doubtless, the osmotic effects of the diffusion on the matrix and the junction to the fibres, the presence of microcracks, and the effects of chemical ions in the medium on the surface fibre composition became evident in the strength degradation of the material.

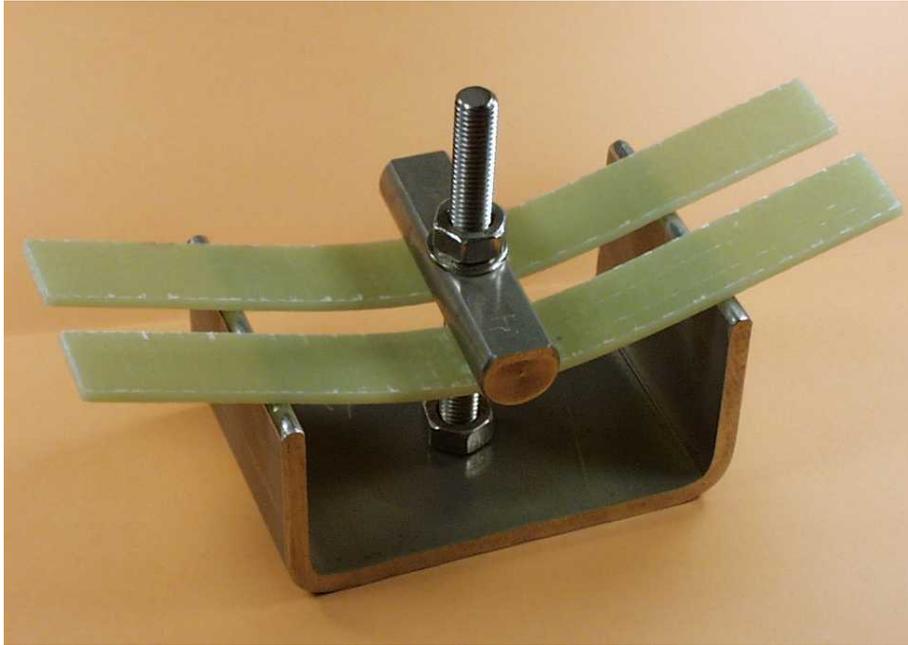
Figure 1. Device to apply the service stress to samples submerged in sea water medium.

A saline medium, imitating sea water, with a salt concentration of 5% was selected. The following immersion times were taken: 0, 1000, 5000, 10000, 15000, 20000, 30000 and 36000 hours. The load levels present during immersion were fixed at 0, 90, 140 MPa, which, respectively represent 0, 28% and 44% of the maximum resistance or ultimate flexural stress. For this, an instrument made of AISI 304L stainless steel such as that shown in Figure 1 was used. Two test coupons were placed inside this instrument and subsequently, forced to take the deflection corresponding to a load of 90 and 140 MPa. Prior to this, the values obtained from the registers of tension-deflection for the reference sample corresponding to 0 hours of immersion, were loaded. Thus, 0, 90 and 140 MPa correspond to deflections of 0, 4 and 6 mm.

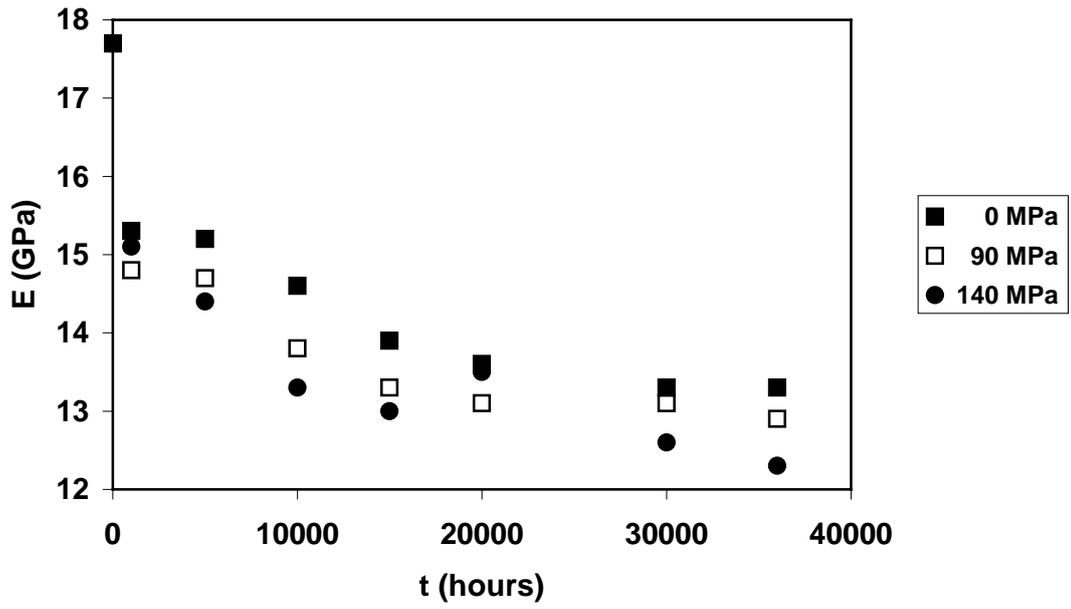
Figure 2. Bending modulus in relation to the immersion time and service stresses.

The evolution of the E elastic modulus with regards to the immersion time is presented in Figure 2. In line with the findings of other authors, an exponential reduction can be observed for several mechanical properties [1,10,19-22]. The composite, not subjected to tension during its exposure, 0 MPa, registers losses of around 25% following those 36000 hours. Thus, modulus lowered from 17.7 GPa to 13.3 GPa. Specimens exposed to a 90 MPa tension, which is within the limit of the zone corresponding to the elastic period, show slightly superior losses, 27%, equivalent to 12.9 GPa. For a working stress of 140 MPa, a tension clearly located within the plastic behaviour of the material, the loss is greater, 31%. In this case, the elastic modulus reaches 12.3 GPa.

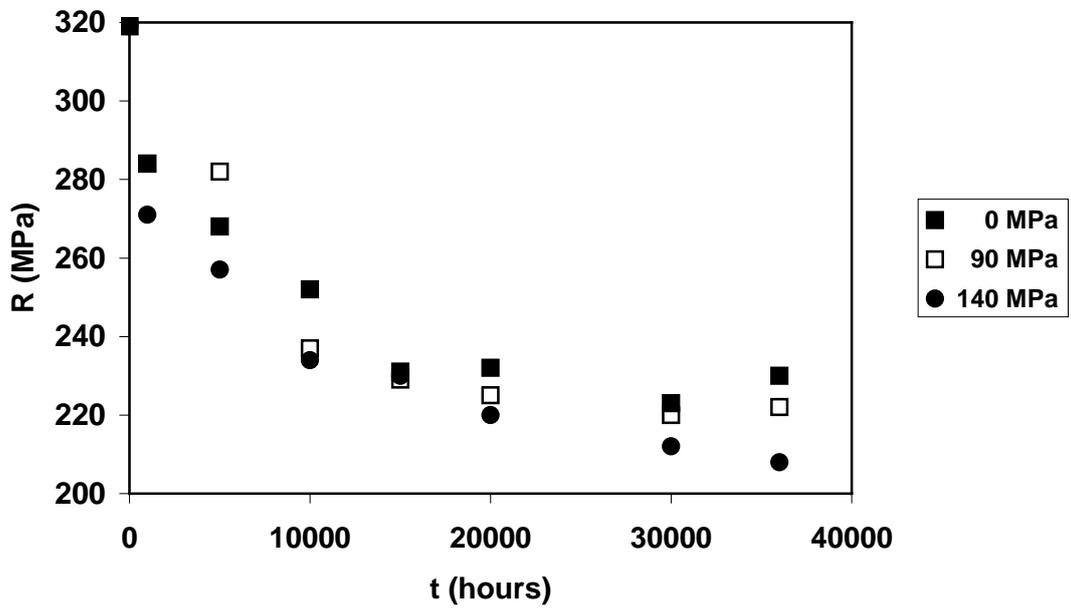
Figure 3. Flexural strength in relation to the immersion time and service stresses.

Once again, in Figure 3 it can be observed how the flexural strength R of the composite diminishes exponentially with the immersion time. The group of samples which do not support any working load, exposed to the saline medium registers a 28% reduction in its strength following an immersion period of 36000 hours. That means the strength is reduced from 319 to 230 MPa. In coupons submerged under stress of 90 MPa this property varies up to 222 MPa and also registers slightly greater losses, 30%. For the

same period of exposure to the saline medium under a continuous load of 140 MPa, the strength is 208 MPa and losses reached 35%.

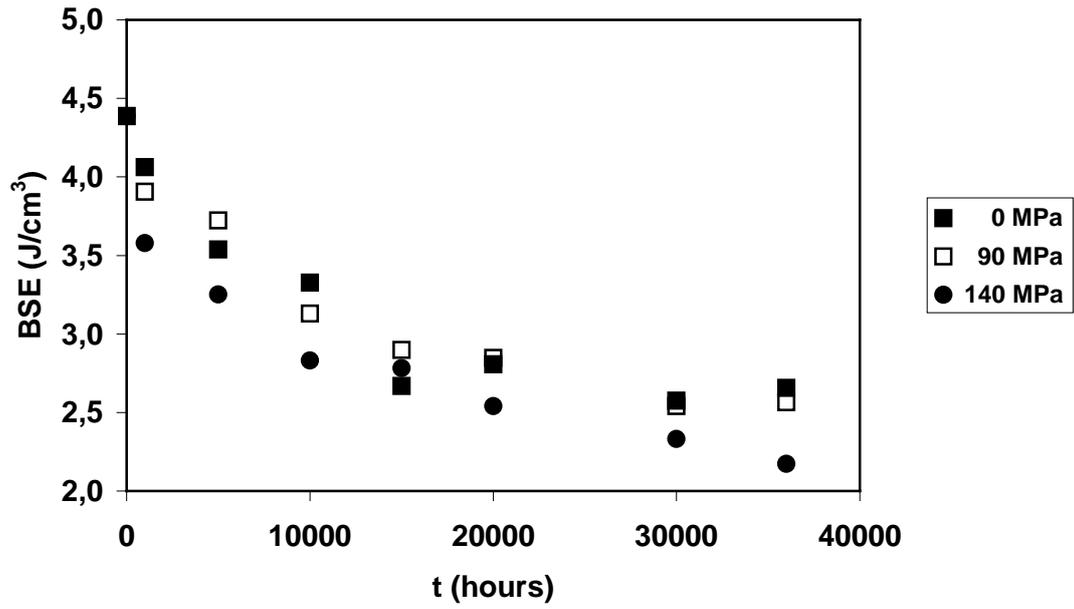
Figure 4. Specific fracture energy in relation to the immersion time and service stresses.

The break specific energy BSE quantifies the toughness of the material [21-24], since it represents the energy balance during the deflection and the loading of the material up to its structural collapse or fracture. Figure 4 shows the results of immersion in a saline medium and the effect under loading. The initial toughness is quantified in 4.4 Jcm^{-3} . After a period of 36000 hours, the material exposed without load exhibits losses of 40%, reaching the value of 2.7 Jcm^{-3} . Almost the same result, 42% is recorded in reference to the losses in the toughness, 2.6 Jcm^{-3} , for the specimens exposed under a 90 MPa of load. These extend to 51% when the test coupons are submerged and put into use under a load of 140 MPa. Their BSE reaches 2.2 Jcm^{-3} . The value of the losses found for this characteristic significantly surpasses the value of those occurring for the characteristics of modulus and flexural strength, regardless of the load to which they have been submitted during immersion. It is also observable that the three mechanical characteristics continue to diminish beyond the 20000 hours of immersion in the case of the samples under a 140 MPa load, an aspect which is decelerated in the other two sample groups.

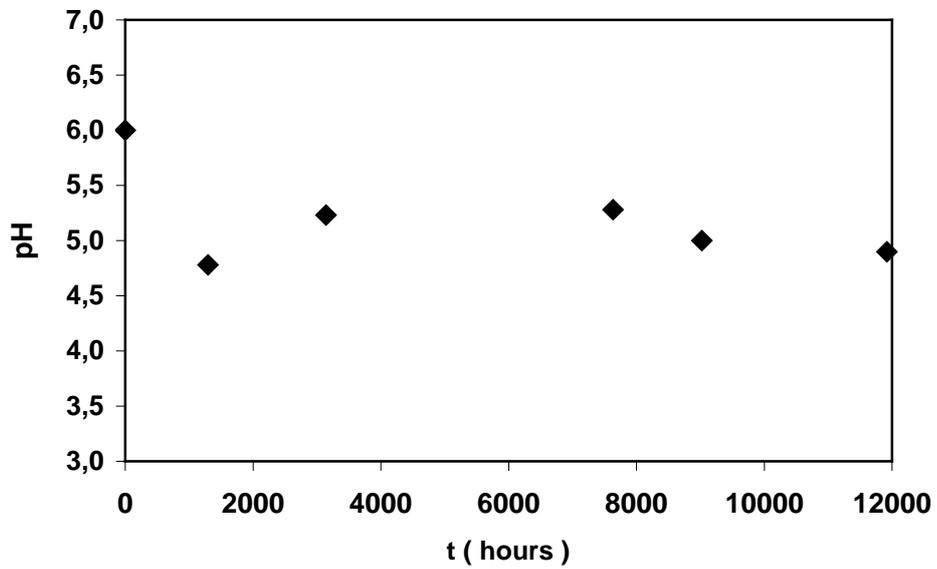
Figure 5. Evolution of the pH of the saline solution with the exposure time

The deterioration of the mechanical properties is justified in the first place, by the resin plasticization caused by the diffusion of water through the polymer and a certain degree of hydrolysis affecting the ester group [1-3,5,10]. Figure 5 shows that pH varied from 6.0 to 4.9 during the first 12000 hours. Consequently, it is very likely that there is

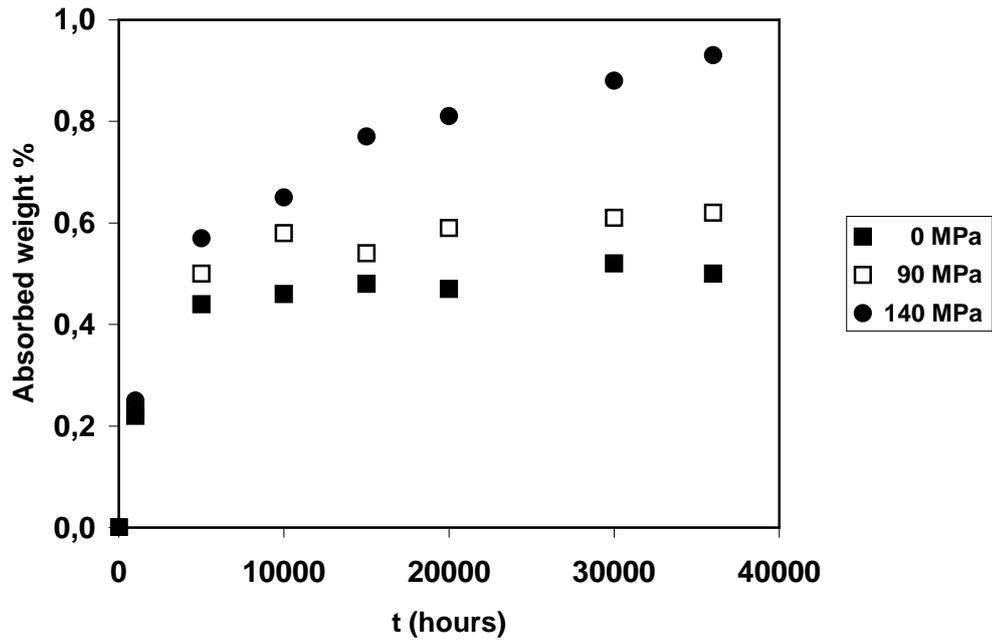
Figure 6. Water absorption in relation to the exposure time

massive hydrolysis of the resin occurring in the faces in contact with saline medium and beneath these ones. In fact, the weight of the composite augments due to water absorption. In Figure 6, it can be seen that the material without load reaches water uptake content close to the saturation point, 0.50%, from 10000 hours onwards. However, the mechanical properties continue to decrease for greater periods of time. The same outcome occurs for specimens immersed under a load of 90 MPa, in which they practically reach the saturation value, 0.62%, between 10000 and 20000 hours. With an increase in the working stress up to 140 MPa, the diffusion capacity of the water up to 0.93% after 36000 hours does not appear to reach the level of equilibrium saturation during such a long exposure period. Meanwhile, it can also be observed that simultaneously the strength properties R and E, and the toughness property BSE, diminish in a continuous mode. This indicates that there must be another cause of greater significance than that of the plasticization or partial hydrolysis of the matrix. Several authors have suggested the need to localise the attack on the fibre matrix interface [5-7].

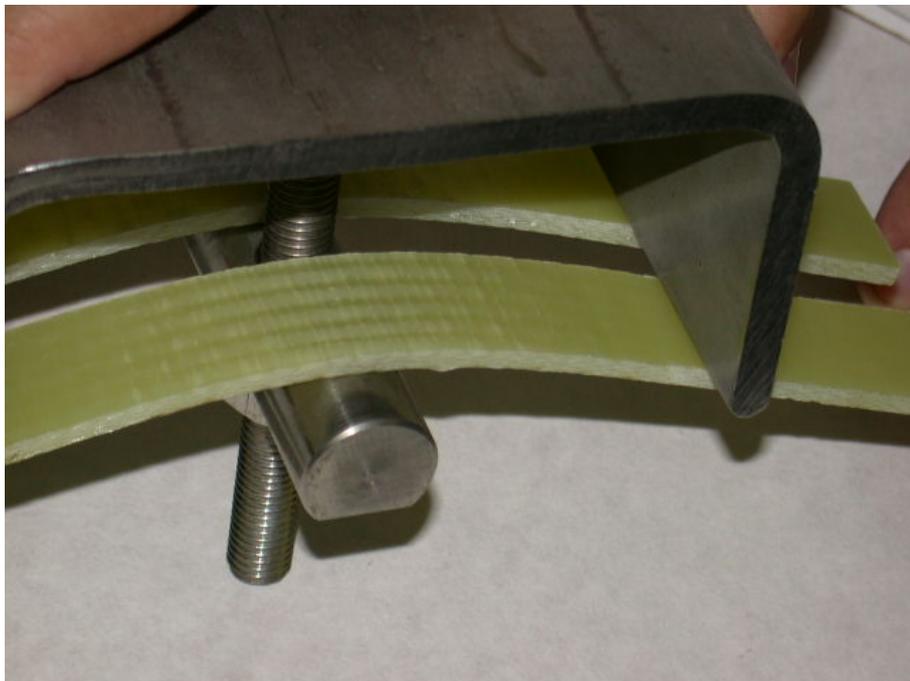
Figure 7. Cracks in coupon for a working stress of 140 MPa after 10000 hours.

When the service load level is increased to 140 MPa, a value within the rank of the plastic behaviour of the material, the existence of an unquestionable superficial cracking can be observed, as illustrated in Figure 7. As a result of the capillary effect, a greater amount of water can penetrate and be distributed through these cracks until it reaches the zones of interfacial micro-cracking, thereby intensifying the attack on the interface at this point [5-7,10]. The result is an escalation in the losses of the strength properties E and R. The increase in the density of cracks in areas where fibres oriented to 90° are present causes the alteration of the fibre-matrix interface after long exposure periods [7,24]. The loss suffered in the BSE fracture energy provides indirect evidence of the deterioration of the interface between the fibre and the matrix [21-24]. This is of a greater extent to the losses which occurred in the resistance and the modulus, and agree with that observed by the researchers [25].

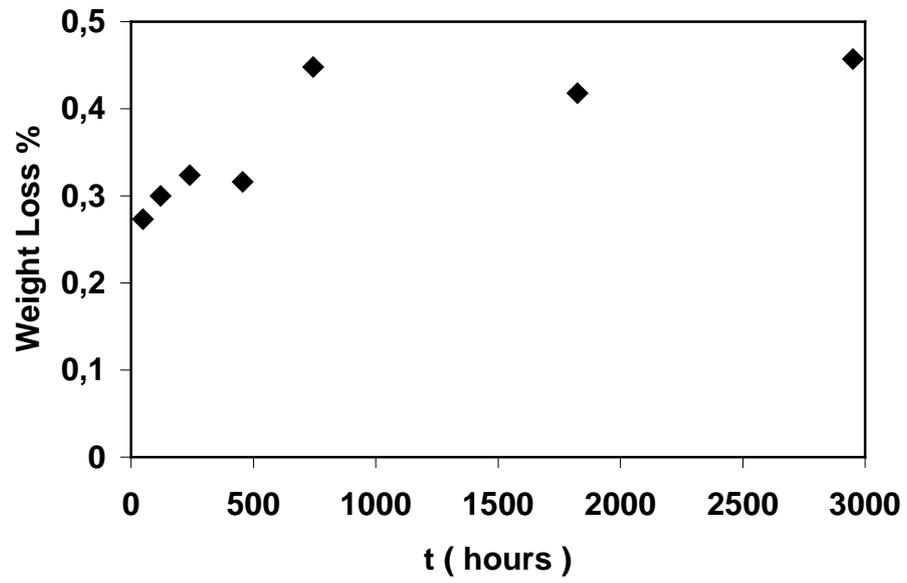
Figure 8. Weight loss in the fibre glass with the exposure time.

Several authors have proven that following the attack on the fibre-matrix interface, an attack on the fibre in the form of a Na⁺, K⁺, Mg²⁺, Ca²⁺, B³⁺, Al³⁺ cation lixiviation through the effect of the H⁺ of the medium [7,26,27], or due to the attack on the link Si-O-Si [28], contributes to the appearance of the mechanism of corrosion under tension [7,9,19,26-28], and is concentrated in the internal traction tensions at the fibre surface. This phenomenon sometimes appears and is intensified when the hydrolysis process of the ester group and the occurrence of osmotic delamination on the fibre interface are very advanced [8]. These chemical attacks on the fibre have been proven to be more energetic under temperatures above 60°C or in media where the pH becomes more extreme, both for acid media and with regard to alkali. In connection with our study, the saline medium, including hydrolysis products from resin, shows a weak acidic pH between 6.2 and 4.9, see Figure 5. The existence of unquestionable damage to the surface of the fibre, following long exposure periods, is highly probable as shown in

Figure 8. The fractography of figure 9 shows the effects of the attack to the fibre surface. Because of the weakness of the attacked fibre, its surface presents a smooth aspect, cleaved resin, and massive pull-out. Even in the absence of external working stress, the reductions in the mechanical properties are greater than those presented by Liao [7]. The variations with an upward (+) or downward (-) trend for different immersion times for the content of the elements constituting the fibre are presented in Table I. The majority elements, Si, Ca and Al and the minority elements Mg, Na, K, Fe, register changes, which demonstrate the credibility of the hypothesis regarding the attack on the fibre by the saline medium lightly acidic.

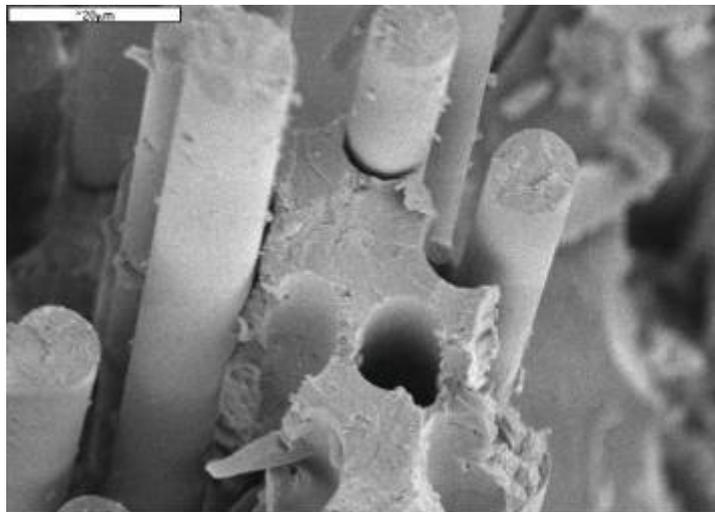
Figure 9. Debonding and pull-out of glass fibreglass at 13000 hours. X1500.
