## POLYCHROMY OF LATE GOTHIC CIVIL ARCHITECTURE: A WORLD HERITAGE MONUMENT CASE IN SPAIN

The Silk Exchange of Valencia, Spain, is one of the best examples of late Gothic civil architecture in Europe, and was declared a World Heritage Monument by UNESCO in 1996. Prior to cleaning and conservation, technical examination identified the original pigments used to paint the walls, keys, vaults, arches and columns in the main hall, the Contract Hall. Cross sections of remnants of original colour (blue, green, red, gold, etc.) were investigated with optical microscopy, scanning electron microscopy with energy dispersive X-ray analysis, X-ray diffraction techniques and UV light. The study has revealed that the original paint today remains only in very limited areas. Evidence for a later maintenance operation of repainting was also found in the inscription that runs around the Contract Hall. The information has been very useful for deciding on the cleaning and conservation process.

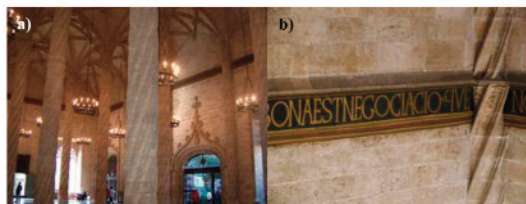
**Figure 2:** a) The Contract Hall. b) Horizontal band in the Contract Hall.

The Contract Hall is a magnificent hall, in Flamboyant Gothic style like the rest of the ensemble. The interior is divided into three main aisles by five rows of slender spiral columns ending in elegant vaults. The Contract Hall (35.60m x 21.39m x 17.40m height) is also called the "Hall of Columns" due to its 24 spiral columns, 8 slender freestanding columns and sixteen columns embedded in the paraments of the hall (Fig. 2-a). The simplicity of the plain walls is only interrupted by a broad horizontal band at 11 meters high (Fig. 2-b).

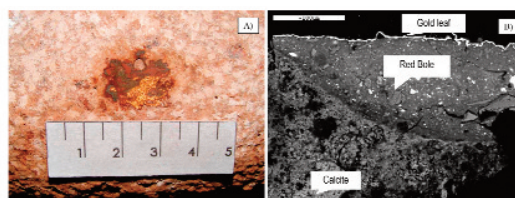
**Figure 3:** a) Gold over red bole (scale in cm). b). Cross section. Backscattered electrons image.

The presence of gold leaf was observed in traces of paint on arches, vaults, and keystones, always on red bole (Fig. 3a-b). Red bole, also known as Armenian bole is an iron-rich material (hematite compound) particularly suitable for applications such as substrates for water gilding where a high surface polish is required. This finding is in line with bibliographic documentation stating that the Contract Hall was built with terraces and in 1516 the vaults were damaged by humidity caused by infiltration from the roof. A tile roof was constructed to prevent further damage and the master Anthoni Ribesaltes was given the task of repainting. After the intervention, the keys and arches were coated with gold leaf.

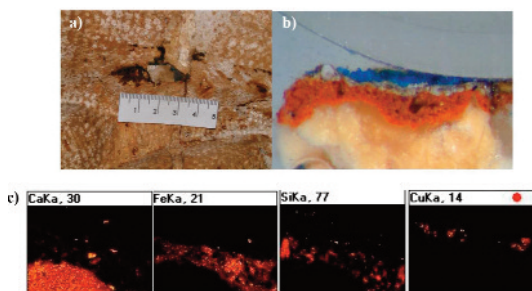
**Figure 4:** a) Colour remnants (scale in cm). b) Microphotography 50X. c) Mapping of elements Ca, Fe, Si and Cu.

Blue pigment remnants corresponding to azurite pigment were observed in the keys and vaults on a thin white lead layer. The Fig. (4) shows the distribution of elements in a sample. According to

documentation in 1498 the vaults were painted with gold stars on blue by master Marti Girbes to simulate the sky (a common practice in similar Gothic buildings).

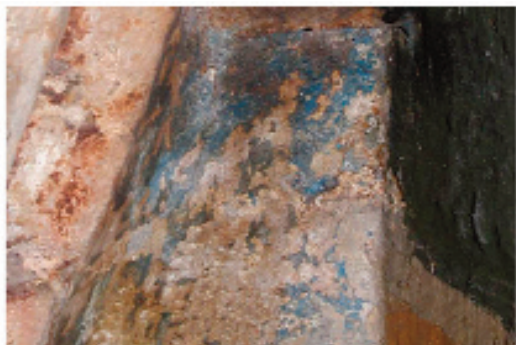
**Figure 5:** Colour remnants in column embedded in the wall.

Green remains have been found in some arches corresponding to copper-based green pigment (malachite or verdigris) on white lead layer and remnants of some undocumented geometric decoration. Traces of blue (azurite) and red (vermilion) were found in columns with no previous documentation of polychromy (Fig. 5).

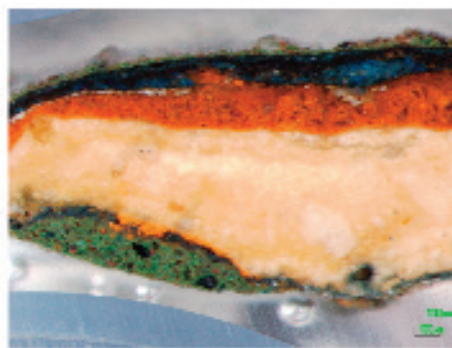
**Figure 6:** Superposition of layers in the band.

As regards the inscription around the Contract Hall, an original band was found under the repainted one which is currently observed. Sample analysis has allowed a comparative study of both bands, establishing similarities and differences between pigment compositions. The pigment causing the exterior colour is azurite on a thin white lead layer which gives more light to the overlayer. Azurite

was the most important blue pigment in European painting during the Middle Ages and Renaissance because it produced a beautiful colour and was much less expensive than ultramarine. A greenish colour has appeared on the external pigment layer due to alteration in malachite. This pigment has darkened through exposure to sulphur fumes. Barium sulphate (barite), a compound frequently used as an extender, has been detected. Analysis of the ground white layer shows the presence of calcite. Below this layer, another blue layer was found with a similar composition to the upper blue layer, that is, malachite over azurite. The presence of this new blue layer indicates that a repaint with the same pigment, azurite, was done over the original band (Fig. 6).

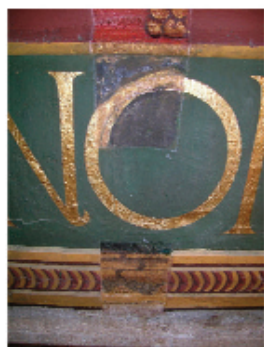
Figure 7: Overpainting of original band (Ramírez et al., 2006b)

The cleaning works have revealed the original figures. The design of the upper and lower part of the original band differs from the more recent band. The top part of the original band shows a mixture of foliage and there is a great difference between the bottom parts of the original and repainted bands. The original design had a greater sensation of three dimensions in contrast with the two-dimensional aspect of the more recent band (Fig. 7). The red color in the more recent band is due to hematite pigment, whereas, in the original decoration the red pigment was vermilion. Vermilion is a reddish orange long-lasting pigment with

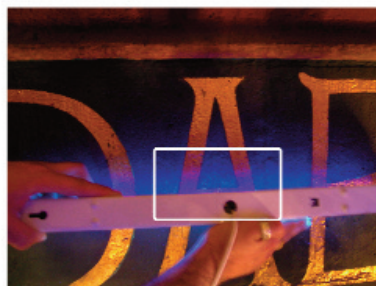
Figure 8: UV illumination of band.

Small differences in calligraphy were found using ultraviolet illumination. The overpainted band is lightly displaced in relation to the original band, whose gothic characters are much purer than the repainted one (Fig. 8).
