Research-Based Contemporary Intervention in Heritage Architecture: The New Doorway of San Juan del Hospital

The Church of San Juan del Hospital in Valencia (Spain) is a Gothic church whose main architectural feature—the western façade—remained unresolved, posing structural and compositional challenges. The intervention addressed this issue while preserving the historical integrity of the building and its heritage context. A systematic methodology was applied, following principles of reversibility, sustainability, and compatibility with medieval ribbed-vault construction. The project resolved five key aspects: completion of the nave's façade, coverage of the former atrium remains, access from the north courtyard, compositional coherence of the west courtyard front, and integration of the church and museum entrances. Contemporary materials and techniques, including aluminum, recycled wood, and handmade ceramic brick, were selected to harmonize with historic stonework, ensure durability, and minimize environmental impact. Design strategies guided visual perception, emphasizing the lower façade and resolving dispersive compositional elements, while creating functional spaces for venti

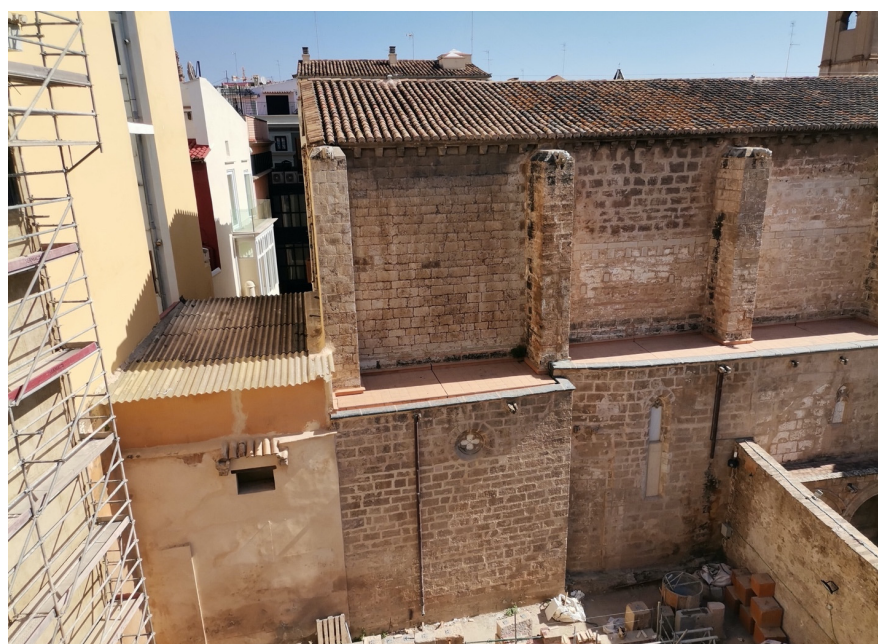
Figure 4. View of the exterior from the Hortensia Herrero Foundation, showing the roof on the left side of the church.

Additionally, it presented an indecorous appearance for a monument, particularly for visitors to the Hortensia Herrero Art Center (Figure 4). The fiber-cement sheets used in the roof pose environmental and health concerns, as they may release harmful dust particles containing asbestos or silica if deteriorated or improperly handled [14]. Additionally,

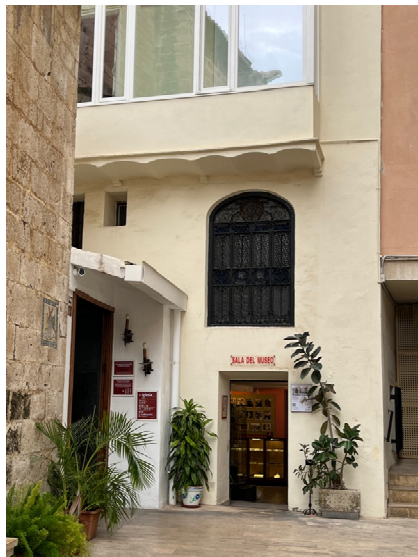
Figure 6. (a) View of the main entrance to church and museum; (b) Project for the west façade for the church, Moya and Pons-Sorolla, 1971.

As a result of urban development and the street pattern inherited from the historic alleyways, the entrance to the complex had been preserved at the foot of the church, as would be typical for this type of building. However, this entrance was not positioned on the main axis—as would normally be expected—but instead sat at the corner of the north façade, where an alley intersects with the north courtyard. Consequently, the entrance becomes visible only when approaching from the north courtyard, appearing on one's left, corresponding to the current alley that leads toward Milagro Street. This created a problem of entrance focalization, further aggravated by the poor material quality of the existing door and its awkward visibility from the alleyway. In the 1970s, Ramiro Moya and Pons-Sorolla drafted a project to create a new plaza at the foot of the church and relocate the main entrance along the central axis of the nave (Figure 6) [23]. This problem of focalization is further intensified because the back of the north courtyard corresponds to the rear façade of building no. 10, whose main architectural feature is an enclosed lookout with a glazed front belonging to the principal floor. This lookout is displaced from the central axis of the courtyard, and it is flanked by two continuous balconies, while openings of different

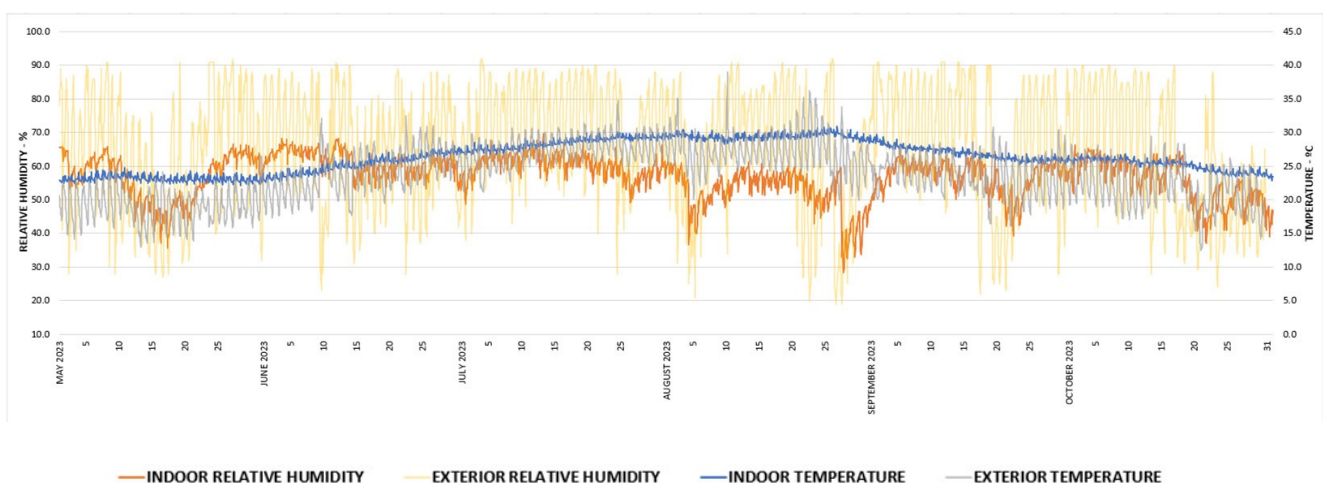
Figure 7. Complete monitoring of the Church of San Juan del Hospital: indoor temperature, outdoor temperature, indoor relative humidity, and outdoor relative humidity.

- During summer months, internal temperatures range from 23 °C to 30 °C, exceeding outdoor conditions.
- Relative humidity inside the church ranges between 50% and 70%, with insufficient natural ventilation.

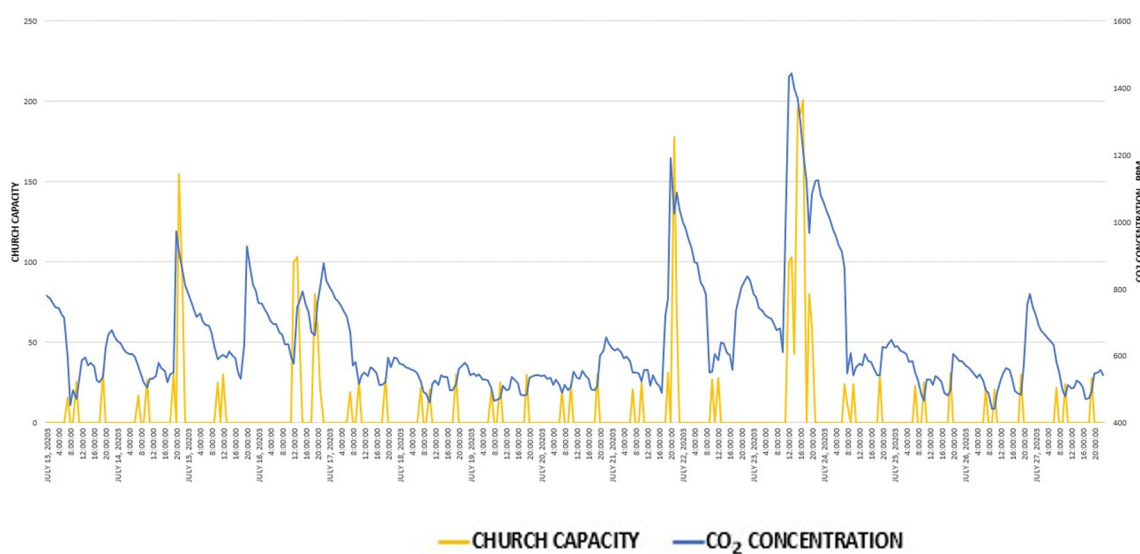
Figure 8. Comparison between CO₂ concentration and visitor capacity inside the church.

- Internal conditions do not recover quickly because the building cannot dissipate visitor-generated CO₂ as fast as it is accumulated (Figure 8).
- These temperature, humidity, and CO₂ levels exceed recommended thresholds for heritage conservation, risking paintings and coatings.

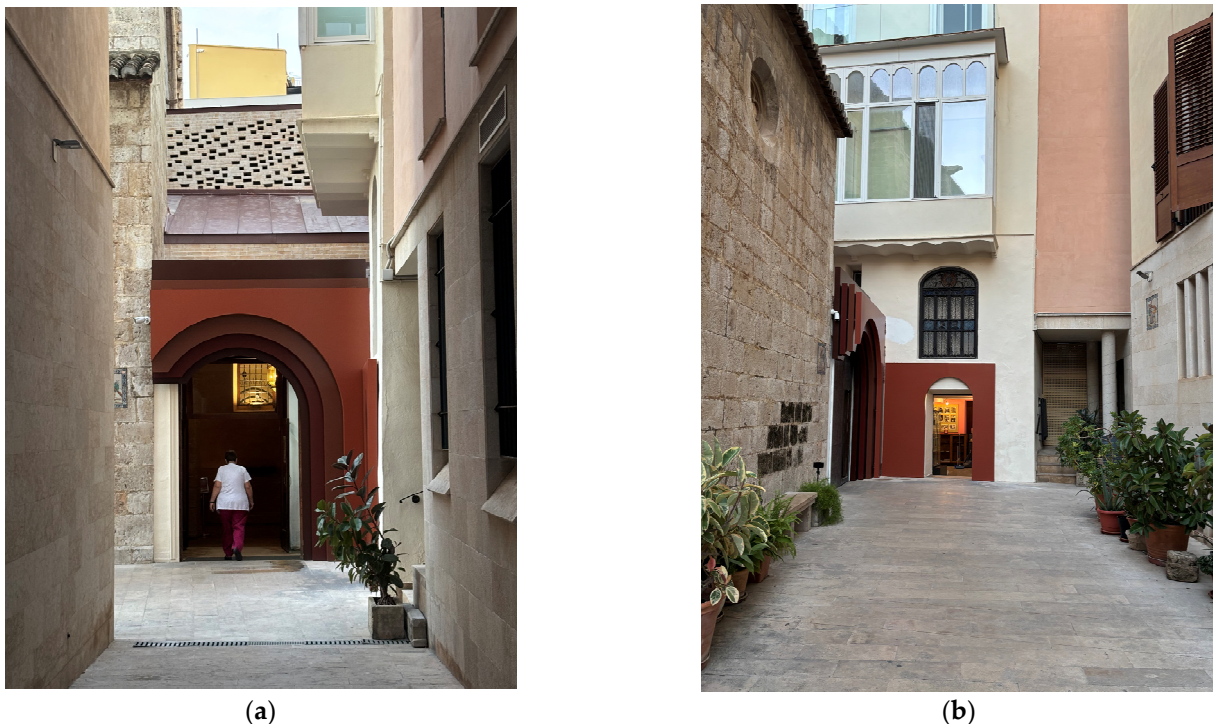
Figure 9. (a) Front elevation of the new entrance; (b) View of the entrances to the church and the museum in the north courtyard.

Furthermore, this portal solution (Figure 9) had to integrate access to both the church and the museum, each with different dimensions and forming a 90° angle. Accordingly, a smaller order was applied to the museum entrance and a larger order to the church entrance, ensuring the most appropriate proportionality between the two. The partial removal of the jamb and the staggering of the archivolts help to focus viewers' attention toward that corner.

Moreover, this solution evokes a section of ribbed vaults, where the vault ribs require flying buttresses or supports. Reducing the dimension of the left jamb adds dynamism, better directs the visual path toward the church entrance, and prevents tripping or wear on the jamb.

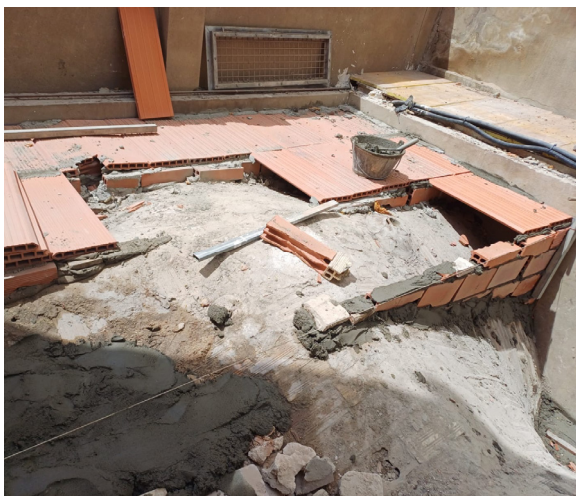
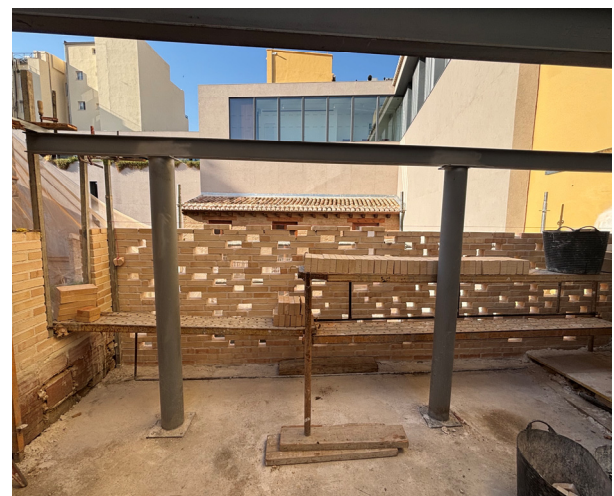
Figure 10. (a) Construction of the partition bricks over the ribbed vaults; (b) Construction of the columns on the slab and of the ceramic brick façade.

The materials and techniques used are contemporary, but sustainability criteria were followed, as well as a structural system compatible with the medieval ribbed vault solution to reduce CO₂ in the intervention. Over the ribbed vaults, small partition walls were installed with a layer of concrete, creating a resilient framework [36] to support the circular pillars that bear the roof (Figure 10). The roof features panels of recycled wood, topped with a reddish zinc sheet to match the color of the church roof, which is made of ceramic tiles, and to harmonize with the tones of the new portal. The zinc sheet serves as the waterproofing system itself. Traditional fixation methods are used, placing the sheets over a wooden board and securing them with nails. The overlapping arrangement of the sheets ensures complete watertightness.

The façades are built with handmade ceramic bricks, and for the new portal, aluminum was chosen due to its greater durability against atmospheric corrosion, better transportation logistics, and ease of assembly.
