# The Collapse of the Vaults of the Ambato Matriz Church in the 1949 Earthquake: A Response with a Technical Approach

**Abstract:** This research examines the structural behavior of the central vault of the Matriz church that collapsed during the 1949 earthquake in Ambato, Ecuador. Following the disaster, the church and Episcopal Palace were demolished. The central vault lacked buttresses and had large cracks two years before the collapse. A study was conducted using graphic restitution and the theory of limit analysis of structures to analyze the mechanical behavior of the central vault. The aim was to provide a technical explanation for the cause of the collapse beyond the impact of the earthquake. The limit analysis of structures is a tool that determines the technical stability conditions of a masonry structure using graphic statics. In this case, the respective checks of the structural behavior could be made, concluding that the structural ensemble of the central vault was unstable and could have collapsed at any moment, not necessarily due to an earthquake. The article is based on the research project “Architectural analysis of the central nucleus of Ambato between 1895 and

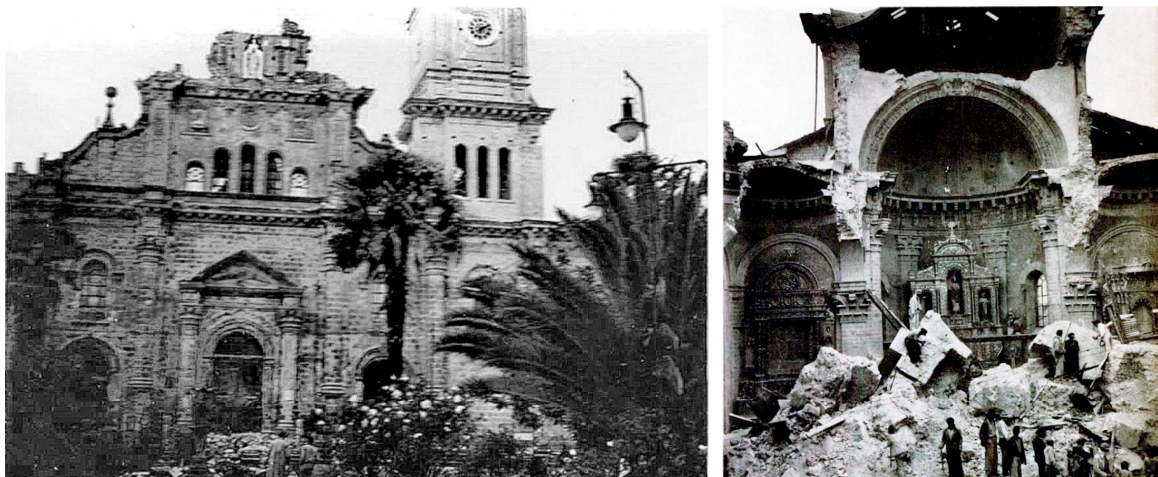
**Figure 2.** Ambato Matriz Church. Front facade [4] and interior of the central aisle after the 1949 earthquake [6].

The structure in question is of monumental character and was built with quarry stone walls featuring five aisles, carved cornices, capitals, columns, and other details, all made with the local stone known as Pishilata [7]. The vaults, on the other hand, were constructed with pumice stone. During an earthquake, the central vault and a portion of the domes of the side aisles collapsed, but the walls and tower remained standing.

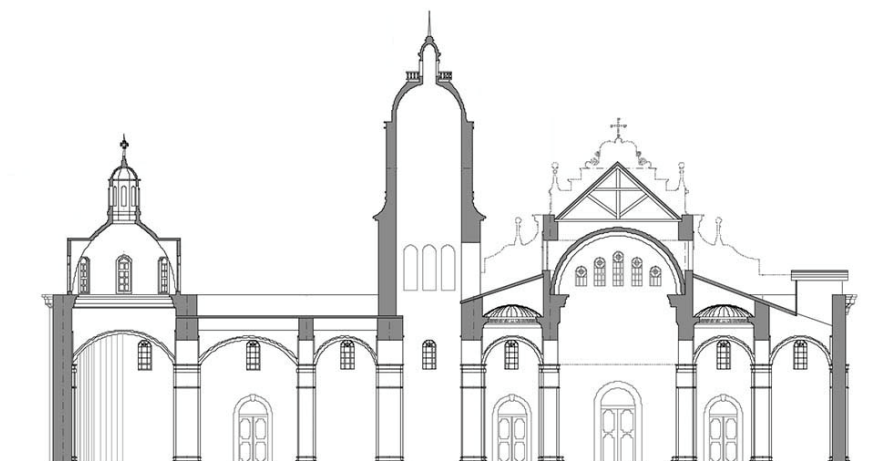
**Figure 7.** Ambato Matriz Church. Graphic restitution of the transverse section at the foot of the temple and transversal chapel.

In addition, complete transversal sections of the church were made: one in the narthex, high choir, and transverse chapel complex (Figure 7), one in the center of the church, and one in the presbytery. All plans were properly dimensioned and included a location plan relative to the block and the plan of the city's central core. All included the respective graphic scale references, north direction, and other relevant markings for its correct reading.
