# Vernacular Rural Architecture with Extradosed Vaults. Case Studies from the Inland Areas of Southern Italy

**Topic:** T1.4. Restoration and conservation of vernacular architecture

*This paper examines rural dwellings characterized by extradosed vaults, a vernacular architectural typology prevalent throughout the Mediterranean basin. From the Berber ghorfas to coastal residences, and from rural complexes in the Vesuvian area to the traditional structures of the Sorrentine Peninsula, this architectural form has a rich history. While often associated with coastal regions, this typology also manifests inland, as demonstrated by the municipality of Santa Maria a Vico in the Caserta hinterland. Here, many surviving examples- despite frequent alterations - retain essential original features, shedding light on a broader, often overlooked diffusion of this architectural tradition. These structures typically consist of load-bearing masonry walls made from local limestone and vaulted roofs, with the extradosed frequently visible. Arranged in south-facing rows, their layouts commonly include shared elements such as courtyards, cisterns, ovens, and rainwater harvesting systems, which are vi

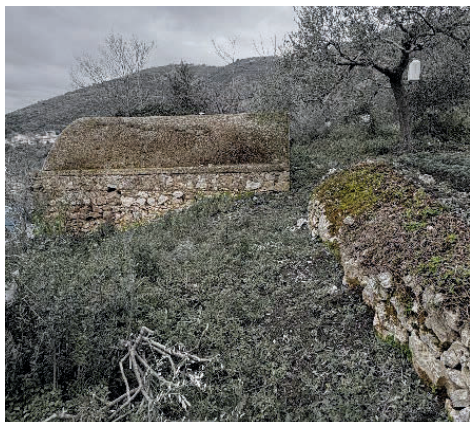
Fig. 2 – Production unit and masonry (Author, 2025).

The architectural forms that define this landscape have been constructed utilizing the residual materials resulting from land excavation, thereby integrating seamlessly into the terrain as essential retaining elements that adhere to the pre-existing hillside topography. These structures consist of homogeneous rows of independent modules, each occupying an approximate area of 30 m<sup>2</sup>. Openings within these modules are minimal, generally restricted to a single entrance door and one window, both of which are oriented toward a shared open space designed for communal activities and services, including the oven, cistern, and washhouse. Although these structures may appear uniform at first glance, a closer examination reveals several variations, largely concerning their intended use and internal spatial configuration. Consequently, two distinct clusters have been selected for in-depth analysis: one that is rural and production-oriented, and another that is residential and urban in character. The first case study focuses on a row of three interconnected units located in a non-urbanized area that has retained its original agricultural function. The contextual framework, characterized by a network of terraces, highlights the cohesion between the constructions and the surrounding landscape. This particular cluster serves as an olive and grape press (*frantoio*) and is composed of a central unit housing a stone mill, with masonry vats strategically placed at each of the four interior corners for the collection of produce. The lateral units are presumed to have been employed for supplementary functions, thus enhancing the overall utility of the cluster (Fig. 2).

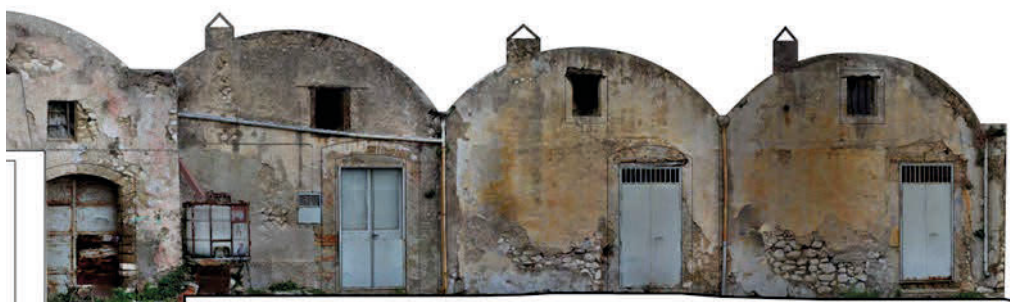
Fig. 3 – South orthophoto of the residential cluster, Via Papi (Author, 2025).

The residential typology most commonly found in the study area is the *casa a botte*, or barrel-vaulted house. The cluster analyzed is located on Papi Road and represents one of the last dwellings at the edge of the natural landscape. It comprises a row of four units, organized around a courtyard that includes a washhouse, a cistern, and a communal oven. Each unit constituted a modest, essential dwelling, characterized by a single interior space. The core of this space was the hearth, which served as the primary architectural and functional element, while small niches carved into the masonry were utilised for storing household items. Some instances of a mezzanine are present, which meet domestic and storage needs simultaneously, suggesting a rational use of space (Fig. 3).

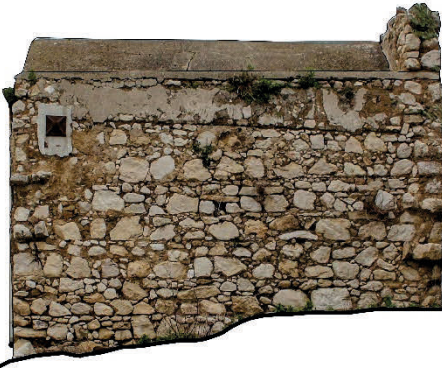
Fig. 4 – East orthophoto of the residential cluster: the masonry with periodic layers (Author, 2025).

After the excavation of the terrain and the construction of the foundations and cisterns, the building process progressed with the construction of the perimeter walls (Ruggiero & Campagnuolo, 1997). The technique utilized involved arranging the wall facings according to the method known as “periodic horizontal courses”, also referred to as the “worksite method”. The masonry was crafted out of roughly hewn limestone blocks of varying sizes, with the largest stones typically positioned at the base of each construction phase (Fig. 4) (D’Aprile, 2001).

These segments, which varied in size, were erected sequentially, and at each stage, a generous layer of mortar was applied to ensure proper settlement and bonding of the masonry.

It can be inferred from the construction technique that employs irregular worksite segments - commonly found in various buildings throughout the region - that the masonry core in question was of a compacted type. This indicates that it was constructed using a three-dimensional method, where the inner and outer facings, alongside the core, were erected simultaneously.

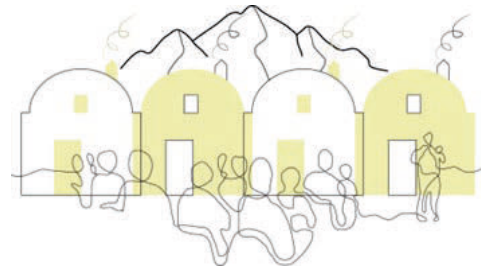
Fig. 8 – Design concept (Author, 2025).

The establishment of multifunctional spaces, achieved through the adaptation of interior environments, would facilitate the reintegration of these structures into collective use, transforming them into venues that reinforce a sense of belonging to the territory (Fig. 8).
