# The *Jaboncillo* Gypsum Plaster in the Traditional Architecture of the Northwest Region of Murcia (Spain): History, Technique and Conservation

**Topic:** T1.2. Study of traditional materials, techniques and construction crafts

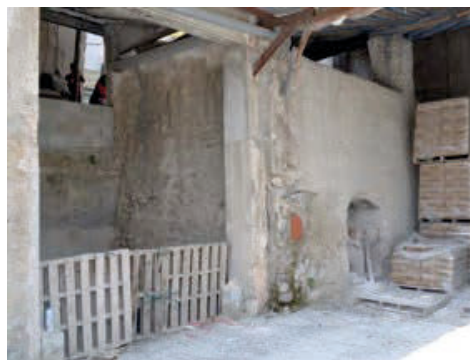
The gypsum kilns of this quarry (Fig. 2), built between 1965 and 1967, operated with a traditional system, using masonry kilns. Grinding was done manually with iron mallets or mechanical crushers. The last batch in these traditional kilns took place in the 1970s (La Spina, 2016).

Fig. 2 – Traditional ovens in Cehegín, Murcia (Grau & La Spina, 2016).

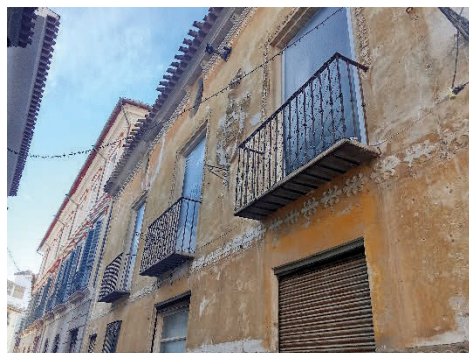
Fig. 5 – Façade of the Casa de las boticarias, Cehegin (Nezreg, 2024).

**Chromatic alteration and staining:** *Jaboncillo* gypsum can suffer chromatic alterations due to exposure to UV rays, contamination and pigment degradation, manifesting in darkening or staining due to run-off and dirt (La Spina, 2018). The Casa de las Boticarias shows variations that affect the homogeneity of the original cladding.

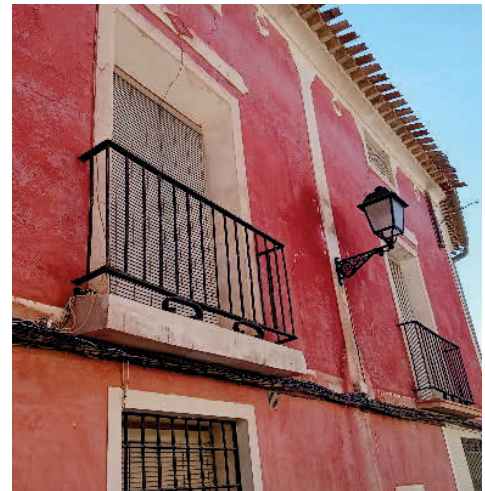
In Cuesta del Parador Street and Cuesta Moreno (Fig. 6), façades stand out with reddish-toned *jaboncillo* gypsum, derived from iron oxides or almagra. Some areas maintain their original color and texture; others show cracking and detachment, especially in zones most exposed to humidity and thermal changes.

Fig. 6 – Façade of a house with *jaboncillo*, Cuesta Moreno Street Cehegin (Nezreg, 2024).

**Detachments and loss of material:** The degradation of *jaboncillo* gypsum is due to humidity, soluble salts and thermal fluctuations, which causes the progressive loss of its surface layers, leaving the masonry exposed (La Spina, 2016). It is the case of the façades of the façades of López Chicheri and Cuesta Moreno streets, where advanced erosion and lack of maintenance have accelerated their deterioration.
