## THE ROYAL PALACE AT THE MECHOUAR CITADEL IN TLEMCCEN (ALGERIA): FROM EXCAVATION TO RECONSTRUCTION

**Keywords:** Royal Palace, Mechouar Citadel, reconstruction, architectural heritage, Tlemcen.

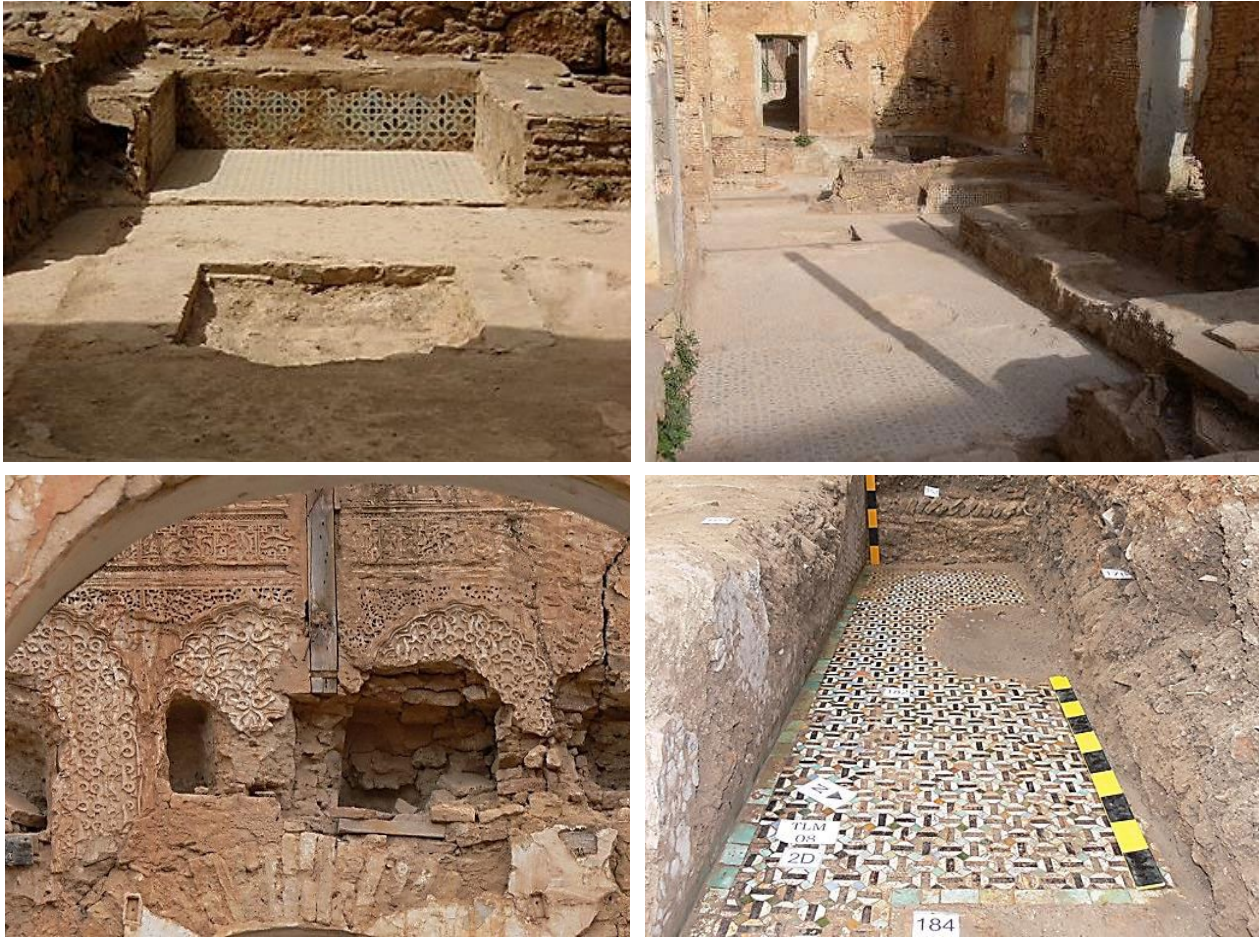
Fig. 3. Some of the architectural and decorative elements uncovered during the 2008 excavation. (Source: Preliminary Report of the Archaeological Fieldwork 2008).

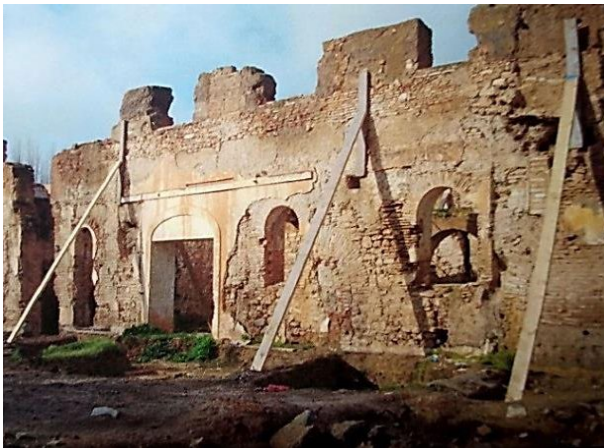
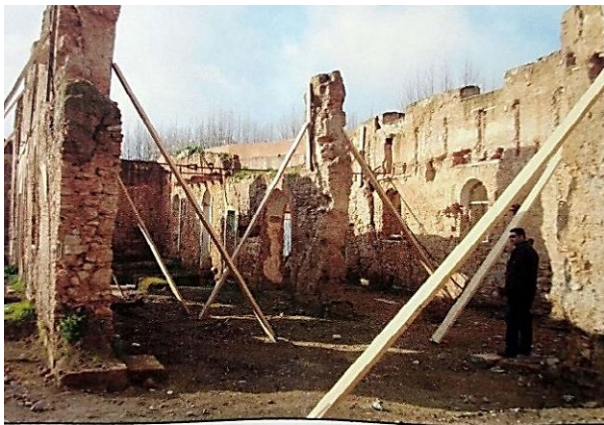
Fig. 6. Wall reinforcement process. (Source: Technical Design Office A.R.C.A.D.E. 2011).

- Removal of debris and vegetation, along with the sorting of stones.
- Installation of a perimeter fence around the site.
- Removal of reinforced concrete layers from the floors.
- Reinforcement of the walls with wooden planks to ensure their stability.
- Construction of a guardroom (Technical Design Office A.R.C.A.D.E. 2011).

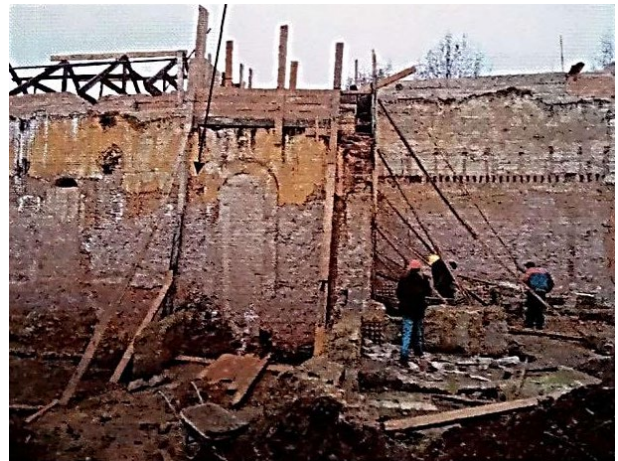
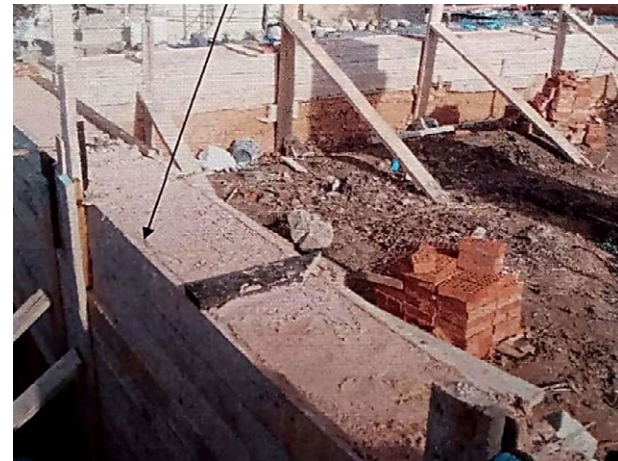
Fig. 7. Placement of formwork for wall construction. (Source: Technical Design Office A.R.C.A.D.E. 2011).

- Preparation of formwork for the construction and completion of the walls.
- Construction of the enclosure wall.

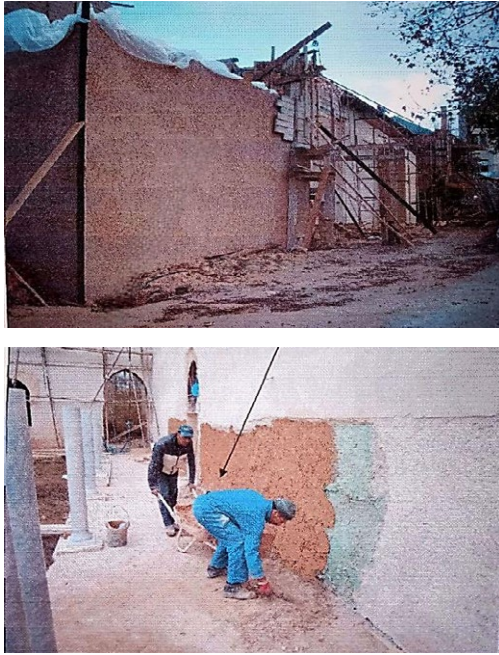
Fig. 8. Wall cladding process. (Source: Technical Design Office A.R.C.A.D.E. 2011).

- Rendering of the walls, with the installation of a nylon mesh beneath the render, followed by the application of the final finish.

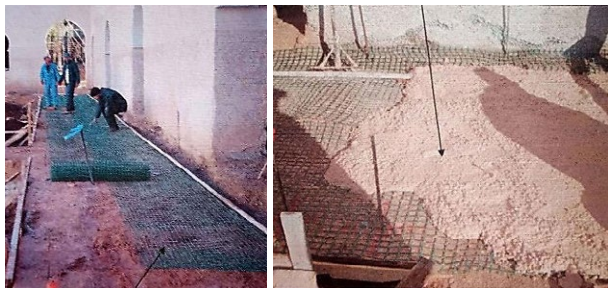
Fig.9. Floor tiling process. (Source: Technical Design Office A.R.C.A.D.E. 2011).

- Covering the floors with mortar and laying a nylon mesh, then tiling them with pieces similar to those found on site, leaving antique windows that reveal the original tiling.

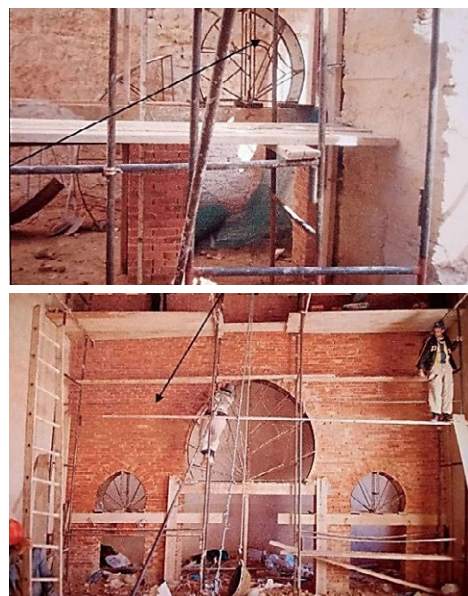
Fig.12. Construction of internal walls and brick arches. (Source: Technical Design Office A.R.C.A.D.E. 2011).

- Building interior walls with bricks and installing arch moulds at the level of the entrance openings to build the arches.

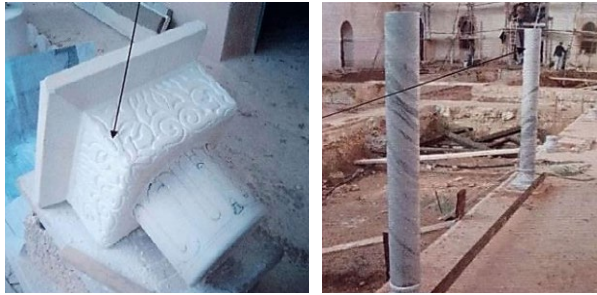
Fig.13. Installation of marble columns supporting capitals along the arcades. (Source: Technical Design Office A.R.C.A.D.E. 2011).

- Installation of marble columns and capitals at the level of the arcades.

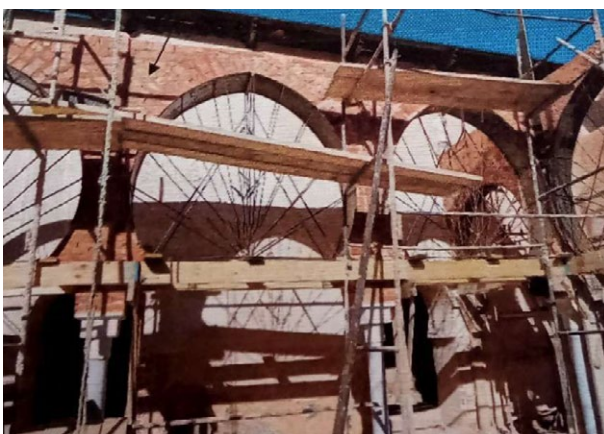
Fig.14. Construction of arches and walls along the arcades. (Source: Technical Design Office A.R.C.A.D.E. 2011).

- Fixing the contract templates above the marble columns at the level of the arcades, and then building the contracts and walls.

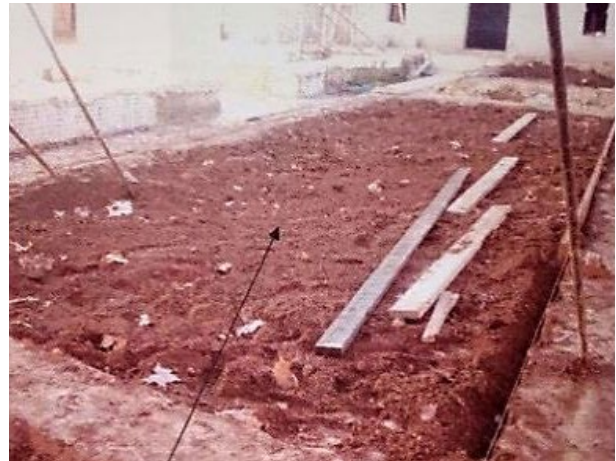
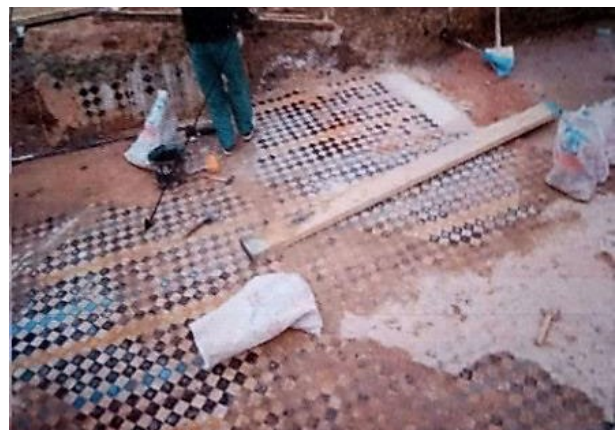
Fig.15. Paving the basin floor with *zellij* tiles. (Source: Technical Design Office A.R.C.A.D.E. 2011).

- Installation of polyethylene pipes to supply water to the basin, then covering it with soil and tiling it with pieces of *zellij*.

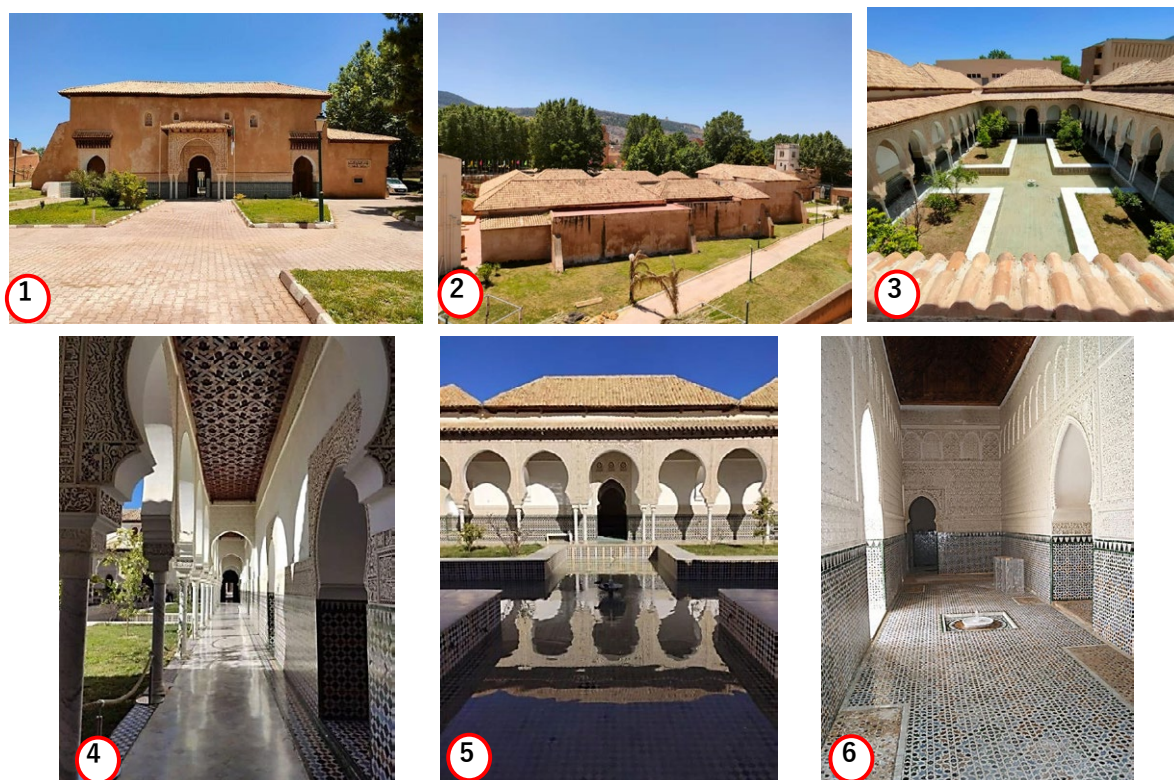
Fig.19. Current plan of the palace after reconstruction. (Source: The authors).

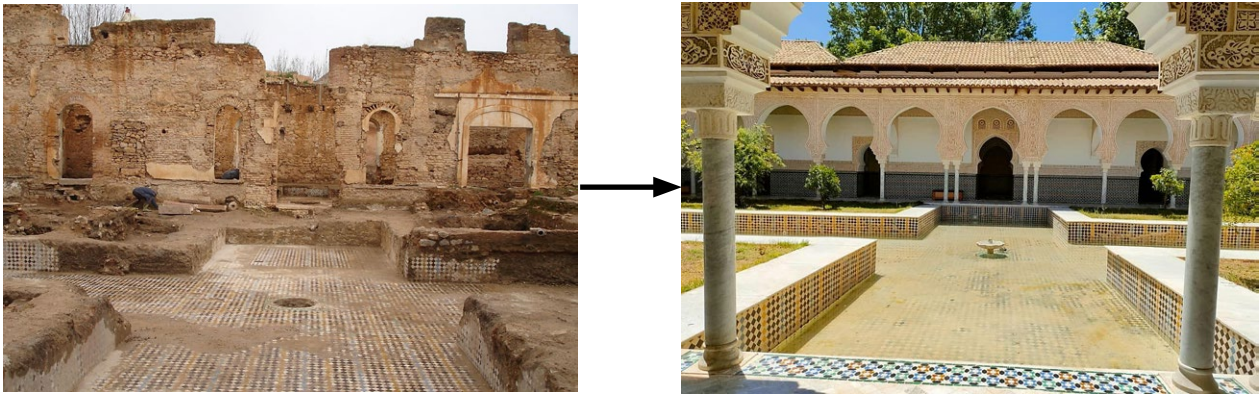
Fig.21. Southern interior façade before and after reconstruction.

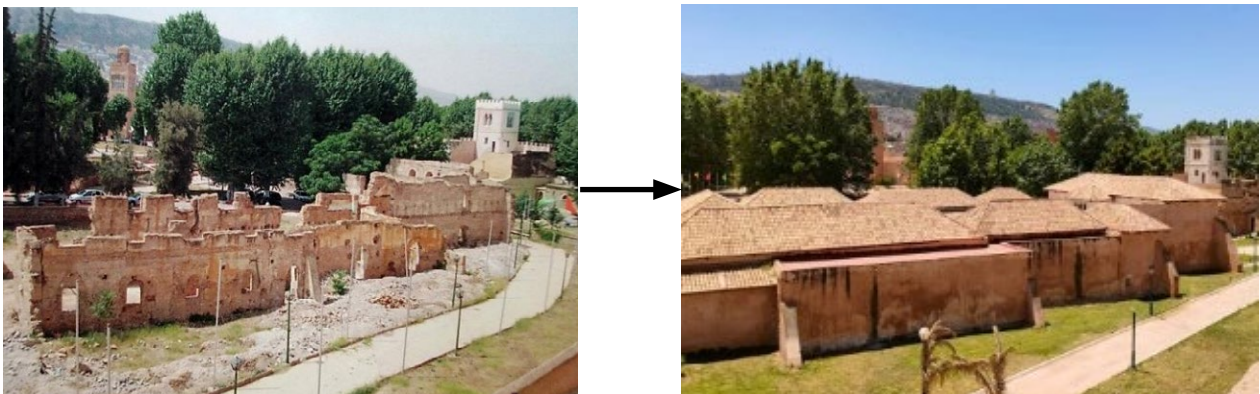
Fig.22. Northern façade before and after reconstruction.

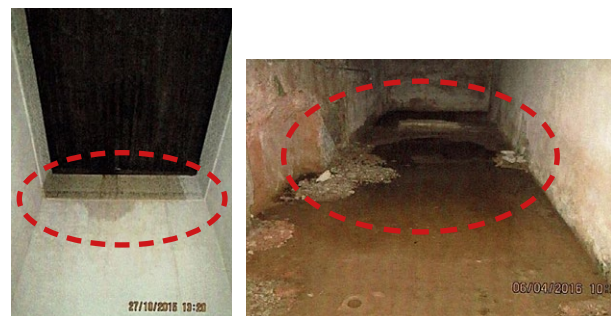
Fig. 23. Rainwater leakage through the roof and the formation of water puddles (photographs taken in 2016). (Source: Interpretation Center with a Museum-Oriented Character Dedicated to Algerian Costume and Traditions, 2018-2019).

This is evidenced by the damage affecting several parts of the building, most notably the slippage of a large number of roof tiles, in addition to the problem of rainwater drainage caused by damaged or entirely absent gutters. This situation has exacerbated the deterioration of the roof sections and led to water infiltration into the building's interior. Such problems emerged only four years after the reconstruction works, despite the fact that the roofing had been newly executed in its entirety (Interpretation Center

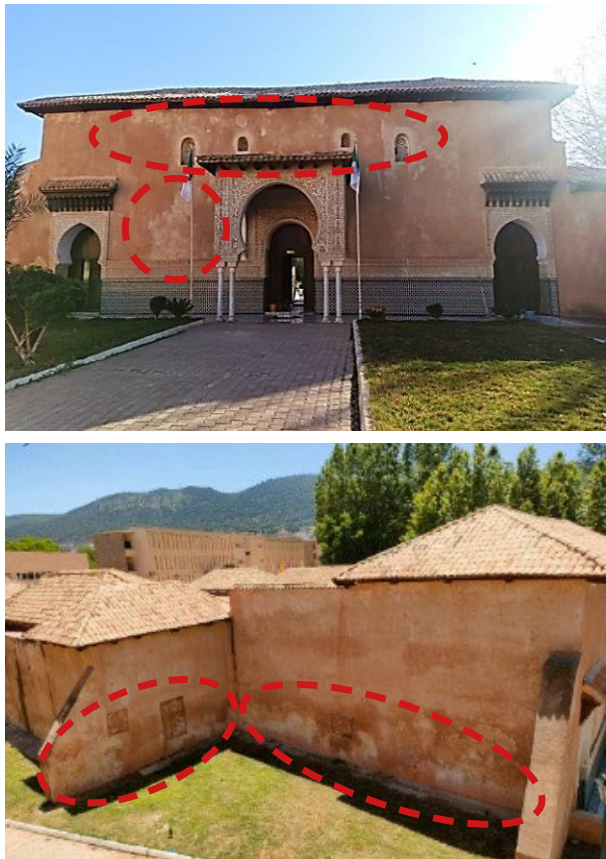
Fig. 24. Signs of disintegration and flaking of plaster and coatings on the exterior façades of the building. (Source: The authors).

Swelling, disintegration, and flaking of plaster and coatings were also observed on the building's

exterior façades, where such damage is clearly visible on the walls. Traces of moisture are likewise recorded in the lower parts of the walls as a result of capillary action, in addition to their presence on certain interior façades, particularly in the section containing the vestibule. This has led to significant deterioration of the ceramic mosaic tiles installed therein.

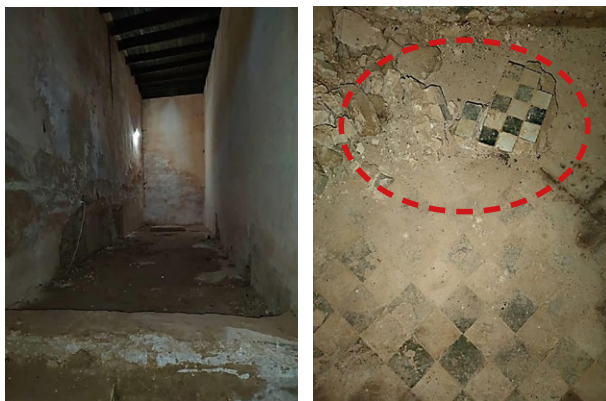
Fig. 25. Effect of moisture on the walls and deterioration of mosaic pieces in the vestibule. (Source: The authors).

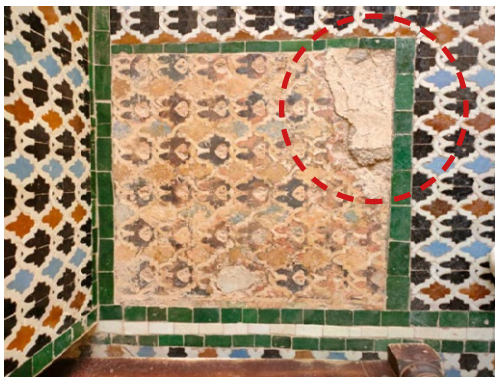
Fig.28. Deterioration of the original mosaic pieces.  
(Source: The authors).

We observed that the original mosaic pieces were directly exposed to external factors, particularly at the level of the floors, where they were subjected to direct foot traffic from visitors due to the high tourist activity inside the palace. This contributed to their deterioration, despite the fact that they represent authentic testimonies reflecting the beauty and originality of Zayanid art. It was therefore necessary to place them within protective glass frames that would help safeguard and enhance them. This was effectively implemented in 2025, when they were finally integrated into heritage display windows covered with glass, ensuring their preservation while allowing them to be presented to the public under suitable conditions.
