# Inventory and Cataloguing of Traditional Houses in the Province of Veraguas, Panama

**Topic:** T2.1. Study and cataloguing of earthen architecture

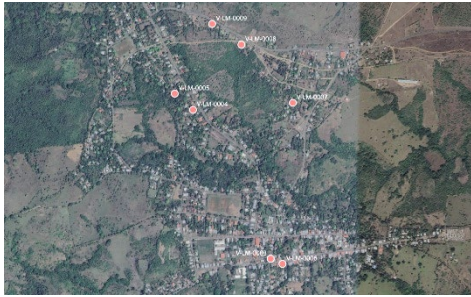
Fig. 7 – Map Enlargement 4: "La Mesa" Subdistrict (Aponte, 2022).

The La Mesa district, located in the center of the Veraguas province, included the Subdistrict of "La Mesa Cabecera", "San Bartolo", and "Bisvalle" in the study. In these areas, a total of 11 buildings were identified that met the necessary criteria to be included in the inventory, providing relevant data for the research.

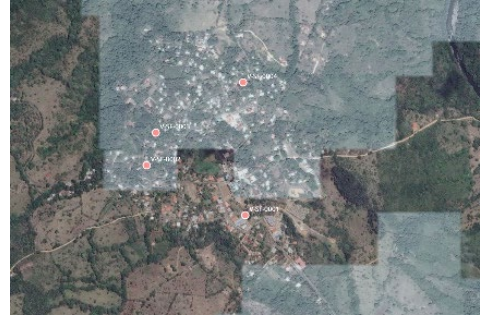
Fig. 10 – Map Enlargement 5: "Santa Fe" Subdistrict (Aponte, 2022).

In the Santa Fe district, located to the north of the Veraguas province, 4 buildings were identified that met the necessary criteria to be included in the inventory, providing relevant data for the inventory.
