## PROCESSES FOR CREATING THE HBIM MODEL OF A PROTECTED 20TH CENTURY HERITAGE BUILDING – THE ROYAL NAUTICAL CLUB OF DONOSTIA-SAN SEBASTIÁN

Josua García Moreno<sup>a</sup>, Iñigo León Cascante<sup>a,b</sup>, Maialen Sagarna Aranburu<sup>a,c</sup>

<sup>a</sup> Department of Architecture, University of the Basque Country UPV/EHU, 20018 Donostia-San Sebastian, Spain.

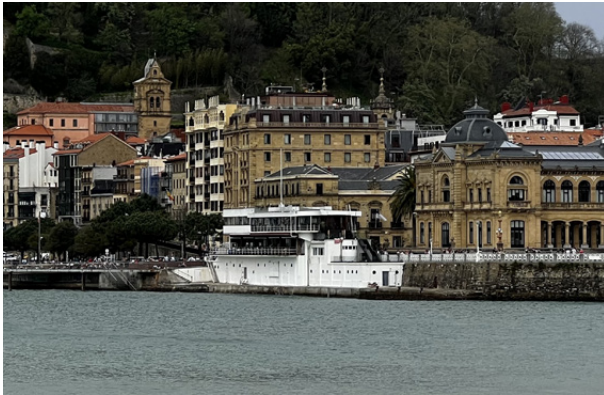
Fig. 1. RCNSS building, Donostia-San Sebastián, Gipuzkoa. (Source: own production, 2024).

and Modern Movement architecture in Spain (Urkia Etxabe, 2021:19,21), which surprisingly exists alongside the eclectic and historical architectural styles around it (Fig. 1).

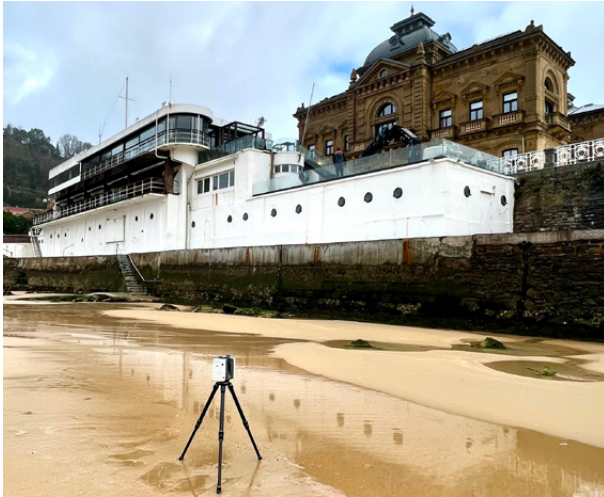
Fig. 8. Scanning process (own production).

To gather that information a laser scanning process was undertaken with 360° photos in an integrated manner using the RTC360 3D laser scanner from Leica Geosystems. The integration of both technologies enables the subsequent generation of a much more complete and accurate 3D model.

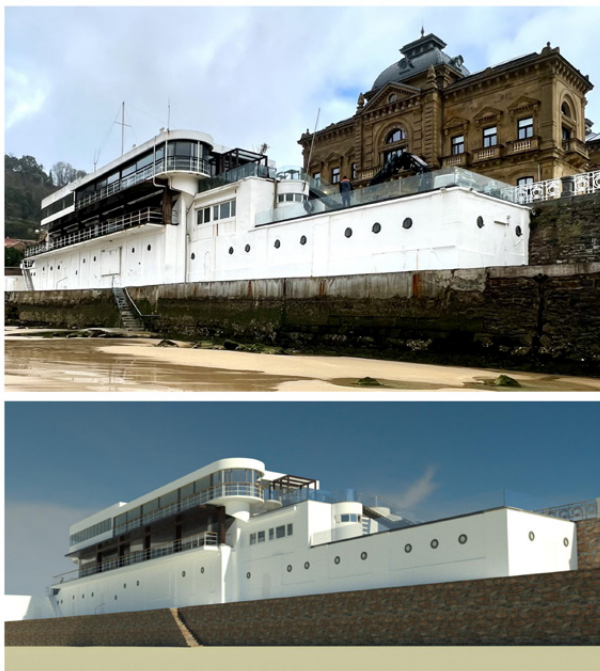
Fig. 16. Real photo during the scanning process and info-graphics generated using the HBIM model (own production).
