## Knowing Earthen Architecture in Albania: Investigating some Case Studies in Tirana and Kavaje

*This paper investigates the building techniques and related materials of some earthen constructions in Tirana and Kavaje in the framework of a scientific collaboration project between Italy and Albania. This architectural heritage is at significant risk of disappearing for many common reasons: the perception of poverty and unhealthy conditions it generates in most citizens, building speculation whereby earthen buildings are considered an obstacle to urban development, and a lack of specific laws to protect it. Furthermore, following the many earthquakes that hit Albania, the last one in 2019, the damaged earthen dwellings were replaced with fired bricks and reinforced concrete constructions. Several unprotected buildings in Kavaje and Tirana were thus studied to collect data and materials that could represent the last existing documentation. This manuscript analyses data relating to construction techniques, mineralogical and granulometric characterisation of the earthen materials constituting the bricks and mortars, and decay phenomena of the built heritage.*

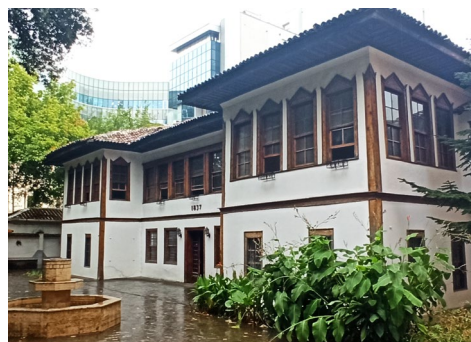
Fig. 1 – Tirana: Adem Toptani house (Rescic, 2023).

- Ottoman houses protected by the Ministry of Culture and subject to recovery and enhancement (Fig.1).
- Elegant/stately houses from the early 20th century, some of which are protected by the Ministry of Culture (Fig. 2).
- Minor architecture without significant value and therefore not listed (Fig. 3).

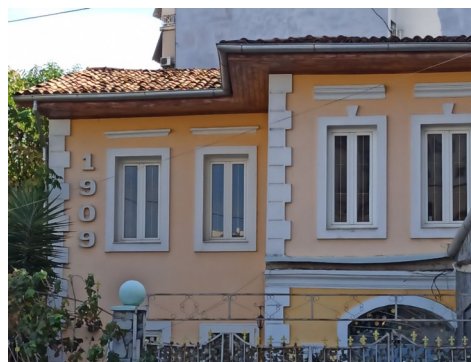
Fig. 2 – Tirana: stately home built in 1909 (Rescic, 2024).

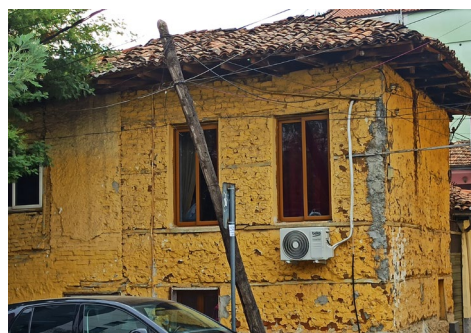
Fig. 3 – Tirana: house of no significant architectural value and therefore not protected (Rescic, 2023).

Thus, although there are various types of earthen architecture (Figs. 1-3), the project focused on houses with little architectural significance. Consequently, these houses are not included in a conservation and safeguarding program, putting them at serious risk of disappearing (Fig.3).

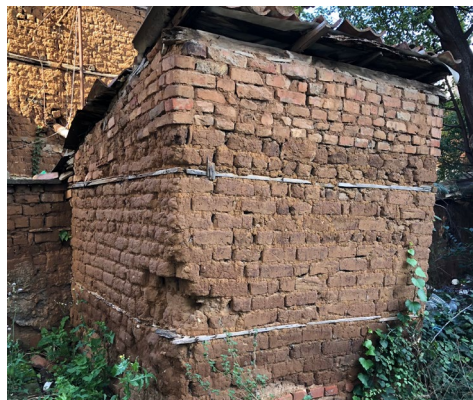
Fig. 5 – Tirana: wall made of *qerpiç* (sun-dried earthen bricks) and reinforced with horizontal wooden beams, fired bricks are present at the base and below the roof (Luvidi, 2024).

The surveyed buildings are mainly residential houses, generally one or two storeys above ground. The walls are about 50 cm thick and are characterised by a 40-50 cm high fired brick or stone foundation (Fig. 5). The building technique uses earthen bricks, known in Albanian as *qerpiç* (Dobjani & Papa, 2022), measuring approximately 20 cm x 12 cm x 10 cm and an earthen bedding mortar approximately 2 cm thick for the masonry (Fig. 5).

The plaster on the walls is often detached, leaving the earthen wall exposed to the elements (Fig. 5). In buildings that have been completely abandoned, the roof is often torn off, and the walls are missing, leaving only the remains of the perimeter wall of the house (Fig. 10). In some cases, the building has been rebuilt, maintaining the external appearance of the house but using modern materials (cement and fired bricks) (Fig. 11).

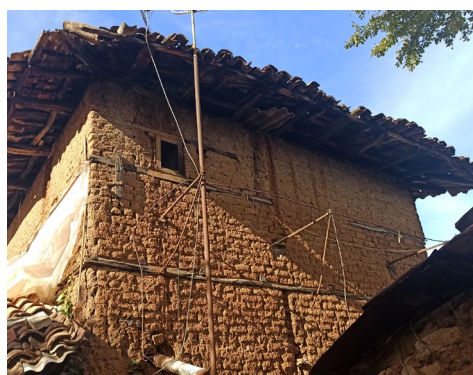
Fig. 6 – Tirana: particular of wooden battens and slightly overhanging roof (Rescic, 2024).

The earthen structures are fitted with 8-10 cm thick wooden battens to ensure greater stability in an earthquake. These are positioned horizontally along the entire length of the masonry. The battens, placed between 80 and 110 cm intervals, are made integral to the wall using minor wooden elements embedded transversely in the masonry (Fig. 6).

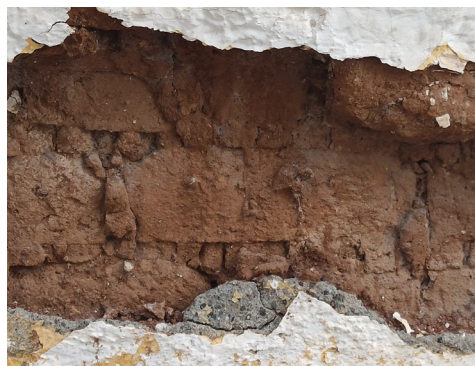
Fig. 7 – Tirana: intervention with cement mortar on *qerpiç* (Rescic, 2024).

In the town of Kavaje, buildings with less projecting roofs are probably observed for two reasons: in some cases, the earthen wall was protected with a single row of fired bricks; in other cases, which are more recent houses, the earthen wall was protected with a thick layer of cement mortar (Fig. 7).

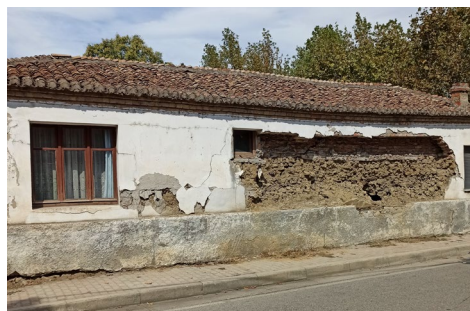
Fig. 8 – Kavaje: building after the 2019 earthquake, the collapse of the plaster shows the layer of earthen bricks and the thick layer of cement plaster; the roof does not excessively overhang (Rescic, 2023).

Interventions to cover the walls with cement mortar can be seen (Fig. 8). Sometimes, instead of the traditional wooden roof, metal sheets are used as a covering in what appears to be a hasty but later permanent intervention (Fig. 9).

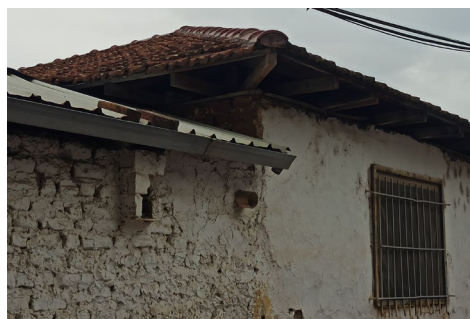
Fig. 9 – Tirana: sheet metal roofing and concrete beams in the attic (Rescic, 2024).

This construction technique makes it difficult to identify earthen buildings without a collapse. The 2019 earthquake in Kavaje brought many earth structures back to light. Other examples of interventions not compatible with the earthen building technique can be seen in Fig. 9, where the roof is sometimes supported on the raw wall by reinforced concrete beams.

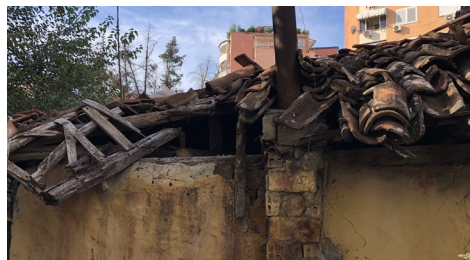
Fig. 10 – Tirana: building where roof is torn off (Luvidi, 2024).

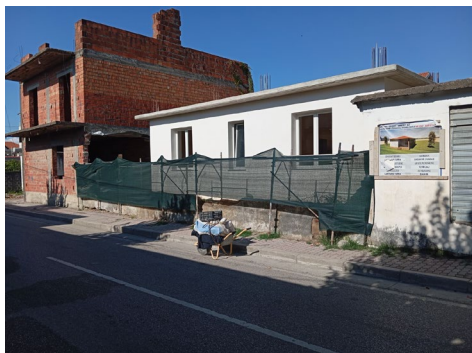
Fig. 11- Kavaje: building completely rebuilt in baked bricks and concrete after the effects of the 2019 earthquake in Fig. 6 (Çapeli, 2024).
