# Conservation and Sustainability of an Earth Architectural Heritage located in the Historic Center of Lima (Peru): House Museum, Challenges and Opportunities

**Topic:** T2.5. Energy efficiency and sustainable design projects

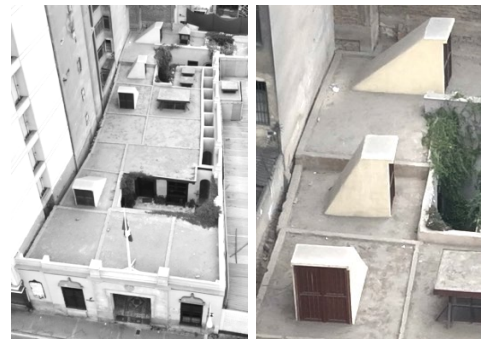
Fig. 1 – Aerial photography and Teatinas on the roof (Díaz, 2024).

Another architectural element of relevance in the Museo Casa de la Cultura Criolla are the teatinas, zenithal components that were used as vertical windows placed on the roof of the rooms, which were mostly made of wood (Fig. 2). This element has been extensively studied by Wieser, who affirms that the teatinas were systematically used in the buildings of the city of Lima from the middle of the 18th century until the end of the 19th century. These architectural devices served mainly for ventilation and natural lighting. In the

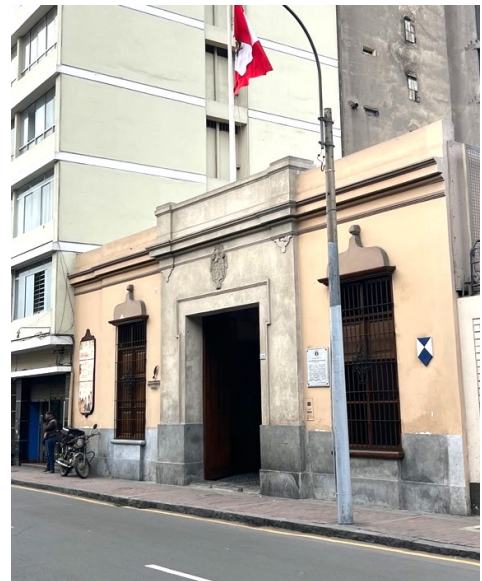
Fig. 2 – Facade of the study building (Díaz, 2024).

The case study building, known as the “Casa de la Cultura Criolla Rosa Mercedes Ayarza” (Fig. 2), is located in the original layout of the foundation of Lima, in an expansion area known as the “damero” of Pizarro. Despite the absence of direct historical sources about the building,

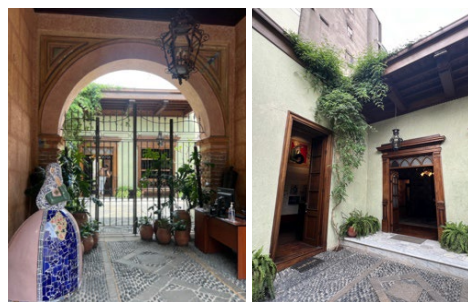
*Fig. 4 – Photograph of Zaguan and patio (Díaz, 2023).*

The House Museum has a spatial organization typical of vice regal houses, with a hallway (zaguan), two courtyards (patios) connected by a side corridor and rooms distributed around these courtyards (Fig. 4), which favors circulation and ventilation. Currently, several rooms house thematic exhibitions aimed at explaining the history of the building and its link to musical culture.

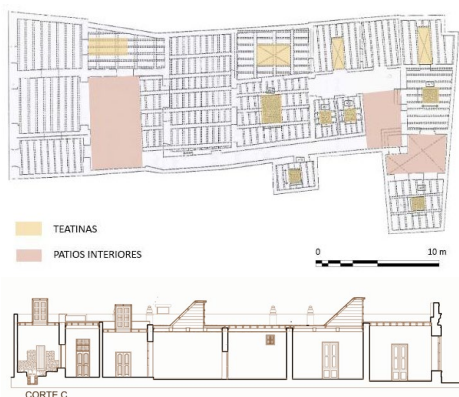
Fig. 6 – Floor plan and Teatinas Casa de la Cultura Criolla (PROLIMA Documentary Archive 2022).

In addition to its representative value, this element reinforces its spatial functionality due to the presence of the Teatinas integrated into the roof (Fig. 6), which provides improvements in terms of ventilation and natural lighting to the interior spaces.
