# Compatibility between Sustainability and Conservation in Earthen Architecture: Initial Analysis of Restoration Interventions and Contemporary Applications in Spain

**Topic:** T2.4. Restoration and conservation of earthen architecture

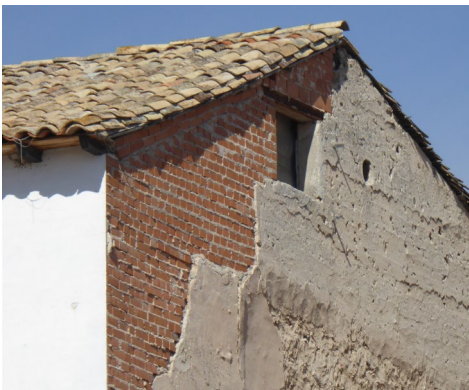
Fig. 3 – Rammed earth wall intervened with industrial brick (Vegas & Mileto, 2016).

techniques which can be used to build these walls (Table 4), rammed earth is the technique with most frequent interventions (51.2%), followed by adobe (24.8%) and heavyweight half-timbered walls (14.7%). In general, spontaneous interventions predominate although planned interventions are slightly more frequent in adobe walls and considerably less so in rammed earth walls (Fig. 3). In terms of technical and material compatibility there is a predominance of different techniques and industrial materials. However, adobe and half-timbered walls often undergo interventions with similar techniques incorporating industrial materials such as industrial brick.

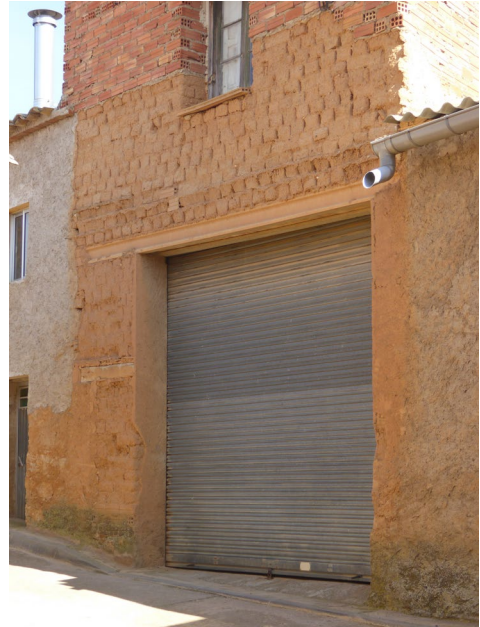
Fig. 4 – Adobe wall where the entrance has been enlarged (Vegas & Mileto, 2016).

Openings are the second most frequent element (24.9%, Table 1) requiring intervention, probably to improve energy efficiency. Although it is often impossible to identify the type of lintel, there is a high percentage of interventions in squared lintels (31.3%, Table 5). As in the rest of constructive elements, there is a clear predominance of spontaneous interventions, with different techniques and industrial materials. In this regard, the replacement of joinery with PVC or aluminium doors and windows, as well as the expansion of openings in entrances to buildings (Fig. 4) and the installation of unsuitable elements such as blinds and railings are of particular note.
