Flexural behaviour of composite slim floor beams

T. Sheehan^{a*}, X. Dai^a, J. Yang^a, K. Zhou^a and D. Lam^a

^aUniversity of Bradford, United Kingdom

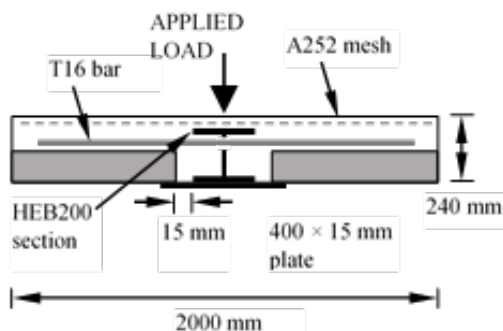
The six beams tested were named BT1a, BT3, BT4, BT6, BT7 and BT8. Fig. 1 shows a cross-section view of BT1a. This was the basic test-specimen type, comprising a 240 mm deep concrete slab (upper portion 120 mm deep), encasing a HEB200 beam section, with a 400 × 15 mm steel plate welded to the underside. Shear connection between the materials was provided by 1400 mm long steel bars passing through a 40 mm diameter hole in the steel beam web. These were placed at 500 mm spacing, designed to provide a degree of shear connection equal to 40%. A252 mesh was employed near the top of the concrete slab to prevent failure of the concrete under hogging moment. The beam spanned 6 m between the two supports and was loaded at two points along the length, each at the centre of the cross-section and at a distance of 2.25 m from the end supports, as depicted in Fig. 2. Specimen BT3 was the same as BT1a, except that it utilised a greater number of transverse bars to provide a degree of shear connection equal to 100 %. Conversely, BT4 had the same configuration, but with fewer bars, to provide 25% shear connection. BT6 had no shear connectors and load was applied eccentrically, BT7 had horizontal shear studs welded onto the beam web instead of transverse bars, BT8 had larger holes in the beam web (80 mm diameter).

Fig. 1. Cross-section view of typical specimen

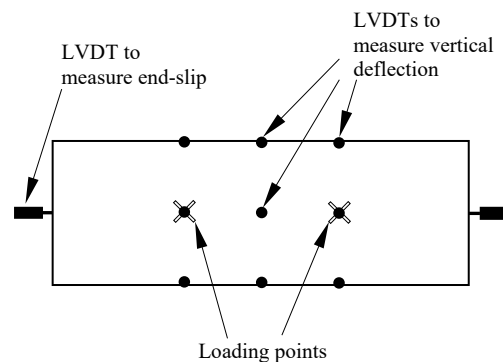
Strain gauges and LVDTs were used to monitor the strains and deflections at different locations along the specimen. Nine LVDTs were used to measure the vertical deflection of the beam under applied loading. One of these was placed directly under each of the loading points and another LVDT was placed halfway between these two, at the mid-span. Six LVDTs were positioned at the edges of the slab, three on each side, in line with the ones in the centre. An additional two LVDTs were used at the specimen ends to measure the slip between the concrete slab and steel section. The positions of the LVDTs are shown in a plan view in Fig. 3.

Fig. 3. Position of LVDTs on beam

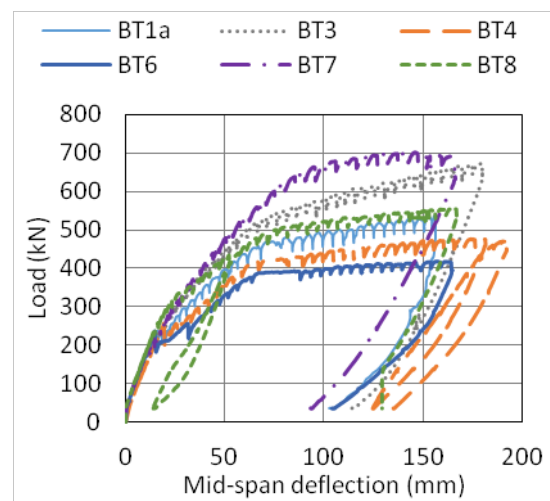
Overall, the six specimens exhibited fairly similar behaviour during the test. The relationship between load and mid-span deflection, shown in Fig. 4, was initially fairly stiff and linear. At around 200 – 250 kN, depending on the specimen, some initial cracks occurred. A drop in load was noticed in specimens BT1a, BT3, BT4 and BT6, which was more pronounced in BT4 than in the other cases. As the applied load increased the stiffness suddenly reduced, to approximately half of the original stiffness in some cases. As the load was increased further, the mid-span deflection continued to increase, along with the crack widths. During the final phase of the test, the stiffness reduced further, as the load reached a plateau, and the test was continued for each of the four specimens until they could withstand no further load. BT4 was unloaded and reloaded again at the end of the test, but a higher load could not be attained upon reloading. BT8 was unloaded and reloaded at an earlier stage of the test owing to an issue with the loading set-up, but this did not appear to affect the load-deflection relationship and curve continued smoothly upon reloading.

As described in the previous section, the load was applied in increments, and as can be seen in Fig. 4, the load tended to drop towards the end of each increment, reaching a minimum value before the next load increment was applied. Using the lower bound curve passing through these minimum points, the maximum applied load and corresponding bending moment (load/2 × 2.25m) can be found, and these are presented for each test specimen in Table 1. As expected, BT6 had the lowest failure load, with higher loads resisted by the specimens designed for higher degrees of shear connection. The larger web holes in BT8 enabled it to resist an extra 36 kN compared with BT1a. The only surprising outcome was the maximum load resisted by specimen BT7, with shear studs instead of transverse bars. The maximum load surpassed that of BT1a by over 33%. In the previous shear beam tests, no significant difference was noticed in terms of maximum load between the specimens using transverse bars and the specimens using studs. Comparing the other test specimens with the previous shear beam series, specimen BT1a resisted a total bending moment of 565 kN·m, which is slightly higher than that resisted by the equivalent specimen SBT2 (529 kN·m) in the previous shear beam tests. BT6 and BT8 also resisted larger moments (455 kN·m and 605 kN·m) than the equivalent shear beams SBT3 and SBT5 (407 kN·m and 575 kN·m). It should be noted that the failure modes of the tests were slightly different, with shear failure dominating the previous test series, while flexural failure was prevalent in the current series.

Fig. 4 Relationship between load and mid-span deflection

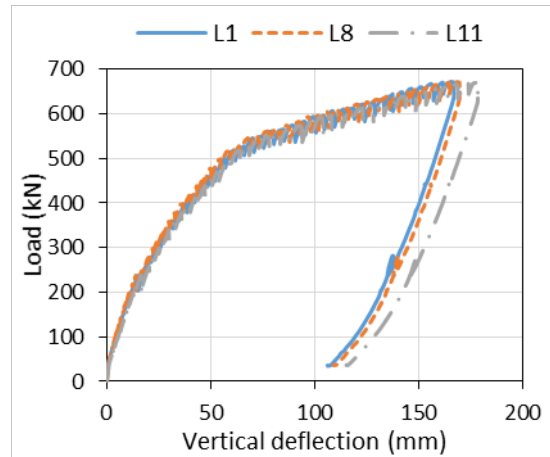
A comparison between the deflections at the centre (L1) and edges (L8 and L11) of the slab at a loading point (750 mm from the mid-span) are shown in Fig. 5 for specimen BT3 and between the centre (L2) and the edges (L7 and L10) at the mid-span for BT7 are shown in Fig. 6.

Fig. 5. Relationship between load and deflection at loading point for BT3

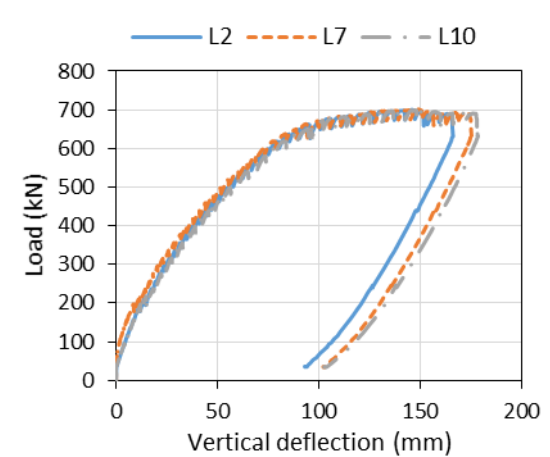
Fig. 6. Relationship between load and deflection at mid-span for BT7

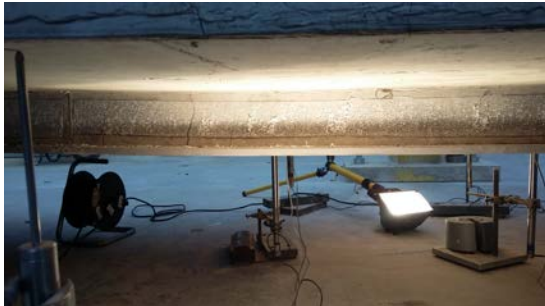
During the initial phase of the test there were no obvious cracks in the concrete. The first cracks became visible during the second phase, which commenced at around 200 – 300 kN for each specimen. Very small vertical cracks were observed in the concrete around the web of the steel beam, as shown for BT7 in Fig 7. During the second phase of the test, these grew in size, and cracks also appeared on the outer edge of the slab, as shown Fig. 8. During the final phase of the test, the cracks became very wide, deep cracks ran along the underside of the slab, connecting the cracks that occurred around the web to the cracks on the outer edge. Longitudinal cracks were also observed on the top of the slab. Comparing the crack pattern with the previous shear beam tests, some small differences were observed. For the shear beam

Fig. 7. Concrete cracks around beam web for BT7

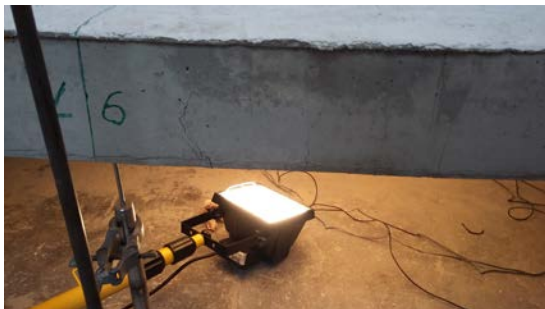
Fig. 8. Concrete cracks on outside edge of lab for BT7

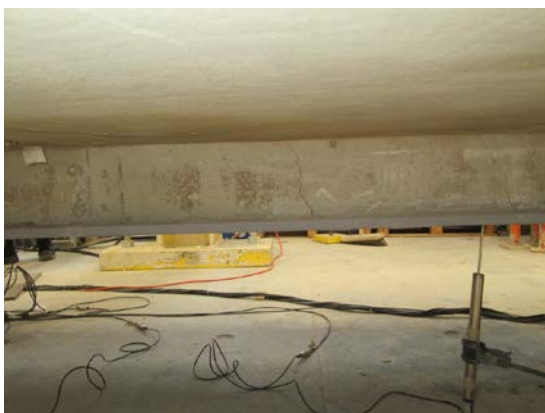
tests, the specimens initially failed in shear, with diagonal cracks occurring close to the loading points, and flexural cracks that were vertical and closer to the mid-span only occurred much later in the test. The shear cracks are shown for SBT1a in Fig. 9. For the bending tests, there was a more even distribution of cracks along the specimen length, showing that the failure was predominantly a flexural failure. This is illustrated for SBT1a.

Fig. 9. Shear cracks in SBT1a from previous test series.

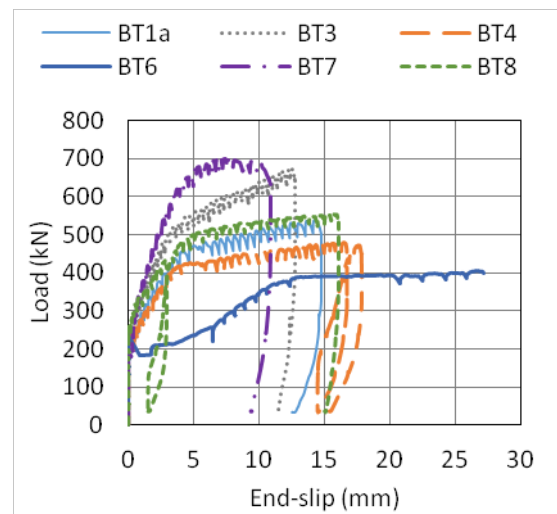
Fig. 10 presents the relationship between load and end-slip for each of the test specimens. In all cases, the degree of end-slip was very low during the initial phase of the test, and then increased rapidly during the second and third phases. With the exception of specimen BT6, in most cases, the maximum end-slip was between 10 and 20 mm, and similar values were measured at each end. These values were significantly larger than the 6 mm value of slippage stipulated by Eurocode 4 for ductile shear connector behaviour [4].

Fig. 10. Relationship between load and end-slip

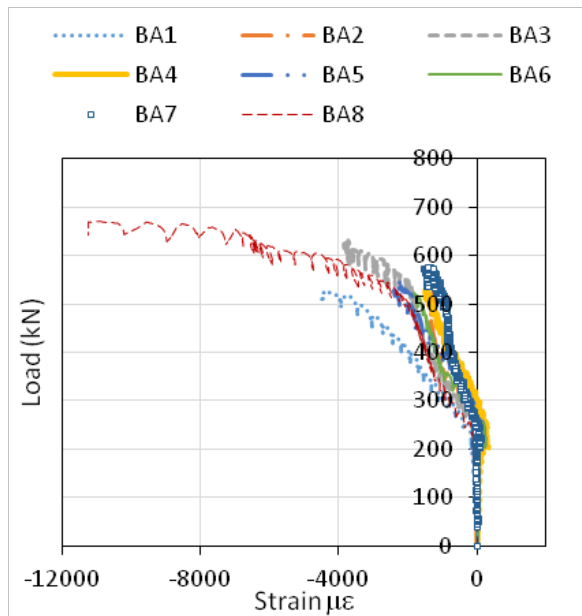
The shear connectors comprised the transverse steel bars and the concrete dowel that surrounded each bar where it passed through the HEB web hole. As the concrete slab began to move relative to the steel beam, the steel bars and the concrete dowel resisted this shearing action and transferred the longitudinal stresses to the steel beam, maintaining composite action between the two components. In specimens

BT1a, BT3, BT4 and BT8, most of the shear connector bars had very low strains during the initial phase of the test, which increased rapidly during the second phase showing that they had been ‘activated’ in transferring stresses between the concrete and steel, as the movement between the components caused the bars to deform. In specimen BT3, the strains were predominantly compressive, whereas for BT8 these were tensile. Both tensile and compressive strains were measured in the bars in BT1a and BT4. Fig. 12 presents the strains measured in the shear connectors for BT3, where positive values indicate tension and negative values indicate compression. The largest strains occurred in the bars, closest to the ends of the beam (BA1 and BA8).

Fig. 12. Strains in shear connectors for BT3

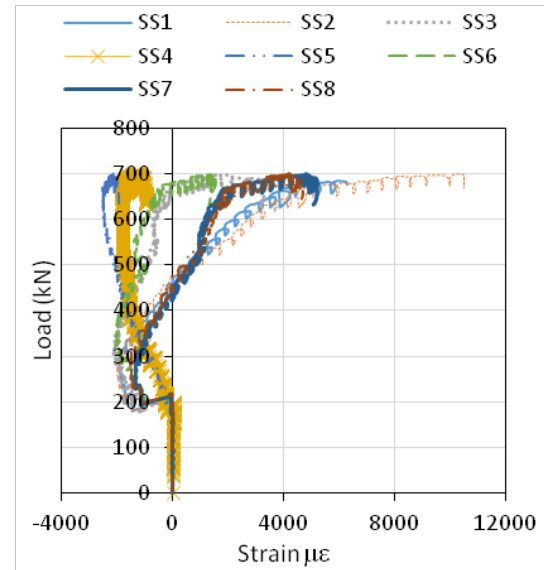
In specimen BT7, the shear studs initially exhibited very low strains, which rapidly increased in compression during the second phase of the test, reaching between $-1000\mu\epsilon$ and $-2000\mu\epsilon$. As the load increased further, this trend was reversed and the strains became increasingly tensile during the later stages of the test. During the initial phase of the test, all shear studs exhibited similar strains but in the later stages, the two studs closest each end (SS1, SS2, SS7 and SS8) underwent the largest tensile strains. This is shown in Fig. 13.

Fig. 13. Strains measured in shear studs
