Ancient masonry arches and vaults strengthened with TRM, SRG and FRP composites: Experimental evaluation

# Ancient masonry arches and vaults strengthened with TRM, SRG and FRP composites: Experimental evaluation

## Abstract

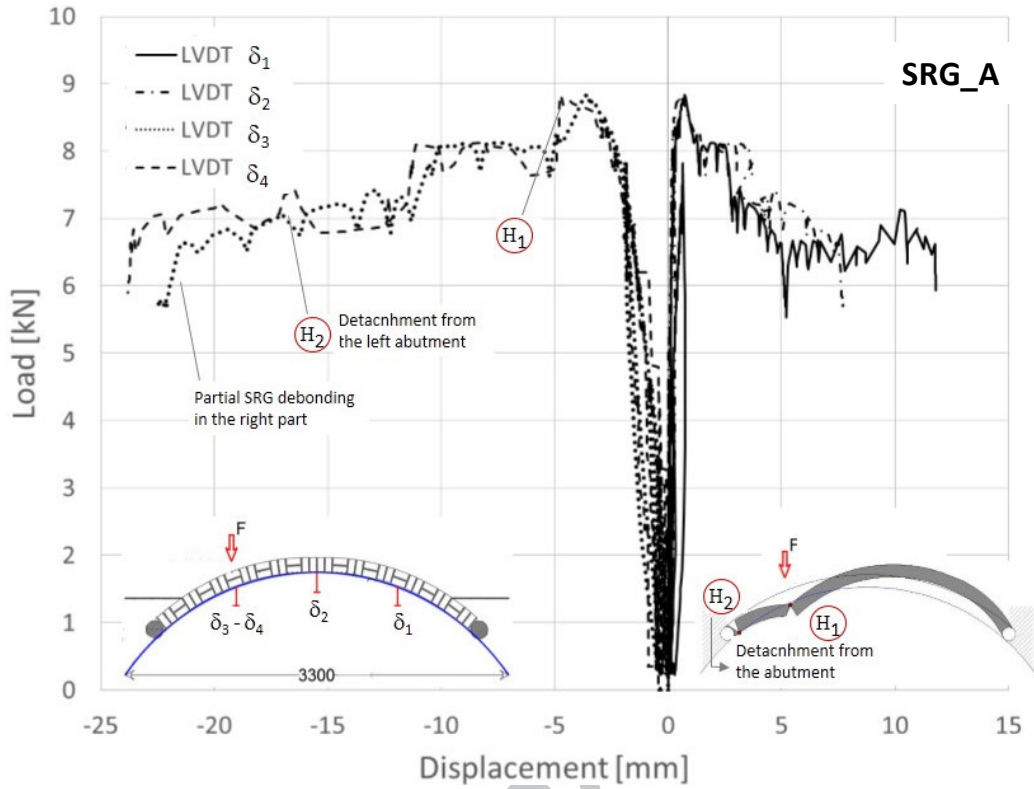
Figure 12: Load-displacement behavior, SRG\_A.

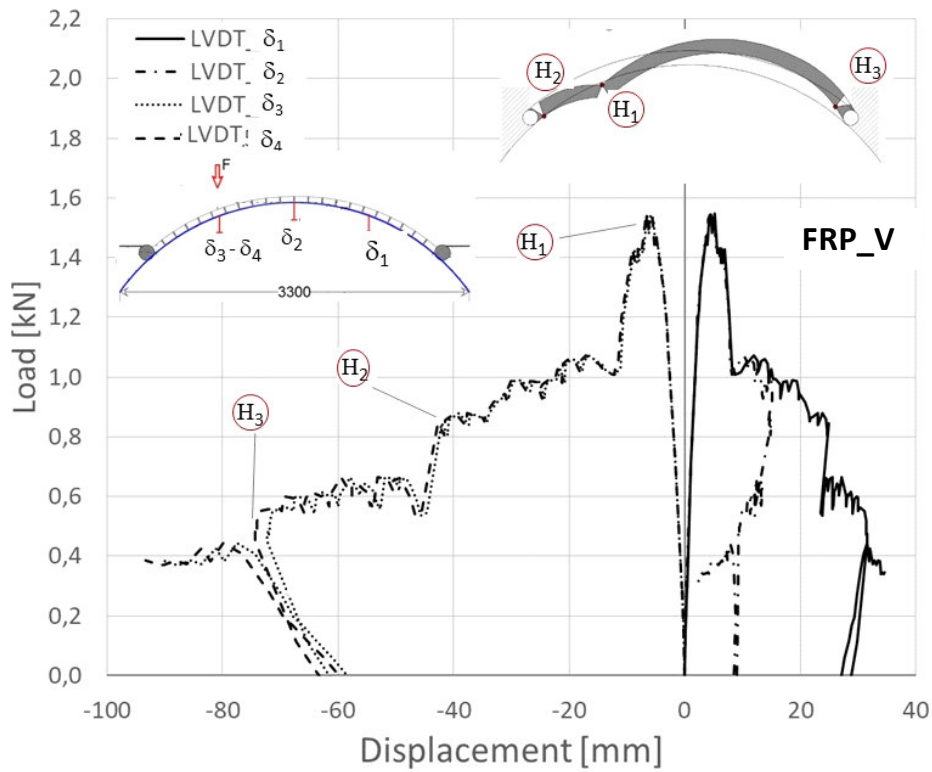
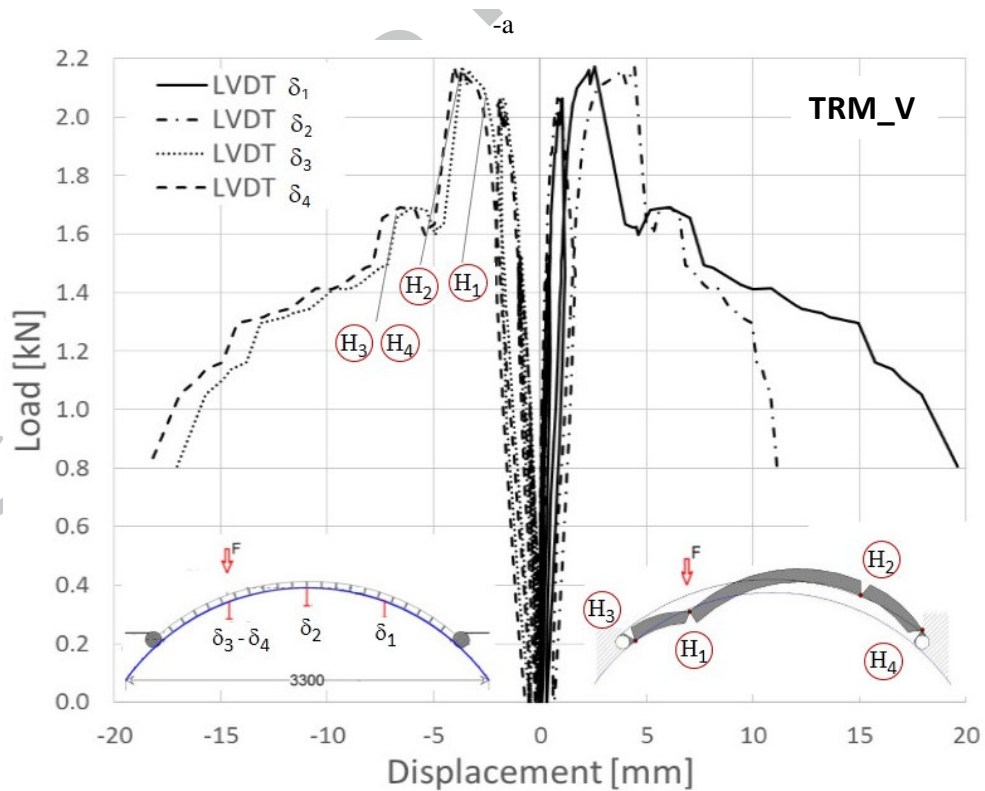
Figure 16 - Load-displacement behavior: a- FRP\_V, b- TRM\_V

The test performed on TRM\_V was characterized by four loading-unloading cycles. The first two cycles were performed in the elastic phase and no relevant residual displacements were measured (the maximum residual displacement after the second unload was equal to 0.22 mm). The first hinge appeared in correspondence to the applied load, at a load approximately equal to 1.8 kN. Then, a new unloading-loading cycle was applied and the maximum residual displacement observed was equal to 0.65 mm. The last load phase exhibited a lower stiffness equal to 451 N/mm. At a load equal to 2.1 kN the second hinge appeared at the extrados at about  $\frac{3}{4}$  of the total span ( $\alpha=106^\circ$ ), and the reinforced mortar cracked. After a drop in the load, the test continued with a relevant increment in the vertical displacement. The structure collapsed for the formation of other two hinges at the abutments. The glass textile collapse in correspondence of the second hinge due to slippage phenomena and tensile rupture of the external filaments of the yarns (see Figure 19).

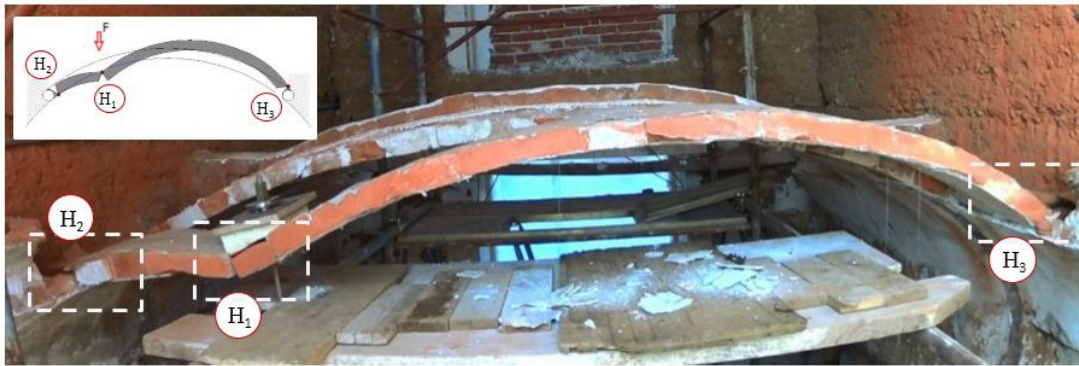
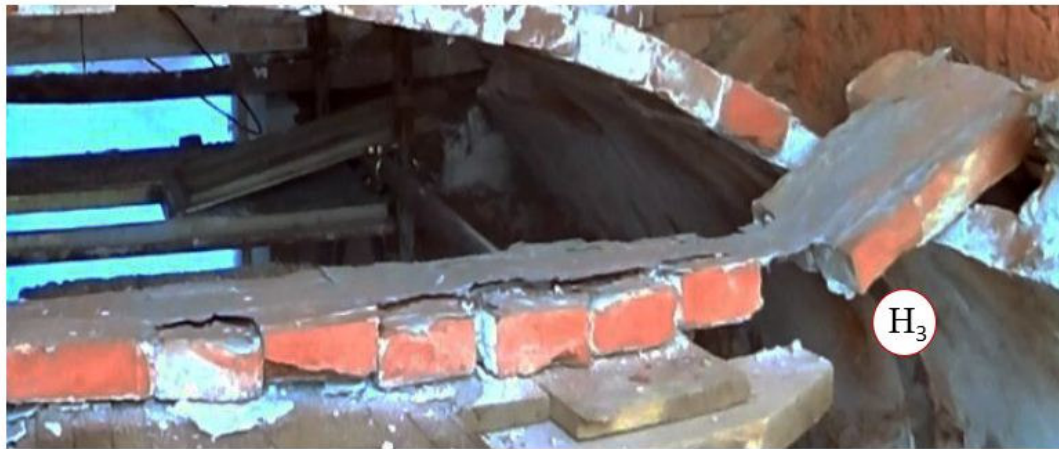
Figure 18: Failure mode for FRP\_V –a: Appearance of the first and second hinges. –b: FRP debonding.

The failure mode was characterized by the formation of a first hinge in correspondence to the applied concentrate load, that corresponds to the drop in the load carrying capacity. The FRP prevented the appearance of the hinge at the extrados at the opposite quarter of the span. The second hinge appeared at the left abutment with a complete detachment. The test continued with an increment of the displacement up to the collapse that was caused by the detachment from the right abutment and the debonding of the FRP reinforcement in the right part of the vault.

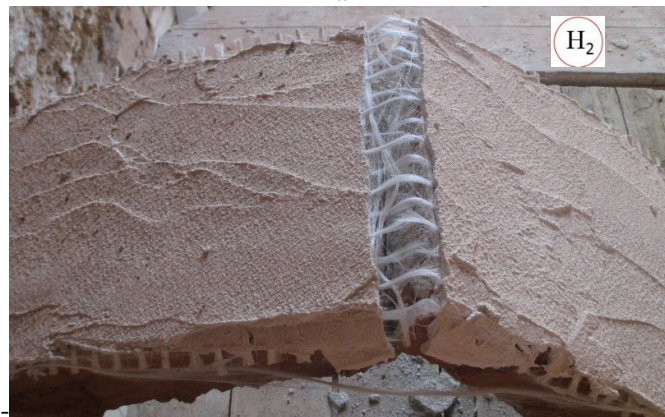
Figure 19: Failure mode of TRM\_V. –a: hinges appearance. –b: TRM collapse.

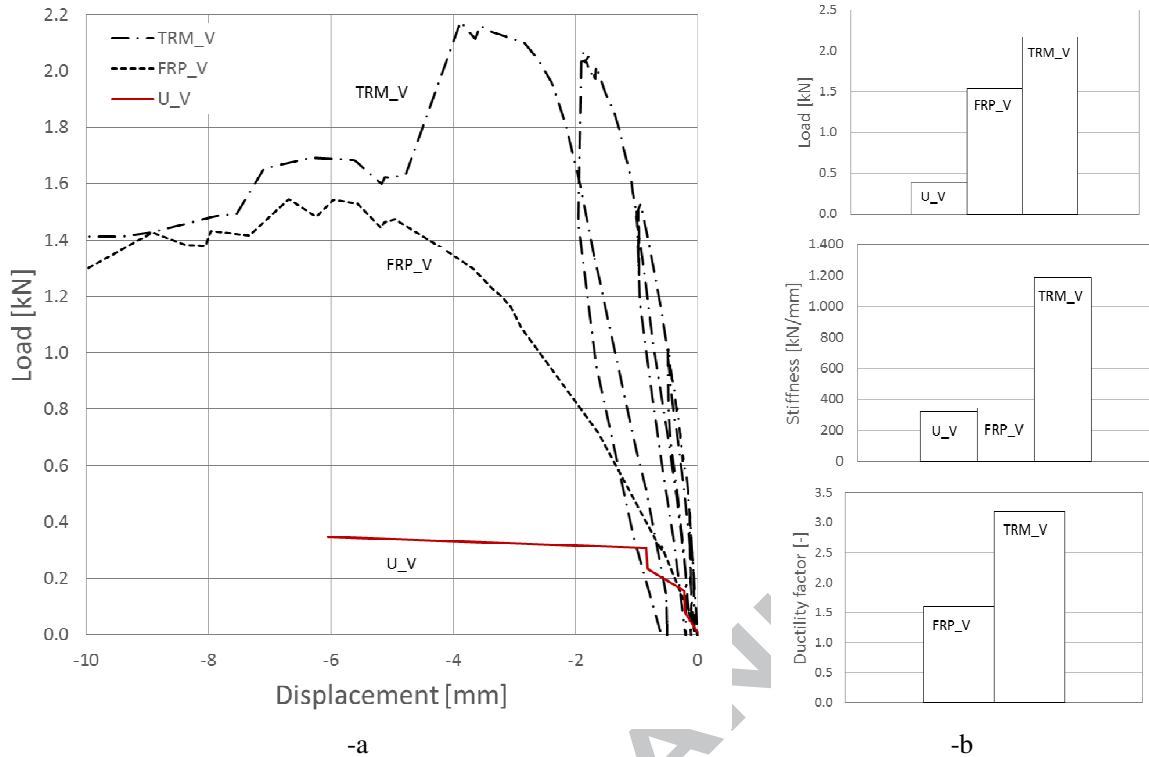
Figure 20: Comparison between unreinforced (U\_V) and reinforced (FRP\_V and TRM\_V) vaults. -a: Load-displacement curves. -b: Load, stiffness and ductility comparison.

In Figure 20 a concise comparison among the experimental results obtained for the unreinforced and reinforced barrel vaults (i.e. U\_V, FRP\_V, TRM\_V) is reported. The peak load reached was increased by 4 times using FRP reinforcements and by 5.5 times reinforcing with TRM. The TRM system presents a better behavior also in terms of ductility, that was equal to 1.6 for FRP\_V and 3.2 for TRM\_V. On the opposite, the application of the TRM resulted into a relevant increment in the stiffness of the structure.

Also the maximum load reached in the tests on the vaults increased significantly. The peak load reached was increased by 4 times reinforcing with FRP and by 5.5 times reinforcing with TRM. The TRM system presents a better behavior also in terms of ductility, that was equal to 1.6 for FRP\_V and 3.2 for TRM\_V. On the opposite, the application of the TRM resulted into a relevant increment in the stiffness of the structure. The FRP systems modified the typical failure mode, because FRP prevented the appearance of the second hinge at the extrados at the third quarter of the span. The second hinge appeared at the left abutment and the collapse was caused by the detachment from the right abutment.
