FINAL PROJECT HISTORICAL, CONSTRUCTIVE AND PATHOLOGICAL ANALYSIS OF MODERNIST BUILDINGS IN SZCZECIN

AUTHORS OF PROJECT:
JORGE SENDRA SENDRA
CLARA SAIS GIRONÉS

4.3 Problems in the building

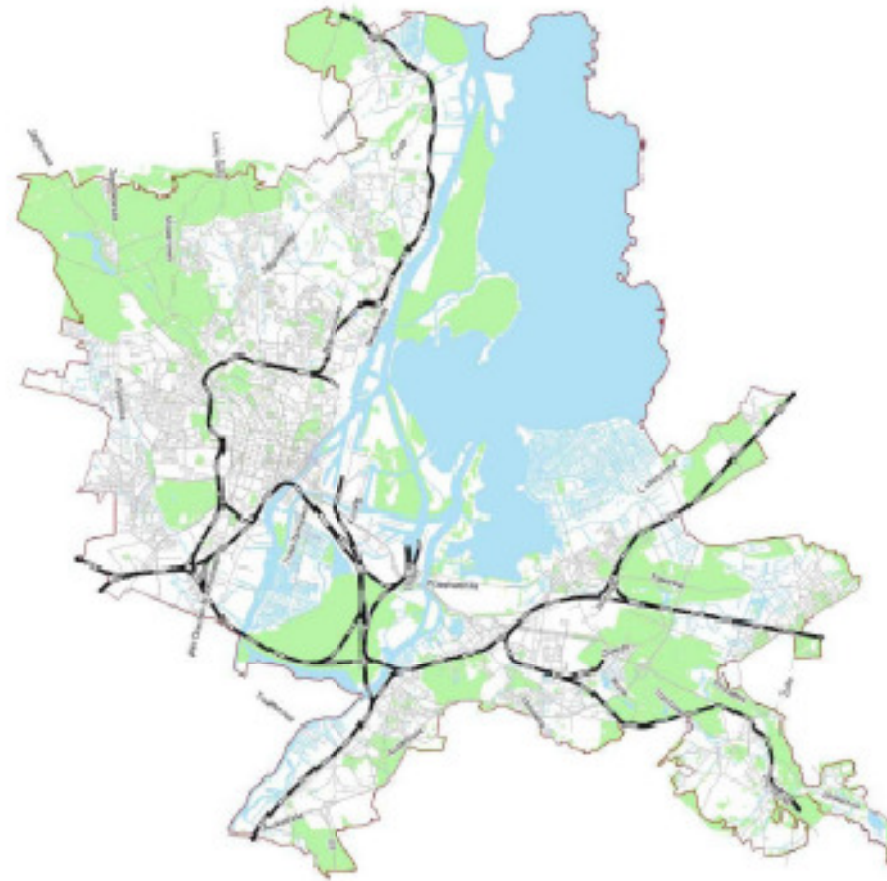
Railroads lines

In this plain there are indicated the railroad lines that cross the area of the city of Szczecin. The lines of the **north** communicate with the cities of the north like Police, and with the industrial areas of the area. The lines of the **west** connect with the German cities, especially with his capital, Berlin While the lines of the **east** communicate with the rest of Polish cities.

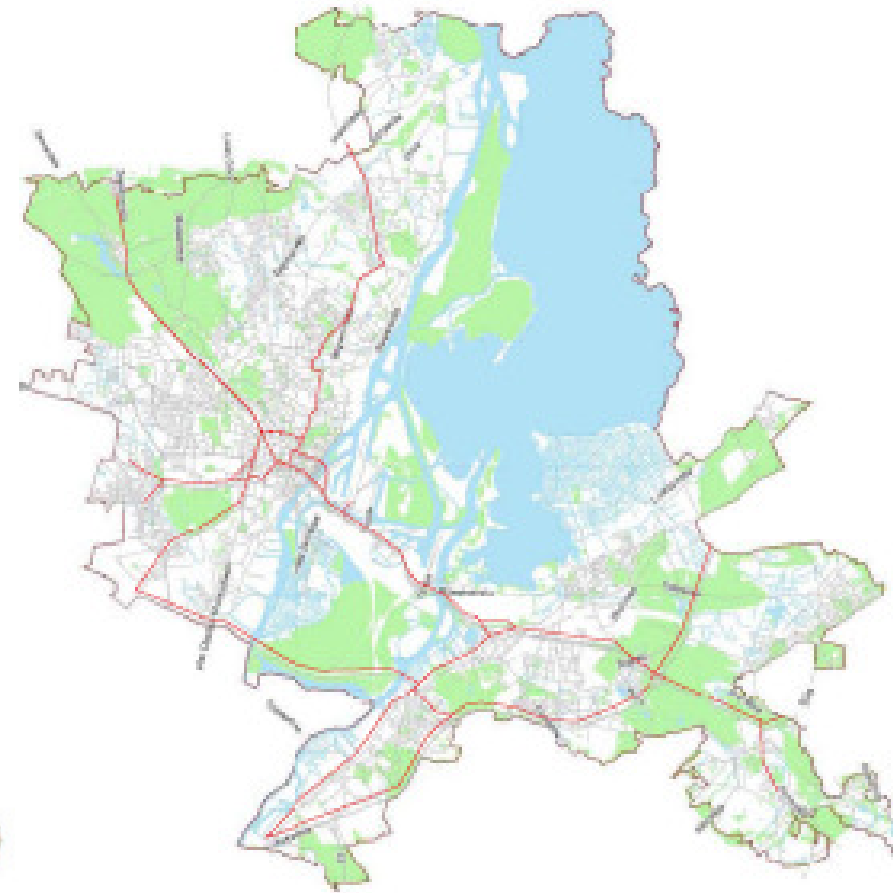
Highways and main streets

In this plain are indicated the principal accesses by highway. To the **north** with Police and the coast, on the **west** with Berlin and to the **southeast** with the rest of Poland. It is necessary to emphasize the step of the **freeway A-6**.

Also the principal arteries of the city are indicated.

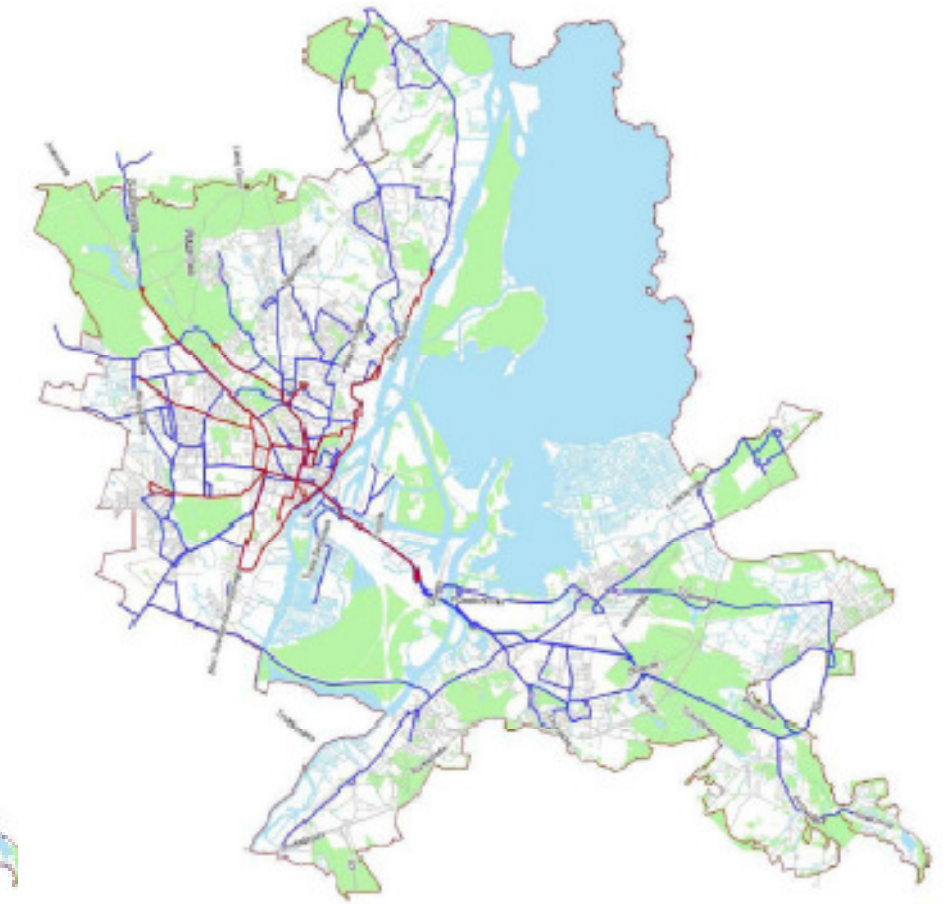
Public transport network

In this plane there is indicated the network of public transport of the city.

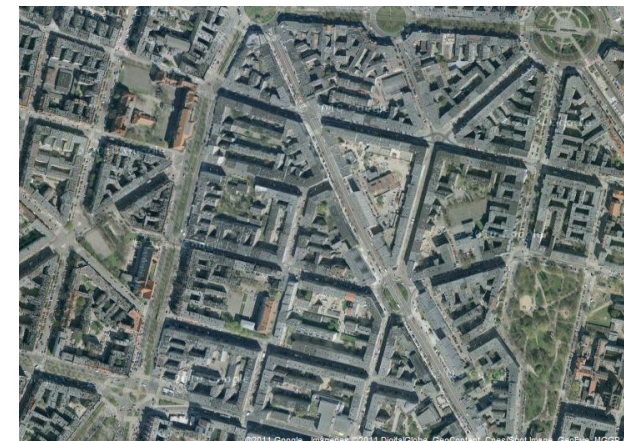
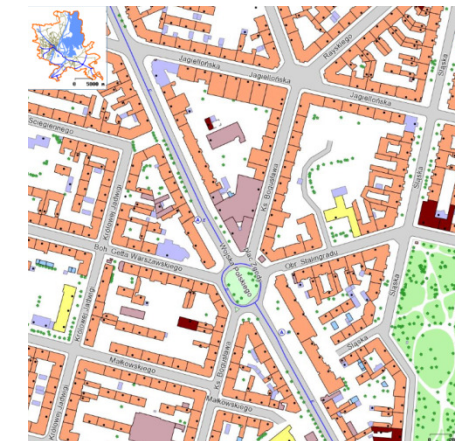
ENLARGEMENT ZONE

In this area we find a urban variable of residential type of closed apple. This typology is the most predominant in the central area of the city, as we can observe in the plan of urban arrangement enclosure. The buildings are in general of 4 plants high more garret and they present a homogeneous total height that ranges between height of 18 and 20 meters.

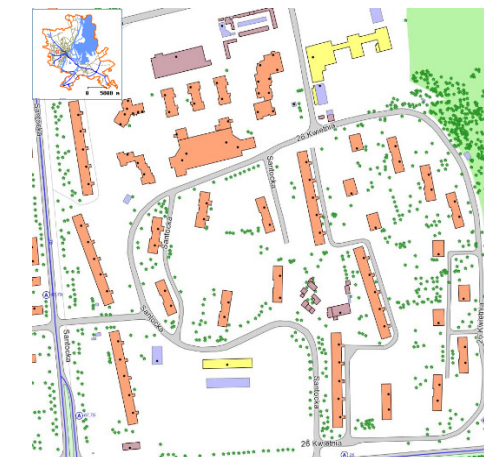
OPEN BUILDING ZONE

We find this type of building in more peripheral areas of the city. It presents a urban variable of the multiple residential type of exempt blocks.

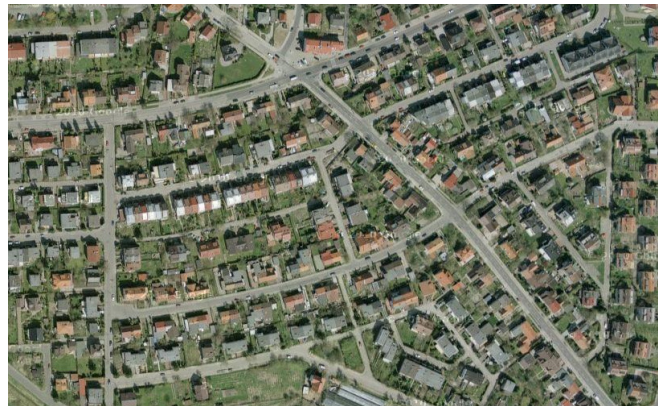
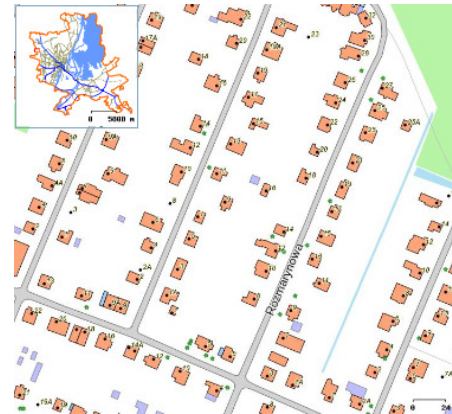
ISOLATED HOUSES ZONE

It belongs to the urban variable of residential unitarily of exempt blocks. As we observe in the general plan, this type of area is located in the periphery of the city, and the small downtowns that surrounds Szczecin. In general there are buildings of 2 plants high more garret, with an total height that ranges between the 10 and 12 meters.

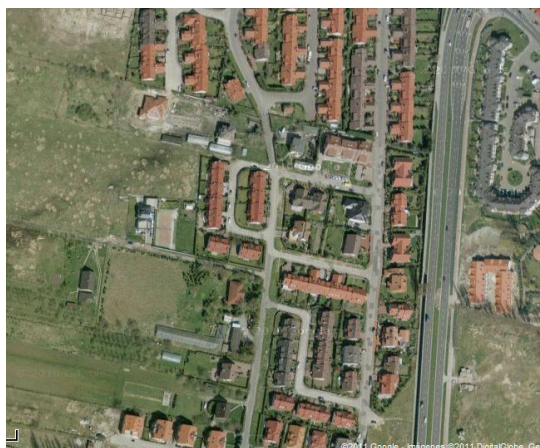
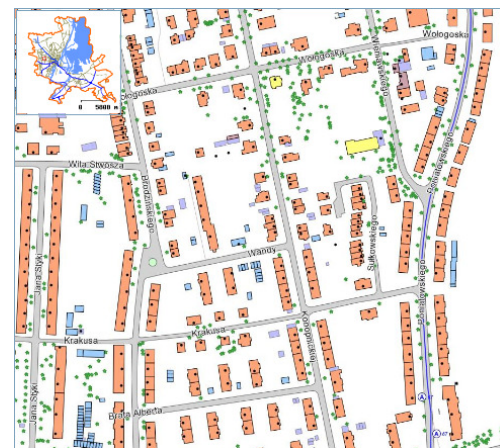
ATACHED HOUSES ZONE

This area presents the urban variable of residential unitarily of attached blocks. As the area of isolated housings, we find this type of area in the periphery of the city, where the residential use is predominant. The houses usually have two heights more garret and the total height ranges between the 10 and 12 meters.

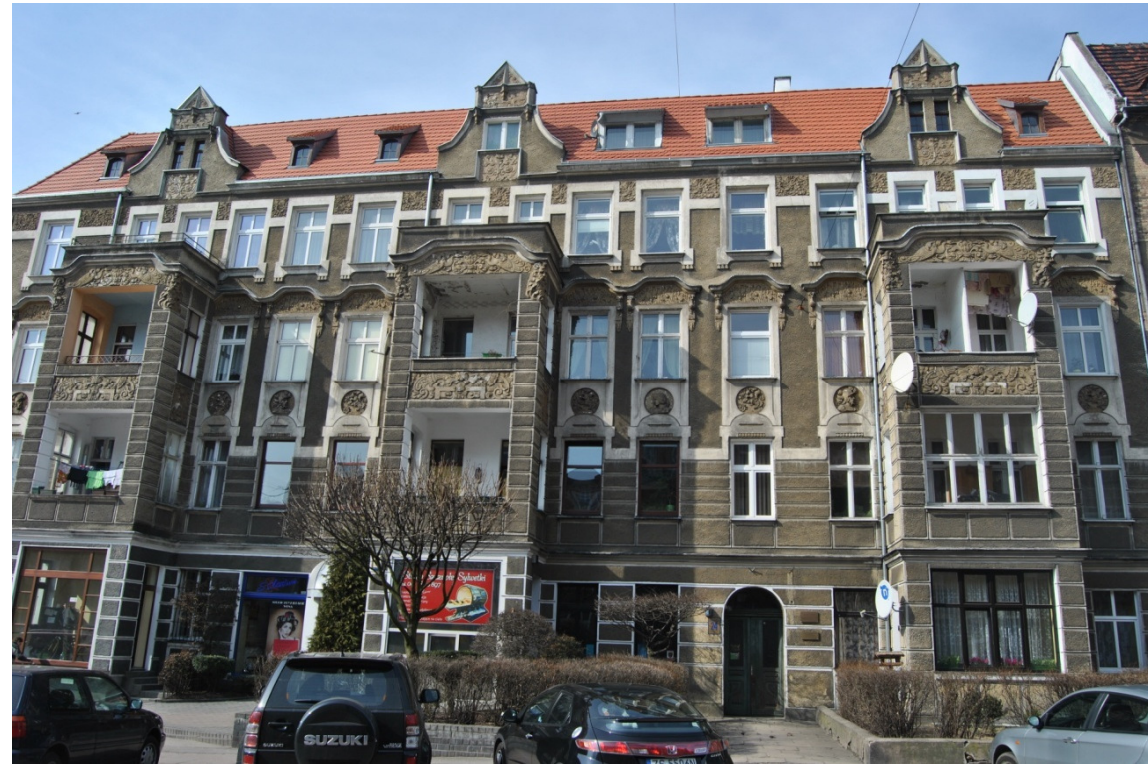
Facade C/ Bolesława Smialego

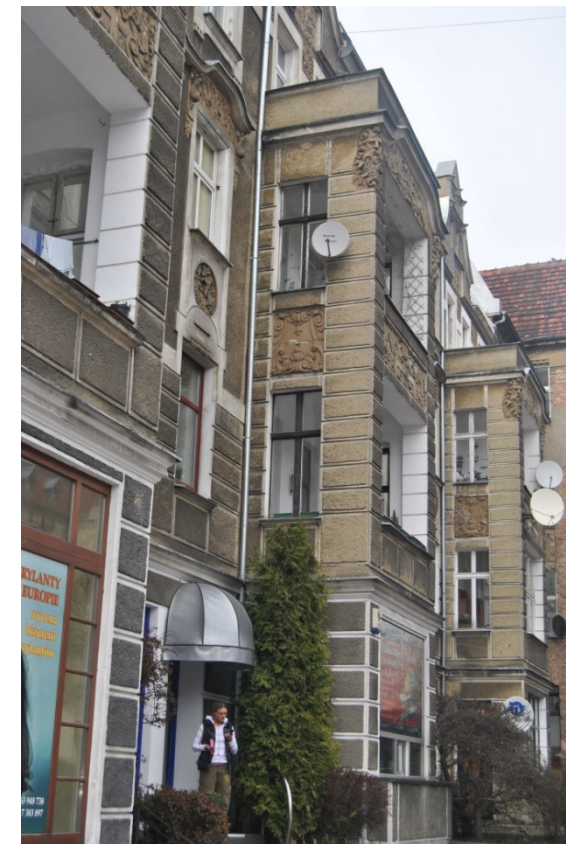
Profile c/Bolesława Smialego

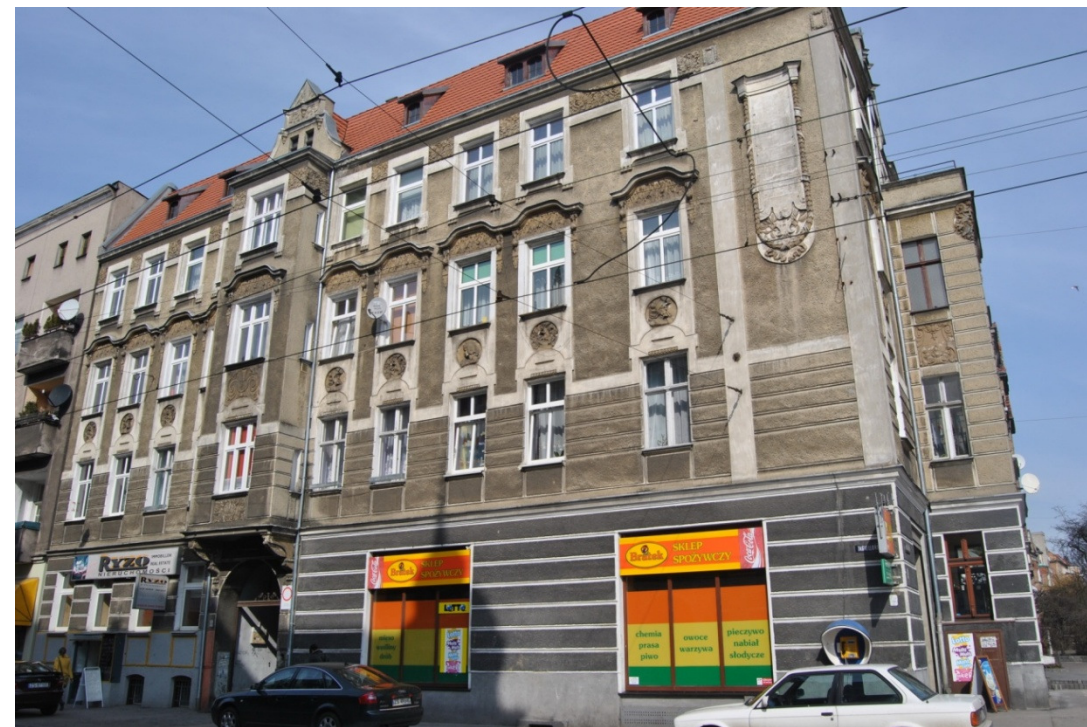
Facade C/ Jagiellonska

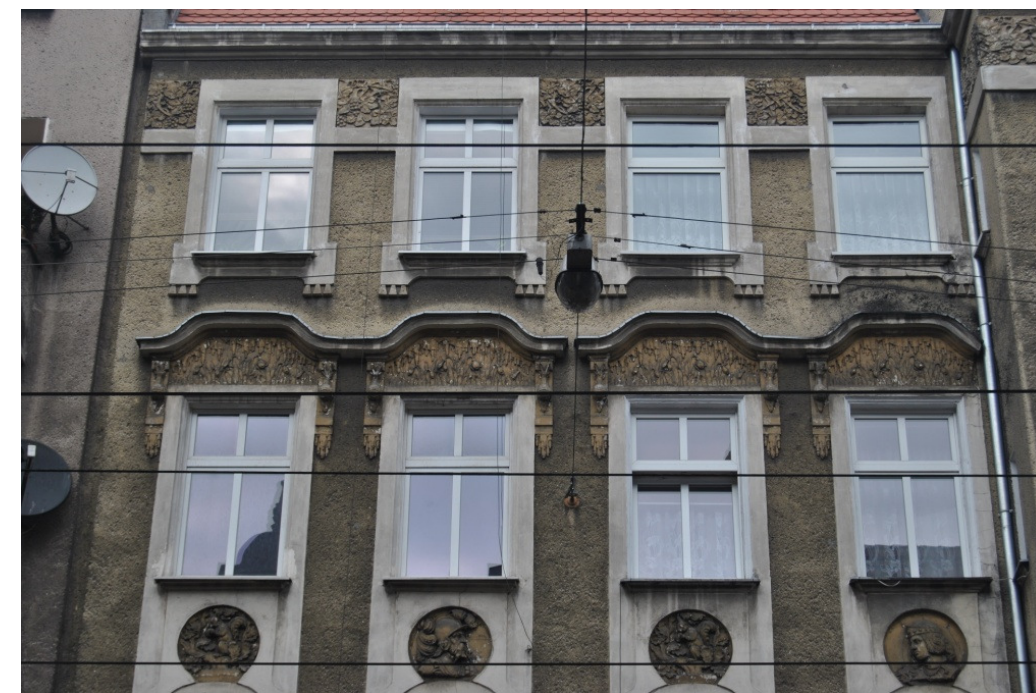
Openings.

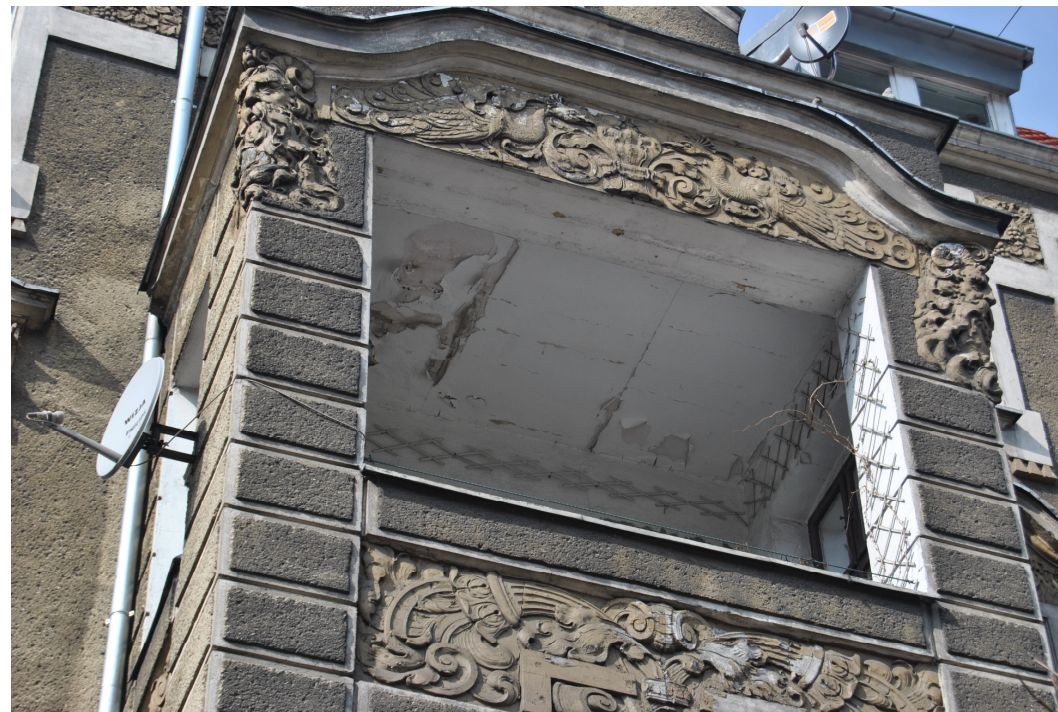
Bay Window

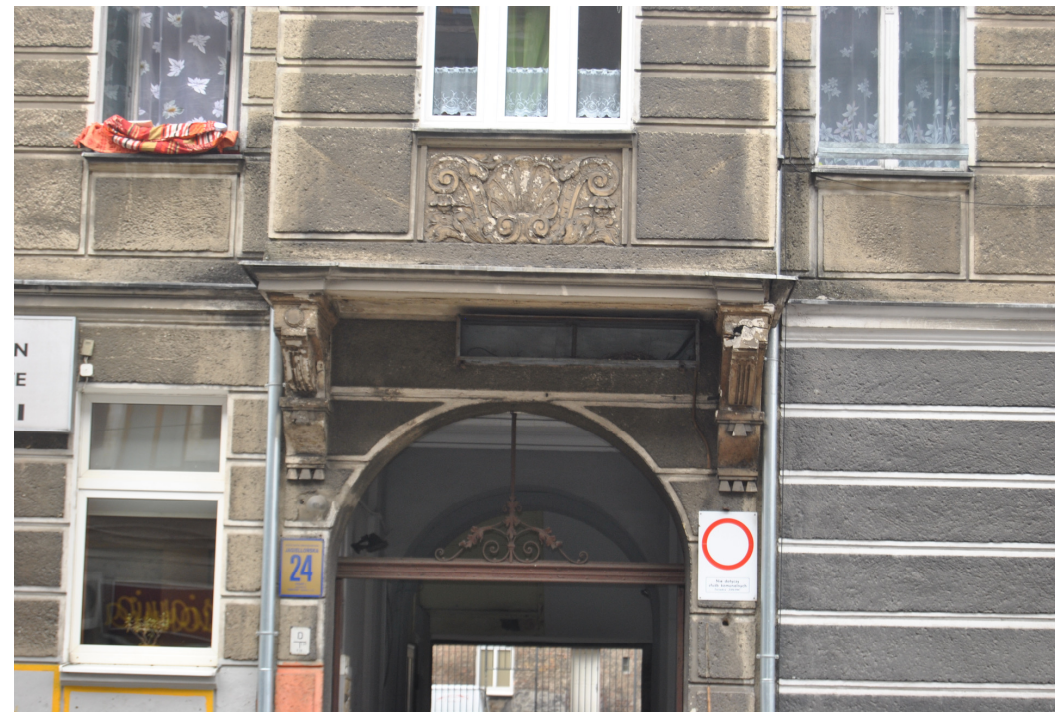
Secondary access

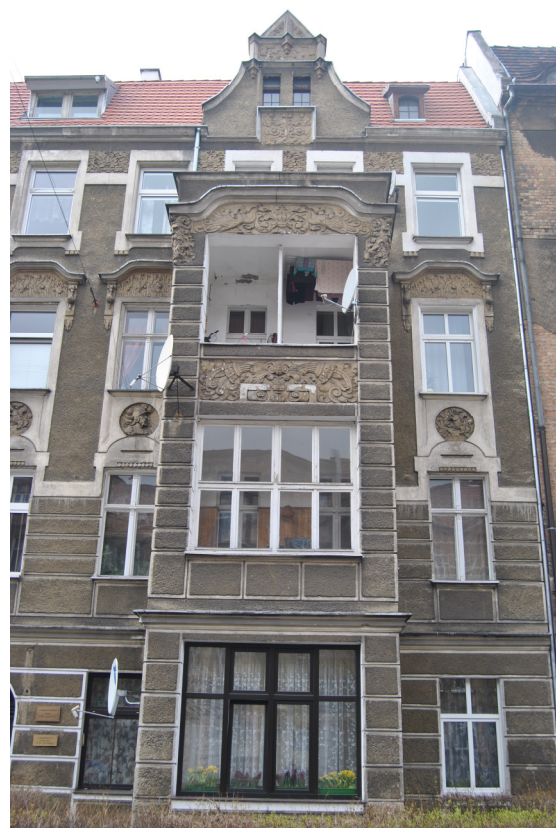
Bay window

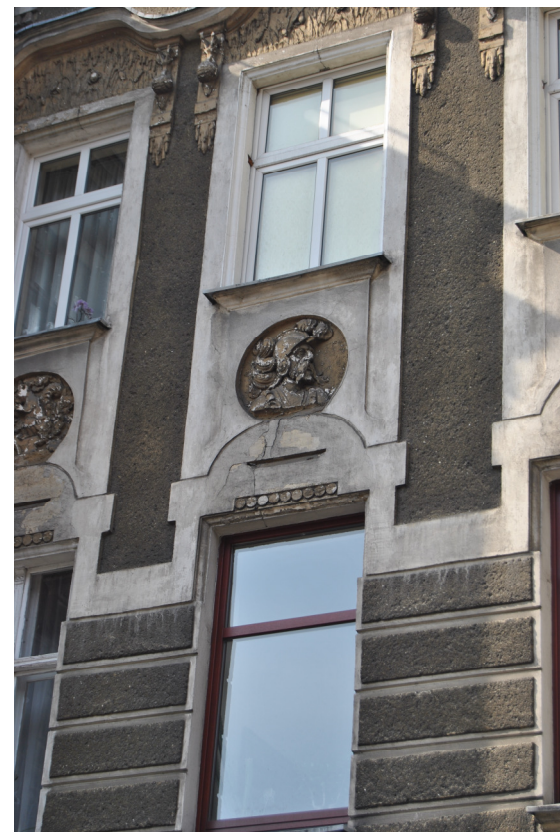
Opening

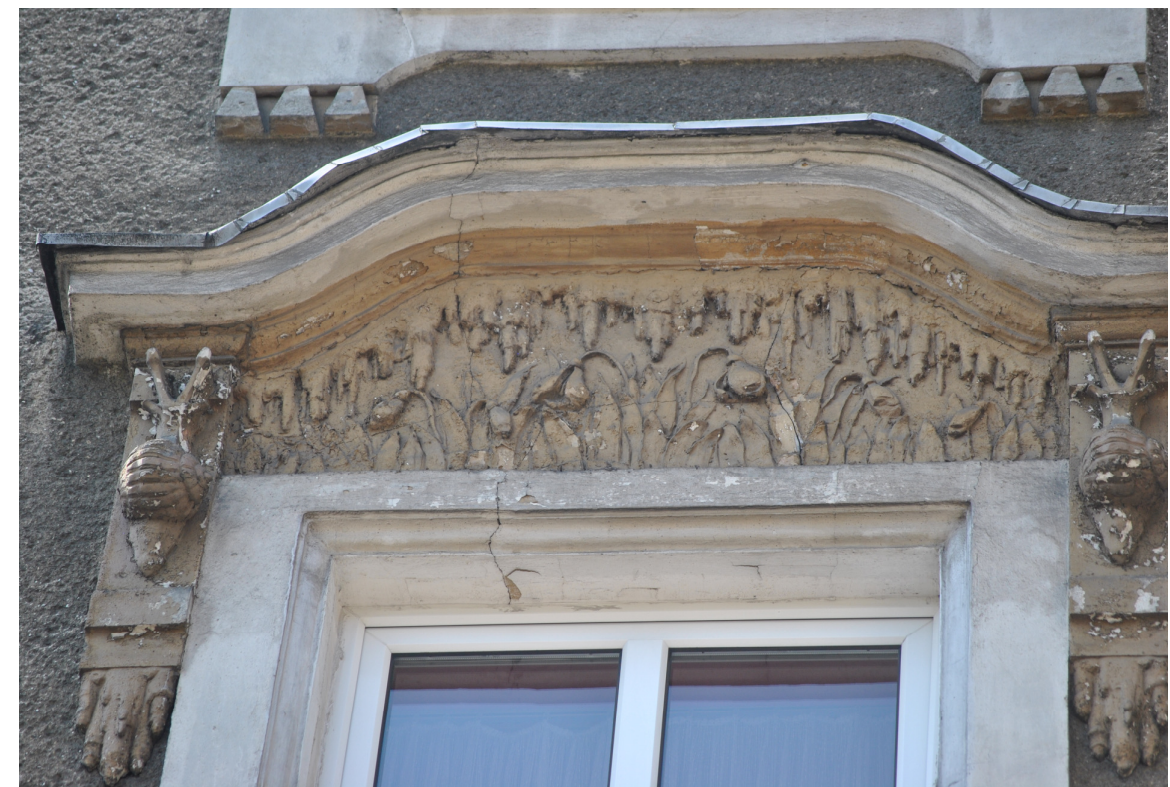
Lintel

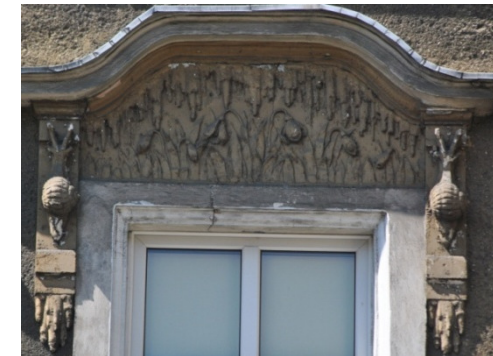
(2) and (5)

Also exist small cornices that finish off the openings in the second plant (5). The cornices are realized of plaster, and there are metallic sheets on that protect them from the weather. All the decorative elements have been anchored to the wall face by metal claws.

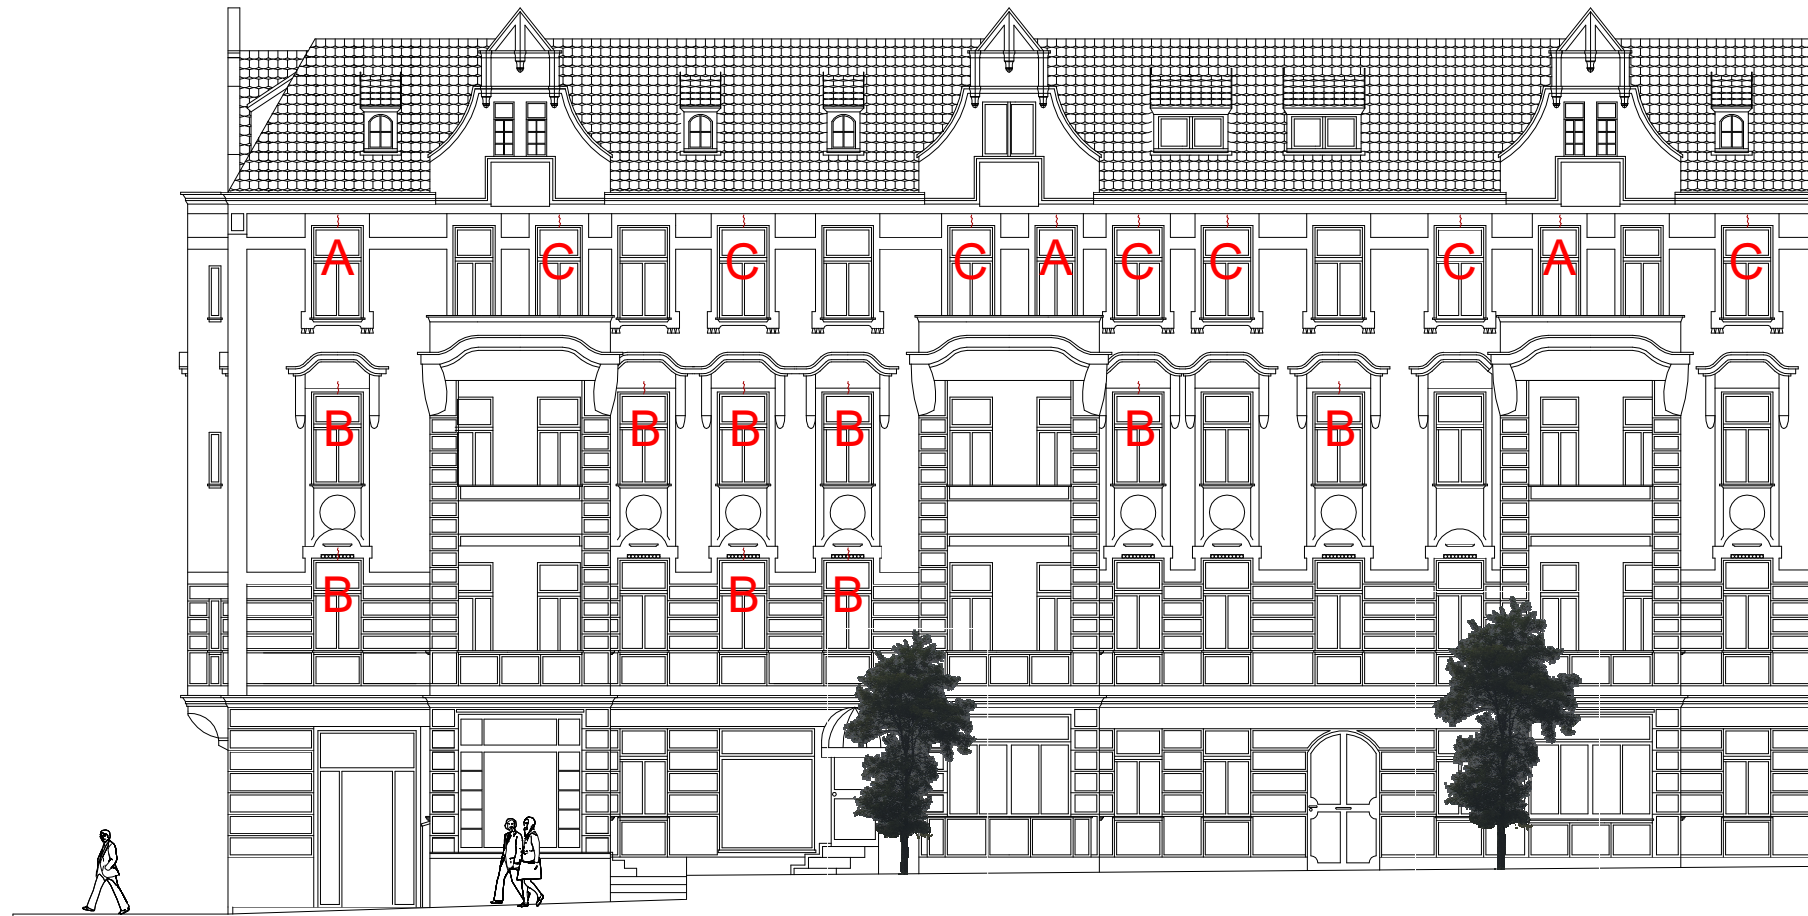
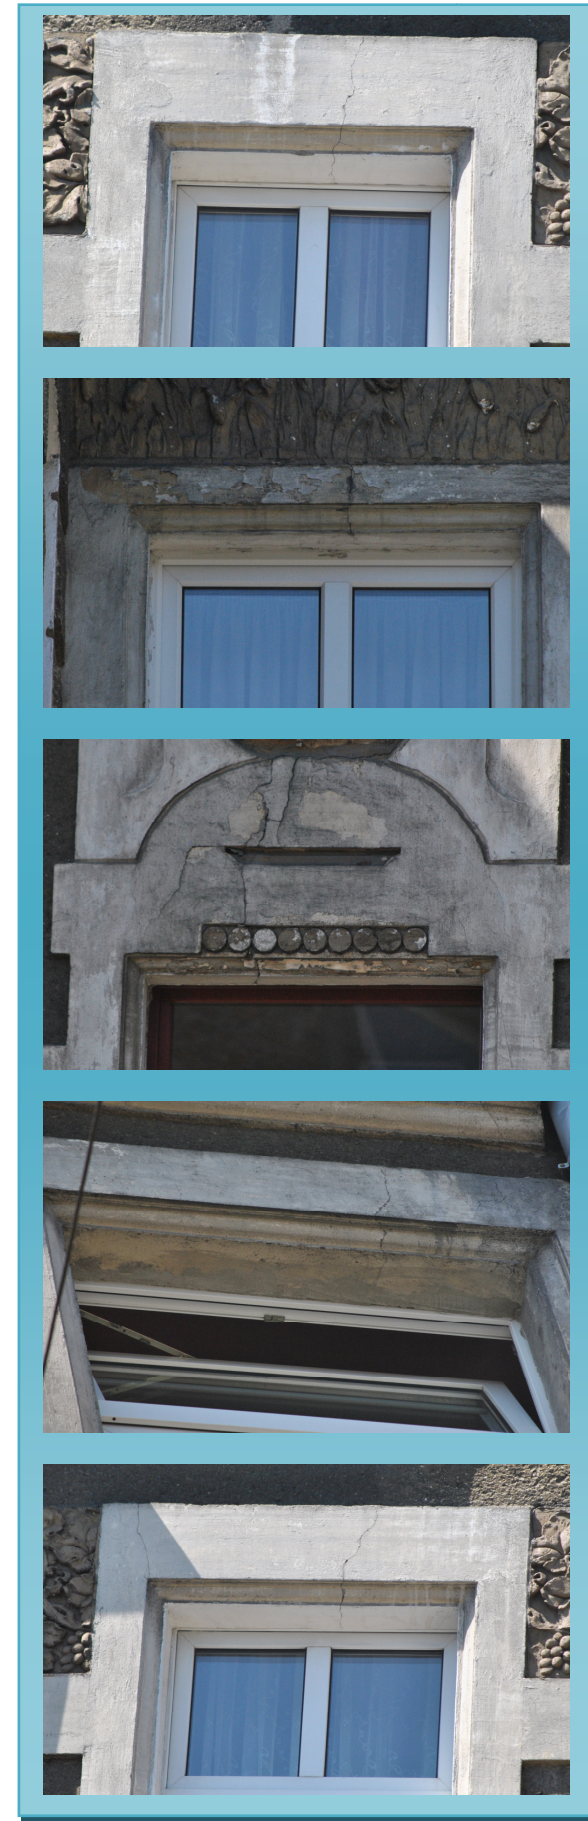
File 24.1: Cracks in lintels

This type is in the third floor. It is the least frequent. Two cracks are appreciated in the lintel. There is one in the center who is born in the low face and climbs for the frontal face, perpendicular to the direction of the lintel. The second fissure is born at the corner of the hollow and extends obliquely towards the low area.

This type is in first and second floors. It is the most frequent. A crack of small size is appreciated in the central area of the lintel, which is born in the low face and climbs for the frontal face, perpendicular to the direction of the lintel.

This type is in the third floor. A crack of considerable size is appreciated in the central area of the lintel, which is born in the low face and climbs for the frontal face, perpendicular to the direction of the lintel.

If the executed lintel presents cracks, it can be because there has been realized an incorrect calculation of the forces that act on him. Because he supports an excessive proper weight of the wall, or because the charges transmitted by the framework are major than the awaited ones. This provokes an arrow excess in the lintel, as it appears in the scheme, which provokes the cracks. Another possible cause is the bad execution of the lintel on the part of the workpeople, as for example, an inadequate anchoring of the metallic sheets, a bad laying of the bricks, or the employment(job) of an inadequate mortar.

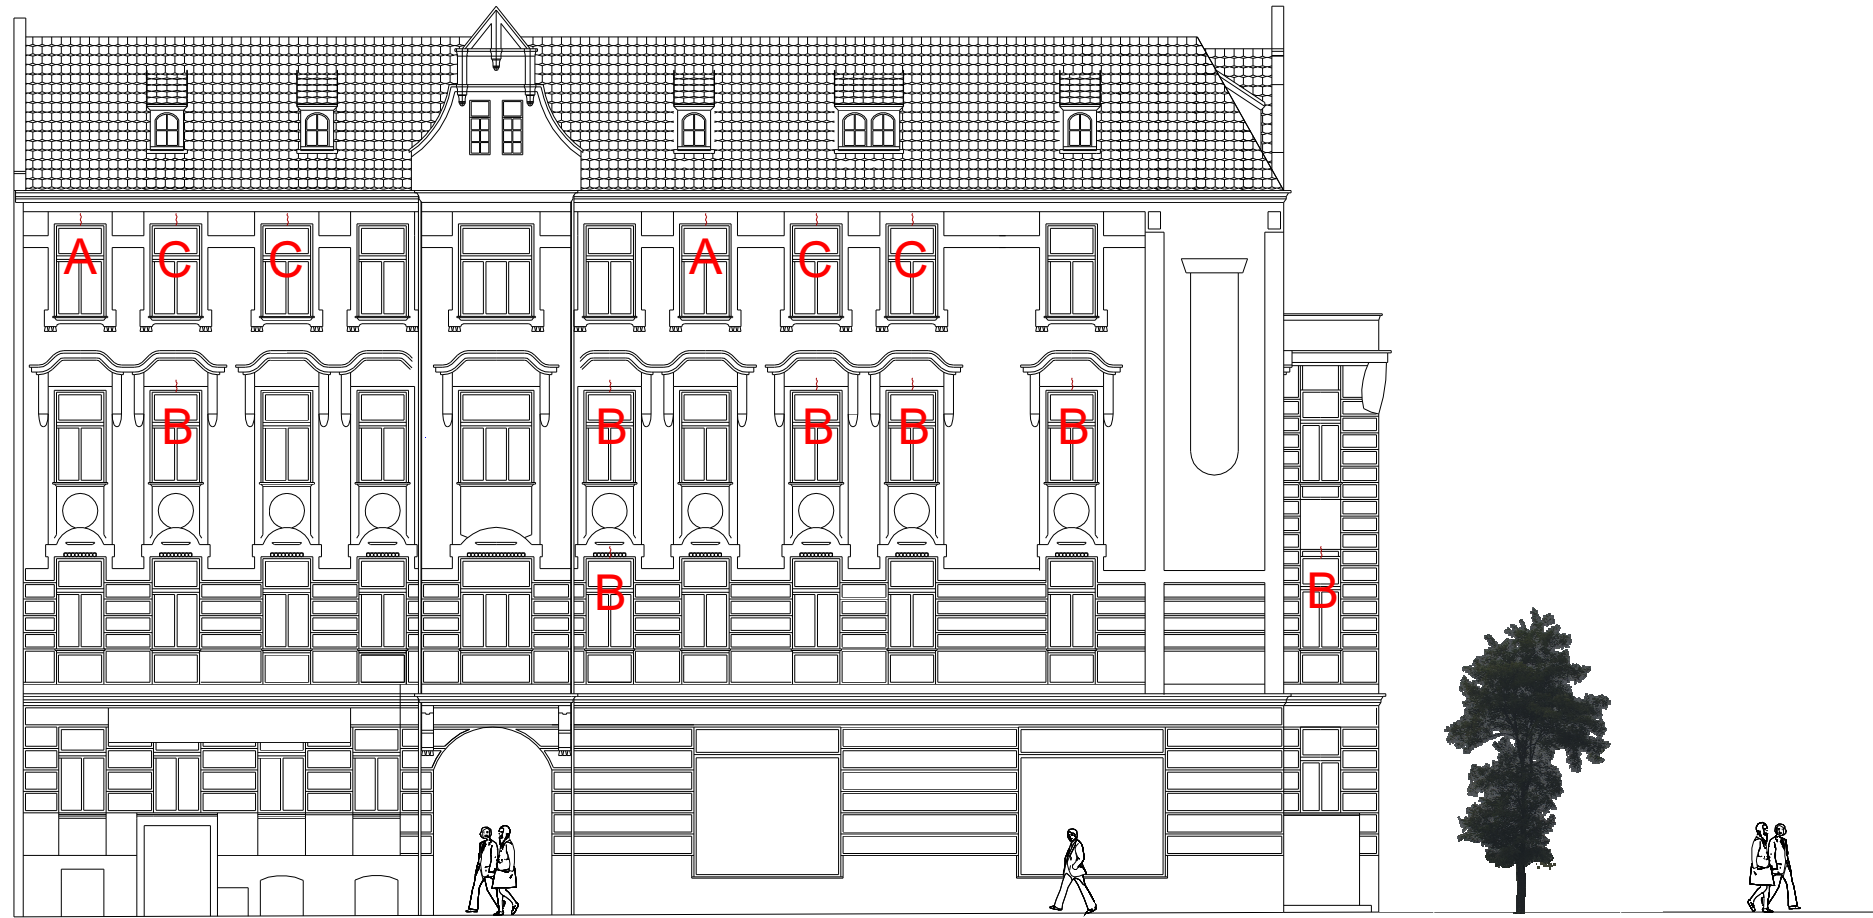
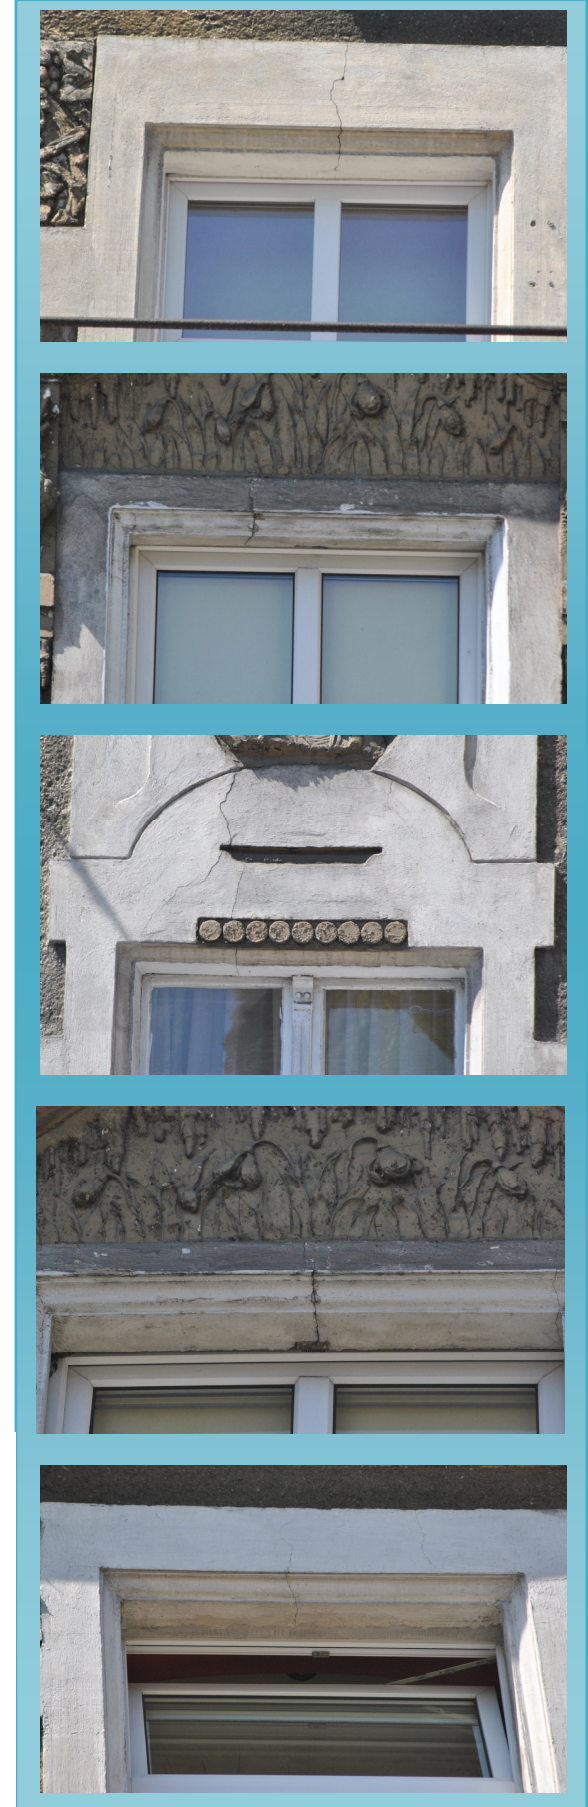
File 24.2: Cracks in the lintels

This type is in the third floor. It is the least frequent. Two cracks are appreciated in the lintel. There is one in the center who is born in the low face and climbs for the frontal face, perpendicular to the direction of the lintel. The second fissure is born at the corner of the hollow and extends obliquely towards the low area.

This type is in first and second floors. It is the most frequent. A crack of small size is appreciated in the central area of the lintel, which is born in the low face and climbs for the frontal face, perpendicular to the direction of the lintel

This type is in the third floor. A crack of considerable size is appreciated in the central area of the lintel, which is born in the low face and climbs for the frontal face, perpendicular to the direction of the lintel.

If the executed lintel presents cracks, it can be because there has been realized an incorrect calculation of the forces that act on him. Because he supports an excessive proper weight of the wall, or because the charges transmitted by the framework are major than the awaited ones. This provokes an arrow excess in the lintel, as it appears in the scheme, which provokes the cracks. Another possible cause is the bad execution of the lintel on the part of the workpeople, as for example, an inadequate anchoring of the metallic sheets, a bad laying of the bricks, or the employment(job) of an inadequate mortar.

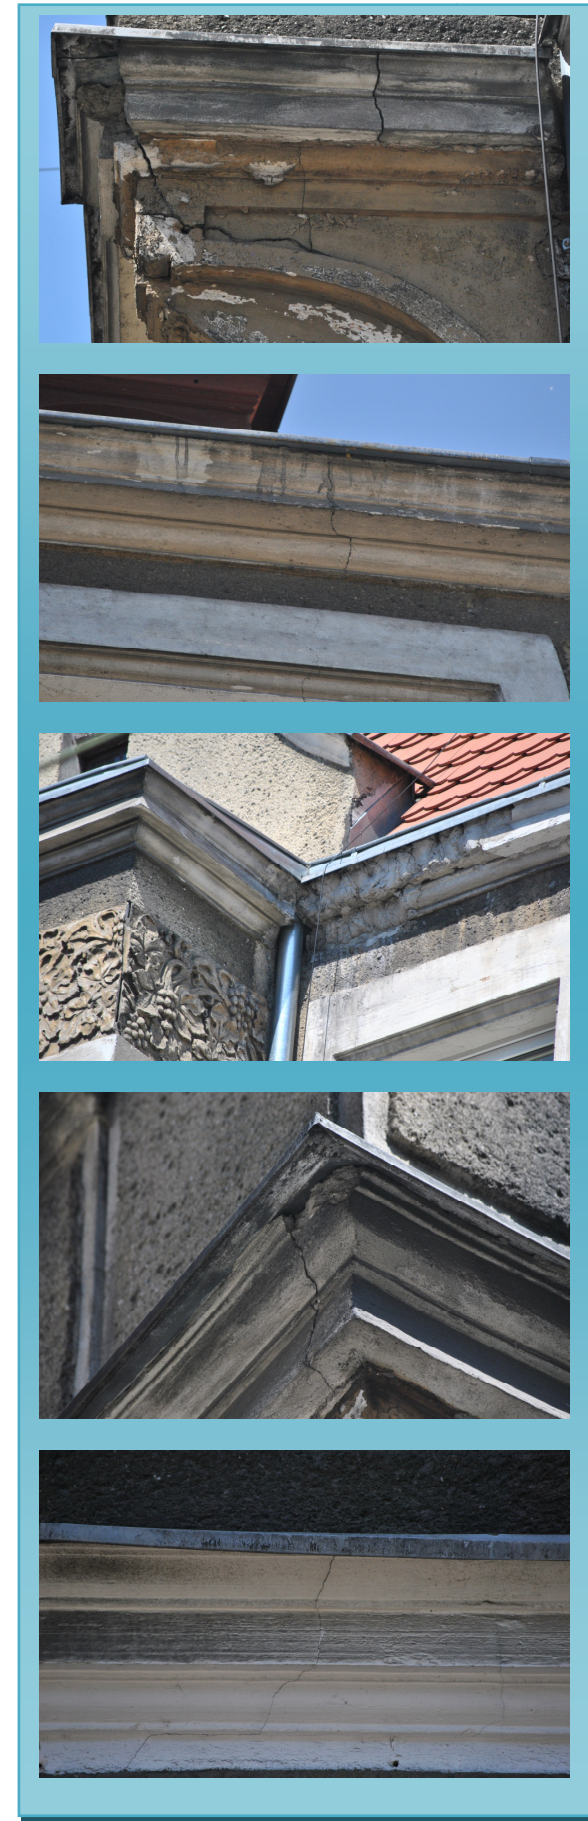
File 24.3: Cracks in the cornices

The cornices that are continuous along the building are coincide with the framework's cants. The efforts that this one could transmit to the load wall, can transmit an excessive effort to the bricks, to which the cornices are adhere. These movements can provoke the cracks in the cornices that are not prepared for this type of efforts. These cracks also can owe to the corrosion of the metallic claws that serve as support to the cornice. When thats claws having corroded experience an increase of volume that provokes a few tensions that the cornice cannot support. The area of the cornice near to the downspout, we suppose that this excessive degradation it stemmed from the break of the gutter the collection of rain waters. But since it is possible to observe in the picture, the gutter has been replaced, for this reason we will center in the repair the cornice.

In this type there qualify the detachments that we find along the front. In the area where the cornices cross the downspout, there is an important detachment. To repair this, there was refilled the area with froth of polyurethane or some of similar product.

Along the length of the top cornice in the building there are cracks, perpendicular to the direction of the same one. The thickness of the craks are between 2 and 5 mm, and the length are between 15 and 20 cm. In some areas, especially in the corners, these problems have provoked a partial detachment of the cornice. The metallic sheets that cover the cornices, present an advanced stated of deterioration. There are areas where the oxidation is very advanced. The sheets have undulated.

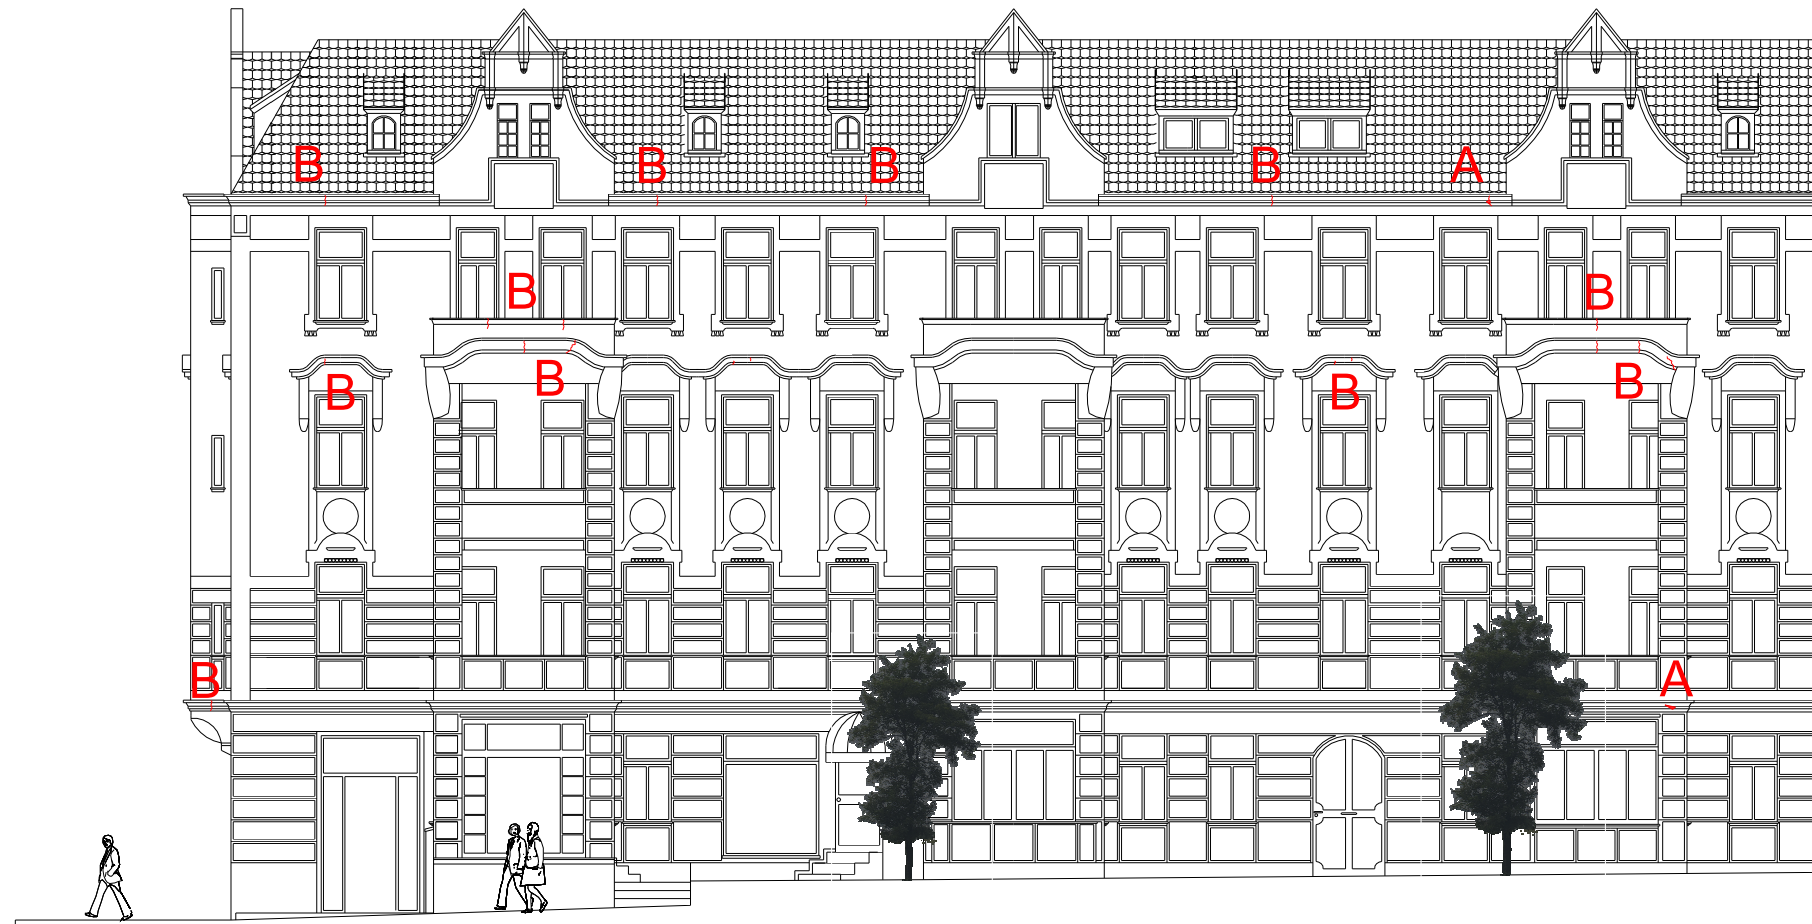
File 24.4: Cracks in the cornices

In this type there qualify the detachments that we find along the front. In the area where the cornices cross the downspout, there is an important detachment. To repair this, there was refilled the area with froth of polyurethane or some of similar product.

Along the length of the top cornice in the building there are cracks, perpendicular to the direction of the same one. The thickness of the cracks are between 2 and 5 mm, and the length are between 15 and 20 cm. In some areas, especially in the corners, these problems have provoked a partial detachment of the cornice. The metallic sheets that cover the cornices, present an advanced stated of deterioration. There are areas where the oxidation is very advanced. The sheets have undulated.

The cornices that are continuous along the building are coincide with the framework's cants. The efforts that this one could transmit to the load wall, can transmit an excessive effort to the bricks, to which the cornices are adhere. These movements can provoke the cracks in the cornices that are not prepared for this type of efforts. These cracks also can owe to the corrosion of the metallic claws that serve as support to the cornice. When that claws having corroded experience an increase of volume that provokes a few tensions that the cornice cannot support. The area of the cornice near to the downspout, we suppose that this excessive degradation it stemmed from the break of the gutter the collection of rain waters. But since it is possible to observe in the picture, the gutter has been replaced, for this reason we will center in the repair the cornice.

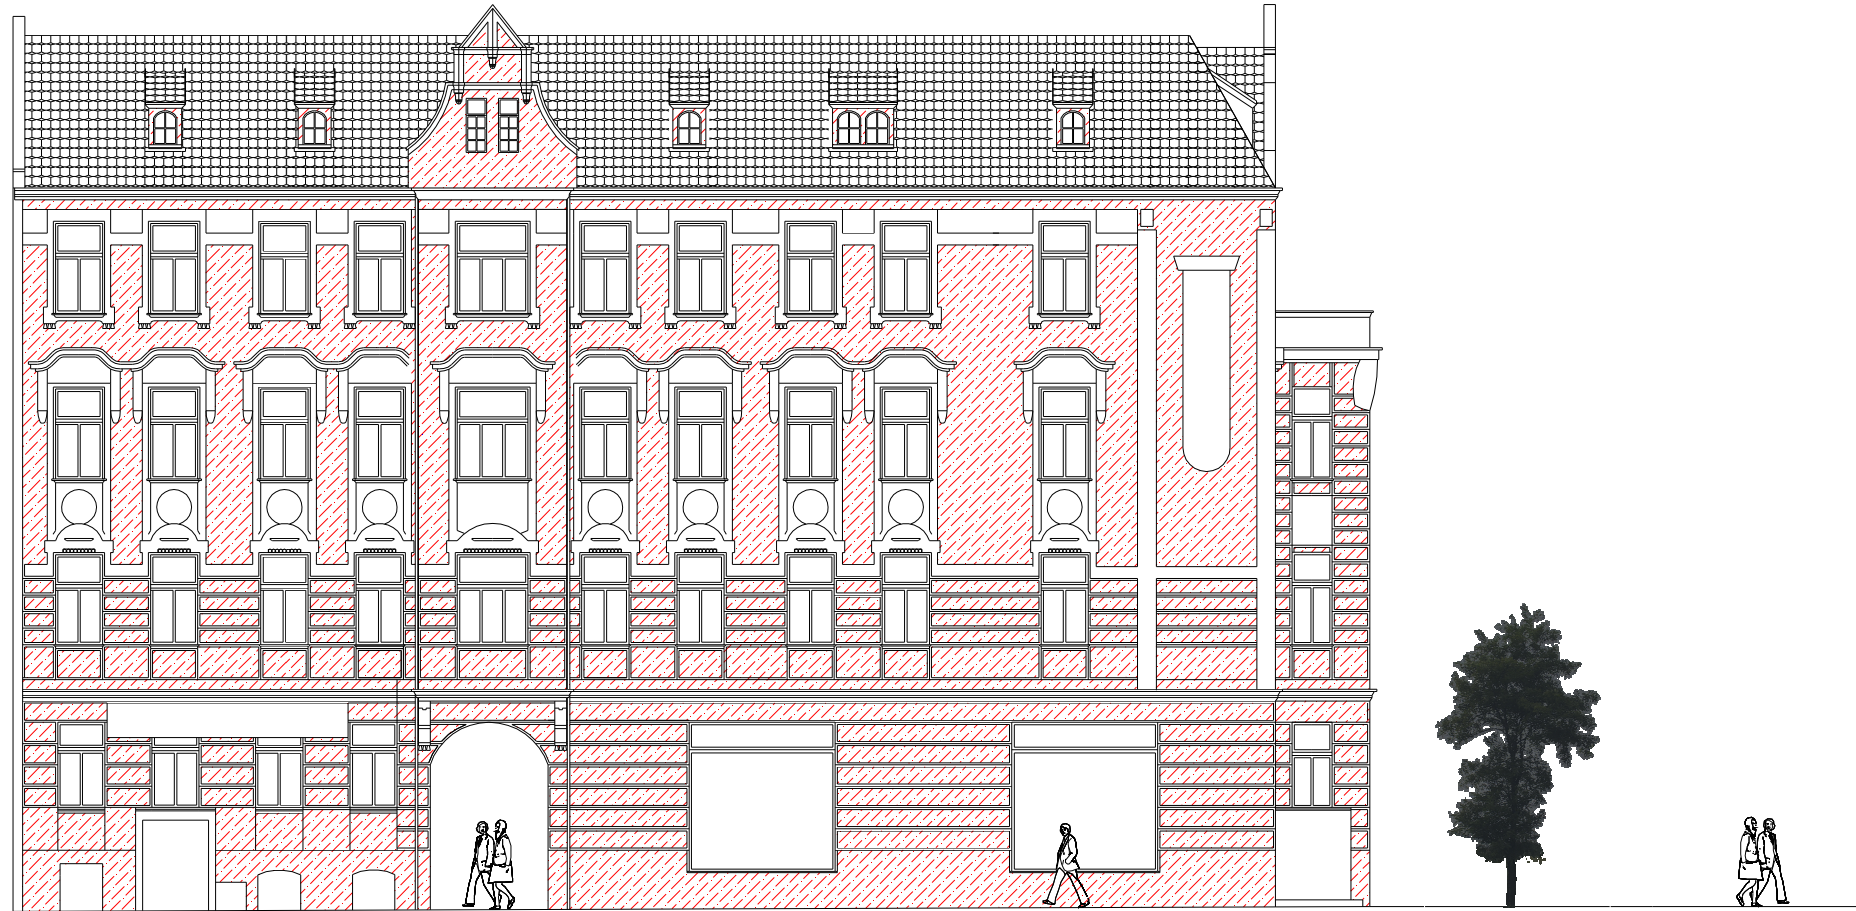
File 24.5: Degradation of lime plaster

There is appreciated an important degradation of lime's plaster that covers the facade, which has provoked the appearance of a big number of pores and cavities in the surface of the ornament. The dimensions of these pores are very diverse. Another important symptom, consequence of the previous symptom is the darkening of the revetment for dirt deposition in the cavities.

The bad quality of the lime's mortar, added the hardness of the atmospheric agents in certain seasons plus the scarce maintenance of the revetment during his useful life, has provoked the wear of the mortar and the posterior appearance of pores and cavities. The water accumulation in these pores, as well as the changes of volume that experiences that one, provoke the increase of size of the pores. The rough surface created, it allows a major facility for the deposition of the dust and the pollution of the ambience in the cavities, which provokes the darkening of the revetment.
