FINAL PROJECT HISTORICAL, CONSTRUCTIVE AND PATHOLOGICAL ANALYSIS OF MODERNIST BUILDINGS IN SZCZECIN

AUTHORS OF PROJECT:
JORGE SENDRA SENDRA
CLARA SAIS GIRONÉS

4.3 Problems in the building

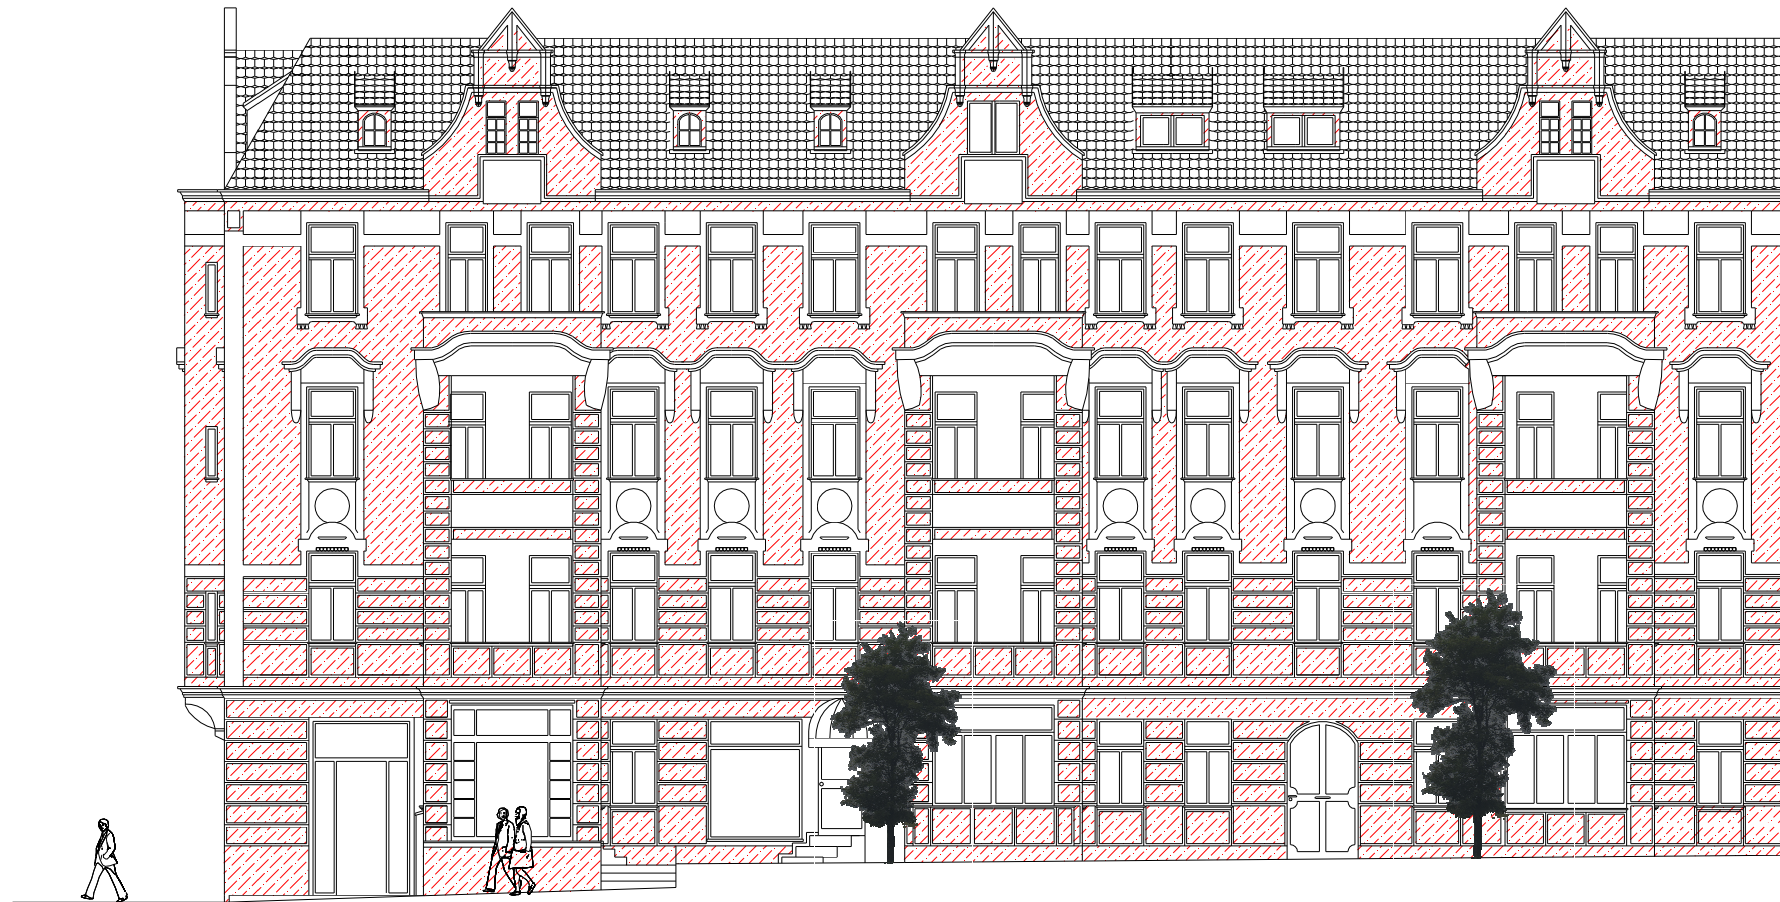
Ficha 24.6: Degradation of lime plaster

There is appreciated a notable degradation of lime's plaster that covers the front, which has provoked the appearance of a big number of pores and cavities in the surface of the ornament. The dimensions of these pores are very diverse, some going so far as to reach several centimeters. Another important symptom, consequence of the previous symptom and that appears in the whole front ornament, is the darkening of the revetment for dirt deposition in the cavities.

The bad quality of the lime's mortar, added the hardness of the atmospheric agents in certain seasons plus the scarce maintenance of the revetment during his useful life, has provoked the wear of the mortar and the posterior appearance of pores and cavities. The water accumulation in these pores, as well as the changes of volume that experiences that one, provoke the increase of size of the pores. The rough surface created, it allows a major facility for the deposition of the dust and the pollution of the ambience in the cavities, which provokes the darkening of the revetment.

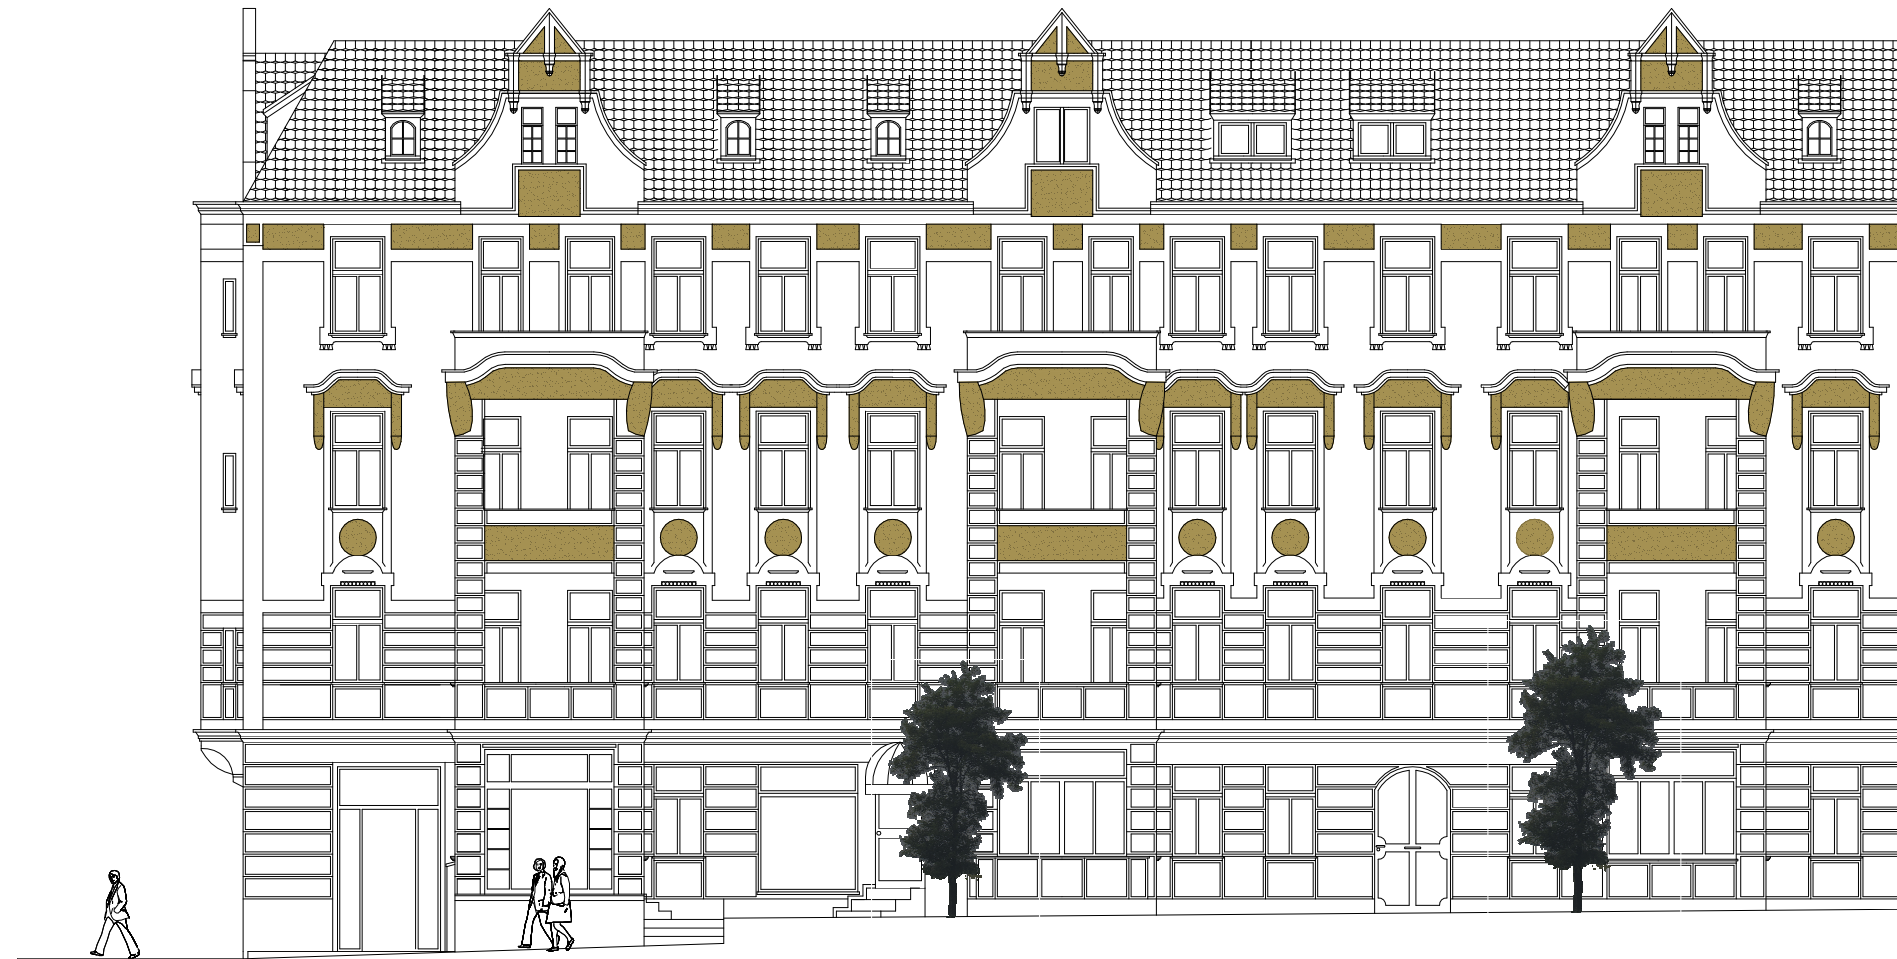
File 24.7: Degradation of decorative elements

In the plaster's veneering that decorate the openings, as well as in the decorations who accompany them, we find small detachment that have left to the overdraft the plaster. In most of the veneering, there are cracks that surround the perimeter of the plates and crackings also in the central areas.

The big decorations placed in the principal facade present the awful conservation state. In one of them there has taken place a detachment of a considerable size, leaving to the overdraft the metallic beam of the cantilever. Also a crack is appreciated in the side face, which is born in the left top corner and descends towards the central area, of approximately 30 cm of length a 5 mm thickness.

The crackings in the plates of plaster in the spaces between windows can owe to the movements that experiment the frameworks on these areas, or from the extension of the problems in the lintels, quoted in previous cards.

Also, an important cause is the void maintenance that the veneering have received, what has provoked the appearance of a big number of detachment and bleaching of the elements.

The decoration of big size present problems owe to the movements that experiences the beam of the framework which they are anchored. Also the crack of the top cornice has provoked the oxidation of the metallic claws, which, on having expanded, provoke tensions that the material cannot support.

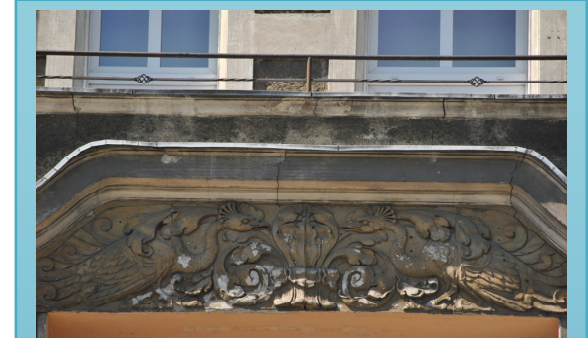
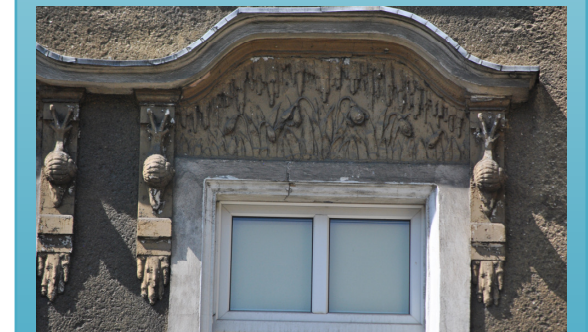
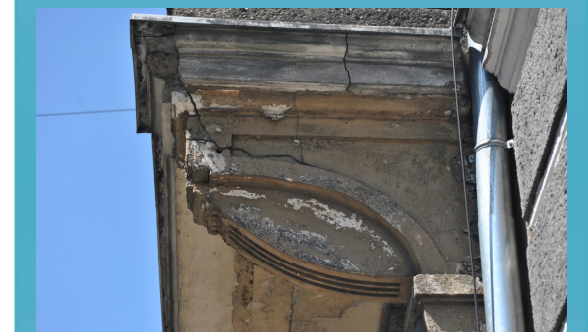
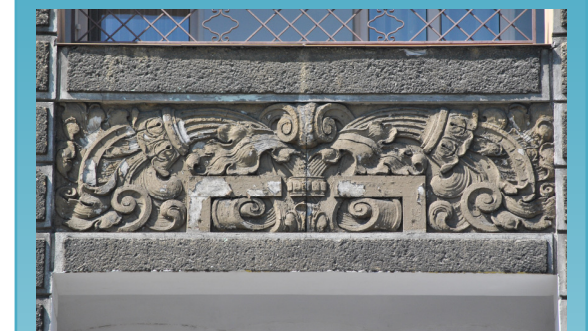
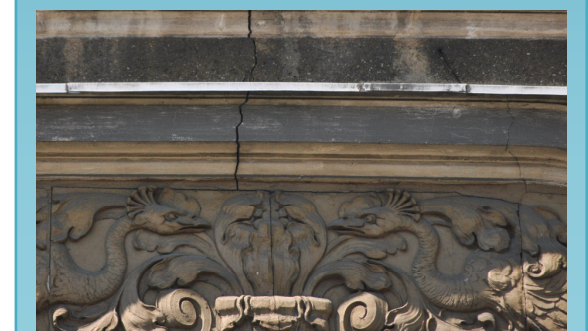
File 24.8: Degradation of decorative elements

In the plaster's veneering that decorate the openings, as well as in the decorations who accompany them, we find small detachment that have left to the overdraft the plaster. In most of the veneering, there are cracks that surround the perimeter of the plates and crackings also in the central areas.

The big decorations placed in the principal facade present the awful conservation state. In one of them there has taken place a detachment of a considerable size, leaving to the overdraft the metallic beam of the cantilever. Also a crack is appreciated in the side face, which is born in the left top corner and descends towards the central area, of approximately 30 cm of length a 5 mm thickness.

The crackings in the plates of plaster in the spaces between windows can owe to the movements that experiment the frameworks on these areas, or from the extension of the problems in the lintels, quoted in previous cards.

Also, an important cause is the void maintenance that the veneering have received, what has provoked the appearance of a big number of detachment and bleaching of the elements.

The decoration of big size present problems owe to the movements that experiences the beam of the framework which they are anchored. Also the crack of the top cornice has provoked the oxidation of the metallic claws, which, on having expanded, provoke tensions that the material cannot support.

As intervention we propose cleanliness the veneering and to refill the cracks with resin repairer, placing, if it is necessary, a mesh that reinforces the union between the weakest areas.

As soon as the cracks were repaired there will be applied a layer of painting that protects the appeared ones of the inclement weather.

As for the decorations in the cantilever, for their bad state of conservation and the number of detachments, we propose completely replace.

2°_ Filling of the cracks by resins repairers who assure the unification of the efforts.

3°_ Laying, when it is necessary, a repairer mesh as reinforcement for the unification of the efforts.

5°_ Extraction of the damaged decoration and formation of mold for making the new ones in workshop.

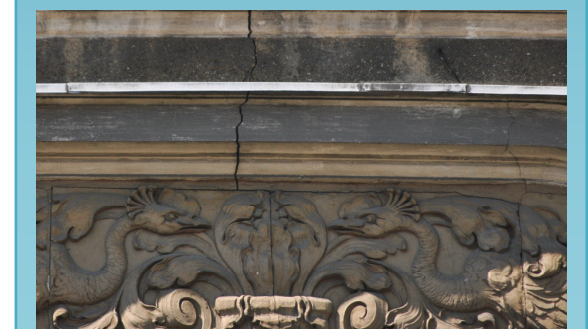
File 24.9: Degradation of the cement mortar

The cement mortar that forms the frames, we observed cracks in the spaces between windows. Many of them are a continuation of the cracks that have appeared in the lintels. Also there are cracks in the sills of a big number of windows. The mortar presents a considerable bleaching in all his surface.

The crackings of the cement mortar placed in the spaces between windows can owe to the movements that experiment the frameworks on these areas, or can stem from the extension of the problems in the lintels, quoted in previous cards. Another important cause is the void maintenance that has received the revetment. That has provoked the appearance of a big number of flaked, and the bleaching of the elements by the sun.

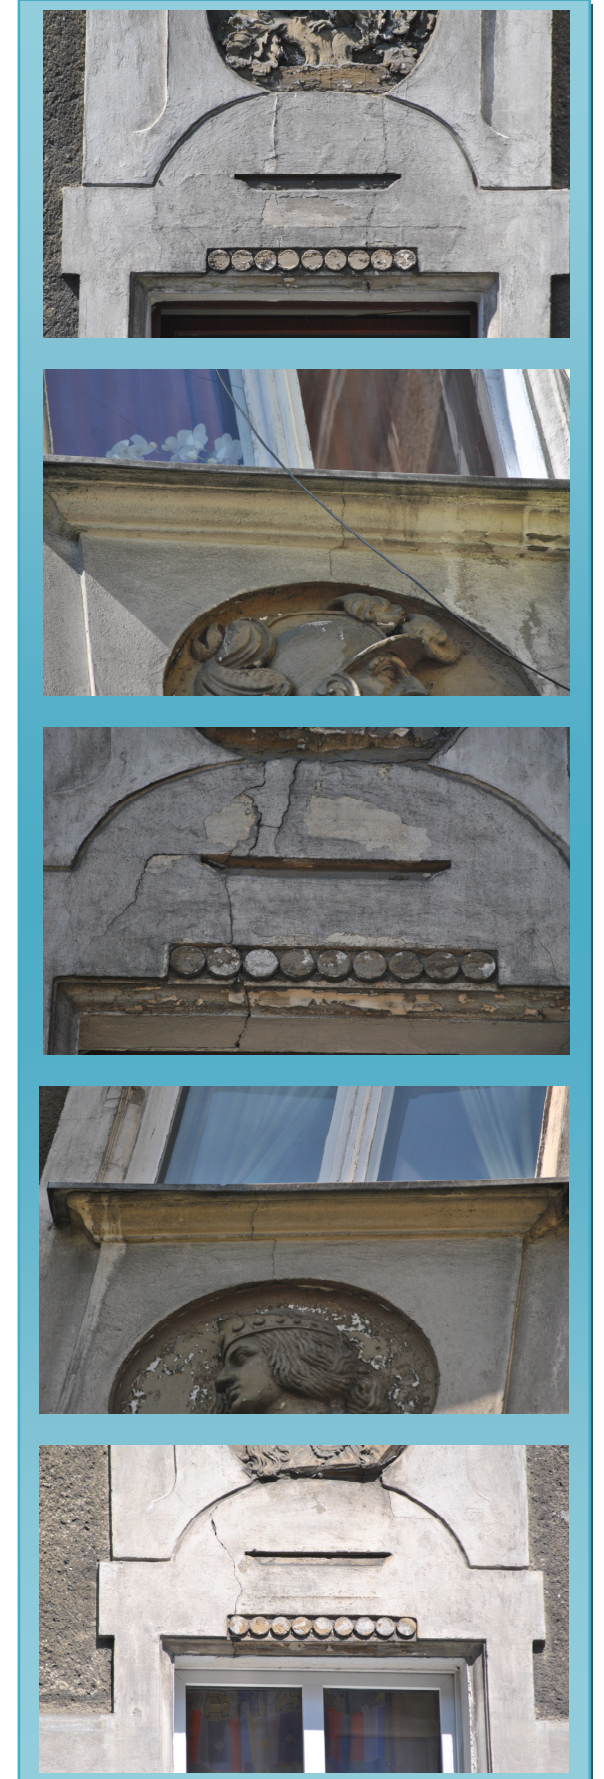
File 24.10: Degradation of cement mortar

The cement mortar that forms the frames, we observed cracks in the spaces between windows. Many of them are a continuation of the cracks that have appeared in the lintels.

Also there are cracks in the sills of a big number of windows. The mortar presents a considerable bleaching in all his surface.

The crackings of the cement mortar placed in the spaces between windows can owe to the movements that experiment the frameworks on these areas, or can stem from the extension of the problems in the lintels, quoted in previous cards.

Another important cause is the void maintenance that has received the revetment. That has provoked the appearance of a big number of flaked, and the bleaching of the elements by the sun.

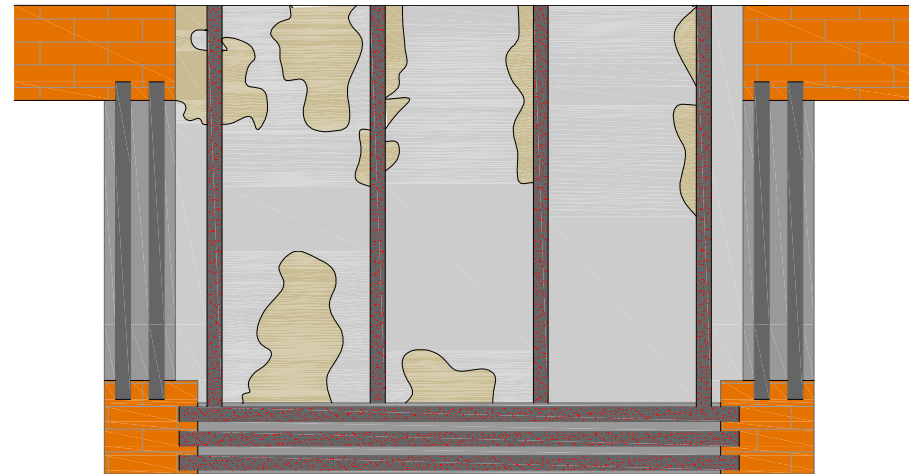
Bay window of second floor

There is corrosion in the joists that form the cantilever, and in the joist of the frontal lintel. As we see in the detail, there are areas where the mortar of revetment the joist has detached. The mortar that still survives is very damaged. The joist of the side openings do not present any problem.

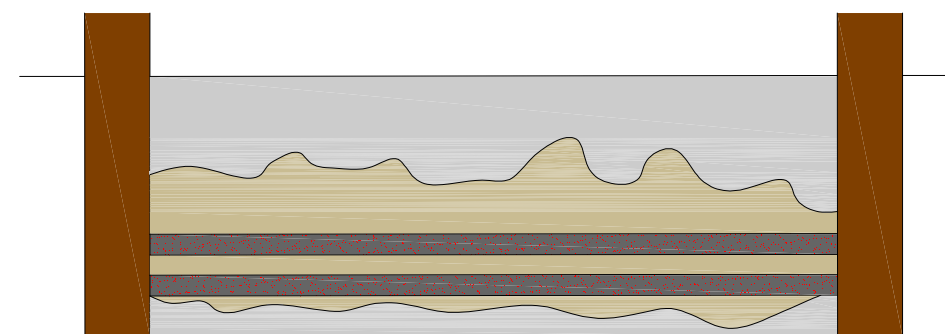
Cantilever of first floor

The revetment mortar is very damaged. Largely surface of cantilever it has got rid, and the joist have stayed to the overdraft. There is corrosion in two metallic joist that form the cantilever.

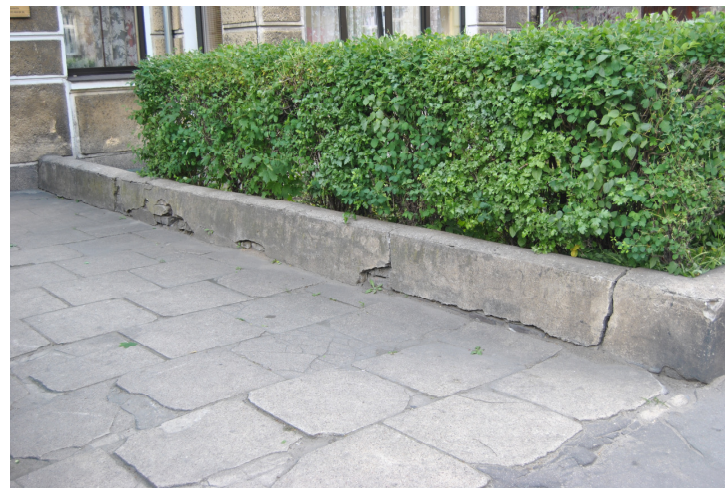
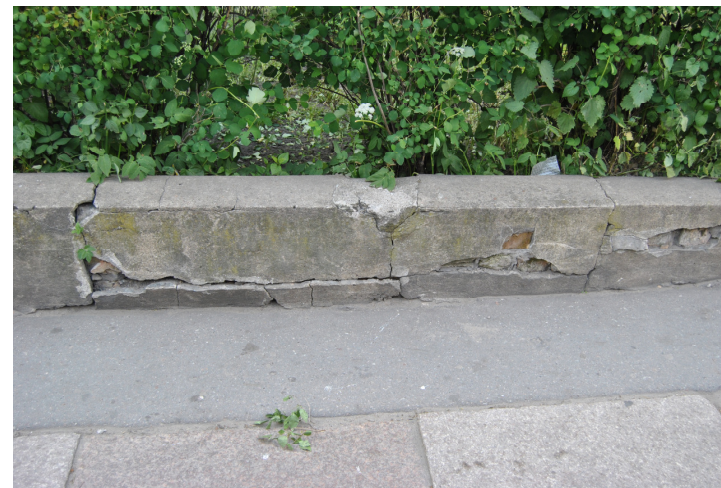
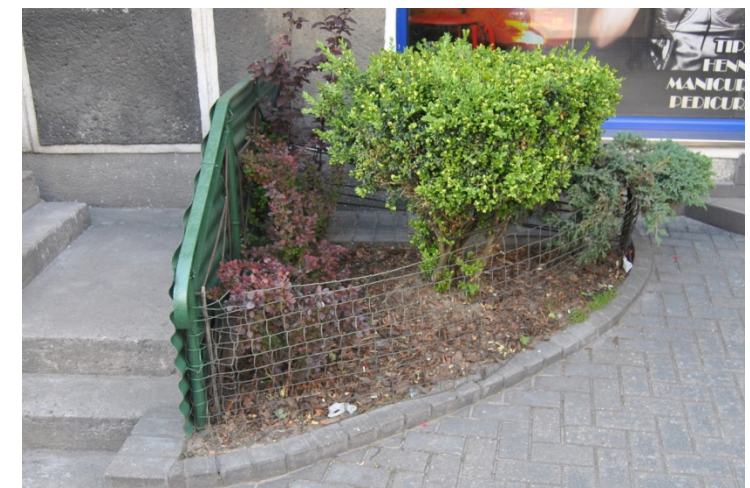
Analysis of problems

The perimeter wall that surrounds the landscaped area of the building is realized by massive ceramic bricks and a recovering of mortar of lime. The above mentioned wall has a big number of cracks in all his length that in some cases reach more than one centimeter of thickness. Also, in some areas these cracks have provoked detachments of a considerable size. The garden is formed by a line of firs that surrounds the area, and several trees distributed randomly.

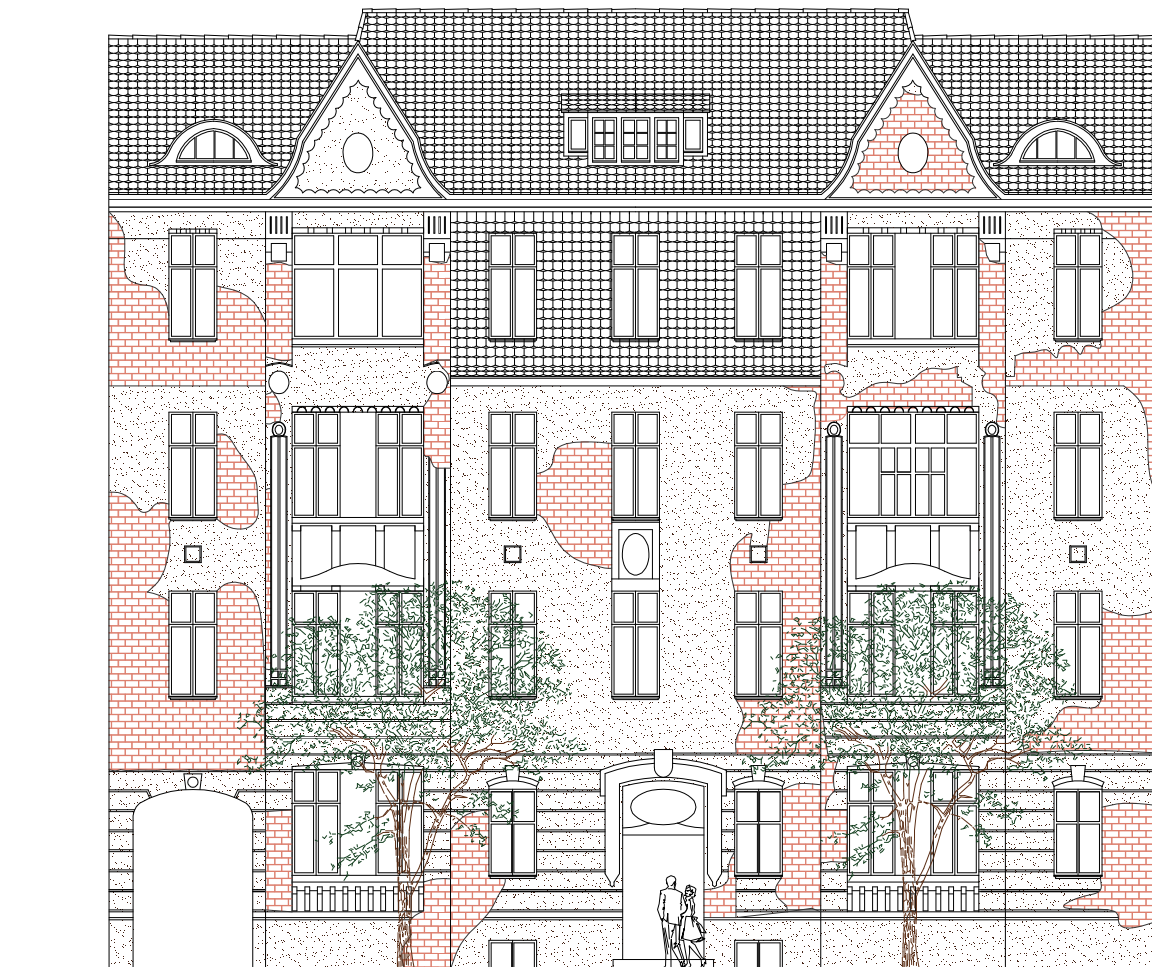
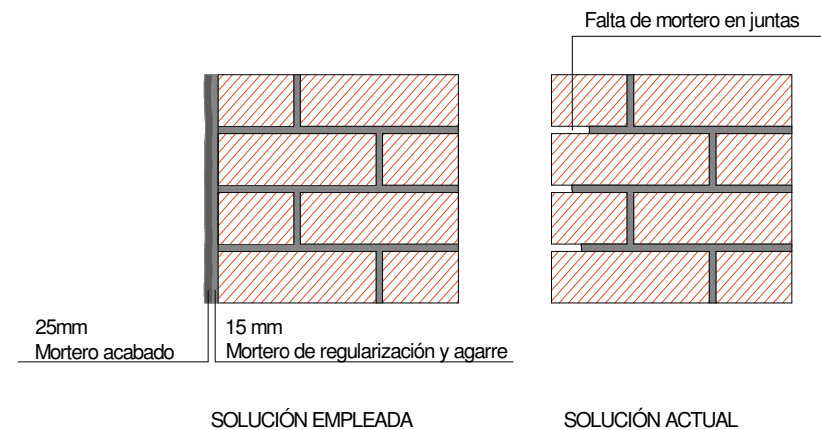
File 7.1: Degradation of the lime mortar

In this facade there is a big degradation of the lime mortar used like vertical revetment. It is in more than 50 % of the entire facade surface, as it is possible to see in the drawing and the pictures, the recovering is completely absent, leaving exposed brick. In some areas, part of the decorative elements are incomplete, because also they have disintegrated. The mortar that is still in his place is much degraded. The revetment presents a porous and darkened aspect.

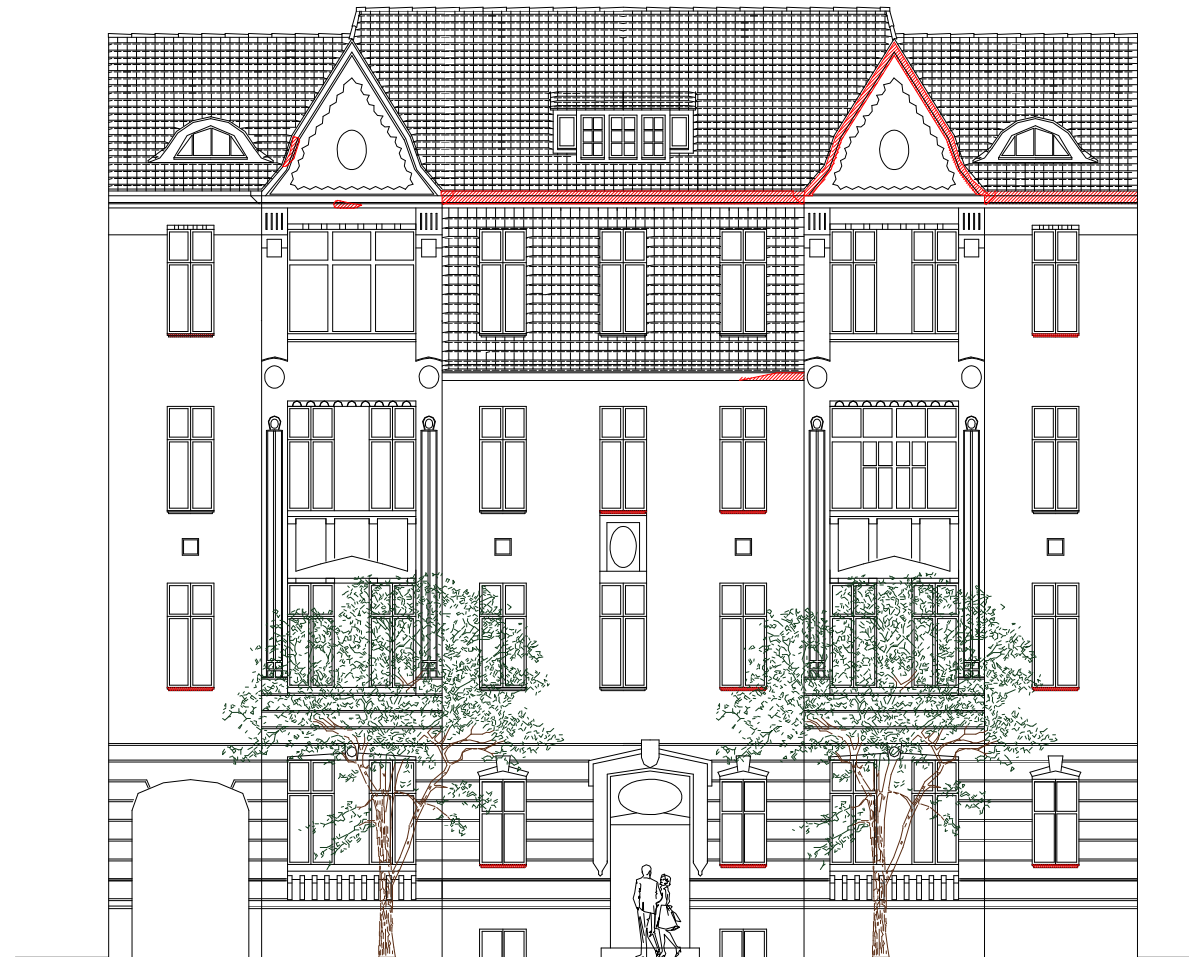
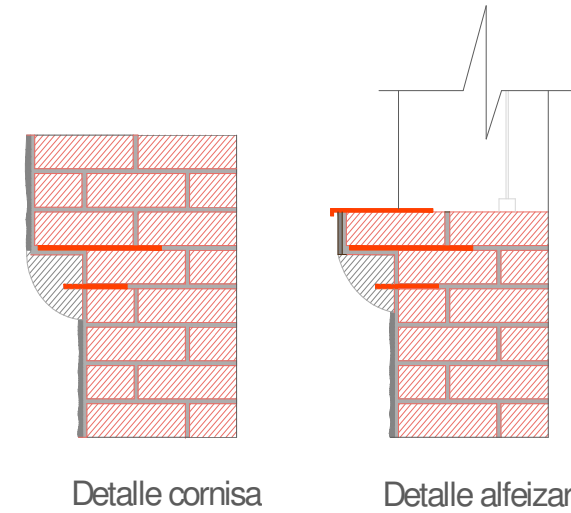
File 7.2: Degradation of the cornices

In this front there is a big detachment of most of the existing cornices. In almost all of them, the bricks that were forming the cornices are exposed. The same way the sheet used to support them. There does not stay anything of the frame that was giving the final score of the cornice, not either of the mortar used as finished end.

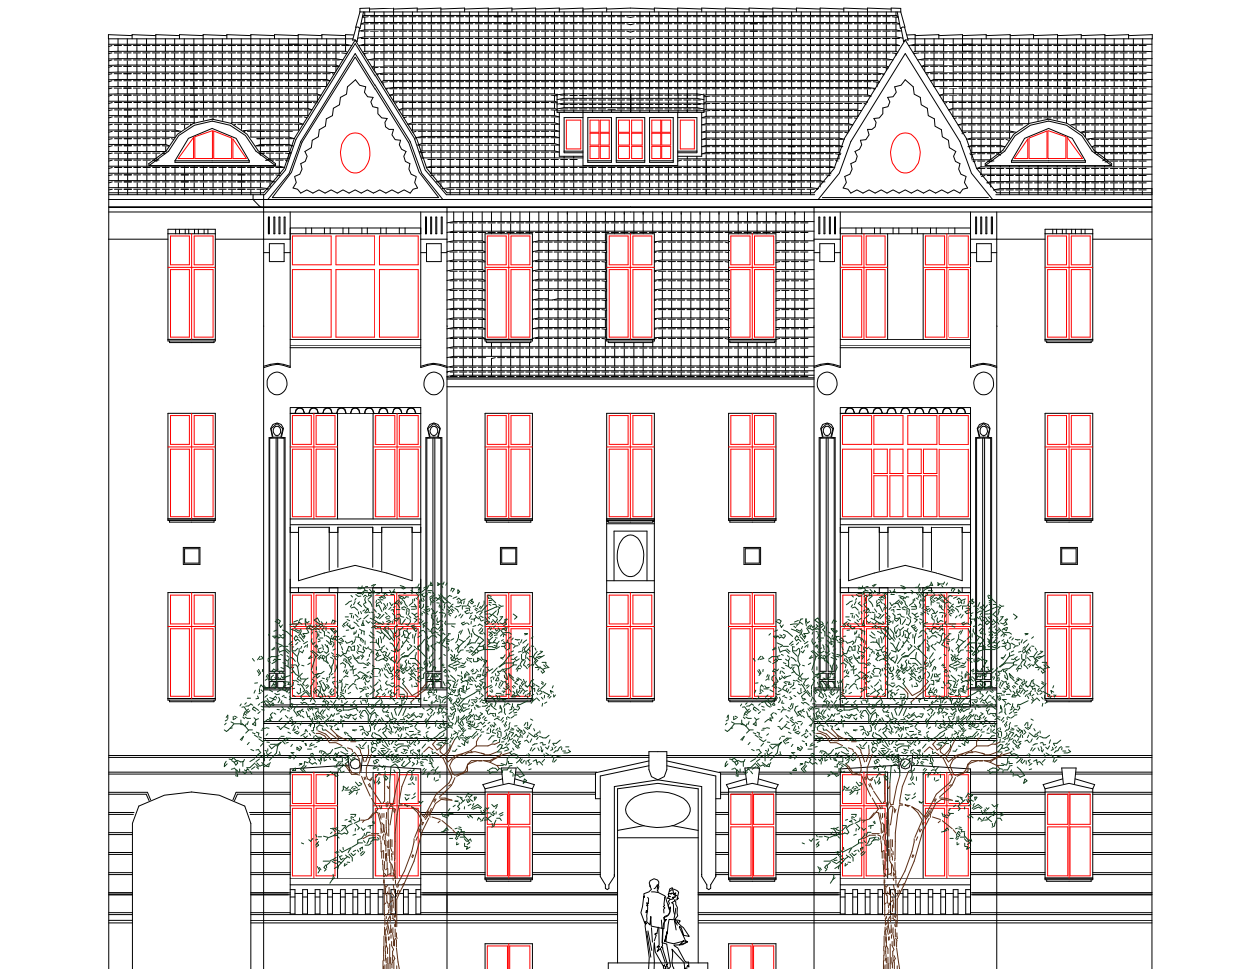
File 7.1: Degradation of the carpentry.

In the front the used windows are of wood with a layer of white painting. The general model of the windows is for parts of two tiers. Some of them have been restored. Some bay windows have placed carpentries making the front slightly homogeneous

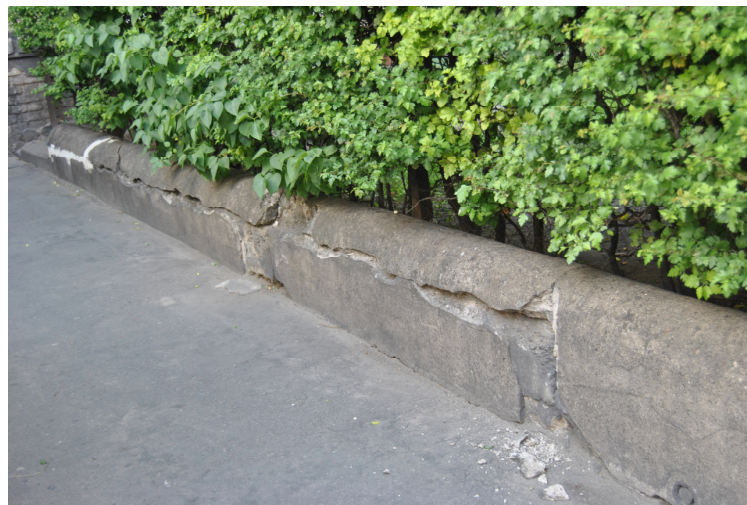
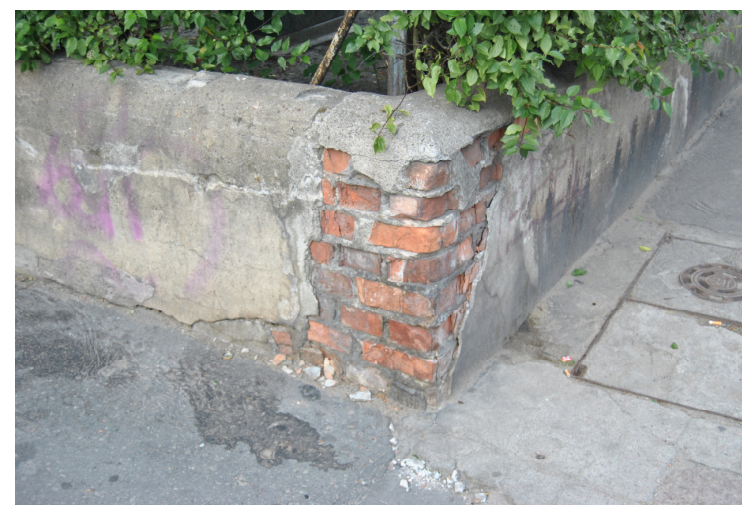
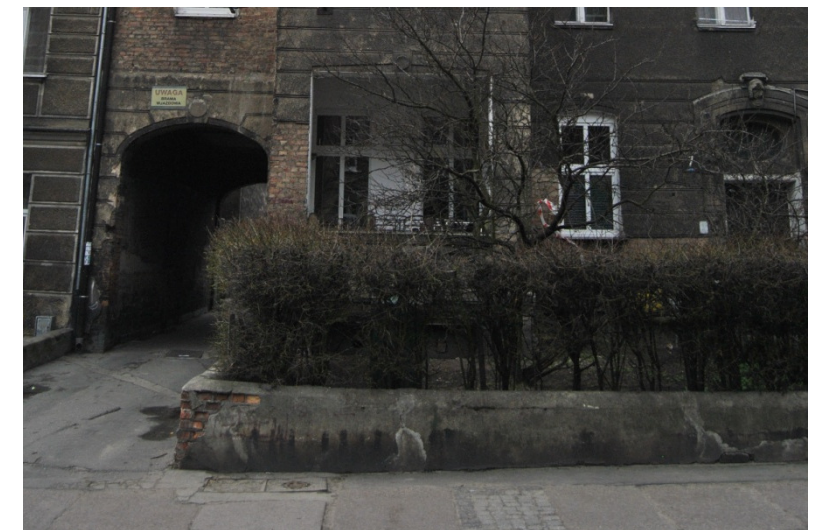
Analysis of problems

The perimeter wall that surrounds the landscaped area of the building is realized by massive ceramic brick and a recovering of mortar of lime. The above mentioned wall has a big number of cracks in all his length that in some cases reach more than one centimeter of thickness. Also, in some areas these cracks have provoked detachments of a considerable size. The garden is formed of a line of firs that surrounds the area, and three trees distributed randomly.

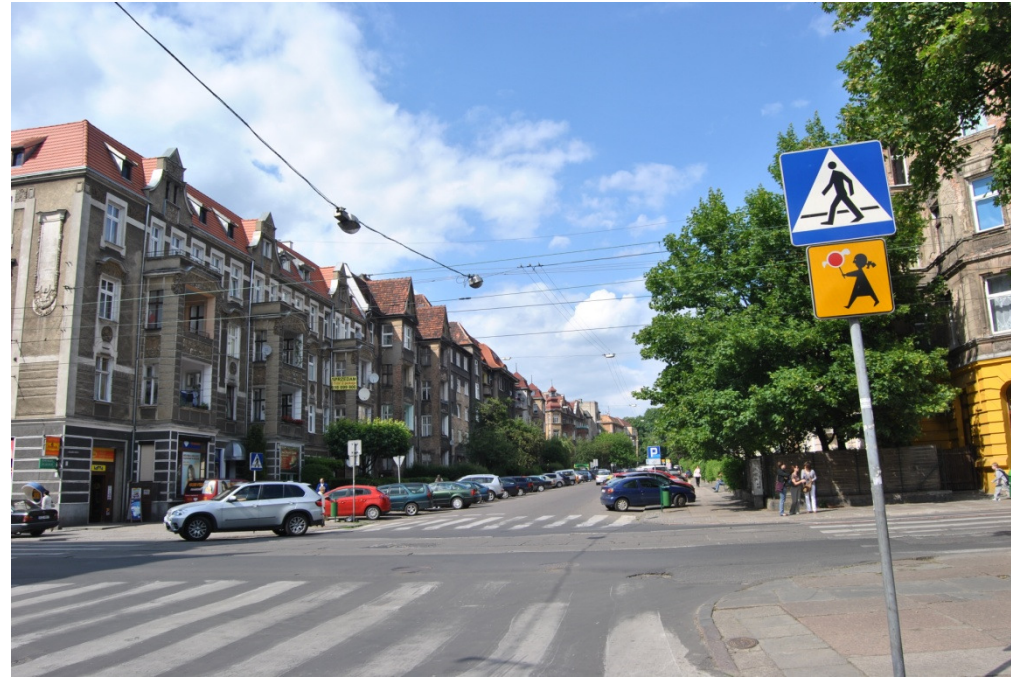
PICTURES AND SECTION ABOUT THE STREET

Building between two part walls of c / Bolesława Smiałego of the quarter commented previously. In this street the buildings have the same height of approximately 19 meters, they all are residential ones destining the first floors some of them to commercial areas.

The C / Bolesława Smiałego takes sidewalks as both sides and double rail for vehicles transit.

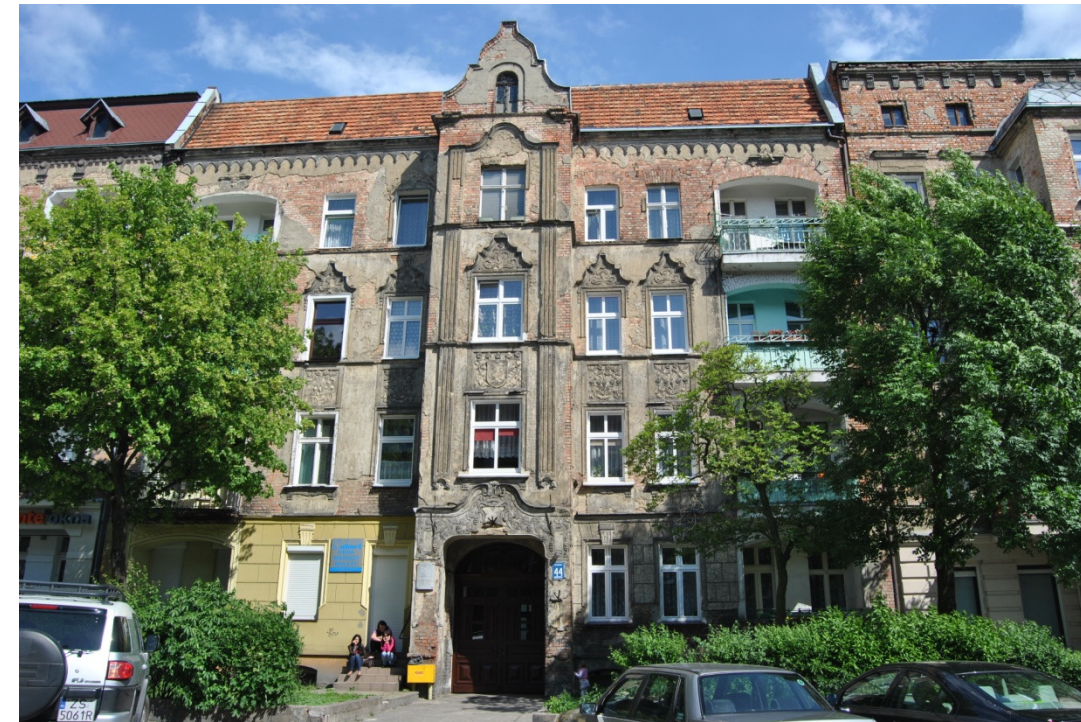
Principal facade

- Residential building of first floor, three plants type more garret.
- Principal access in the center of the facade, the opening have the dimensions: 2.5x3.9m
- The openings are rectilinear of windows of two tiers and four parts.
- Dimensions of elevation: 21.4x19.97m

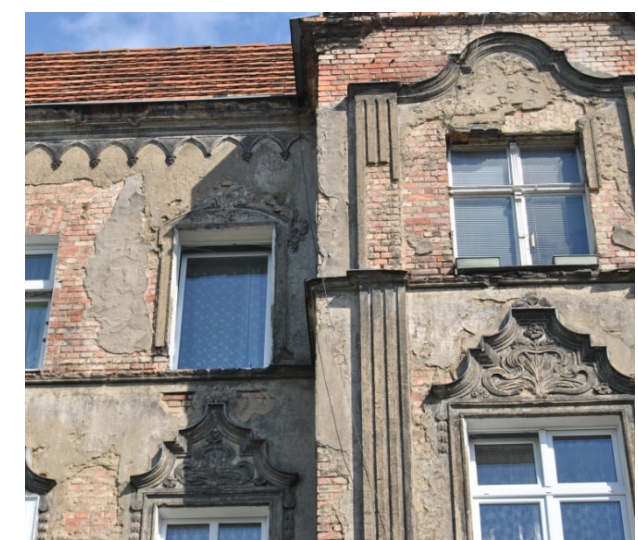
Decoratives elements

In the bay windows there are two vertical tiers simulating columns, one to every side of the hollows.

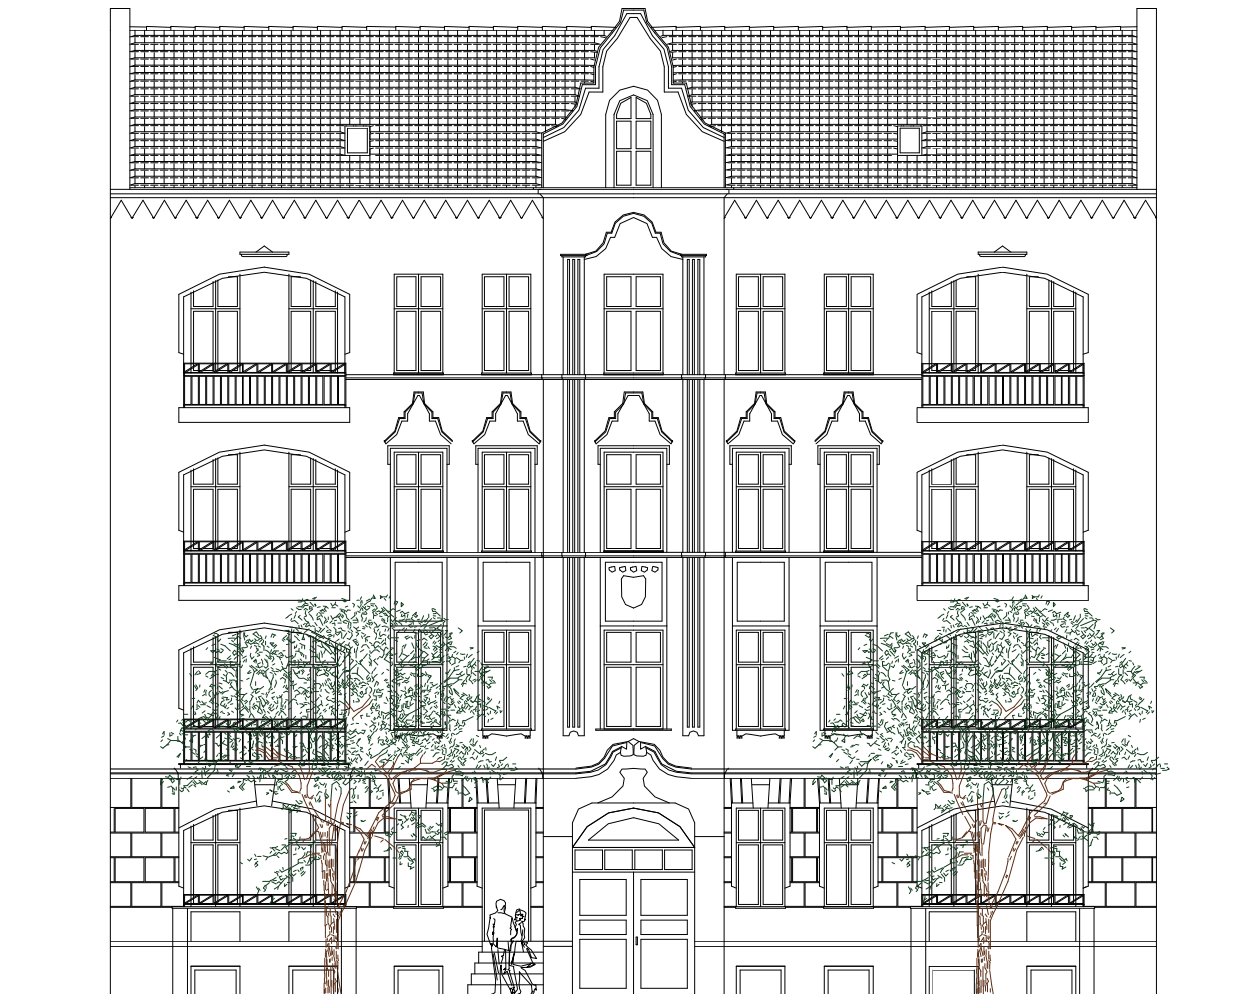
PRINCIPAL FACADE

Openings in bay windows:

Frontal face: 3x1.2x2 m and 1x0.8x1.9m finished in the top with oval form

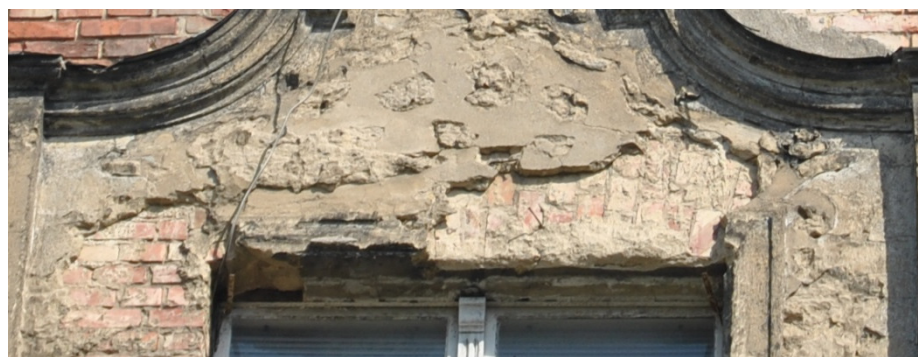
The facade just presents a type of revetment:

Lime plaster: In ground floor, the mortar has a form of false vereering of stone in smooth, while in the following plants it appears without form.

As solution to this pathology we propose the entire replacement of the lime mortar used in the facade for a cement mortar of better quality. Also one will proceed to the cleanliness of the bricks and joints that form the wall. After that we restore the grip mortar and to plaster again the facade. With this, we will prevent the dirt from provoking damages to the new revetment.

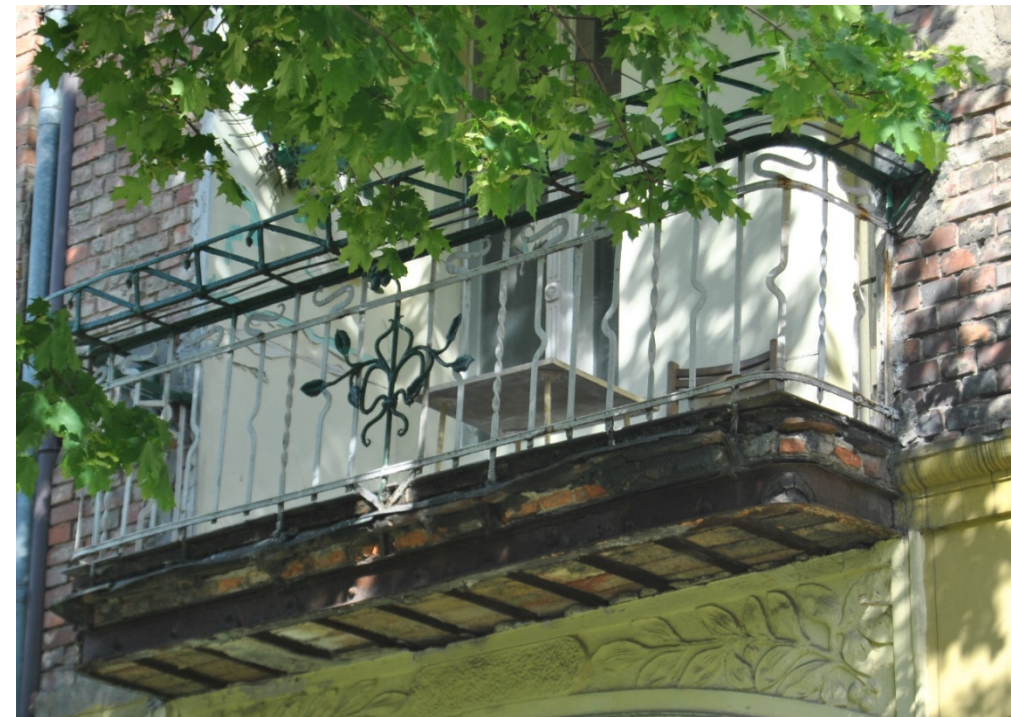
Cantilever's pictures:

In the balcony of the ground floor exists a small wall that provides a trapezium form.

It is the cantilever of the first floor in the left part and it has a detachment of the final revetment and corrosion in the joist that form this cantilever. The oxide provokes an increase of size of the material, this increase provokes the detachment of the plaster.

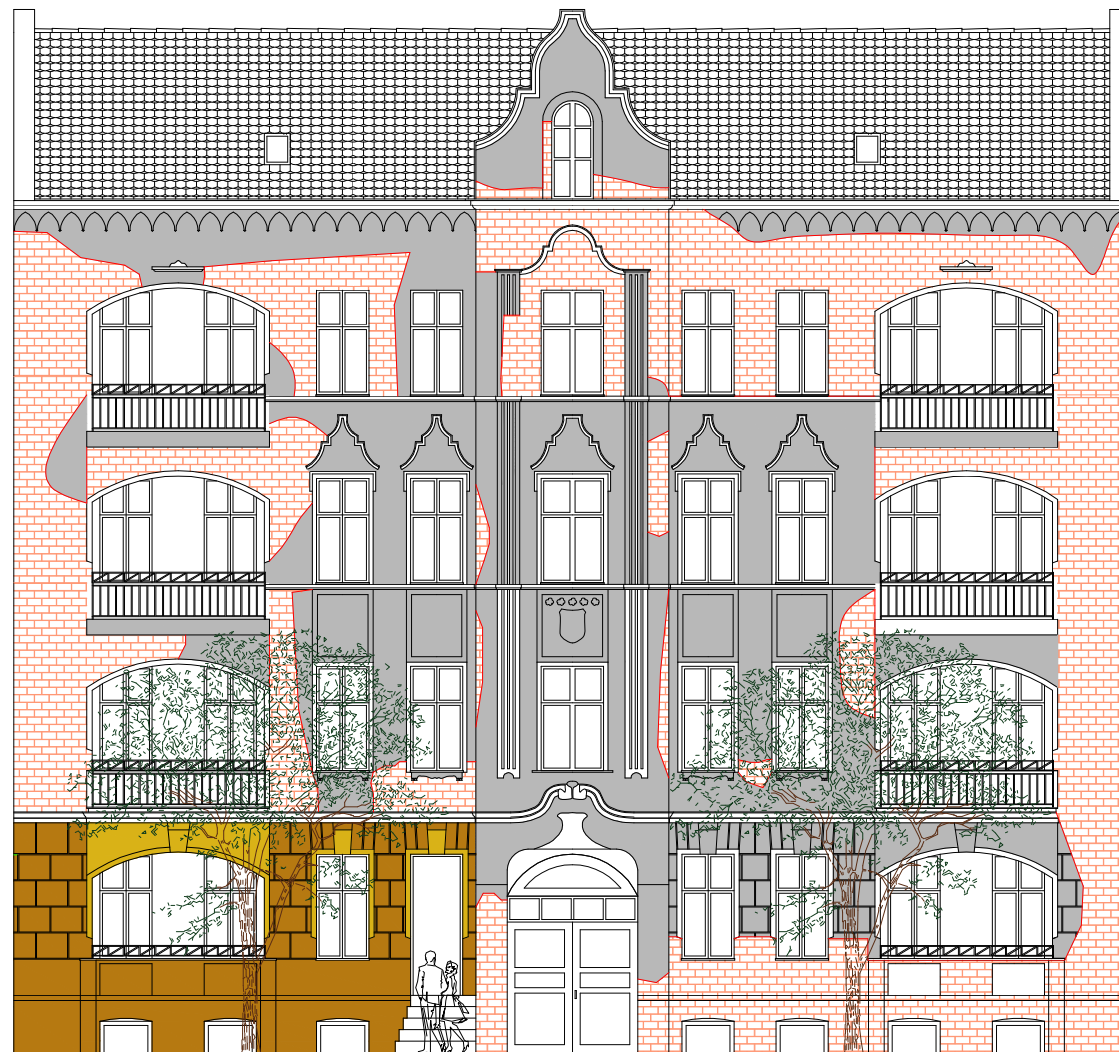
File 44.1: Degradation of lime mortar

This problem can have been caused by the bad quality of the mortar joined little care of the users during the useful life and the meteorological inclemencies of the area. The mortar has gone disintegrating leaving to the air the bricks. The black color stems from the moisture and the contamination of the streets that have provoked that the particles place the pores of the mortar giving him a dirty color.
