FINAL PROJECT HISTORICAL, CONSTRUCTIVE AND PATHOLOGICAL ANALYSIS OF MODERNIST BUILDINGS IN SZCZECIN

AUTHORS OF PROJECT:
JORGE SENDRA SENDRA
CLARA SAIS GIRONÉS

4.3 Problems in the building

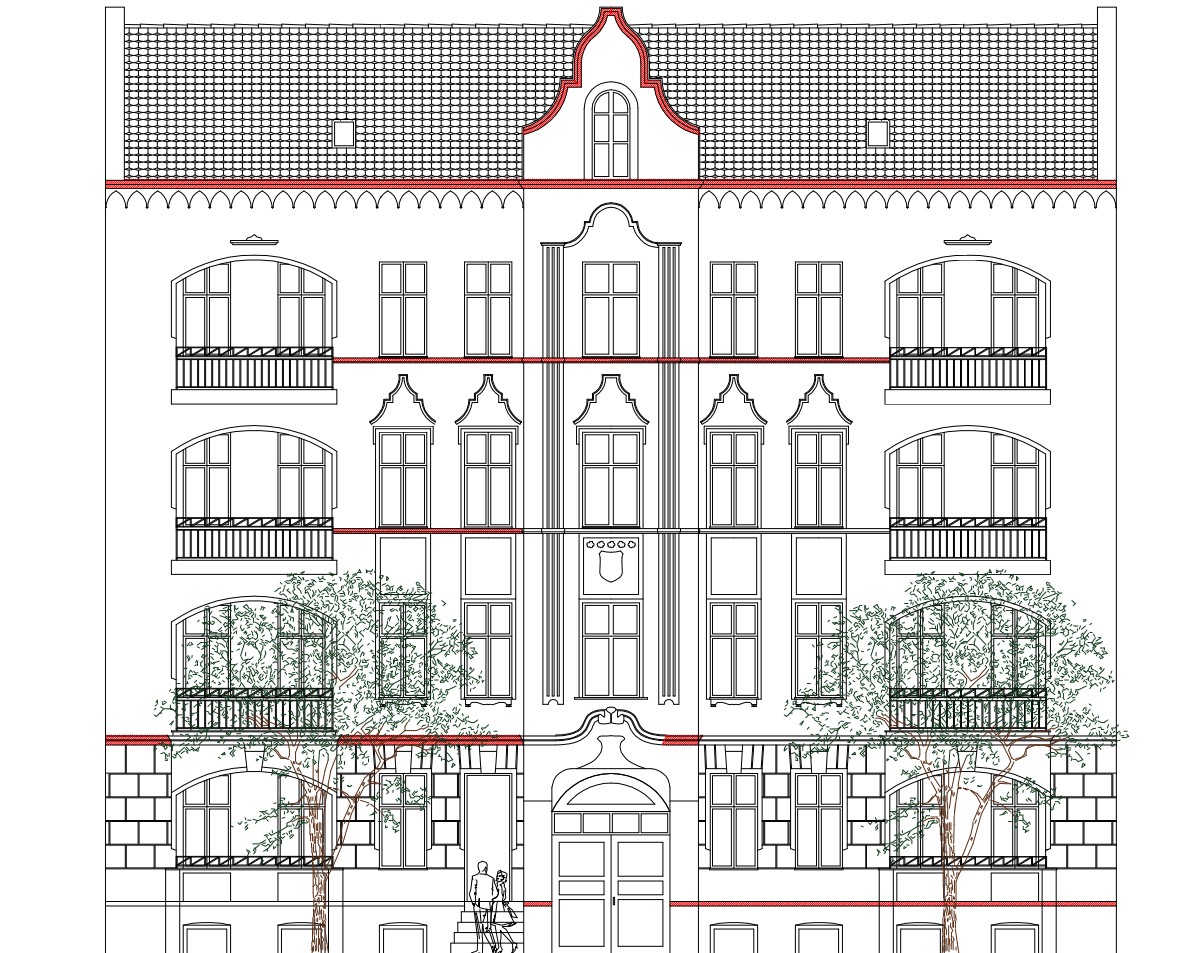
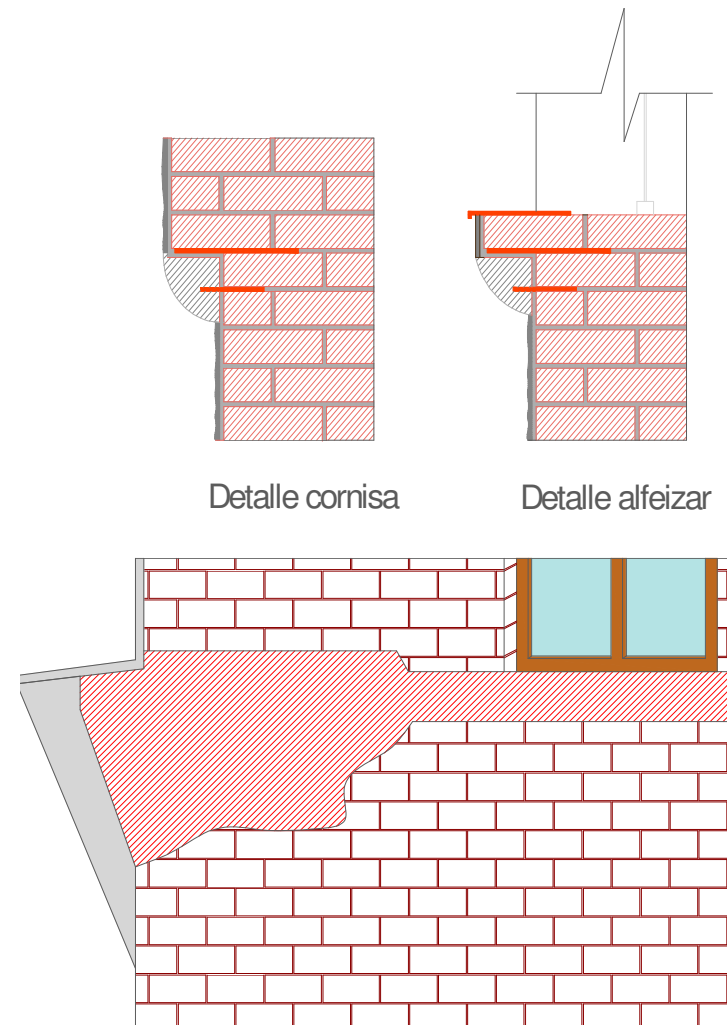
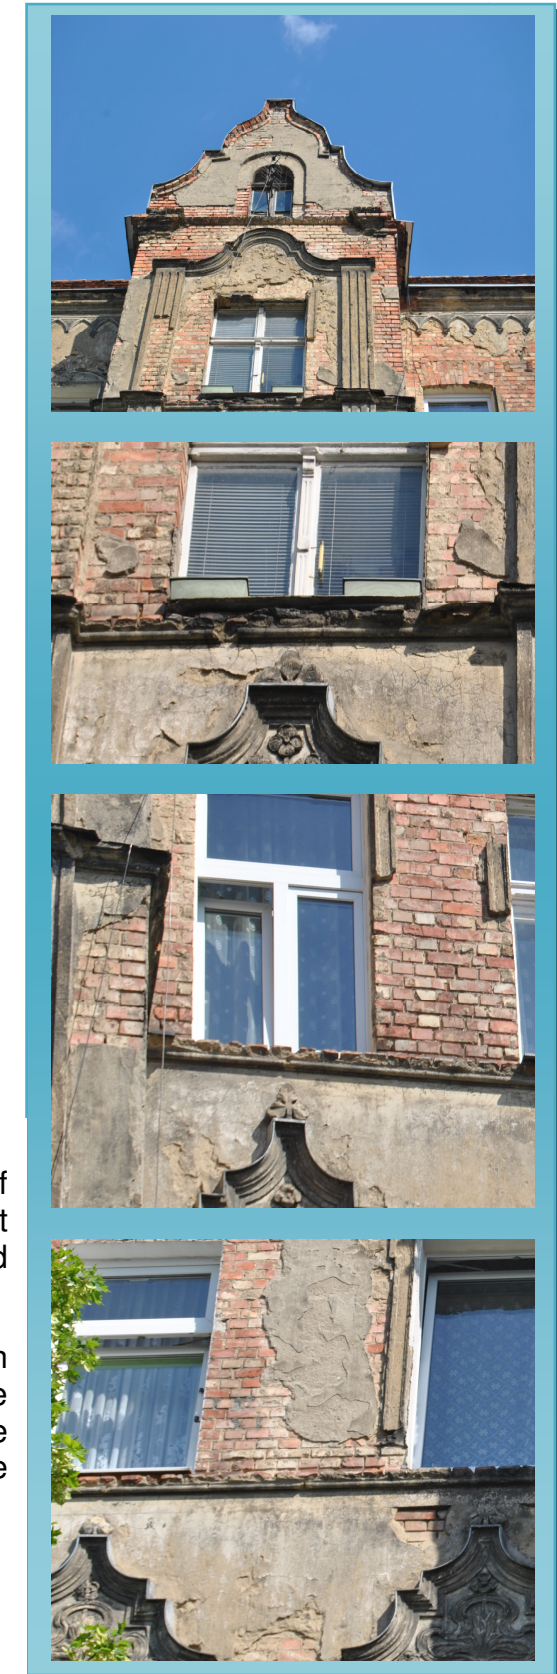
File 44.2: Degradation of the cornices

In this front there is an important deterioration. In almost all of them, the bricks that were forming the cornices has left exposed to the inclement weather. There is seen the sheet used for the grip of the frames of finished because these have disintegrated. For the sills in the windows, they are very damaged.

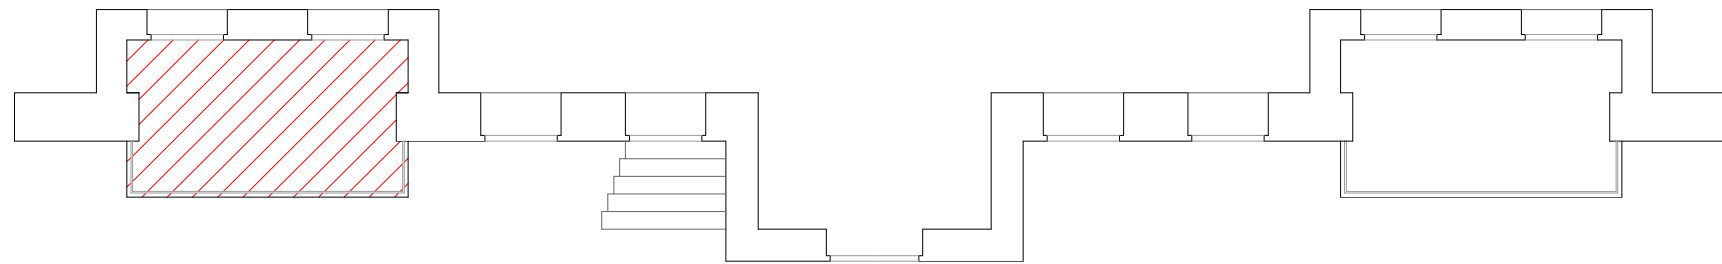
File 44.1: Corrosion cantilever joist

The rails are misshapen and it has oxide in all the cantilevers of the facade. The worst zone is the connection of the rail with the framework strap.

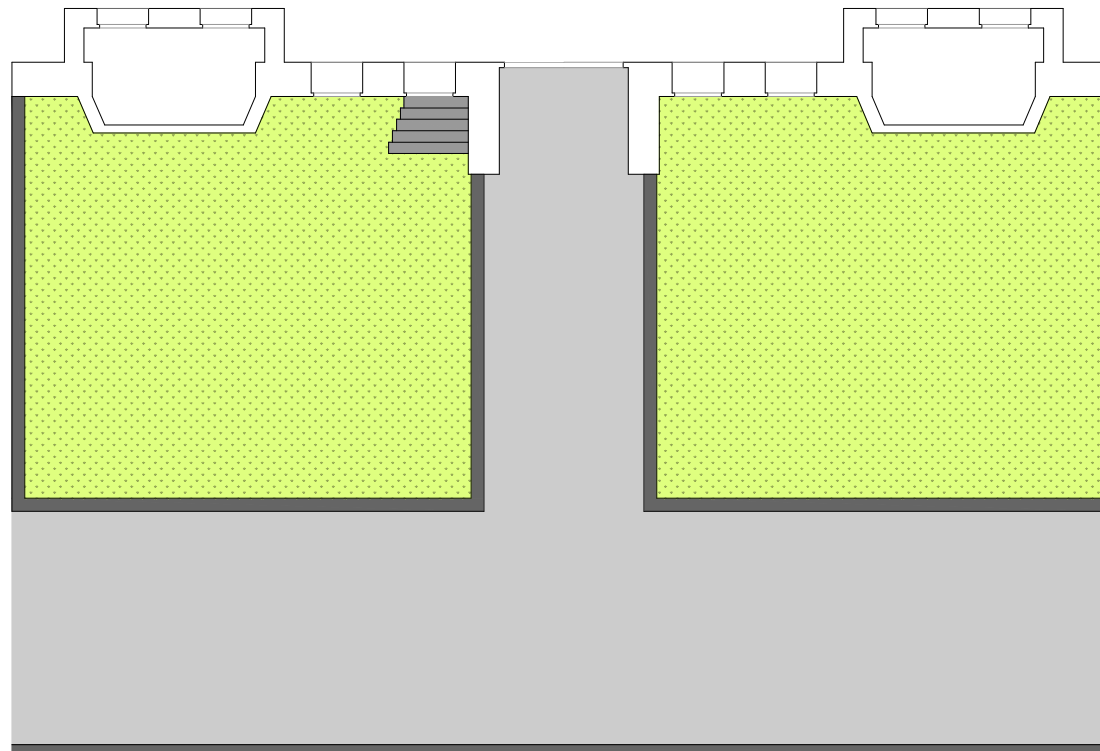
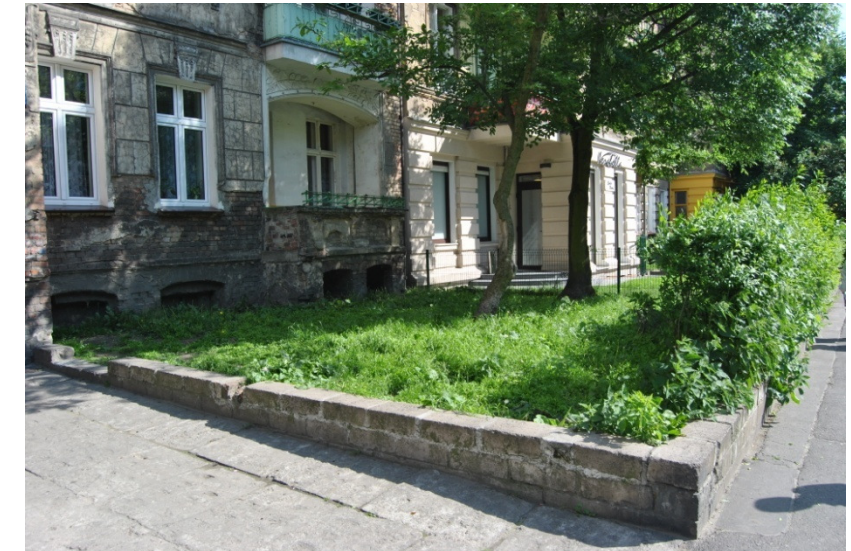
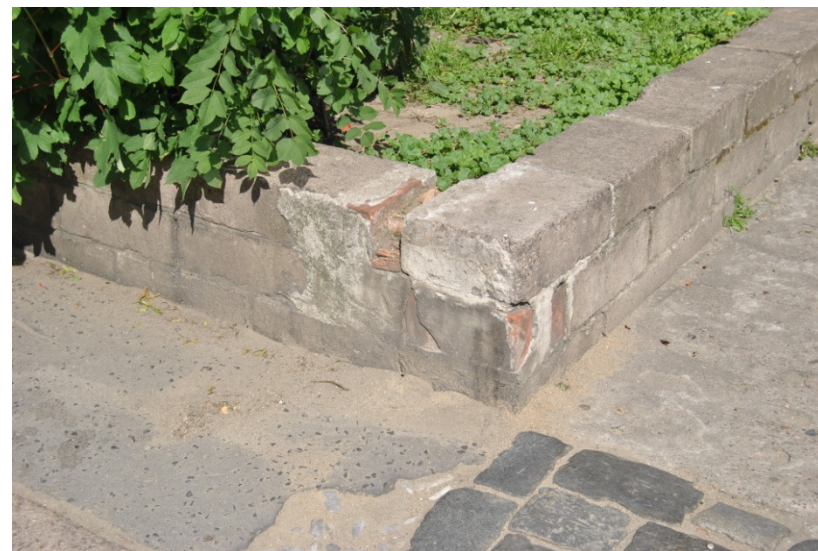
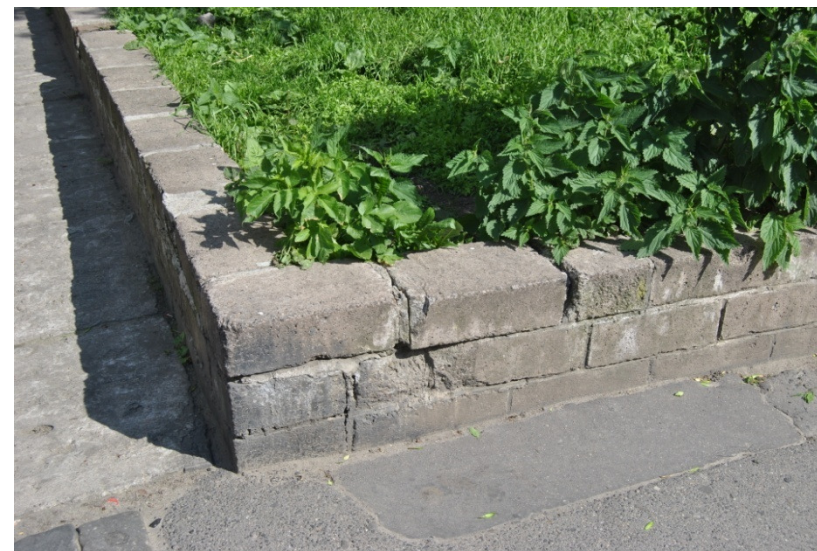
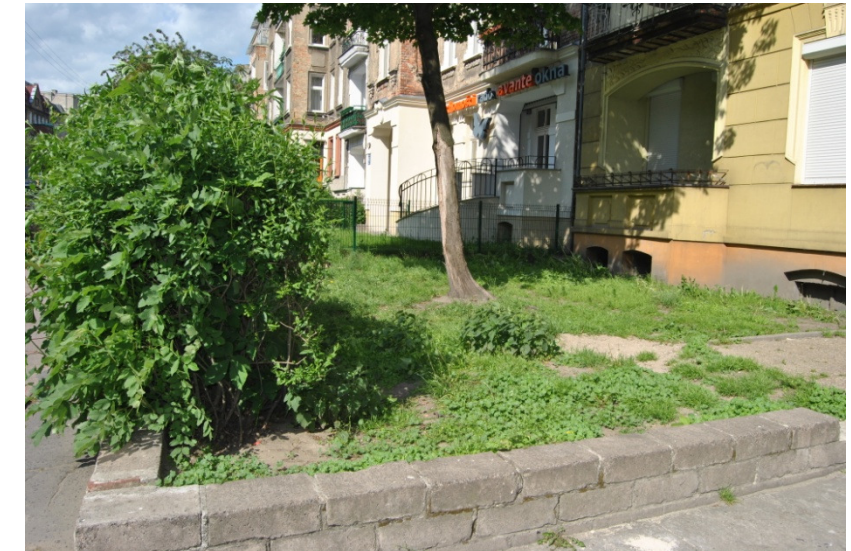
Original model

The perimeter wall that surrounds the landscaped area of the building is realized by massive ceramic blocks and a recovering of mortar of lime. The above mentioned wall has a big number of cracks in all his length that in some cases reach more than one centimeter of thickness. Also, in some areas these cracks have provoked detachments of a considerable size. The garden it is formed by a firs line in the frontal face, and a 5 m tree in both sides of the landscaped area.
