An Investigation of Shear Wall of Moen-Jo-Daro Using Mechanical Properties

Shazada Muhammad Umair Khan¹ Park, Jae Seung²

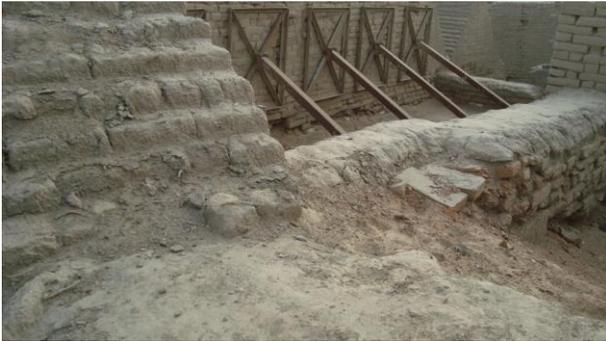
Fig. 1 The exo skeletal support

T sectioned trusses installed at the chief house to prevent the buckling effect for only one side (Fig. 2). This interruption compromised the building structural scheme as shown in (Fig. 1).

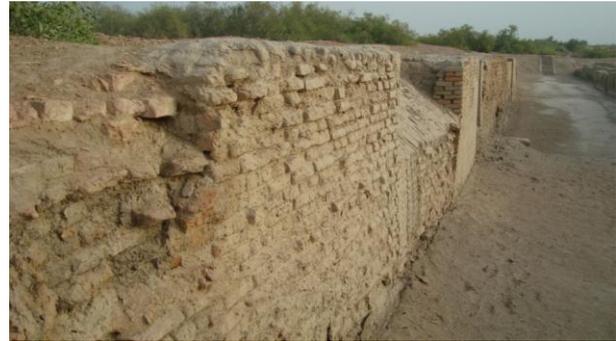
Fig. 3 The brick are being attacked by the salted water from the back, of the inclining wall

As a result, the failure generated due to the excessive horizontal displacements. As far as, the critical crack behavior generally follows as shown in (Fig. 3). The longitudinal cracks generate at the extrados parallel to the edges. This phenomena has been generated doing the inspections of damaged structures but no there is no crack propagation or the distribution of the loads during failure.

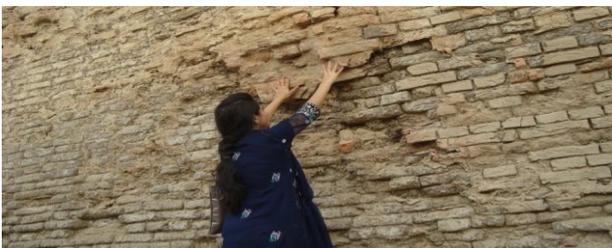
Fig. 4 Showing salt penetration: into the pours of the bricks.

This support for the south room, that consists of square compartments having the height of their vertices reaches in the middle of the lateral elevation as shown in (Fig. 4).

The outer edge it is supported on the wall and attached. Whereas, the edges of support along the wall rest upon the main foundation (Fig. 4). Transverse pointed angle support mark the edge between the neighbouring bays. The diagonal ribs and the transverse wall have the same plain cross section and they spring from a low buried foundation, while the pockets created between the supports of the wall reach the third of the height. The wall is made of load bearing masonry, composed of long thin slabs of regular thickness.

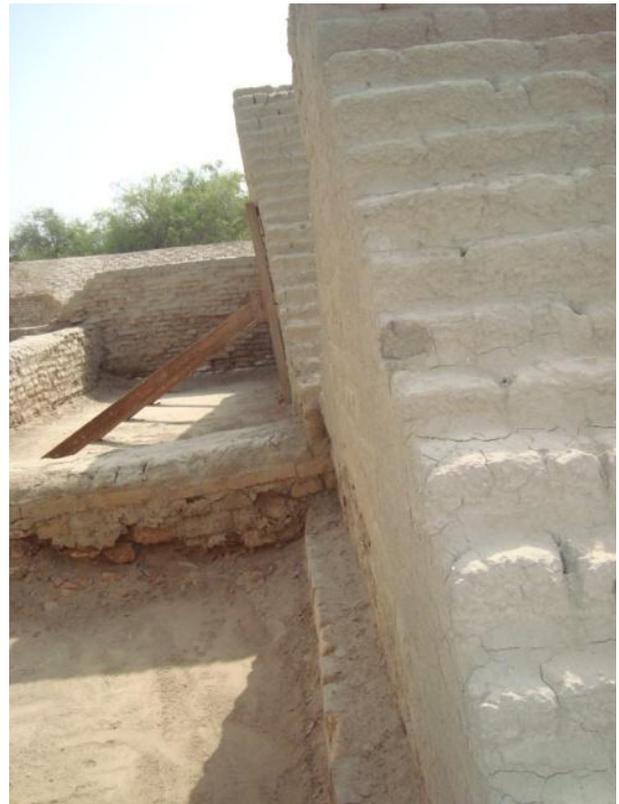
Fig. 6 the view of the deformation

Base don the different types, the signs of ground surface motion that makes more different impact on buildings being determined (Fig. 6). For horizontal tensile deformations the cracks are generated in external walls and the nature of

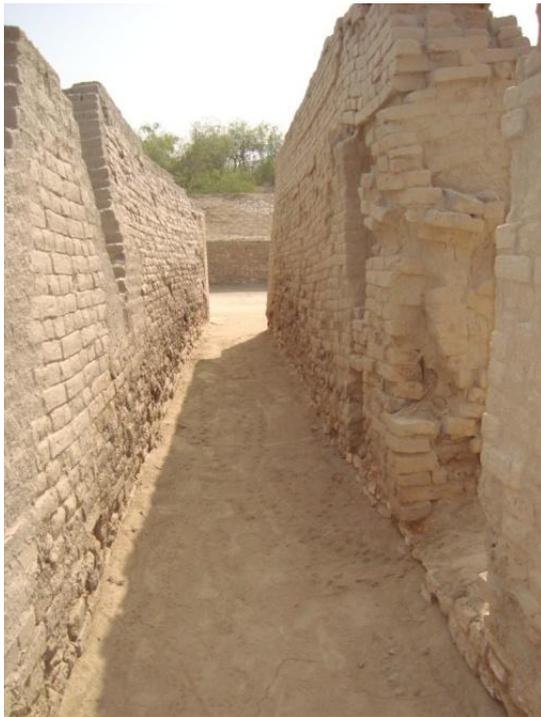
Fig. 11 The deformation is seen in the perspective from the other side

In (Fig. 12) the displacement figures within the wall nodes it can be found either by fixing the labels as originally shown in (Fig. 11) at a very casual manner by selecting them using select tool. It will generate the comparative results it appears in results pane for specific identification. The result can also be evaluated by using the inspector pane. The different test cases describe the basic performance of present wall elements. Currently, its very easy as differentiate to every issues that specified on this explanatory example. It highlight the different situation that apply forces with differences in between the current elements. For an individual bricks it has not the rotational degrees of freedom due to bond. In (Fig. 13) that shows the output that obtained by the standard uniaxial loading and boundary condition configuration ($P = 24$ k).

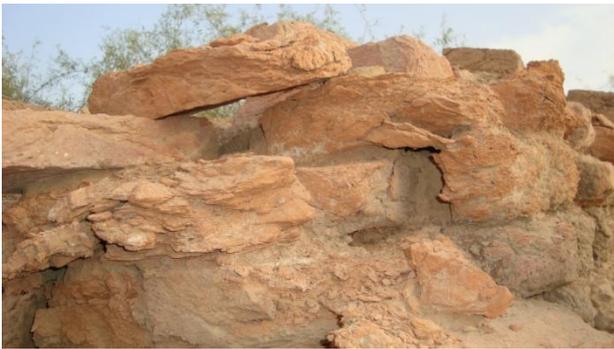
Fig. 16 View of deformation Shows the crumbling bricks

The vitrified bricks have a capability to accept the dampness slowly as shown in (Fig. 16). This action is due to only path for the humid and moisture is the mortar. In account of this, the following action is helpful;

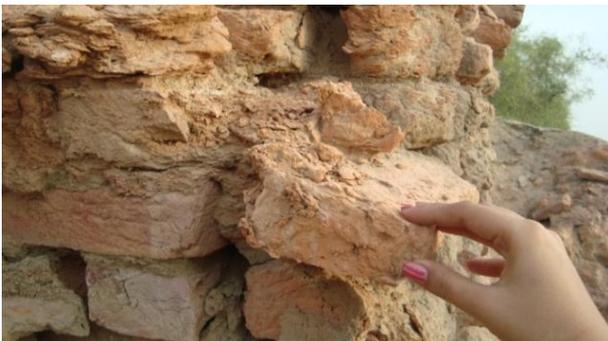
Fig. 18 The wall brick deteriorating

In Fig.18 as we can see that the water material height that is highly porous bricks with high open porosity.

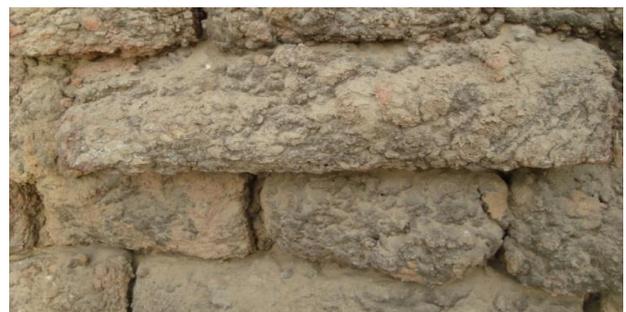
Fig. 19 The penetration of the water vapour, and expansion, inside the pore.

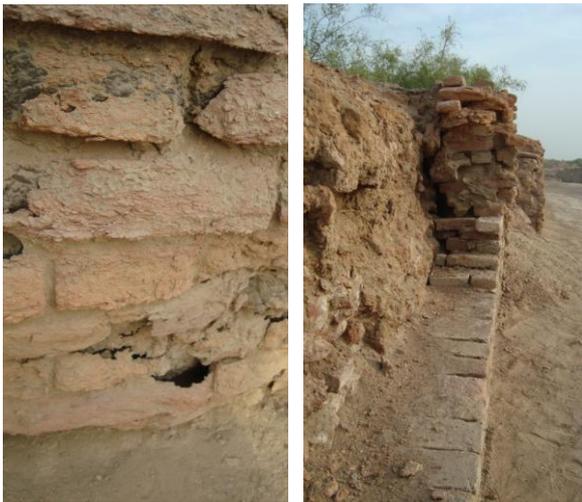
Fig. 20 The deterioration of the wall

This presence of water and expansion as shown in (Fig. 20) of the pores is visible in the close up of the bricks, as shown in the below picture, the wall disintegration is visible, where the bond broke.

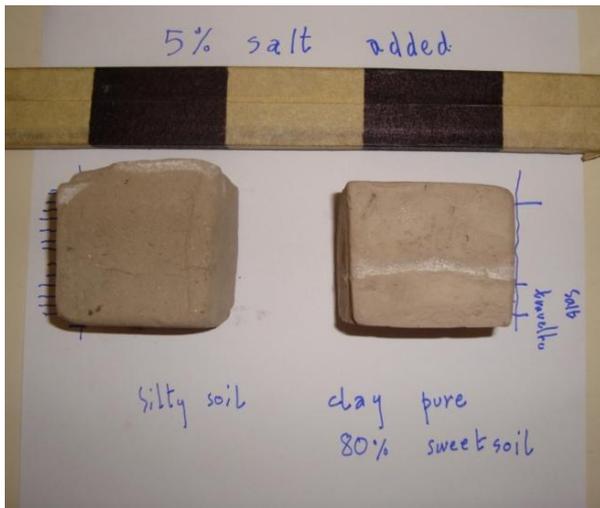
Fig. 22 Experiment of submerge the clay cube into salted water.

The experiment has conducted through making the clay cubes having the dimension of 7 cm by 7 cm. It has dipped within the water at 5 percent salt. It kept during overnight and the salt is being recrystallised and moved as shown in (Fig. 22).

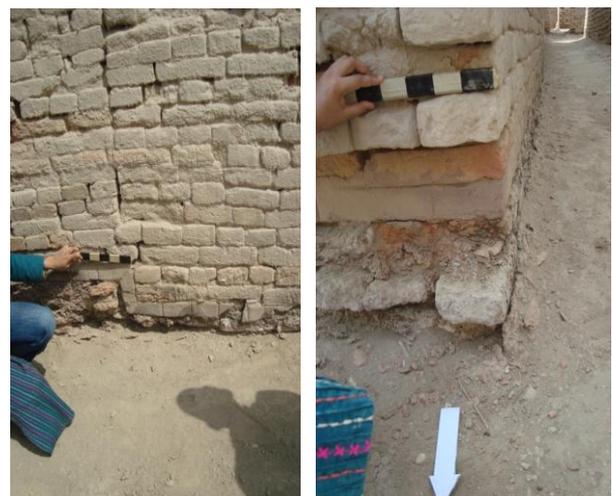
Fig.25 Shows the salt travel effects

In (Fig. 25) the few aspects that we have been studied in a location of Mohen Jo Daro. The
