A Full-scale Timbrel Cross Vault Subjected to Vertical Cyclical Displacements in One of its Supports

Benjamín Torres, Elisa Bertolesi*, Pedro A. Calderón, Juan J. Moragues, Jose M. Adam

Up-and-down cyclical displacement of supports-foundations, due for example to the presence of expansive soils, can affect the integrity of a structure and may even lead to its collapse. A recent study carried out at the ICITECH laboratories of the *Universitat Politècnica de València* analysed the effects of earth settlements on the behaviour of masonry cross vaults. One of the tests involved the construction and testing of a full-scale timbrel cross vault, one of whose supports was subjected to up-and-down vertical displacement cycles. The 4×4 m² vault was composed of four 3.6 m diameter arches supporting a masonry web. Vertical displacements were applied to one of the supports by means of two synchronised mechanical jacks. The results of the tests provide valuable information to the scientific community, architects and engineers on the behaviour of timbrel cross vaults when one of their supports is subjected to cyclical movements.

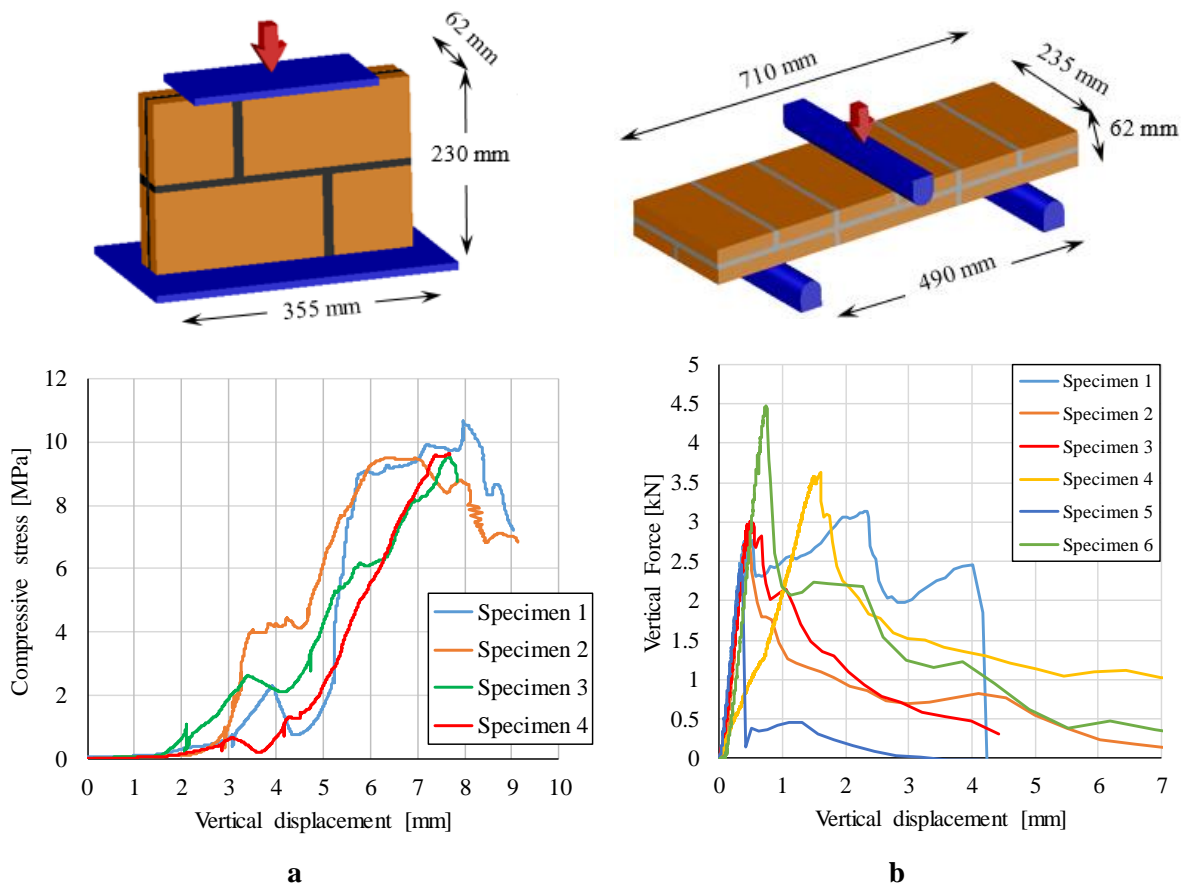
Figure 4: Laboratory test set-up and obtained results: compressive test (a) and three-point bending test (b).

The analyses comprised the experimental testing of a total of 10 masonry prisms to identify the mechanical properties of the masonry in the web. Four of the samples were tested under compression and the remainder were tested by a three-point bending test. The two experimental set-ups are depicted in Figure 4, together with the specimen dimensions. The results obtained are shown in Table 2.

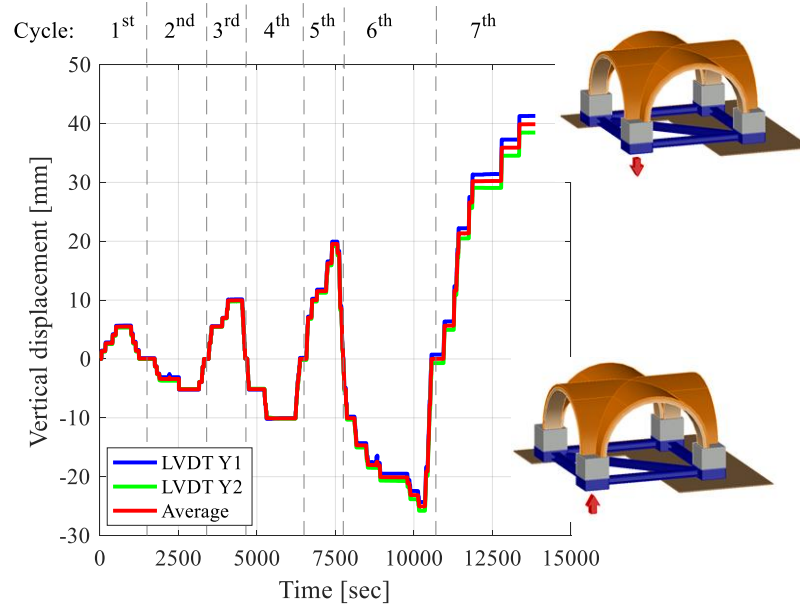
The experimental investigation consisted of the laboratory testing of a full scale timber cross vault under the controlled displacement of one of its supports. The cyclic settlement history is depicted in Figure 5. As can be noted, the lab protocol consisted of the application of a series of controlled vertical displacement (downward-upward) cycles, gradually increasing the magnitude of the imposed displacement. Each amplitude was executed by one complete cycle (upward/downward displacement) in which the movement was gradually increased by doubling the vertical displacement applied at the end of the previous one. The experimental test was stopped when the crack widths compromised the stability of the structure. Indeed, after the test, the damaged cross vault was repaired with textile-reinforced mortar (TRM) placed on the extrados surface. The strengthened vault was then re-tested by applying a series of cyclic settlements to support S1 to evaluate the effectiveness of the cement-based materials (TRM/FRCM) for the retrofitting of full-scale masonry cross vaults. The analysis of this test is outside the scope of this paper and will be disseminated in the near future.

Figure 5: Displacement history of one of the supports of the cross vault tested.

To explore the behaviour of the timber cross vault when loaded by a series of cyclic settlements, support S1 was subjected to the displacements depicted in Figure 5. The maximum displacements imposed were equal to 40 mm and -25 mm, considering a downward and upward movement, respectively. The time evolutions of the vertical reactions of all the supports are shown in Figure 10. As expected, the four monitored supports experienced a series of loading-unloading cycles. The distribution of the vertical forces on the four supports is quite symmetric. When a downward displacement was applied to support S1, the loads increased on the two opposite sides (S2 and S4), while S1 and S3 remained unloaded. Conversely, when an upward movement was applied to the vault, the opposite behaviour was observed. This trend could be seen throughout the entire test and even beyond the elastic limit of the vault, as can be seen in Figure 10.

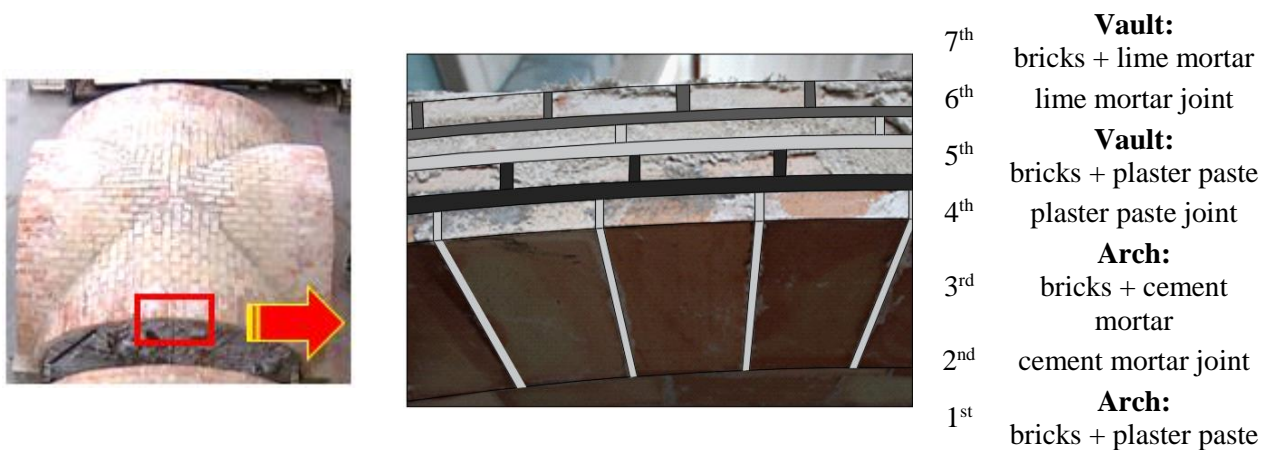
Figure 8: Masonry cross vault: detail of one of the arch.

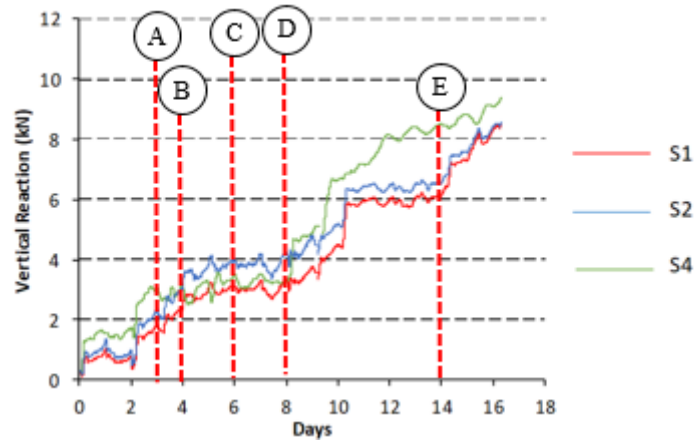
During the construction process, the vertical reactions of three of the four supports were constantly monitored. The time evolutions of the vertical forces are given in Figure 9, together with the time steps at which the images shown in Figure 7 were extracted. The third support, S3, was completely fixed. Although it was not possible to monitor the vertical reaction at this point, an indirect estimation of the vertical force was obtained by means of the vertical equilibrium of forces of the total weight of the cross vault (35 kN). This value was approximately 9 kN. As can be seen in Figure 9, the vertical forces followed approximately the same trend during the construction process, as was confirmed by the total values of the vertical force on each support at the end of the construction process, which was symmetrically distributed along the four supports and approximately 9 kN. The slight differences found can be explained by several concurring factors, which are always present in experimental tests: the material's heterogeneity, the unsymmetrical geometry induced by the construction process and the masonry texture.

Figure 9: Time evolution of the vertical reactions during the construction.

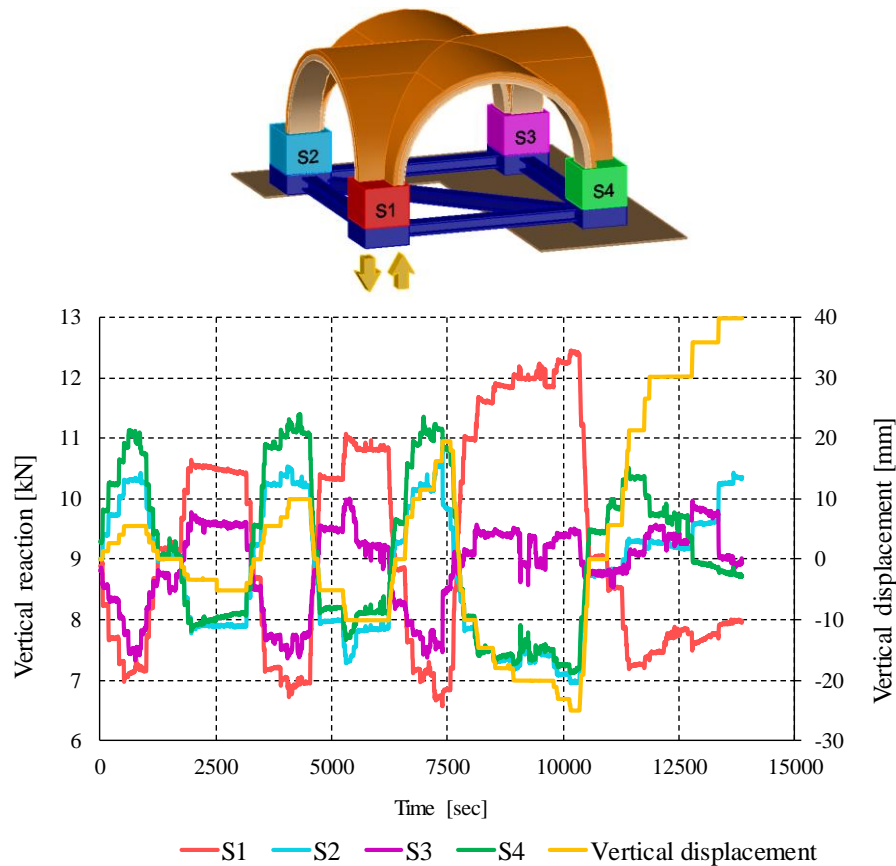
Figure 10: Time evolution of the vertical reactions monitored in the supports.

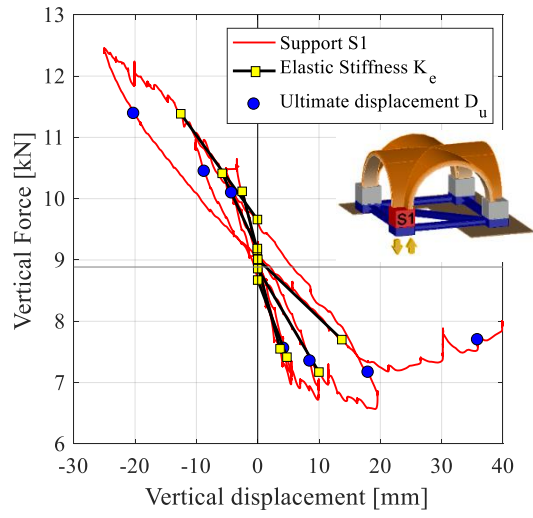
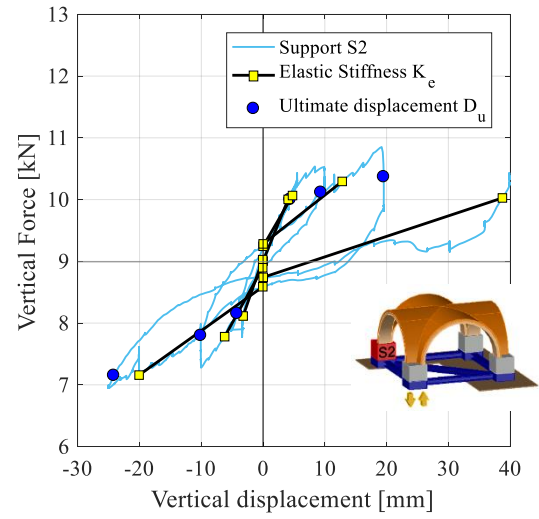
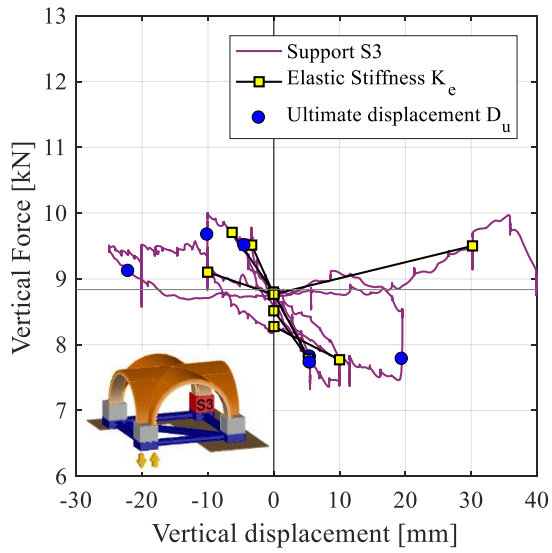
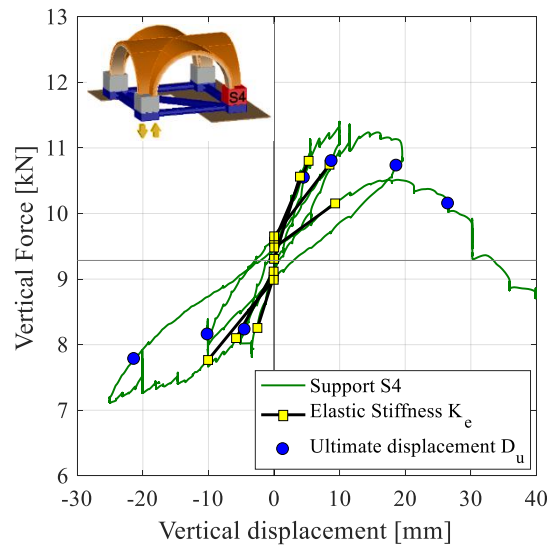
Figure 11: Force-displacement curves in all the abutments: S1 (a), S2 (b), S3 (c) and S4 (d).

Supports S2 and S4 showed quite similar behaviour during the whole test, as confirmed by Figure 11-b and -d. Conversely, slightly different results were found in S1 and S3. This asymmetric behaviour was noted not only in the experimental load-displacement curves, but also in the damage patterns at failure. The cracking mechanism is usually strongly influenced by the heterogeneities of the masonry material, which can be present in the vault from the beginning or produced during the experimental test, and by the wide variability in the characteristics of the constituent materials.

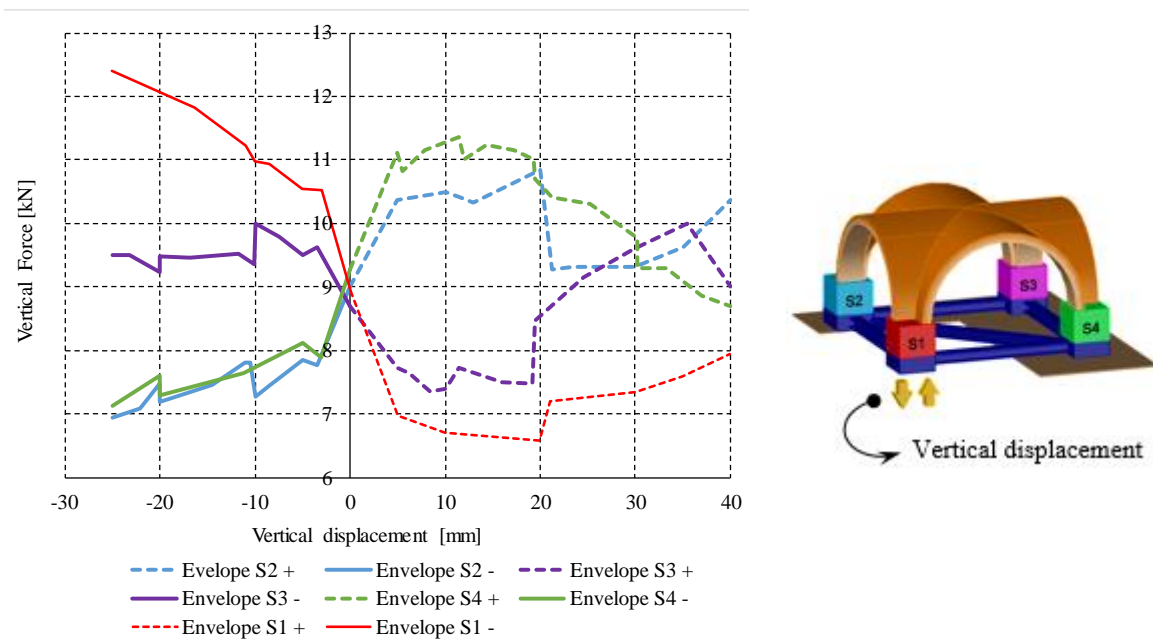
The load-displacement envelopes are shown in Figure 13 for all the supports monitored during the test. The first linear elastic phase is present at the beginning of the test. As confirmed by the visual inspection during this phase, no damage had occurred. The behaviour of the vault within the elastic branch was quite symmetric. However, a slight difference was found in their threshold values (5 mm and -3 mm). After cracking, the vault behaviour changed significantly. When upward displacements were applied, the trend of the reaction forces beyond the elastic phase was characterized by increasing values until reaching approximately a displacement of -10 mm. Although the results of S2 and S4 were more consistent with those of S1 and S3, all the supports showed a sudden drop in the vertical force of around

Figure 13: Experimental envelopes of maximum values of the force-displacement curves obtained for the four monitored supports.

-10 mm. After this phase, strength gradually degraded in supports S4 and S2, as confirmed in Figure 12-b. Support S3 experienced a fairly constant trend in the vertical force, while it continued to increase in S1 until the test was stopped (Figure 12-b).

The behaviour of the vault when downward displacements were applied was quite different from the upward case. In almost all the supports the vertical force reached the peak load at approximately 15-20 mm. When the displacement reached 20 mm, the reaction load suddenly dropped and the strength rapidly degraded. Around 20 mm, a crack appeared along one of the diagonal elliptic arches which separated the vault into two independent parts. The displacement at failure increased by 25% with respect to the elastic limit, which partially confirmed one of the most important features of masonry cross vaults: their capacity to withstand movements of the supports. Several case studies in the technical literature [10] confirm that they frequently exhibit a significantly higher capacity to sustain vertical support displacement than horizontal movements.
