DOI: https://dx.doi.org/10.4995/FORTMED2020.2020.11482

# Recovering of an identity: restoration works of the Orsini-Colonna castle in Avezzano, Italy

## Marco Felli<sup>a</sup>, Antonello Incerto<sup>b</sup>

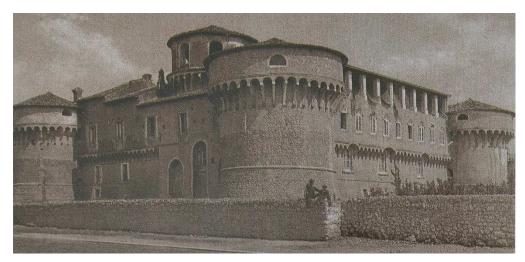
Fig. 3. The Orsini Colonna castle of Avezzano before the earthquake of 1915 (Lustri's collection, from Di Domenico, 2002).

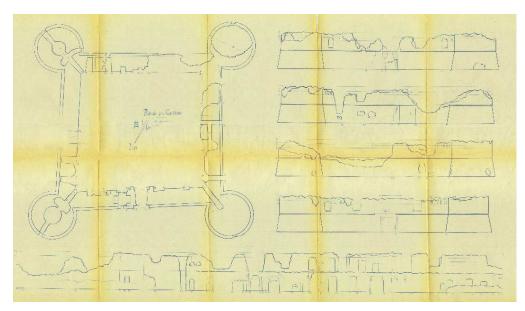
Fig. 6. Survey of the castle, with the identification of the collapses of the perimetral walls (Orlandi, 1962, from Historic Archive of Genio Civile, section of L'Aquila, subsection of Avezzano).

The most important works in this recovery phase focused on the structural preservation and fortification, with the aim to recreate also the top trench of defensive, recovered in one-thirds (Fig. 7).

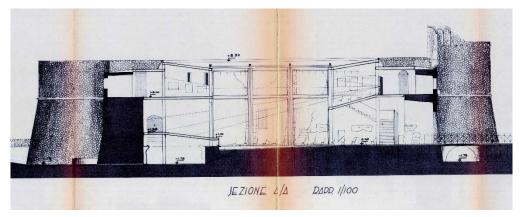
Fig. 9. Section drawing of the project (Del Bufalo, 1994).

Alessandro Del Bufalo, the works of restoration and recovering of the building started in 1994. While around the castle it has been recreated also the defensive moat, the most interesting part of the work focused on the interior of the building. In particular, the most important part of the project is related to the insertion of a new structure, completely independent from the masonry walls, in steel and glass, so lightweight and transparent, in a way to reconstruct with a modern key the lost architectural spaces, which contrast their lightweight to the material presence of

the walls. The new purposes of the building are divided according to the floors; in particular, the ground floor can be used as a concert/conference hall, thanks also to the insertion of a stage in one side of the courtyard; the upper level, instead, is characterized as an exposing space, for paints, drawings. (Figs. 7 and 8) The structure, composed of square section columns and beams in steel, interested also two new floors, always in steel, in a way to reduce the thickness of the slab, and inserted inside the courtyard (one floor is 5.00 m height from the ground, while the upper one constitutes the crawl space). The use of glass and steel let the users able to see and understand all the sides of the courtyard, and also to see the paints and the other exposed elements. The lower level, also, could be used as a conference/concert hall, thanks to darkening sails.

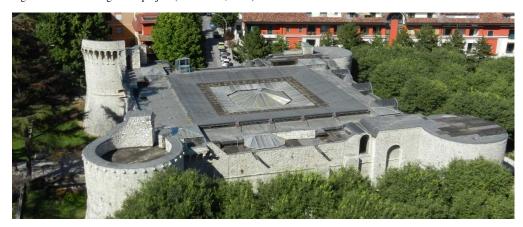
Fig. 10. The castle nowadays, with the steel and glass structure (Arch. Aldo Cianfarani, Avezzano).

The spaces next to the perimetral walls, can be used as exposing spaces for the archaeological ruins of the castle, which are in the best conditions of preservation, being not exposed to the external climate, and still visible with the sunlight thanks to the glass elements. (Figs. 7 and 8).
