# Effectiveness of Textile Reinforced Mortar (TRM) Materials in preventing Seismic-Induced Damage in a U-Shaped Masonry Structure Submitted to Pseudo-Dynamic Excitations

This paper presents the experimental results obtained from tests on a 2/3 scale U-shaped masonry building constructed in one of the *ICITECH* laboratories at the *Universitat Politècnica de València* (Spain). The prototype measured 3.31x4.19 m<sup>2</sup> by 2.15 m high and had a wall thickness of 230 mm. The masonry was composed of 230x110x50 mm<sup>3</sup> solid clay bricks with approximately 10 mm-thick mortar joints arranged in English bond. The tests were aimed at evaluating the effectiveness of cement-based reinforcing materials (Textile Reinforced Mortar) applied to weak masonry substrates severely damaged by horizontal loads such as those induced by a seismic event. The tests were carried out in three phases: (i) testing of the as-built structure, (ii) application of one external layer of TRM to restore the masonry's original load-bearing capacity and then (iii) testing the TRM-strengthened structure. Dynamic behaviour was monitored by both traditional and fibre optic sensors (FO), including 28 Linear Vari

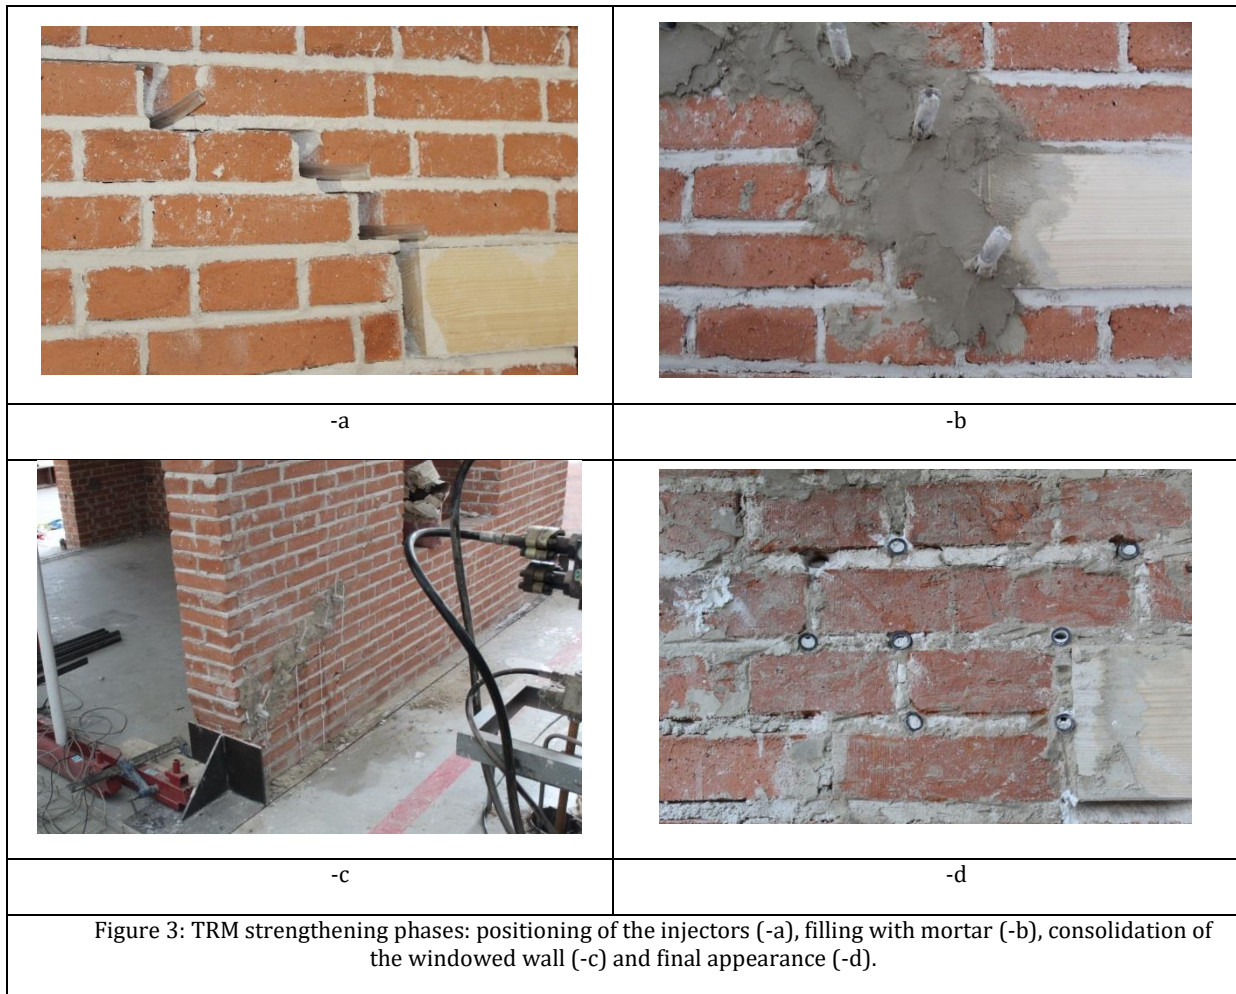
The tests were divided into two parts: (i) the application of a series of cyclic pseudo-dynamic excitations to the unreinforced prototype, and then (ii) the repetition of a partially extended loading protocol on the TRM-reinforced masonry structure. Before applying the TRM reinforcement, the masonry support was restored to its original load-bearing capacity. The retrofitting involved the following phases: (i) drilling 20-40 mm holes through approximately 2/3 of the wall thickness, (ii) positioning the plastic injectors (Figure 3-a), (iii) filling external

cracks to avoid slurry leaks (Figure 3-b and -c), (iv) injection of super-fluid slurry and (v) removal of the plastic injectors (Figure 3-d).

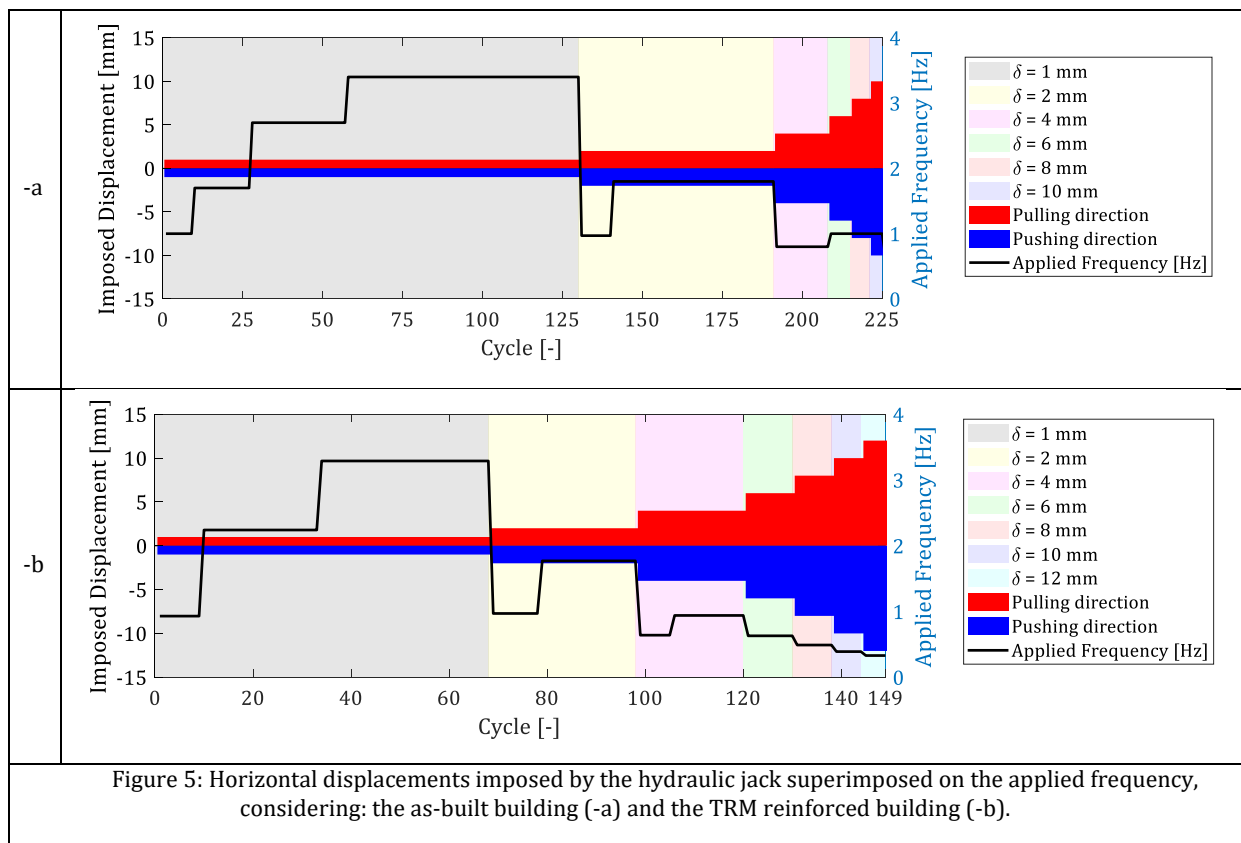
A total of 6 (225 cycles) and 7 (149 cycles) series of pseudo-dynamic excitations, each lasting 10 seconds, were applied to the unreinforced (URM) and TRM-strengthened structures. Figure 5 summarises both tests in all the series of dynamic excitations, horizontal displacements imposed by the hydraulic jack on the side panels, and the associated excitation frequencies.

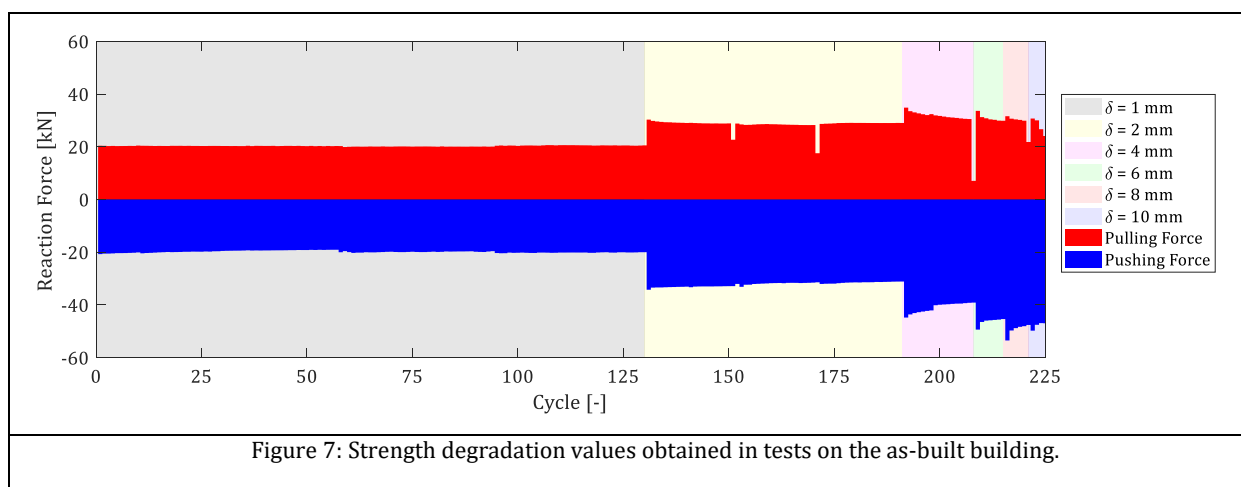
The strength degradation values shown in Figure 7 were computed from the maximum reaction forces read by the load cell in each cycle during the hydraulic jack's pulling and pushing actions. The behaviour of the masonry building can be seen to be quite symmetric ( $\pm 20$  kN) at low displacement values (up to 2 mm). As expected, the reaction forces increased with the imposed displacement, meaning that up to 4 mm negligible damage mechanisms took place.

After 4 mm, the structural behaviour of the as-built prototype clearly experienced strength degradation when subjected to pushing loads. Two different mechanisms can be seen from 4 mm till the end of the test: (i) reaction forces increased as the imposed displacement increased, but not in proportion, and (ii) different strength degradation trends were observed at each level of the imposed displacement. It should be noted that each displacement set was characterized by a steeper strength degradation slope as the cracking mechanism progressively worsened the building's structural response. This behaviour was also seen during pulling loads. Indeed, after 4 mm, the pulling forces did not increase with displacement, which could be explained by the cracking mechanism which spread to the loading areas and threatened the transmission of the pulling force to the building.

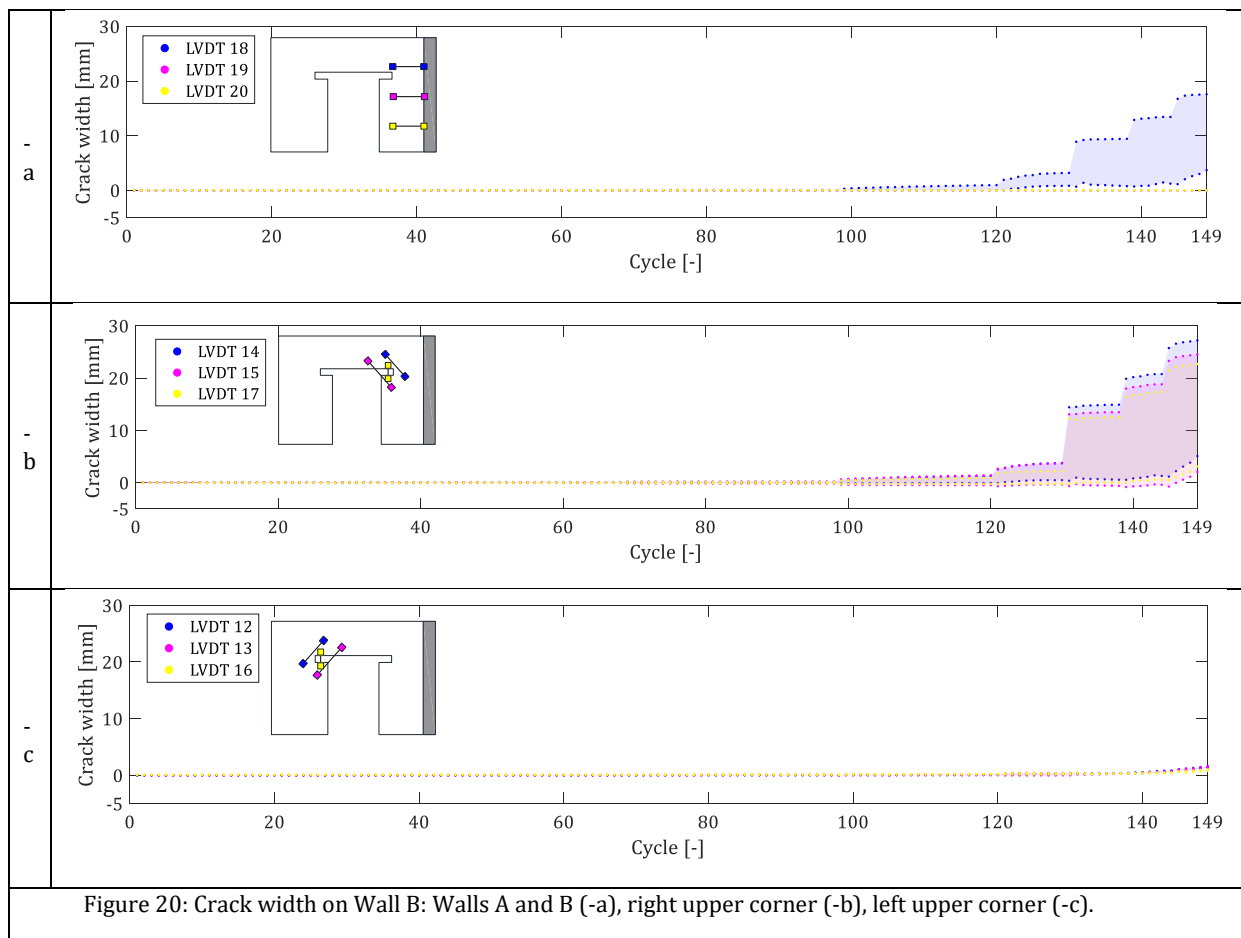
The crack opening histories detected by all the LVDTs on Walls B and C of the reinforced structure are given in Figure 20 and Figure 21, respectively. In Figure 20-a and -b LVDT 18 detected the formation of a crack approximately around the 100<sup>th</sup> cycle, which started close to the right upper corner of the door opening and propagated as far as the gripping plate. The crack formation was tracked by LVDTs 14 and 15 and had a maximum opening of approximately 28 mm and also influenced the out-of-plane behaviour of the solid wall, on which LVDT 18 registered a maximum relative displacement of 18 mm.
