Effectiveness of Textile Reinforced Mortar (TRM) Materials for the Repair of Full-Scale Timbrel Masonry Cross Vaults

Elisa Bertolesi*, Benjamín Torres, Jose M. Adam, Pedro A. Calderón, Juan J. Moragues.

Keyword: Textile Reinforced Mortar (TRM), Timbrel Masonry Cross Vaults, Settlement-Induced Damages, Masonry Strengthening.

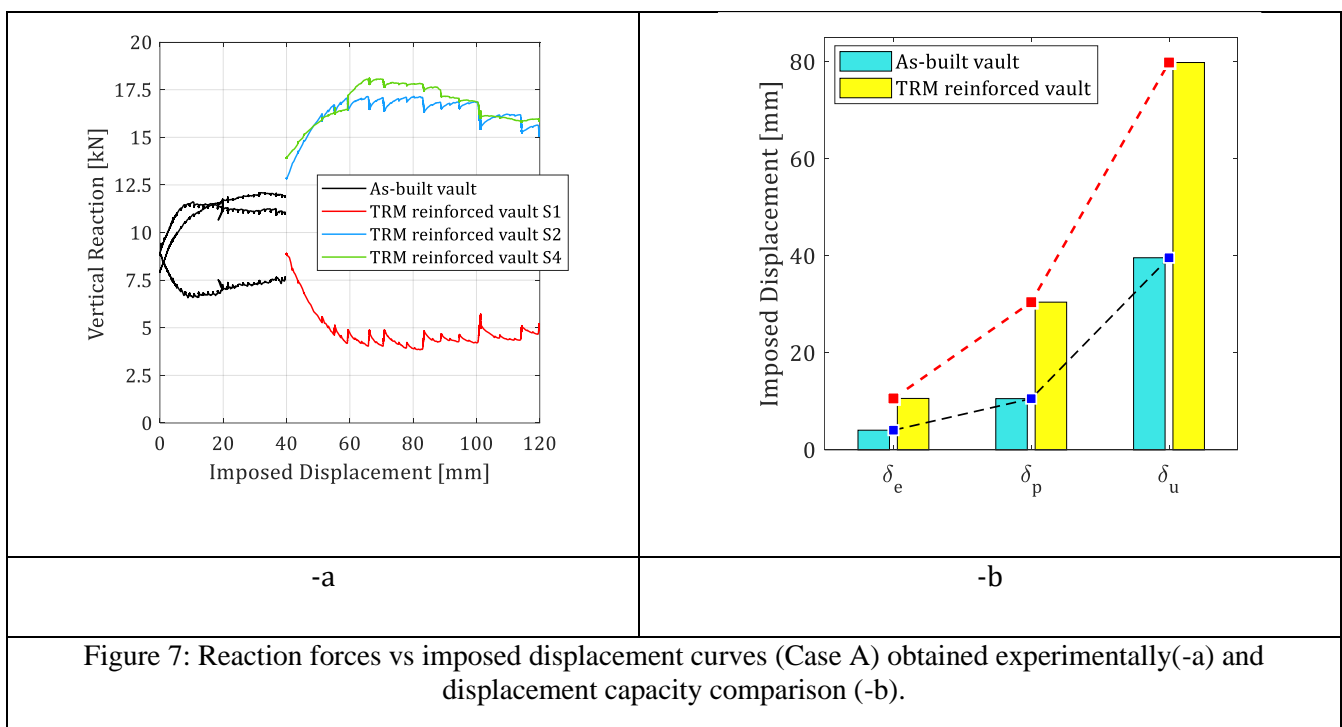
Figure 7: Reaction forces vs imposed displacement curves (Case A) obtained experimentally(-a) and displacement capacity comparison (-b).

236 As can be seen in Figure 7-a, the vaults behaviour can be divided into three phases: (i) the initial
 237 elastic response was obtained up to 10 mm, (ii) from 10 mm to 30 mm, behaviour was non-
 238 linear until the peak reaction value (R_p), and (iii) in the third phase a negligible reduction of the
 239 reaction forces was observed up to failure at 80 mm. Further results are provided in Figure 7-b
 240 and Figure 8. Figure 7-b compares the displacements reached by the as-built and TRM
 241 strengthened timbrel vaults : (i) at the end of the elastic phase (δ_e), (ii) at peak reaction forces
 242 (δ_p), and (iii) at failure (δ_u). The TRM had a twofold effect: (i) it helped to extend the elastic

243 phase, which doubled (from 5 mm to 10 mm) and the vault displacement capacity, (ii) it
 244 considerably delayed the vault failure, which occurred at 80 mm, instead of 40 mm as happened
 245 for the as-built structure.

234 Figure 7-a depicts the reaction force-displacement curves obtained experimentally in supports
 235 S1, S2 and S4 (Case A).

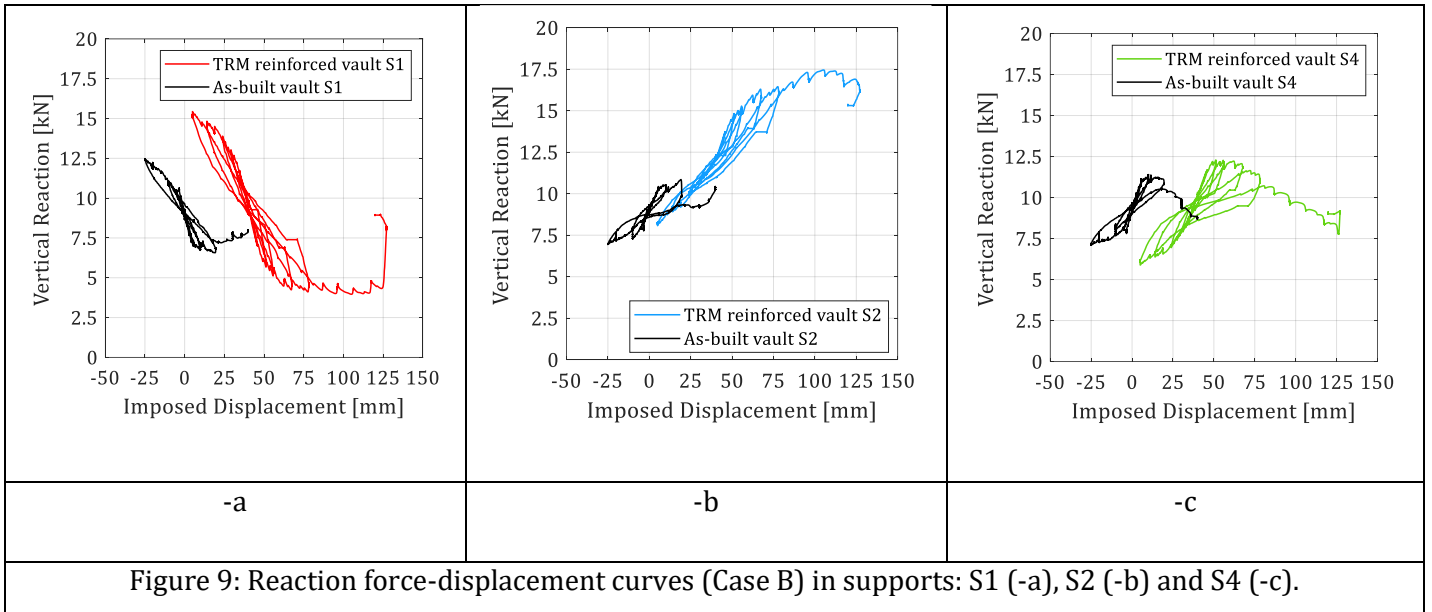
Figure 9: Reaction force-displacement curves (Case B) in supports: S1 (-a), S2 (-b) and S4 (-c).

286 As expected, in the TRM-strengthened vault the initial elastic stiffness progressively degraded
 287 up to a maximum of four times at 80 mm in support S1. As in the unreinforced case, this
 288 behaviour was due to the triggering of a progressive damage mechanism, which will be
 289 discussed in the next section. The initial stiffness values in the first cycle (Case B cyclic) (see
 290 Figure 10-a) were quite similar to those of the undamaged unreinforced vault (Case B cyclic) at
 291 the beginning of the test and to those of Case A shown in Figure 8-c.

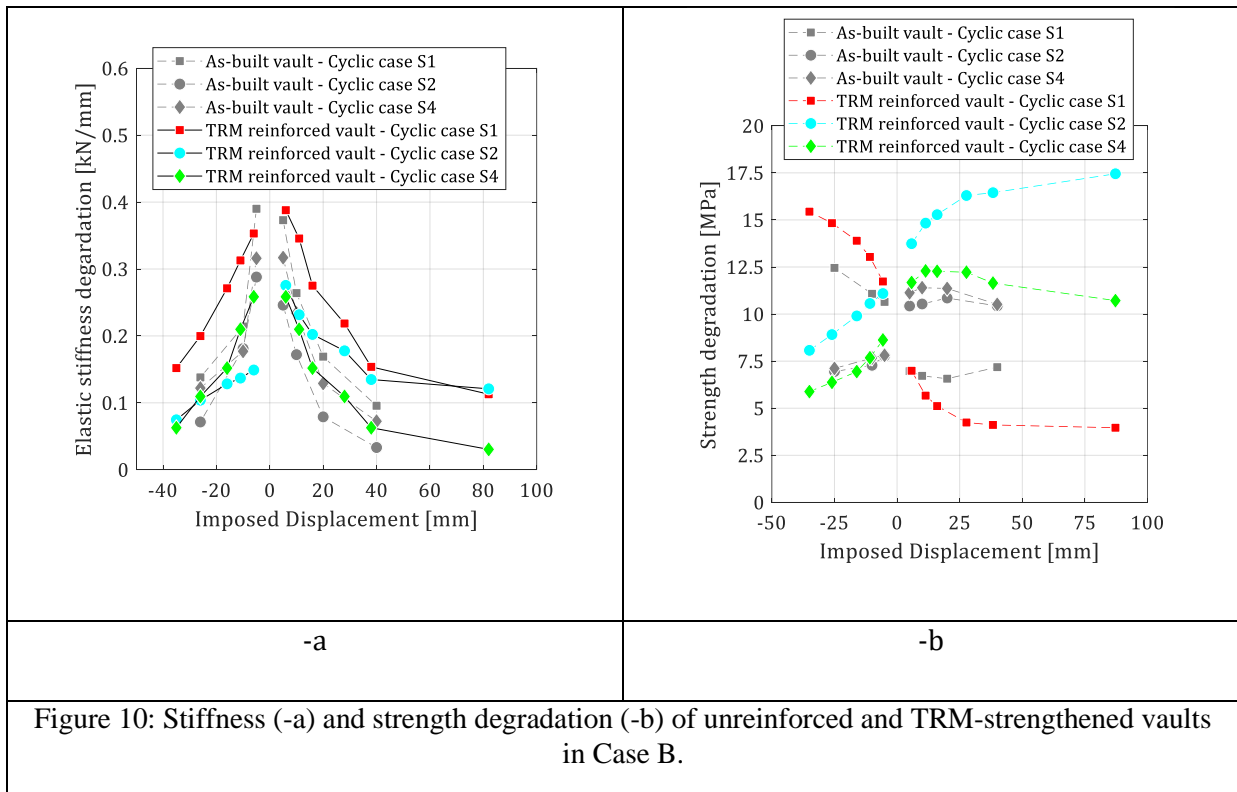
Figure 10: Stiffness (-a) and strength degradation (-b) of unreinforced and TRM-strengthened vaults in Case B.

292 Although negligible differences were detected due to material heterogeneity, the consistency of
 293 the values from the beginning of the test confirmed the effectiveness of TRM in recovering the
 294 structure's original stiffness (see Figure 10-a). Strength degradation is another important
 295 parameter (Figure 10-b). The strength degradation curves were drawn using the peak reaction
 296 forces obtained in each cycle of all the monitored supports. As can be seen in Figure 10-b, the
 297 TRM strengthening changed the unreinforced vault's strength degradation trend found in [2].
 298 Unexpectedly, both up and down movements showed a clear increasing trend common to all the
 299 supports in all cycles, except for the last cycles. Theoretically, due to the symmetry axis
 300 connecting supports S1-S3, the structural response of support S4 should be similar to S2. This
 301 behaviour was completely lost in support S4, which evidenced a different trend (see Figure 10-

302 b). The obtained behaviour could be justified by the asymmetric cracking mechanism which
 303 forced the vault to evidence not negligible torsional effects. The effect of the induced torsion
 304 was to increase the gravity load on support S2, while decreasing the reaction forces in his
 305 symmetric counterpart S4. From a general point of view, the TRM-strengthened vault's
 306 behaviour was quite symmetric under upward and downward settlements. However, the slope
 307 of the strength degradation curve abruptly changed in all the supports after 40 mm, meaning
 308 that the triggered collapse mechanism was about to threaten vault stability.

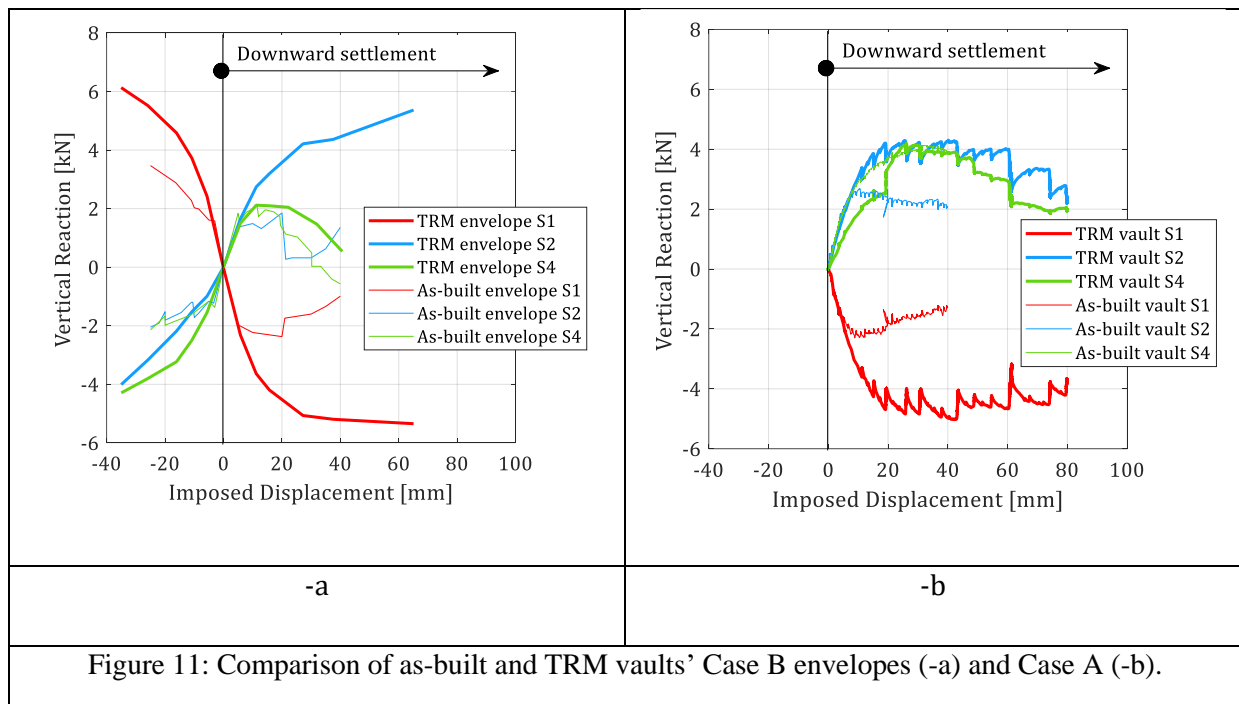
Figure 11: Comparison of as-built and TRM vaults' Case B envelopes (-a) and Case A (-b).

309 Figure 11-a compares the envelope curves obtained from the unreinforced and TRM-
 310 strengthened vaults in Case B, while Figure 11-b gives the increments in the reaction force-
 311 displacement curves obtained in the as-built [1] and TRM-strengthened vaults (Case A). For the
 312 as-built vault [2] (Figure 11-a), the envelope curves were constructed starting from the peak

313 forces obtained during the cyclic settlement and the corresponding displacements imposed in
314 each cycle. Theoretically, the curves so obtained can be used to estimate the vault behaviour
315 with either up or down movements. It is thus particularly interesting to compare the envelopes
316 of the downward movements shown in Figure 11-a to those in Figure 11-b, which confirm the
317 previous findings on TRM materials. This type of reinforcement allowed the vaults to: (i) almost
318 fully recover the vaults' initial elastic stiffness, (ii) double the elastic phase of the structures and
319 (iii) double the displacement capacity at failure.

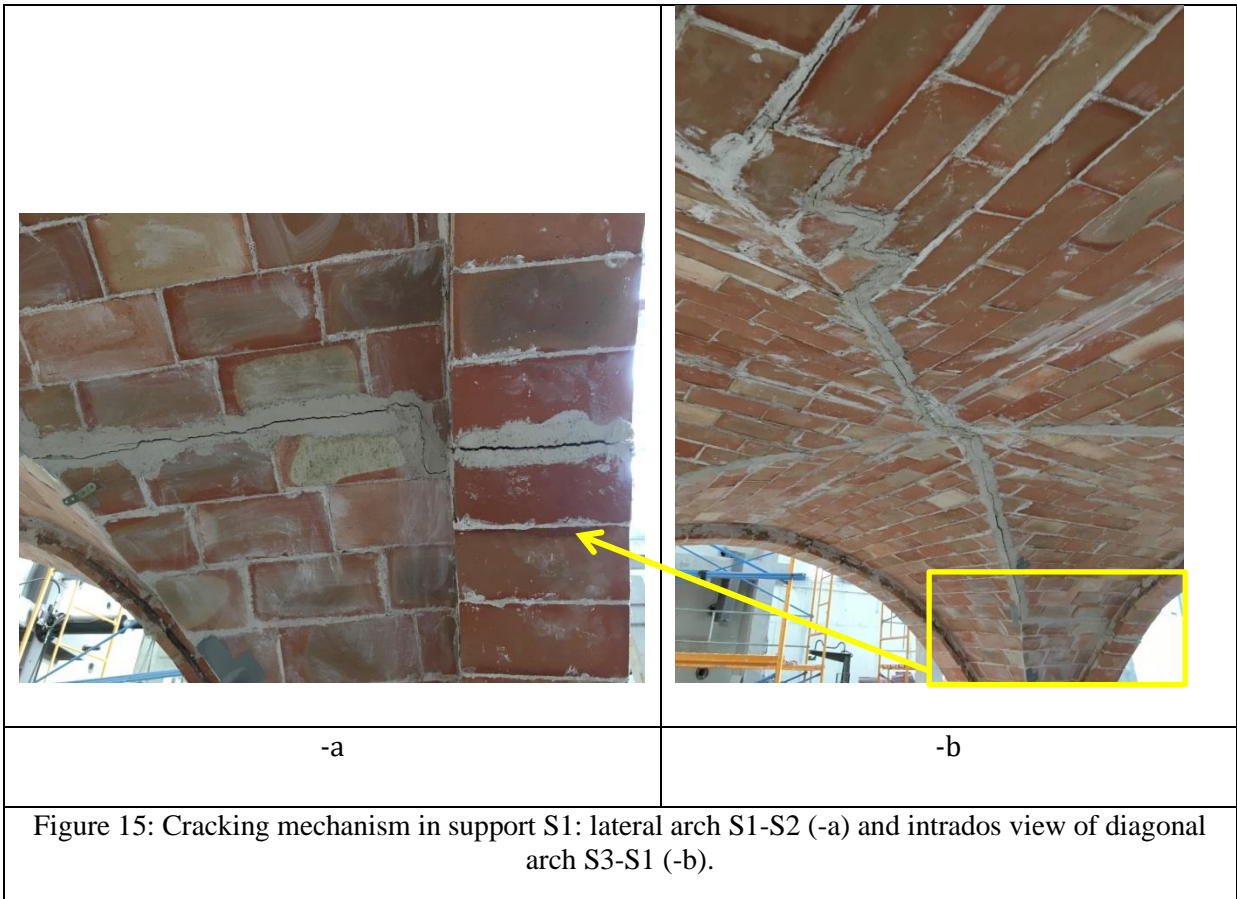
343 It should be noted that the cracks on lateral arches S4-S1 and S2-S1 attempted to join up with
344 the diagonal hinge between supports S2-S4. This peculiar failure mechanism also occurred in
345 the unreinforced vault [1] (Figure 15). This behaviour was monitored by the sensor network.
346 Figure 16 gives the displacement read by the LVDTs on the unreinforced vault (between 0 to 40
347 mm) and the TRM-repaired vault (between 40 to 120 mm). In support S1, maximum
348 displacements ranged from 0.05 mm in the unreinforced to 0.15 mm in the reinforced vault.
349 LVDT 2 and LVDT 3 detected two cracks with maximum openings of 3-4 mm in support S2
350 (Figure 13). LVDT 4 (Figure 12-c) captured a maximum displacement of 4.5 mm, again in
351 agreement with the crack pattern previously described. LVDT 5 monitored the formation of the
352 hinged diagonal crack along supports S2-S4 on the vault extrados, which doubled in size from

353 2.5 mm in the unreinforced case to 5 mm in the reinforced vault. This again confirms the ability
354 of TRM materials to extend masonry displacement capacity and delay failure.

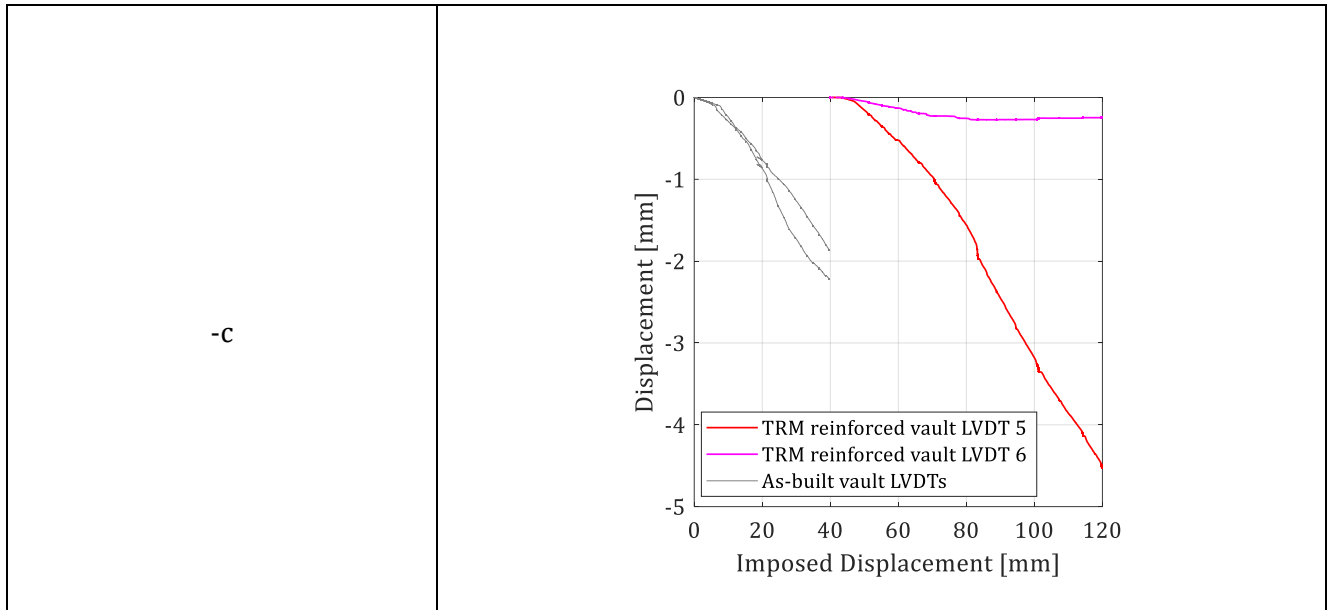
Figure 16: Displacements (Case A) recorded by the most important LVDTs: in S1 (-a), in S2 and S3 (-b) and on the vault extrados (-c).

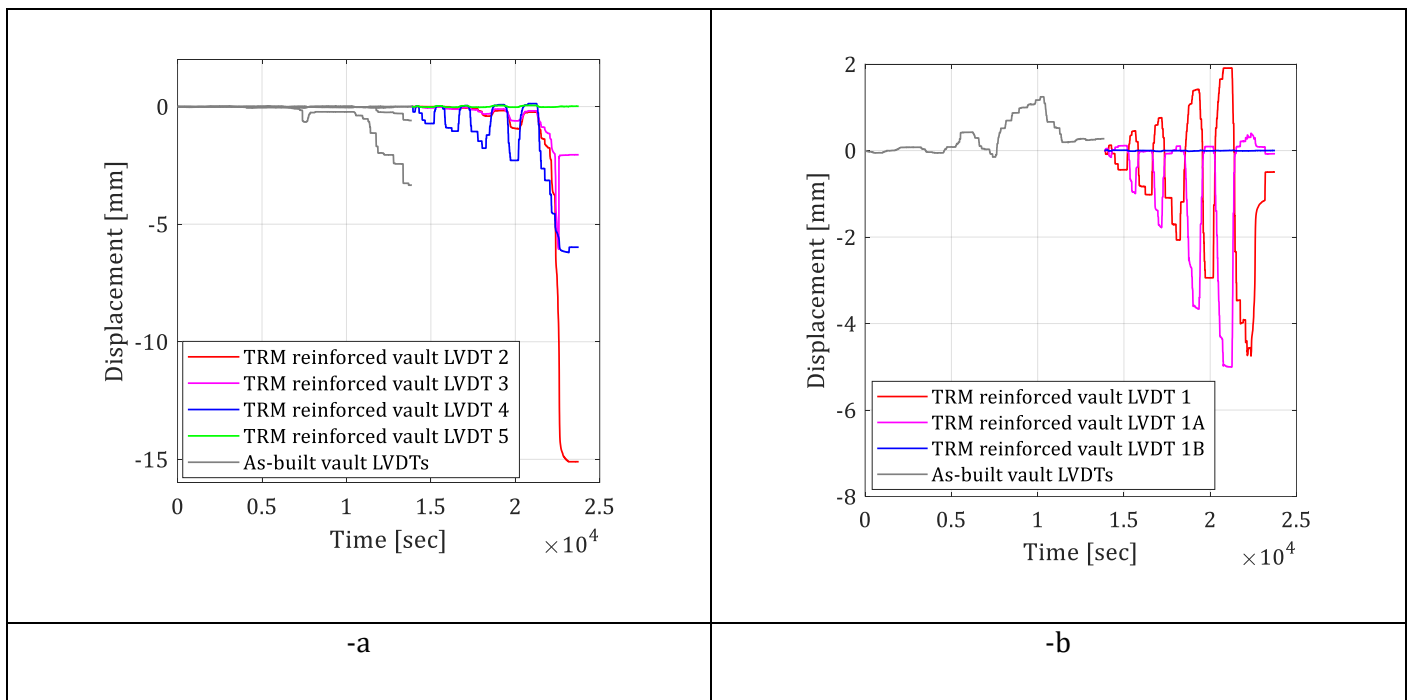
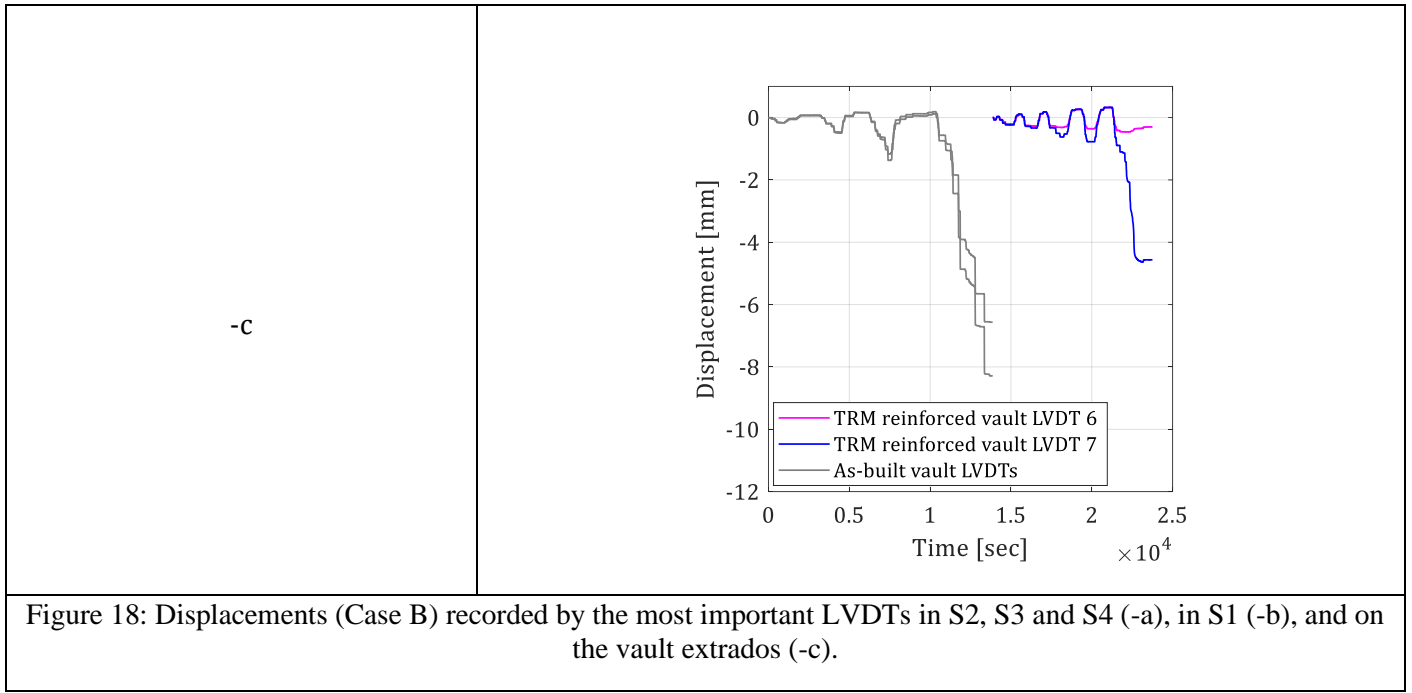
376 Similar cracks with lower displacement values were detected in support S1, as shown in Figure
 377 18-b and Figure 20-a.

379 Figure 18-c depicts the LVTDs placed along the vault extrados. Only one LVDT tracked the
 380 formation of the diagonal hinge that opened between supports S2-S4 on both extrados and
 381 intrados due to the cyclic settlement (Figure 20-b). As in Case A, a maximum value of 5 mm was
 382 detected on the extrados. Unlike the unreinforced case (Case B), the TRM avoided the
 383 premature separation of the vault into two independent parts (Figure 21). Figure 21 compares
 384 the crack patterns at the end of the cyclic test in the reinforced and unreinforced vaults. The
 385 cracks on the extrados were diverted by the reinforcing materials to the masonry away from the
 386 retrofitted zones. The TRM radial configuration prevented the crack on the top of the extrados
 387 from propagating. This effect is particularly evident in Figure 18-c. The cracks reached a
 388 maximum value of 8 mm at the end of the test in the unreinforced vault, or approximately half
