**“CHANNEL STABILITY ASSESSMENT AND ECOLOGICAL
RESTORATION DESIGN ON THE BARON FORK RIVER,
ADAIR COUNTY, OKLAHOMA (U.S.A)”**

MASTER THESIS SUBMITTED TO THE ACHIEVEMENT
OF MASTER’S DEGREE IN CIVIL ENGINEERING

Norman (Oklahoma), July 2021

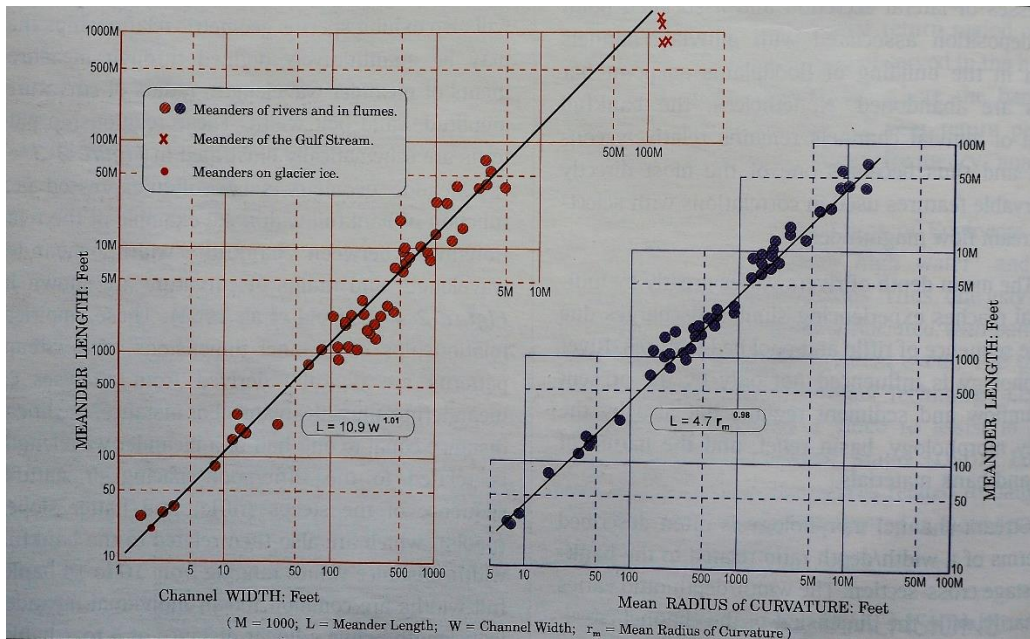
Figure 4 – Relations between meander length and channel width, and meander length and meander radius of curvature (After Leopold, et al. 1964)

Meander geometry is most often expressed as a function of bankfull width. Distance values ranging from 10 to 14 bankfull widths are common for an individual meander wavelength, while a linear distance of 5 to 7 bankfull widths are commonly noted for the spacing of riffle/pool features.¹⁰

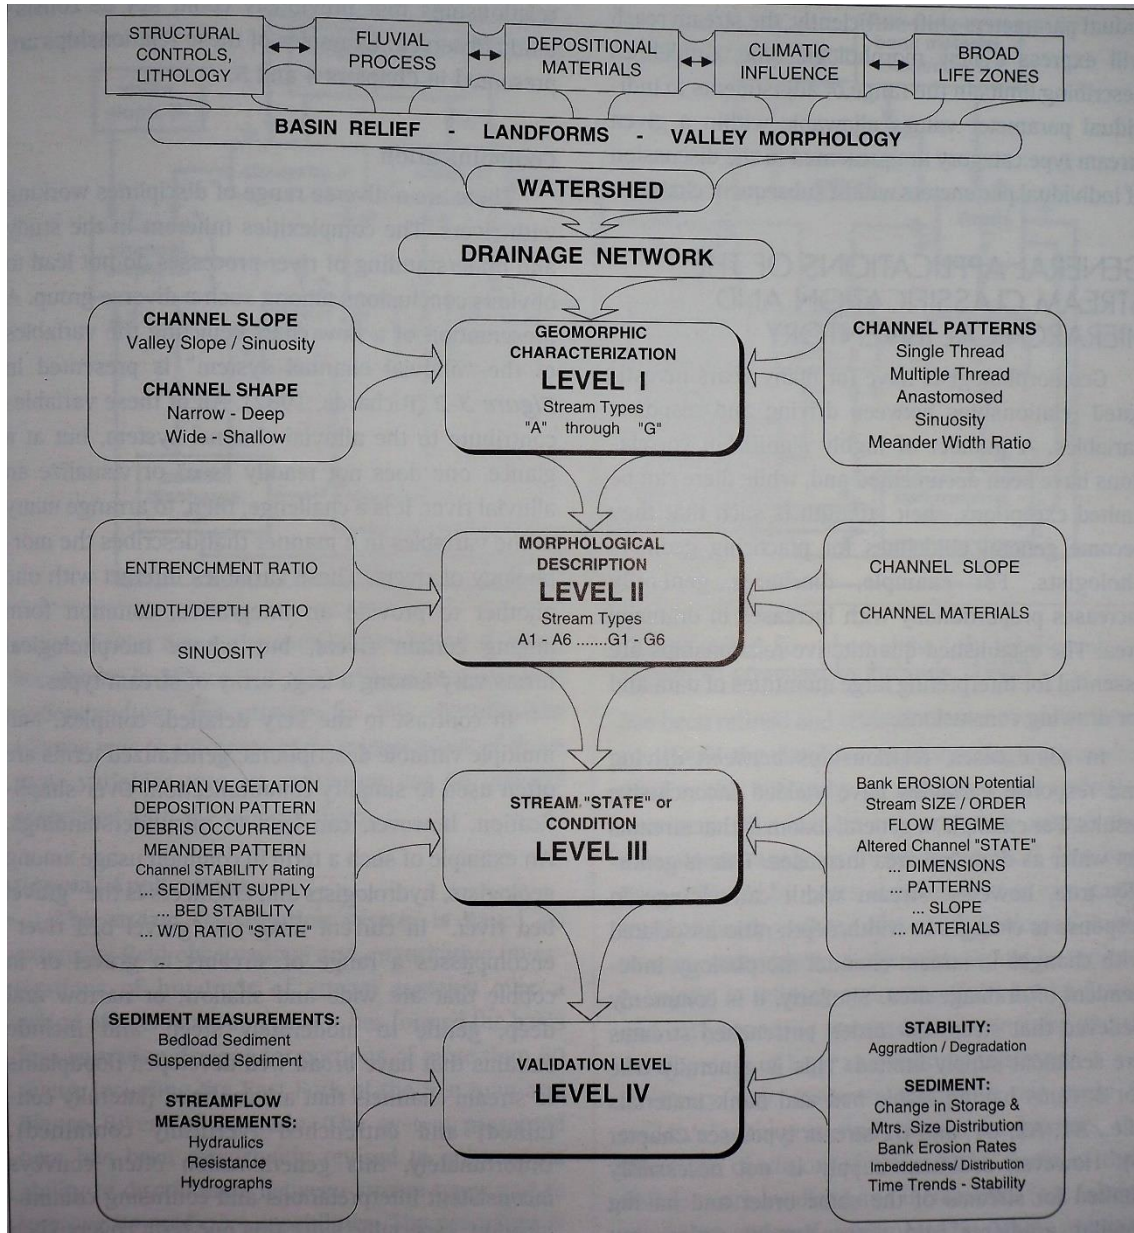
These objectives can be met through the following hierarchical assessment of channel morphology developed by Rosgen (1996):

Figure 5 – The hierarchy of river inventory and assessment. Rosgen (1996)

"DA," "E," "F" or "G." Level II is called the morphological description and requires field measurements. Level II assigns a number (1 through 6) to each stream type that describes the dominant bed material based on the d50 of the reachwide pebble count. Level III is an evaluation of the stream condition and its stability; it requires an assessment and prediction of channel erosion, riparian condition, channel modification, and other characteristics. Level IV is the verification of predictions made in Level III and consists of sediment transport, streamflow, and stability measurements.¹¹

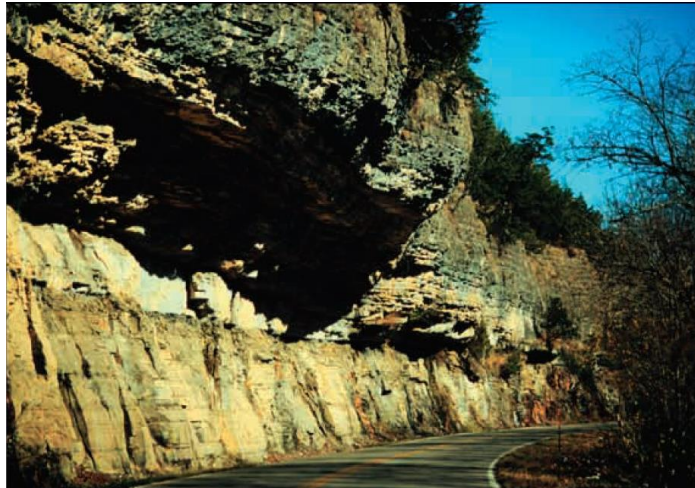
Figure 12-The Ozark Highlands (39) are largely underlain by flat-lying, cherty limestone. Underground drainage, karst features, springs, and perennial streams are common

As described by the EPA and the CEC, The wooded, rugged, Dissected Springfield Plateau–Elk River Hills ecoregion is composed of narrow ridgetops and intervening, steep V-shaped valleys. Carbonate rocks, along with associated karst features, are characteristic. Springs abound in valleys and contribute cool water to perennial streams. Cherty limestone of the Mississippian Boone Formation is extensive, but older shales, limestone, and dolomite are also exposed in valley bottoms. Ecoregion 39b is more rugged and wooded than either the lithologically similar Ecoregion 39a or the lithologically dissimilar Ecoregion 40b. Upland natural vegetation is oak-hickory and oak-hickory-pine forests and woodlands. Livestock and poultry farming, woodland grazing, logging, recreation, and quarrying are the main land uses. Bank and hillslope erosion has choked many channels and filled many pools with cherty gravel. As a result, braided streams and unstable run habitats have become common. The lower reaches of most streams have aggraded; here, enough gravel has accumulated to promote subsurface flow, except during and immediately after rainfall.

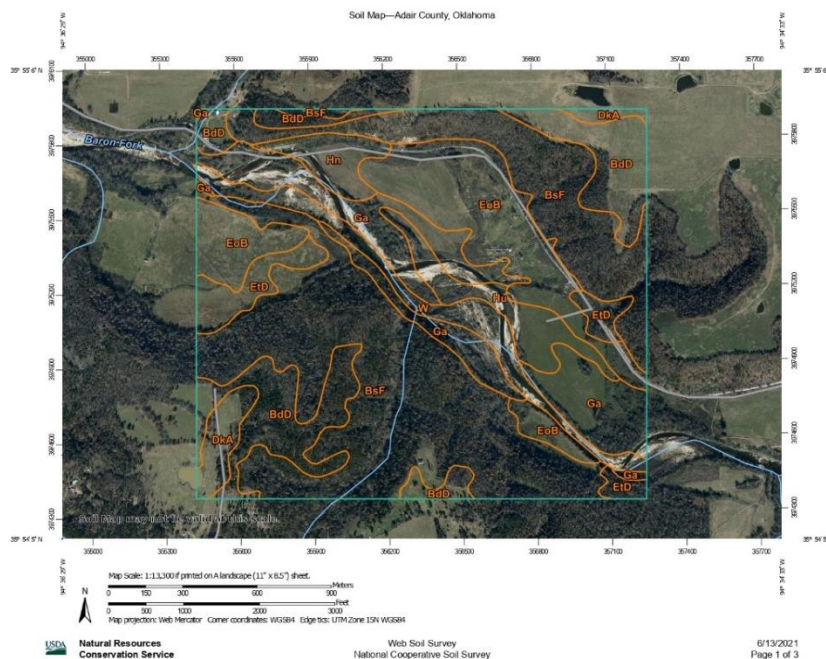
The soil classification for the area of study was found by using the Web Soil Survey (Figure 14) from the United States Department of Agriculture (USDA). The results show that Elshah gravelly silt loam (Ga) covers most of the river's bank, but also Elshah gravelly loam (Hu), Waben gravelly silt loam (EoB), and Clarksville very gravelly silt loam (Bsf) can be found. See “Chapter 8 Appendices; Appendix 8.8 Sketches; soil map”.

Figure 14 – Web soil survey (USDA)

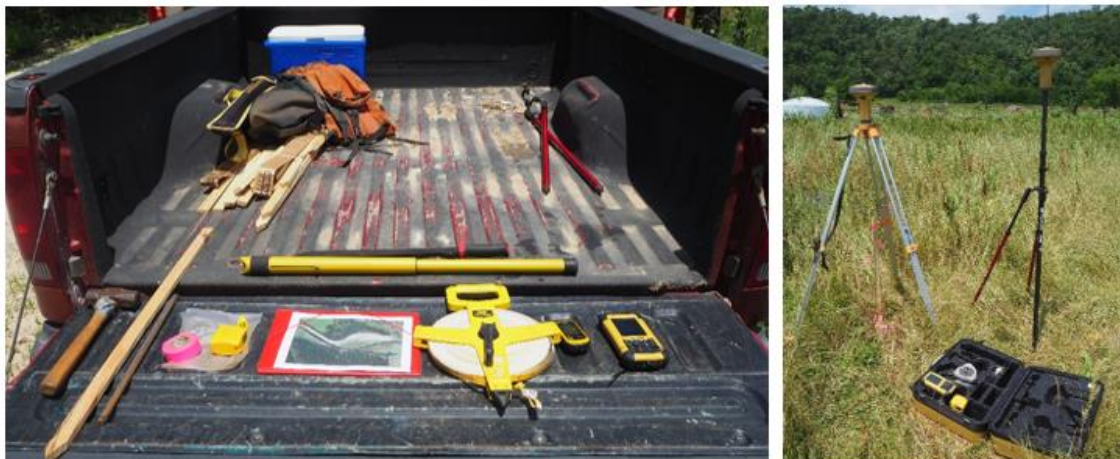
Figure 211 – Equipment used 1

In figure 21 (left) it can be seen a hammer, wooden sticks and flagging, 1/2” re-bar pins, measuring tape, impermeable bags for the phone, maps with the coordinates of the pins and detailed enough to see natural features that might help locate the pins, a metal detector, 300-foot tape, and a small hand GPS.

In figure 21 (right), the RTK GPS equipment used to obtain the cross-sections and profile can be observed. On the left-hand side is the base, at the right-hand side is the rover and at the bottom, the box used for transportation has on top the computer that controls the equipment, the level for the base, and some extra batteries.

The equipment used to survey the cross-sections and the profile of the site is shown figures 21 and 22:

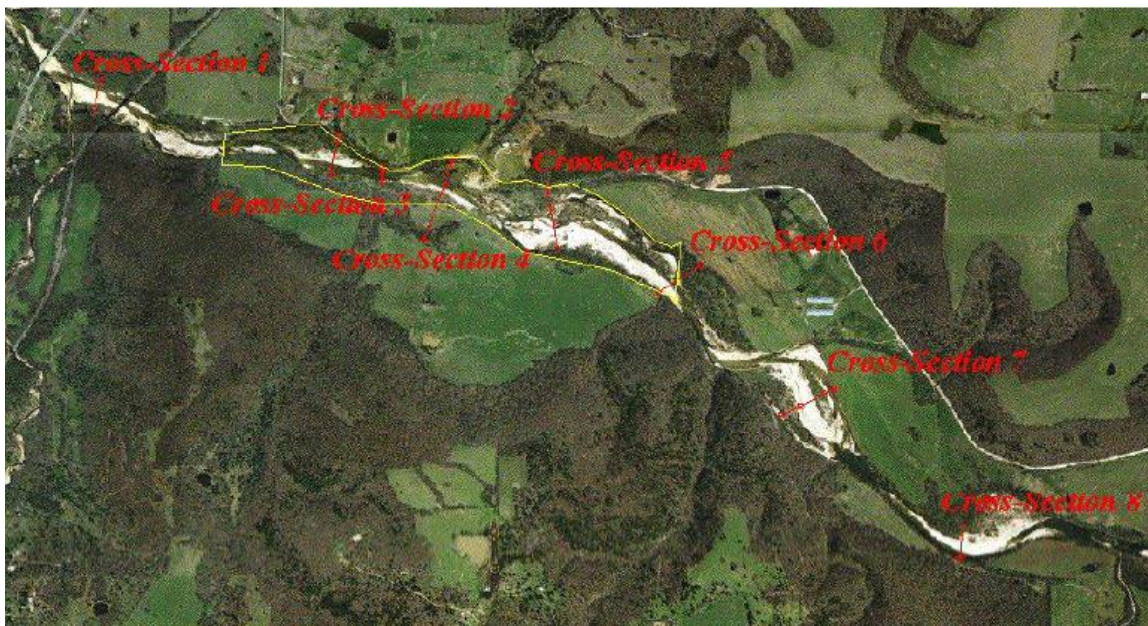
Figure 22 – Aerial photograph from 2005 showing location of cross-sections (Dutnell 2005)

Because this site was previously surveyed in 1998 and 2005m the first task was to find the 1/2” re-bar pins established at each of the cross-sections that were inside the property of the ODWC. These cross-sections are XS5, XS6, XS7, and XS8. To avoid confusion, the label of each cross-section has not been re-named.

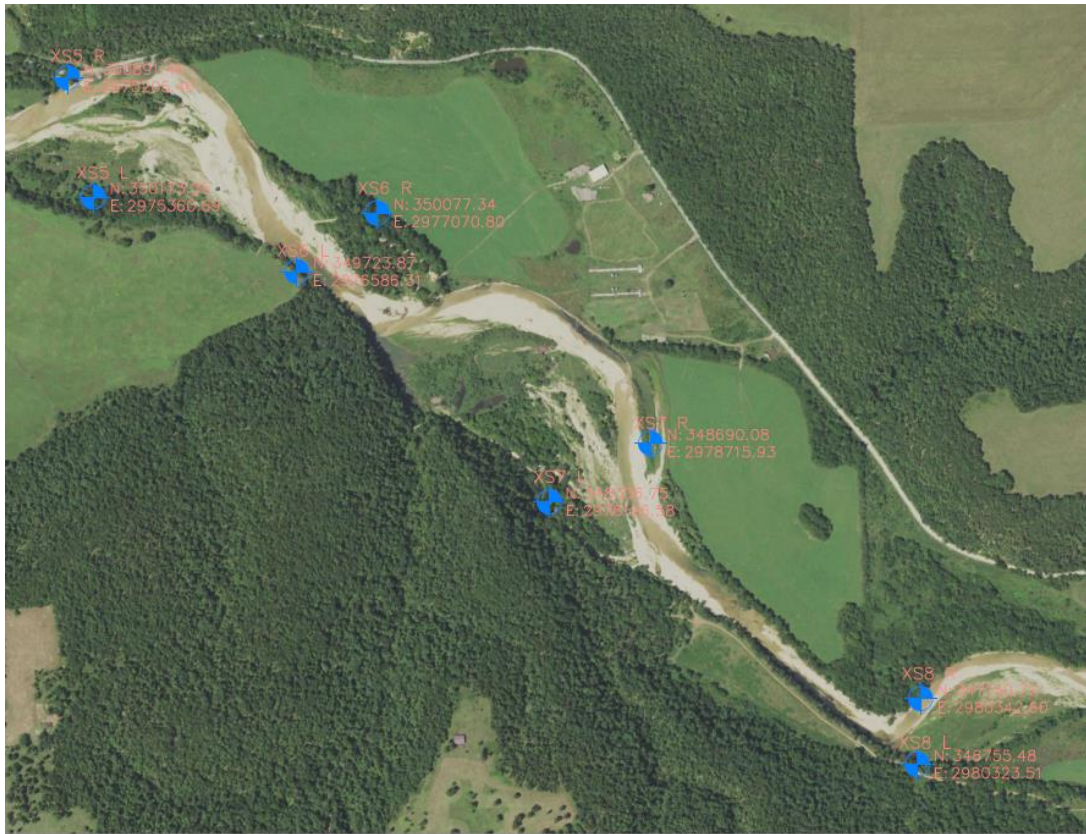
Figure 24 shows the GPS Oklahoma North State Coordinates of the pins of cross-sections 8, 7, 6 and 5 used for the 2021 survey:

Figure 24 – GPS Coordinates of the 2021 survey used for the cross-sections (Oklahoma North State Coordinates)

From the 8 pins, 2 for each of the 4 cross-sections, only 3 were found. Left pin at cross-section 8, left pin at cross-section 7, and the left pin at cross-section 5. The reasons why the rest were not found were different. The right pin at cross-section 8 was washed out. The right pin at cross-section 7 was not found due to the dense vegetation that had been growing over the past 23 years (all the pins were installed in 1998 and never removed, except for the left pin in cross-section 5 which was washed away and replaced in a new location in 2005) and also it was probably buried a few inches due to the deposition of sediments. In cross-section 6, neither the left pin nor the right one was founded due to the fences that were next to them. The wire interfered with the metal detector making it very hard to find them, even though different techniques were used. Also, the dense vegetation and deposition of sediments did not help. Evidence such as fallen trees where the right

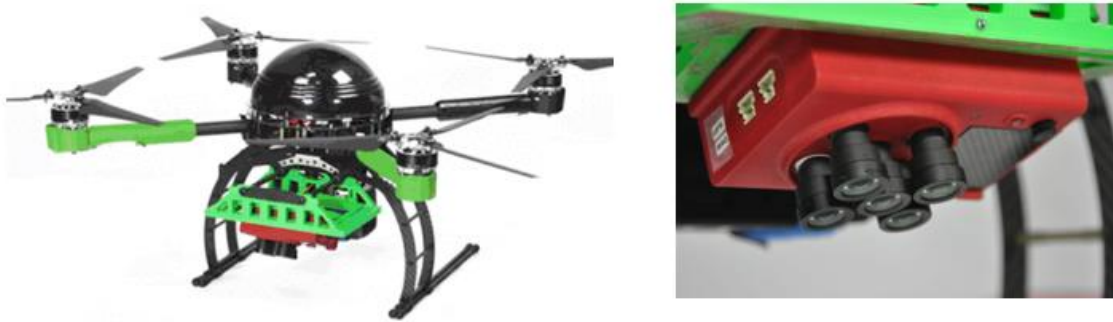
Figure 25 - ATI AgBot

To obtain current aerial imagery and topography of the site, an ATI AgBot, a drone for precision agriculture applications, provided by the University of Oklahoma was used. The drone is outfitted with the MicaSense RedEdge for capturing valuable multispectral

imagery, is fully autonomous, and the installed sensor package was NDVI (Normalized Difference Vegetation Index). It provides very valuable information such as DTM (Digital Terrain Model) used to draw the contour lines, DSM (Digital Surface Model), and also current aerial photography.

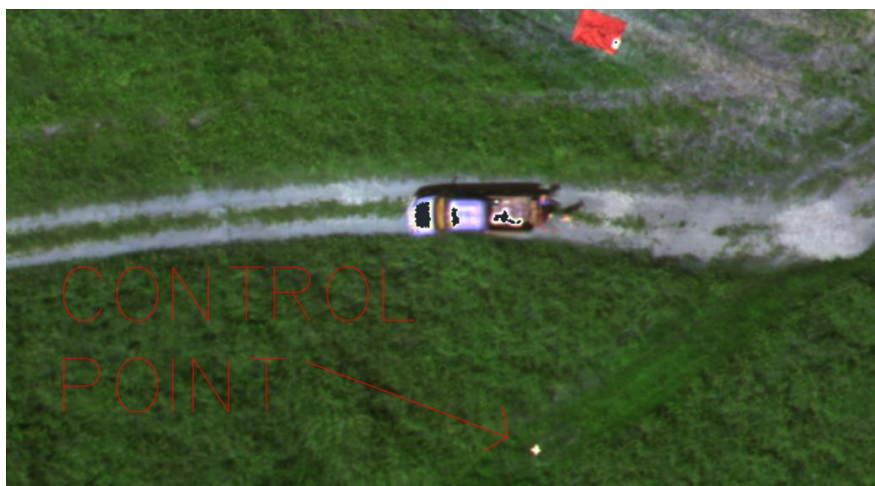
It is important to mention that due to the capacity of the batteries the flying missions were completed in two different days and therefore because the position and the number of the satellites available were different, the coordinates could vary from one day to another. To solve this problem, different control points were established as shown in figure 27.

Figure 27 – Example of one of the control points

Each of the three different flights had in common at least 2 control points to make sure the elevations and rotations matched between them. Once all three were plotted together and corrected using the elevations it looked like figure 28.

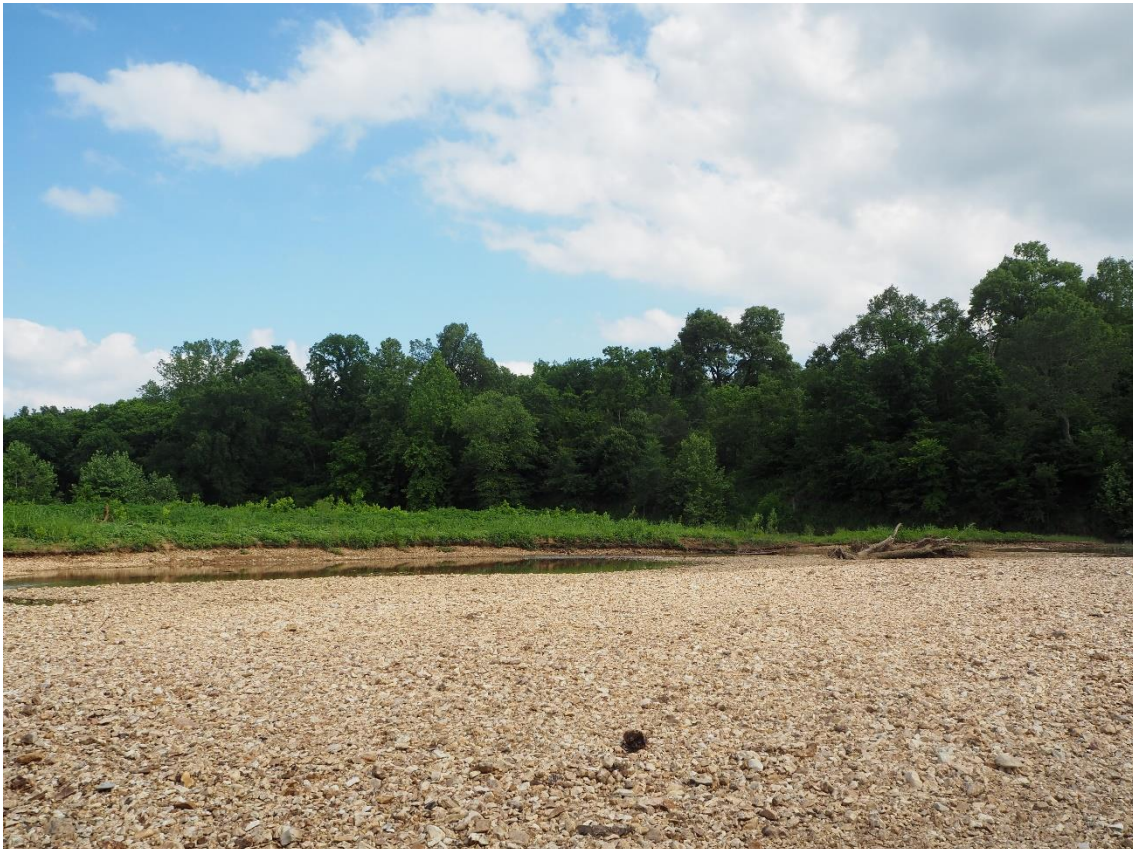
The dominant bed material in the Baron Fork River is gravel, as the results of the pebble count show and as can be seen in Figure 33, obtained in one of the site visits.

Figure 33 – Site image showing the gravel as the dominant bed material

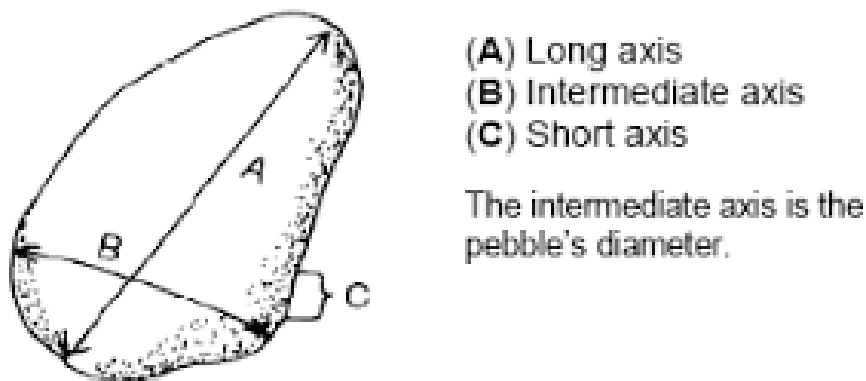
The procedure that has been followed consisted of, first, selecting the portion of the reach to be measured. The portion that has been chosen is where the erosion problems are more severe, where the river is impinging on the road. In particular, 3 pebble counts samplings have been carried out in this area, one upstream another one in the middle, and a last one downstream. Once the site has been selected, the second part is collecting and measuring. Most Standard Operating Procedures (SOP) recommend collecting and measuring a minimum of 100 particles per sample. Starting on the shoreline and averting the gaze the first particle touched by the tip of the index has been picked up. Then the intermediate diameter has been measured as shown in figure 34.

Figure 34 – Pebble count- axis of a pebble

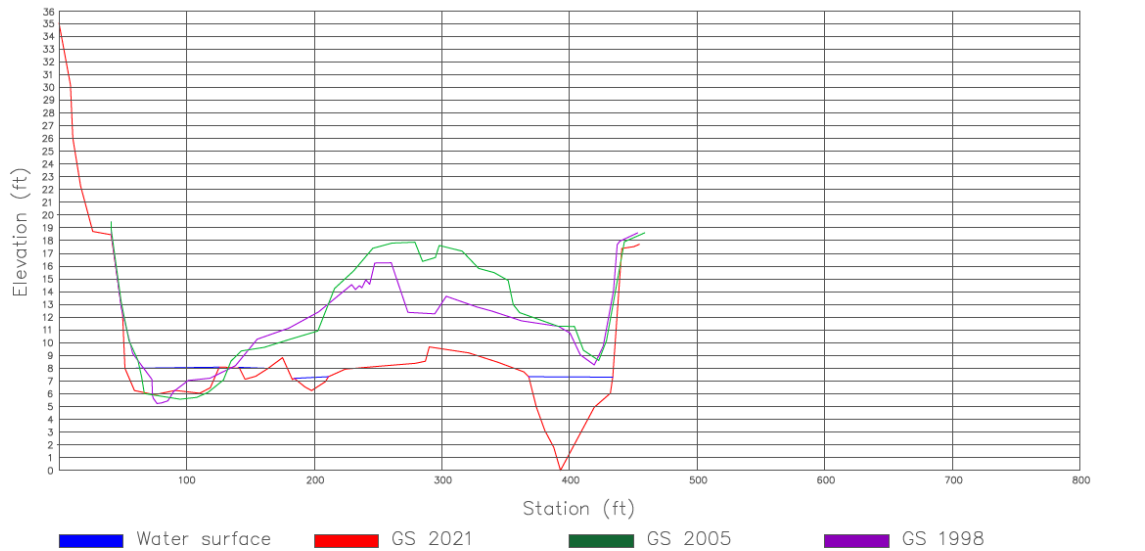
Cross-section 8

According to the Oklahoma North State Plane Coordinates, the point 0,0 is in an elevation of 862.08 feet

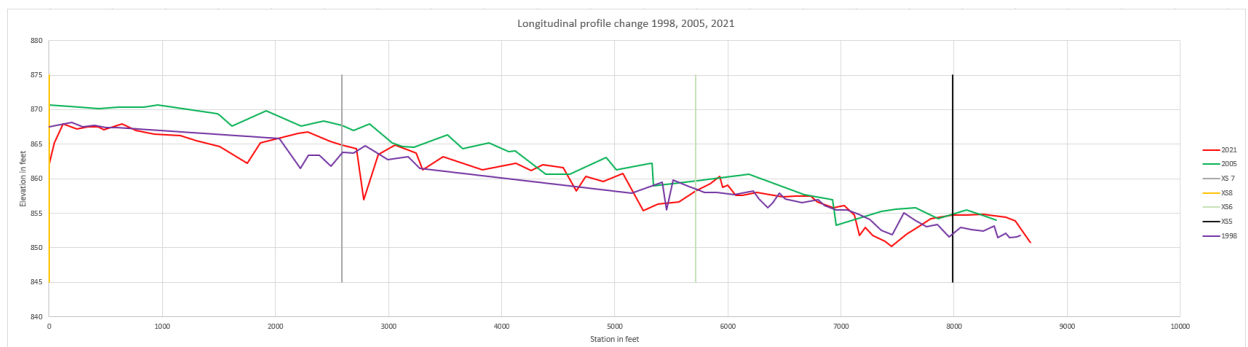
Figure 41 shows how the longitudinal profile has changed over the years. (See appendix 8 for a more detailed image).

Figure 41 – Longitudinal profile change 1998, 2005 and 2021

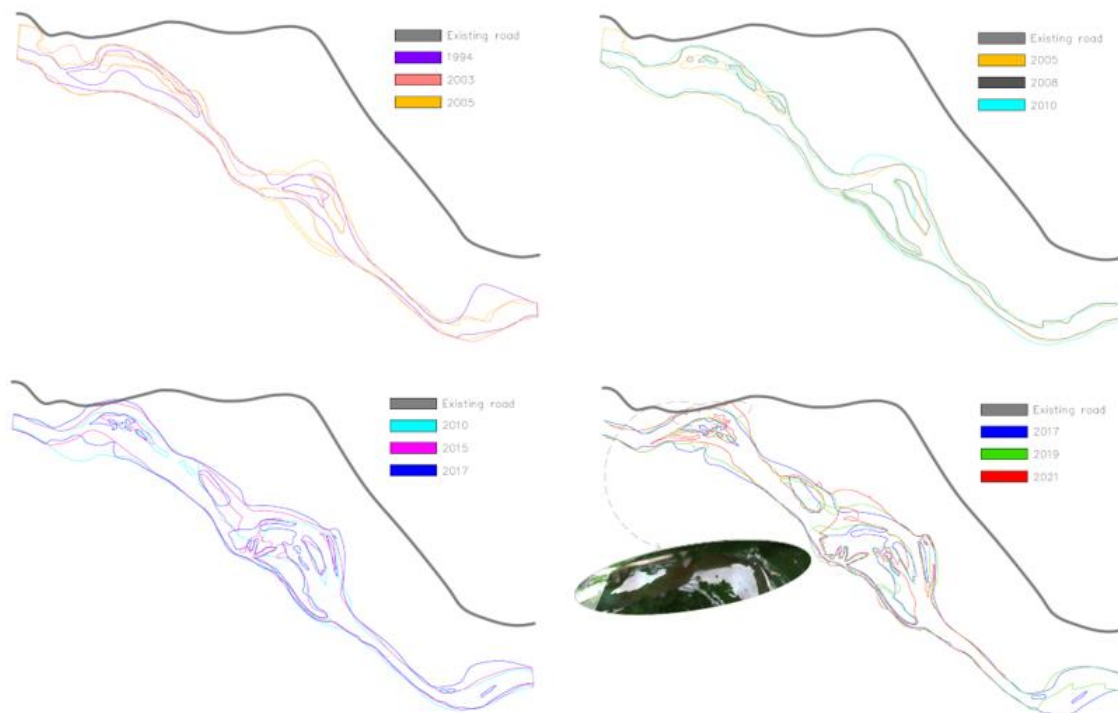
Figure 42 – Tracings of the river from 1994 to 2021

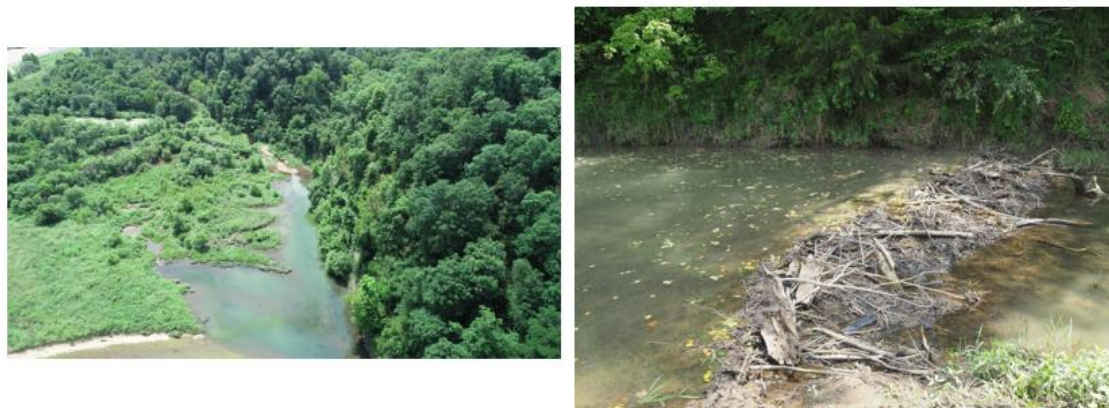
It is also interesting to see that in between cross-sections 6 and 7, on the left bank, beavers constructed some dams, as shown in figure 44. These dams were created in 2015 as can be seen in figure 42 -Tracings of the river from 1994 to 2021. These beaver colonies will expand in the future as they rapidly reproduce. It is important to keep track of their activities because even if these dams do not directly affect the road, beaver generations usually move within 0.5 miles to set up new colonies and they could affect it in the future.

Figure 44 – Beaver dams created in 2015 in the left channel of the island between cross-sections 6 and 7

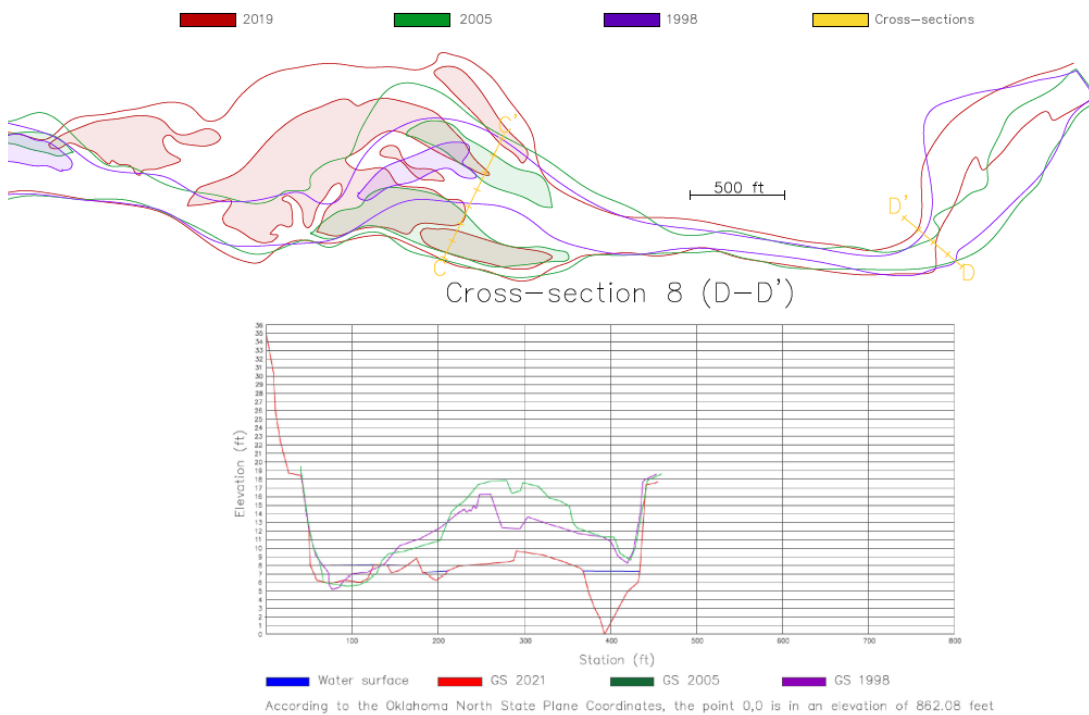
The following figure illustrates a combination of the tracings obtained from the aerial imagery of the upper part of reach, from 1994, 2005, and 2019 and the evolution of cross-section 8 over the same period. In this surveyed the drone did not fly as far upstream as cross/section 8 was and that is why the tracings from 2021 are not shown.

Figure 45 - Aerial imagery of the upper part of reach, from 1994, 2005, and 2021 and the evolution of cross-section 8 over the same period

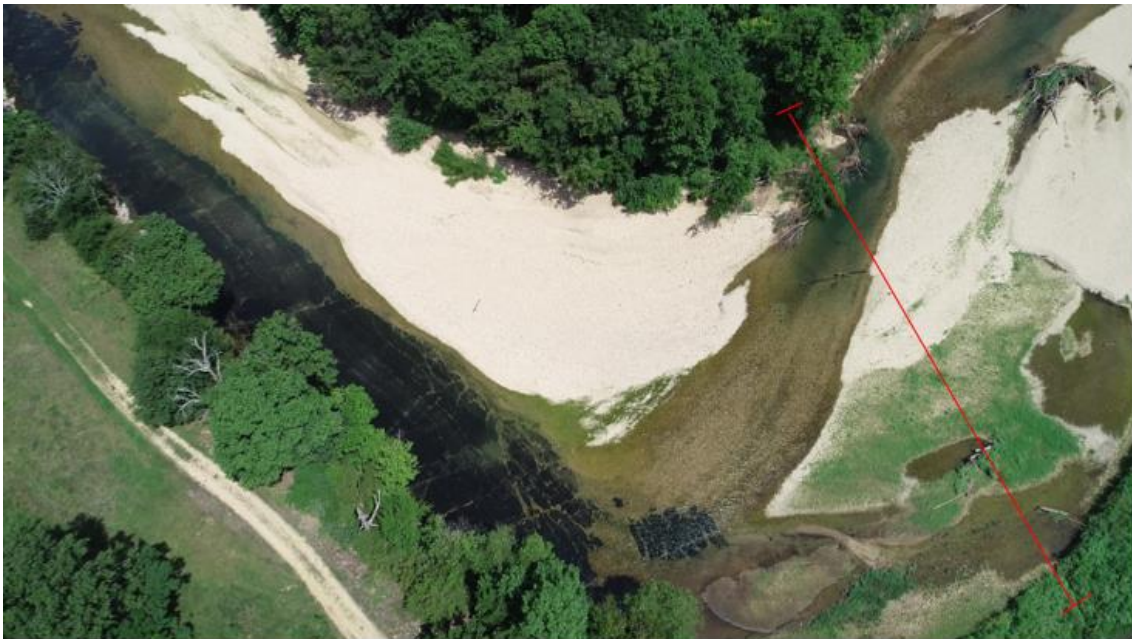
Cross-section 8 has shifted to the right bank and is clearly degrading. This may be because of the presence of several large trees, as shown in figure XXX, that have become obstructions to the flow at high flows, scouring the bottom of the channel and creating that deep pool.

Figure 45 – Cross-section 8 in red showing the trees blocking the flow of water.

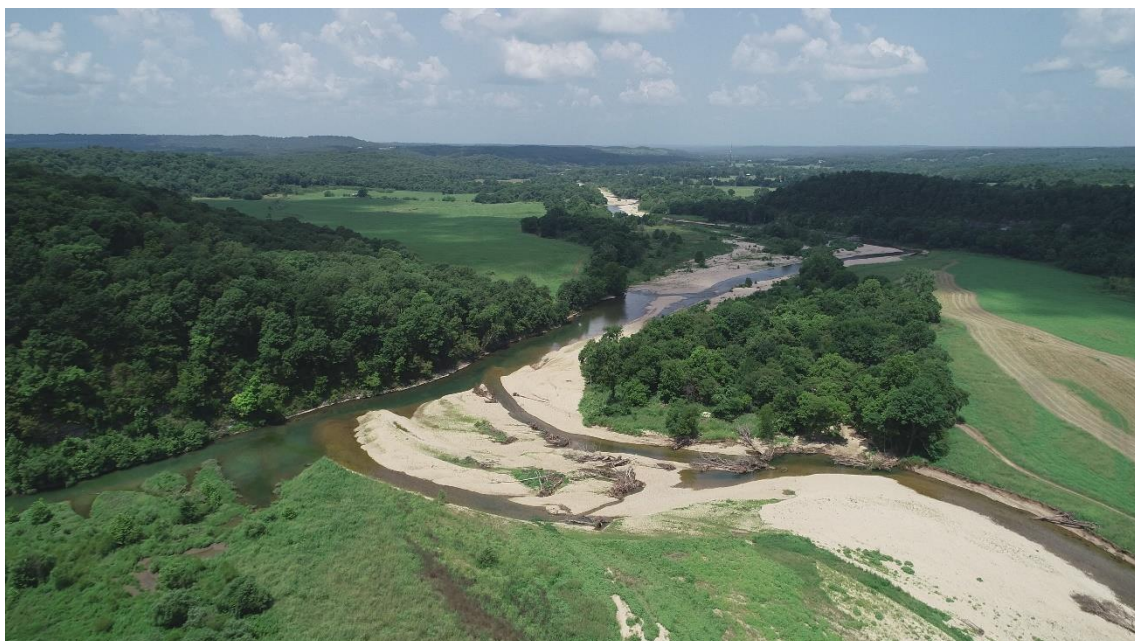
Figure 48 – Reach 1, 2021 drone pictures showing the trees that were washed away blocking the flow of water.

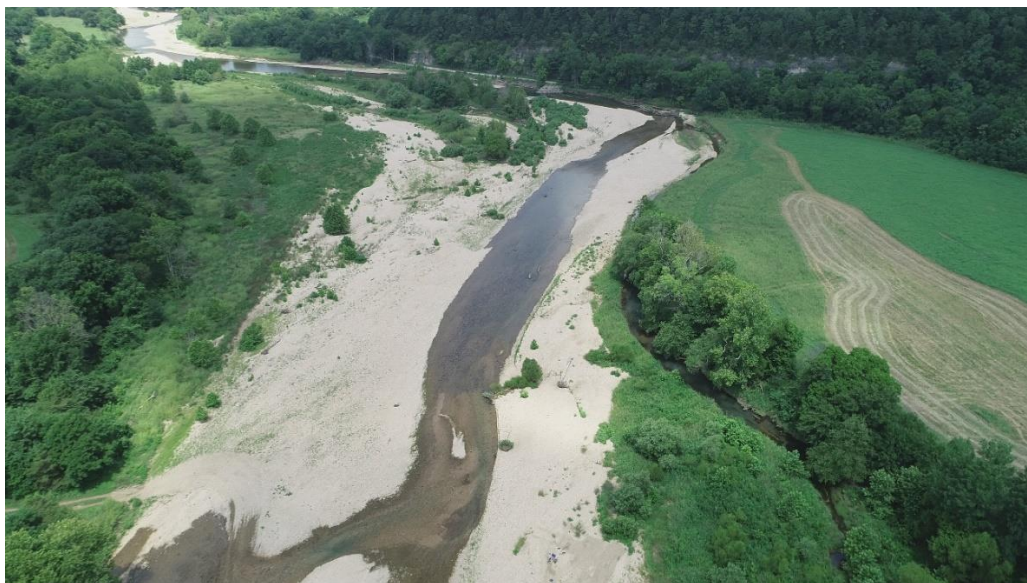
Figure 50 - Reach 2 (at the far top right side), 2021 drone picture showing how the river is trying to increase its length by meandering more but the road is in the way.

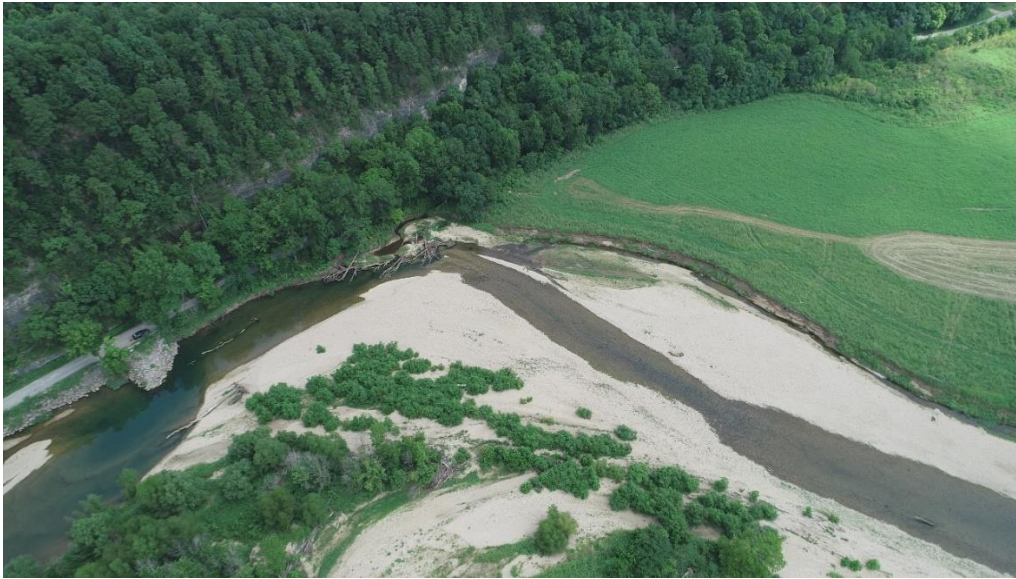
Figure 121 - Reach 2, 2021 drone pictures showing the erosion and the trees that have been washed away

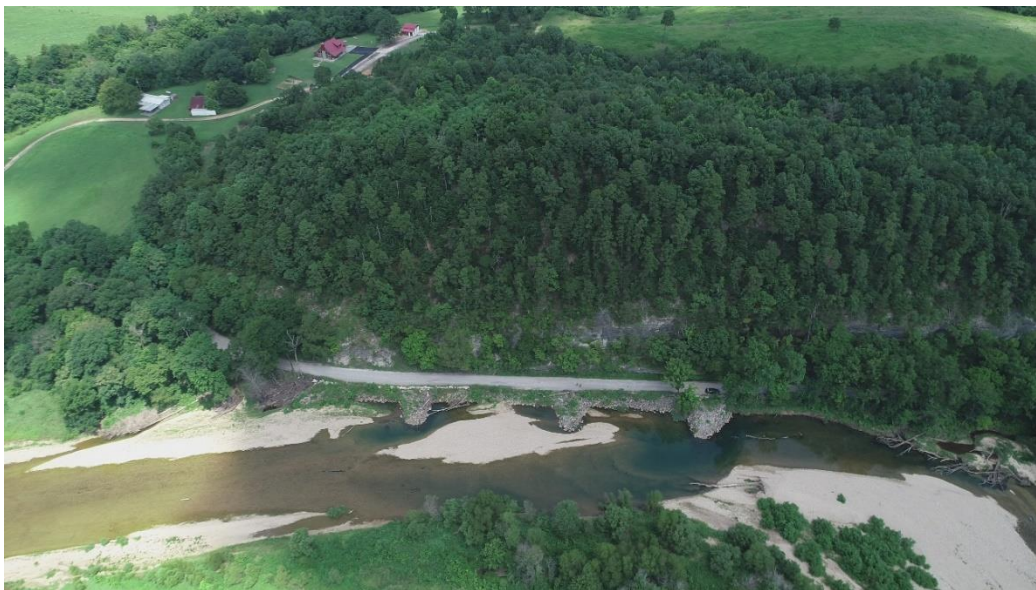
Figure 52 - Reach 2, 2021 drone pictures showing the existing structures protecting the road

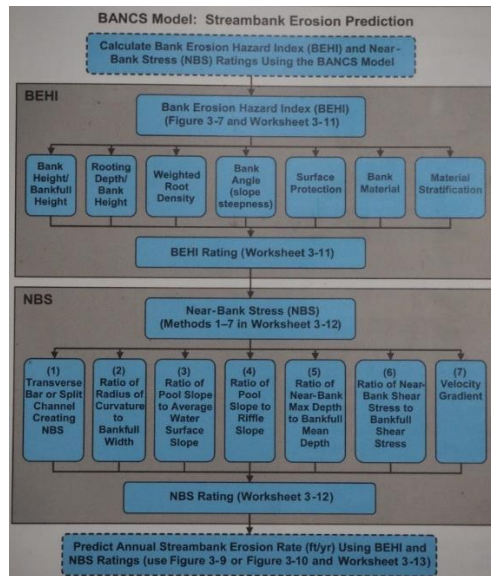
There are different methods used to predict the streambank erosion rate (ft/year). David Rosgen in 1996 proposed the Bank Assessment for Non-point source Consequences of Sediments (BANCS) model. This model uses two bank erosion estimation tools: The Bank Erosion Hazard Index (BEHI) and the Near-Bank Stress. Both methods are explained in “Chapter 1 Introduction; Section 1.4 Preliminary concepts”.

Figure 53 – The BANCS model variables, ratios, and procedures associated with the Bank Erosion Hazard Index (BEHI) and Near-Bank Stress (NBS) to predict annual streambank erosion (Rosgen, 2006b)

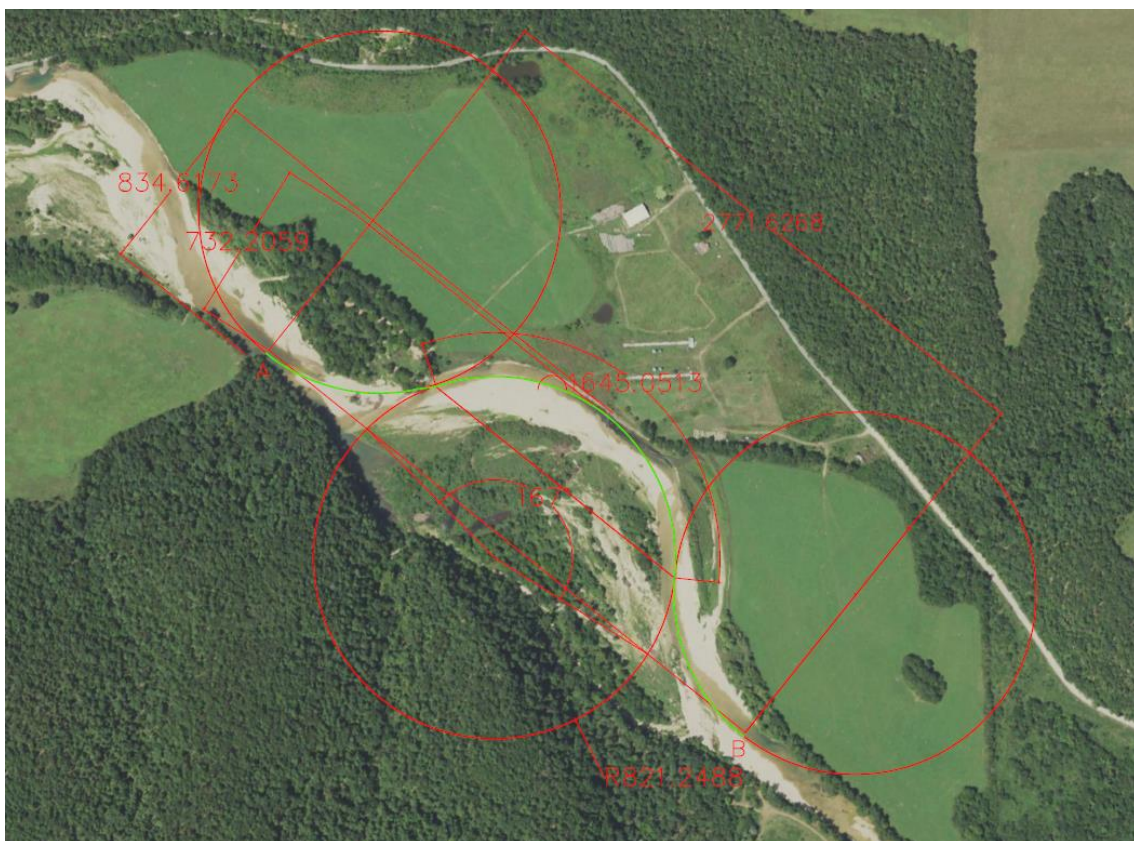
Figure 59 – Reference meander showing the design parameters for the new design

1. Radius of curvature = 821.249 ft
2. Wavelength = 2771.627 ft
3. Amplitude = 732.206 ft
4. Belt width = 834.6173 ft
5. Bend length = 1645.051 ft
 - a. Theoretically, this value should be equal to $\frac{1}{2}$ of the channel distance between A-B (showed in figure 59) ≈ 1470 ft

The meander that has been selected as a reference to calculate the parameters for the new design is the meander just upstream of the site as it was in 2019. This is because after this year some of the trees were washed away blocking the flow of water and eroding the river about 94 feet per year as explained in “Chapter 3 Channel stability assessment; Section 3.2 Streambank erosion rate analysis”, and this feature is not desirable in the new design.

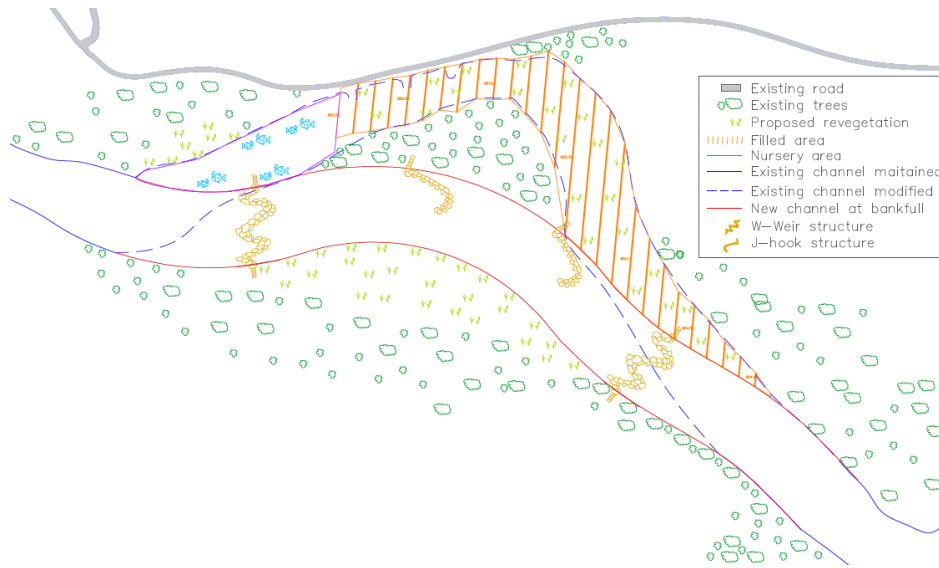
Figure 71 depicts the final conceptual design including all the variables and factors that have been designed in this chapter. A more detailed drawing can be found in “Chapter 8 Appendices; Appendix 8.4 Sketches; Final conceptual design”.

Figure 71- Final conceptual design

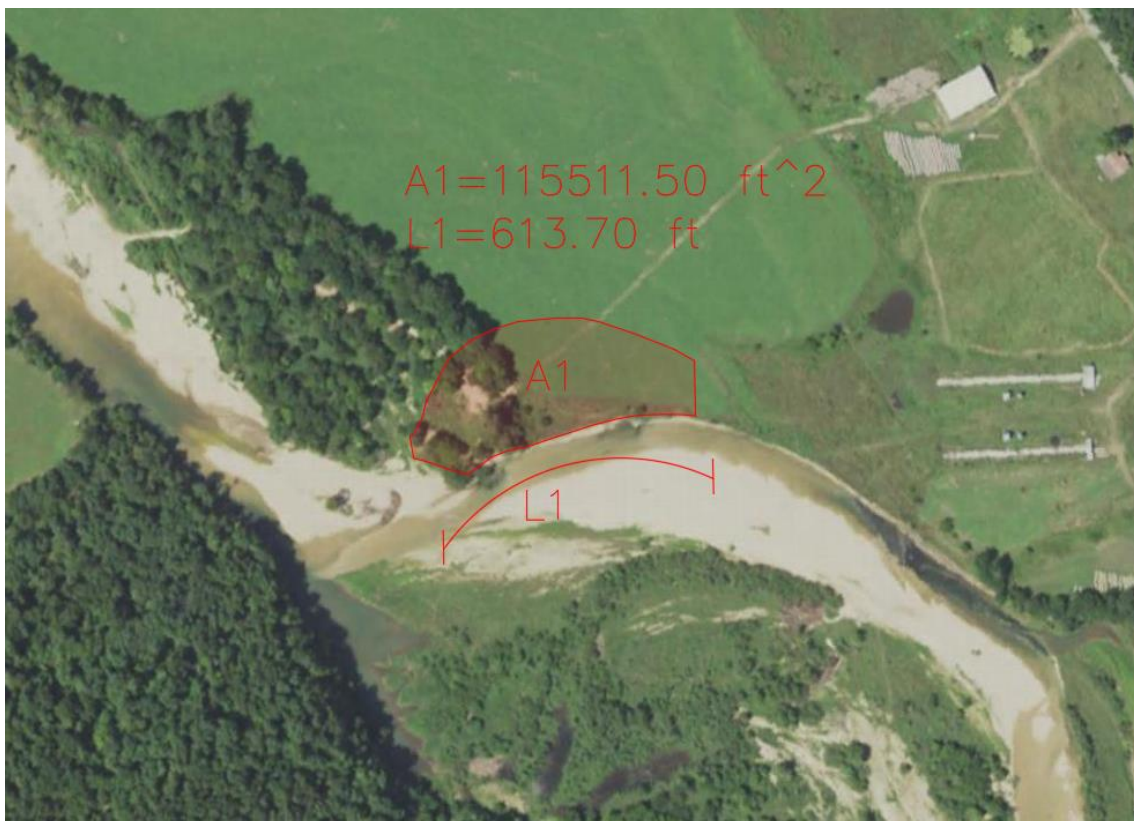
In the following section, the annual streambank erosion rate has been calculated using aerial imagery. To do that, a polyline has been drawn where the river was in 2019 and another where the river is now in 2021, the area of the polygon of the difference between both lines has been measured using the command “area” of Civil 3D and also the length of the reach has been measured as shown in figures 26 (appendix). Then the area has been divided by the reach distance to obtain the retreat every 2 years and then divided by 2 to obtain the retreat per year.

Figure 26 (appendix) – Reach 1, 2019 aerial imagery, showing the erosion in the following 2 years

$$\text{Bank Erosion Rate (BER) every 2 years} = \frac{A}{L} = \frac{115511.5}{613.70} = 188.22 \text{ ft/2years}$$

$$\text{Bank Erosion Rate (BER) every year} = \frac{188.22}{2} = 94.11 \text{ ft/year}$$

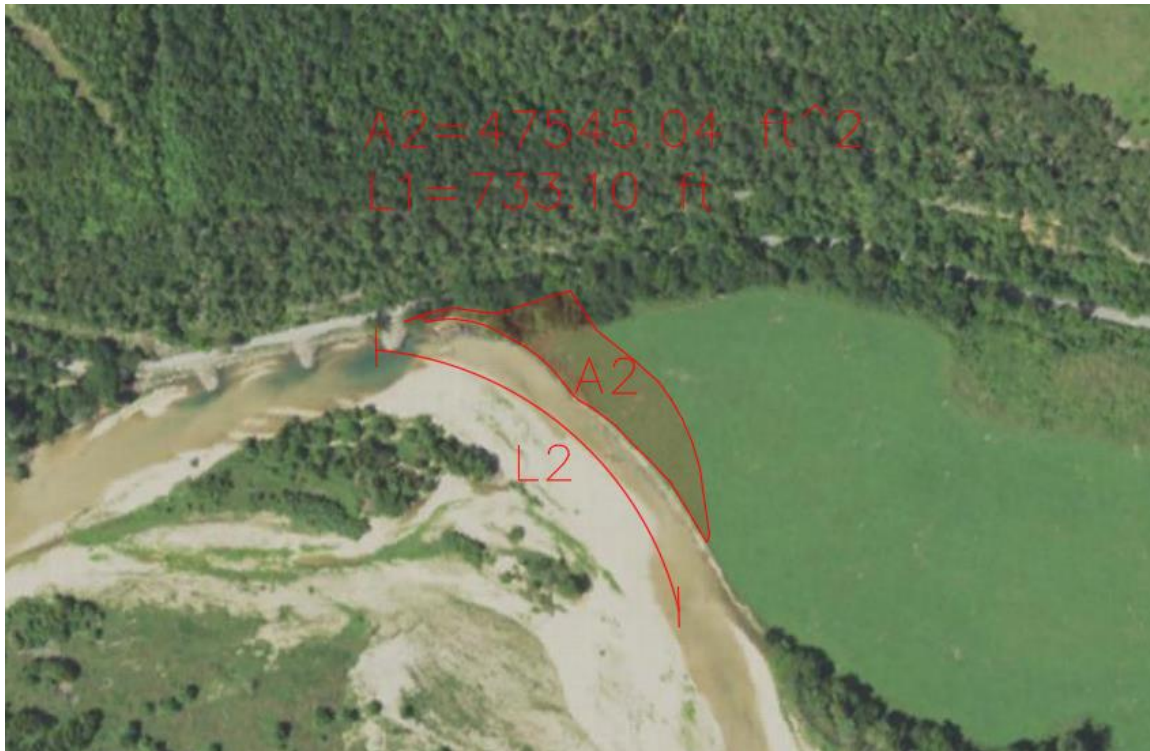
Figure 28 (appendix)– Reach 2, 2019 aerial imagery, showing the erosion in the following 2 years

A2=47545.04 ft²
L1=733.10 ft
