**“CHANNEL STABILITY ASSESSMENT AND ECOLOGICAL
RESTORATION DESIGN ON THE BARON FORK RIVER,
ADAIR COUNTY, OKLAHOMA (U.S.A)”**

MASTER THESIS SUBMITTED TO THE ACHIEVEMENT
OF MASTER’S DEGREE IN CIVIL ENGINEERING

Norman (Oklahoma), July 2021

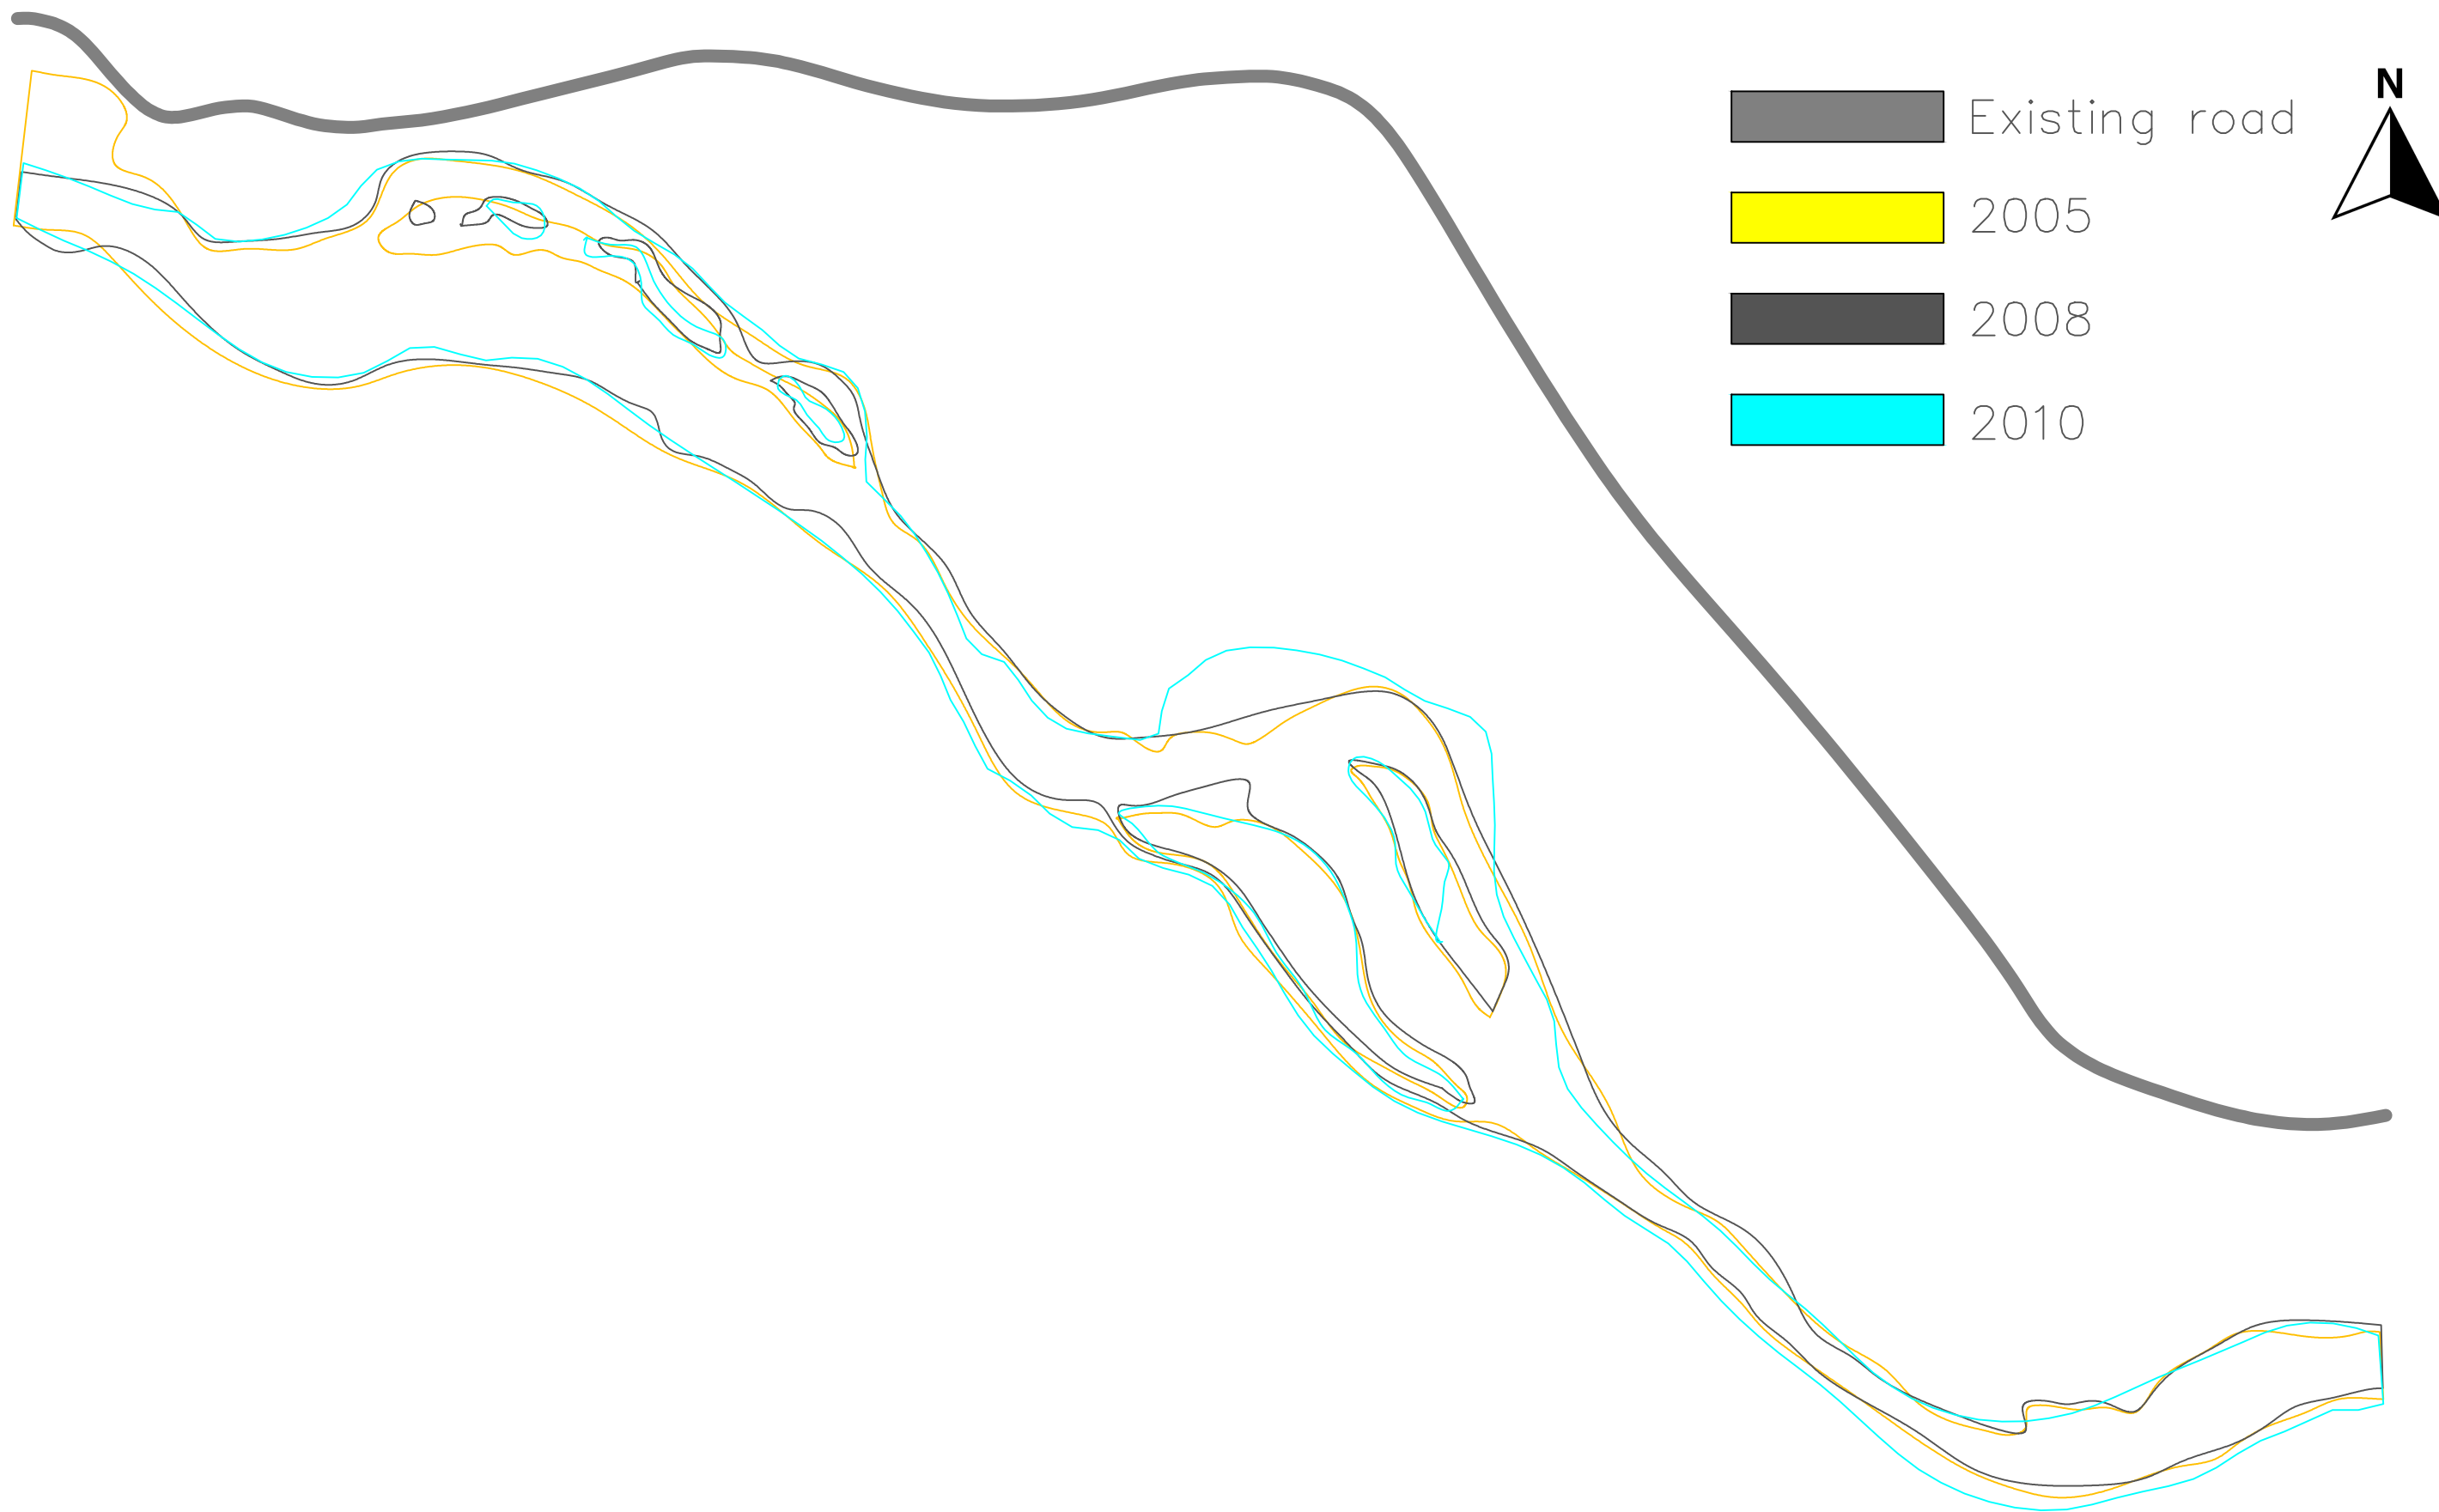
Title:
Channel evolution 1/4

Existing road
