Earthen vernacular architecture in flood-prone areas: characteristics and typologies in the Ebro basin

Francesca Trizio¹, Torrijo Echarri², Camilla Mileto³, Fernando Vegas⁴

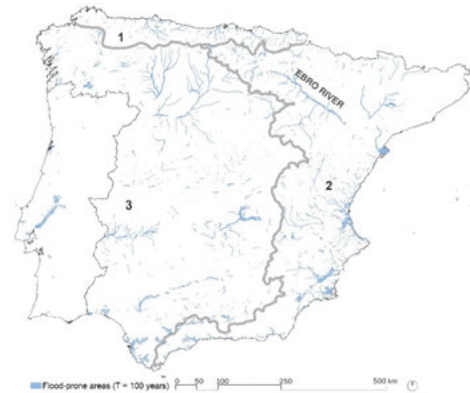
Fig. 1. Basins and flood-prone areas of the Iberian Peninsula. Legend: 1. Cantabrian Basin; 2. Mediterranean Basin; 3. Atlantic Basin (Source: Authors, 2021).

The study area of this paper is the basin of the river Ebro, where there are urban centres at high risk of flooding in the flood plain (ANEXO I Municipios y Núcleos de Población Situados En Zona A de Alto Riesgo, a Efectos de Emergencia Para Poblaciones, Incluidos En El Anexo XII (Tabla 12), Del Decreto 201/2019, de 8 de Octubre, Del Gobierno de Aragón., 2019). The Ebro is one of the rivers of the Mediterranean basin of the Iberian Peninsula (Fig. 1).

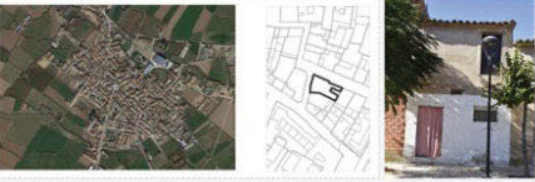
VERNACULAR ARCHITECTURE FORM
Floods susceptibility factors
10V

Location: C. Chulvi, 17
UTM: 38 151135, -0 440368
Typology: Between party walls
Property: Private
Occupied area: 173 m²
Floors: 2
Use: temporary
Conservation state: good
Intervention: yes

Fig. 4. Data collection form (Source: Authors, 2021).

As a result, the town of Torres de Berellen, with a high proportion of adobe buildings, was selected as a highly suitable case study. Subsequently, fieldwork was used to obtain information on the characteristics of the earthen buildings, which was then organised into synoptic data collection forms. These contain all the building characteristics that are essential to this analysis, divided into three categories: environmental, morphological and constructive. The characteristics identified in the data collection forms have been used as susceptibility parameters for assessing the flood vulnerability of earthen architecture. In order to simplify the analysis, the number of susceptibility, urban typology, number of floors, rendering and additional protection (Fig. 4).

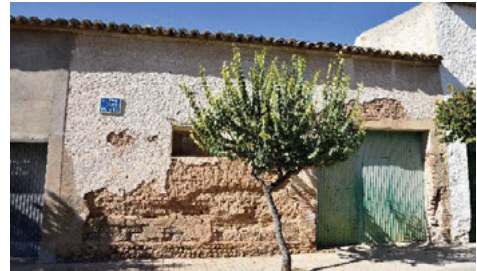
Fig. 6. Vernacular adobe building with visible erosion.

Siedel (2010) explained that floods occur in a short time with wide intervals between events. As a result, the saturation of materials, which modifies their characteristics and damages architectural components, takes place in a short period. The effects of excessive saturation may also include the loss of material, especially in the plinth, as found in some case studies (Fig. 6). This material degradation is mainly due to the characteristics of non-stabilised earth, which has a strong hygroscopic nature.
