Rediscovered earth heritage becomes motor for local change The Guérande Peninsula (France)

Topic: T1.1. Study and cataloging of vernacular architecture

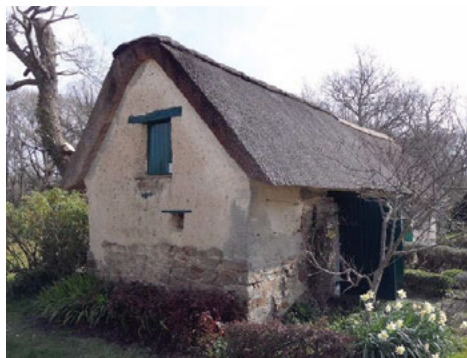
Fig. 1. A cob outhouse at Kerhebé, dating from the mid-19th century (Source: Hilton, 2015).

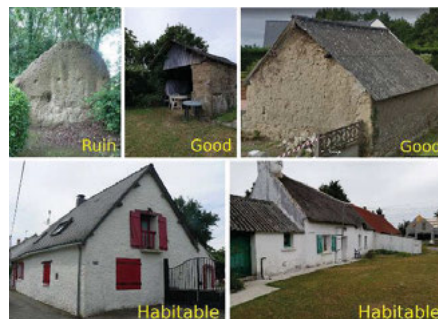
Fig. 7. Cob buildings in different states of preservation

We classified the 46 cob buildings identified according to one of four states of preservation (Fig. 7):

- *Destroyed*: present on old photographs collected from local inhabitants but not present on site
- *Ruin*: not usable, no roof, only the walls or part of the walls
- *Good*: usable as an outhouse, existing roof
- *Habitable*: the building is still used as a permanent dwelling
