## Joint strengthening by external bars on RC beam-column joints

Joaquín G. Ruiz-Pinilla <sup>a,\*</sup>, Antoni Cladera <sup>a</sup>, Francisco J. Pallarés <sup>b</sup>, Pedro A. Calderón <sup>b</sup>,  
Jose M. Adam <sup>b</sup>

### ABSTRACT

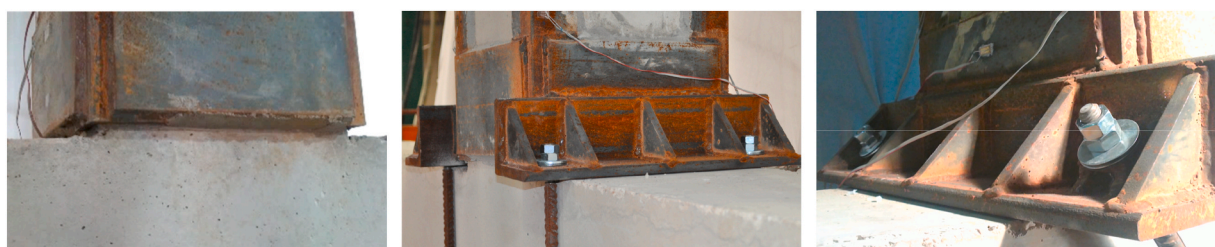
Fig. 3. Joint strengthening.

A reference specimen (A.W.L0) was not strengthened at the joint, while others were strengthened in two different modes: with vertical bars or diagonal bars (Fig. 3). The steel used for these bars was B500SD Ø16 mm (yielding and ultimate strength of 560/660 MPa, respectively), in which threads were cut at each bar end to fix capitals with nuts. Each capital was welded to the steel cage on three borders: one longitudinal along the capital and batten, and two transversal ones between the capital and steel angles.

a. W typology. No connection. b. VB typology. Vertical bar. c. DB typology. Diagonal bar.

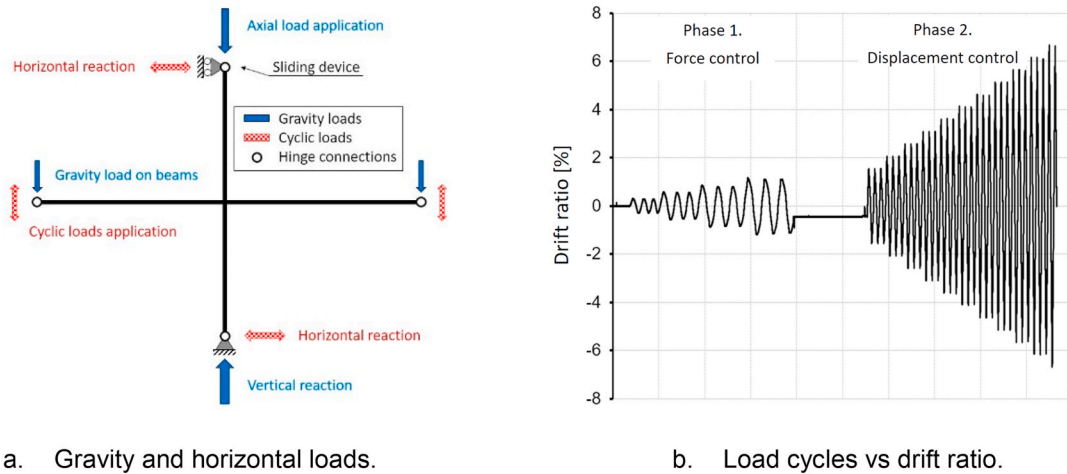
Fig. 4. Loads applied to specimens.

axial load is found in detail in Table 1), and on beams by two double effect hydraulic actuators (set at 30 kN to simulate slab loads). Authors like [37,58,59] have also considered gravity loads on beams. Reversed cyclic loads were applied with varying drift to the main beam up to specimen failure by keeping ends of columns fixed in the horizontal direction (Fig. 4b).

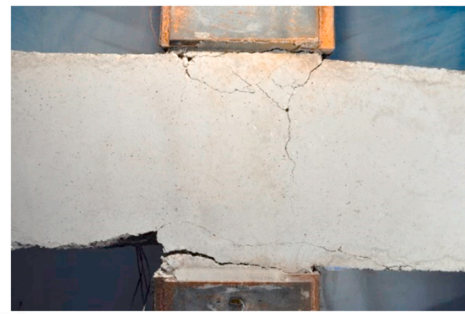
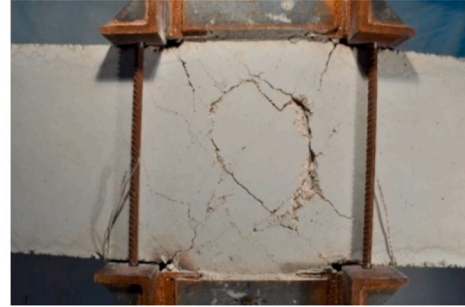
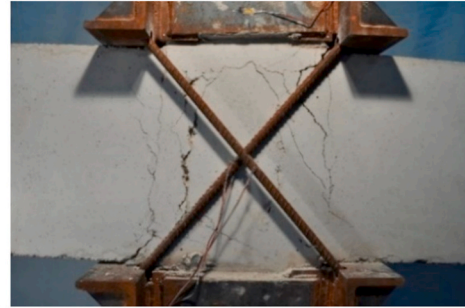
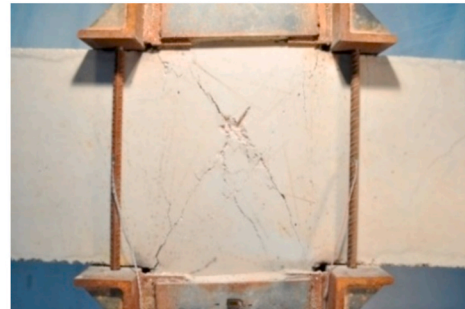
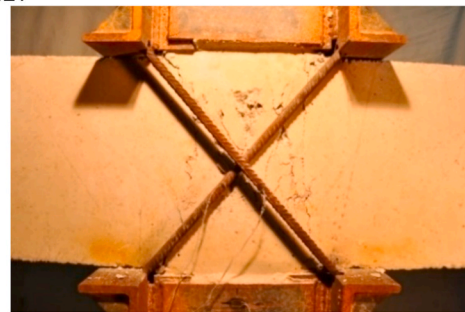
**Fig. 7.** Left: column shear force vs. drift ratio. Right: joint view at the 3.5% drift ratio in the specimens without axial loads (L0), and the 2.5% drift ratio in those with the axial load (L1).

Fig. 7 shows the hysteretic curves and failure modes obtained during the tests for the five different configurations. The hysteretic shear load on the column versus the relative displacement is represented on the left. The state of the specimens at the 3.5% drift ratio for the test without gravity load on the column and the 2.5% drift ratio for the specimens with the axial load is shown on the right. These percentages have been

From Fig. 7, we can see major differences between the tested specimens. A strong pinching effect was noted on the specimens without axial load on columns (specimens *LO*) (Fig. 7a, b, Fig. 7c), but they showed excellent ductility. The specimens with the axial load (specimens *L1*) evidenced greater strength, but less ductility (Fig. 7d and e).

Crack patterns significantly differed in each test. With specimen *A.W.LO* (Figs. 7a and 8a), cracks concentrated at the column-joint interface due to the column reinforcement yielding in this zone.

The external vertical bars and capitals (Figs. 7b and 8b) incremented the bending capacity in this zone, where the steel caging ended and allowed strengthening continuity through the joint between the top and bottom columns. Therefore, no large cracks were observed at the column-joint interface. Instead failure was transferred inside the joint, which was seriously damaged. On the *A.VB.LO* specimens (only specimen *A.VB.LO-1* is shown in these figures), diagonal cracks developed at the joint and joint's shear deformation are seen in Figs. 7b and 8b.

When external diagonal bars were installed instead of vertical bars, once again the crack pattern changed completely: cracks developed at the beam-joint interface due to these sections' bending capacity, and no significant damage was observed on the joint (Figs. 7c and 8c).

When an axial load was applied to the column, failure took place at the joint by shear and compression cracks (Fig. 7d, e, Fig. 8d and e), regardless of whether the external reinforcing bar was installed diagonally or vertically. When *A.DB.L1-2* testing finished, the disaggregated concrete of the joint core was removed to check the size of the affected area and reinforcement buckling. As Fig. 8f depicts, the affected area was bigger than the original joint, which indicates that capitals allowed joint size to increase, which improved its strength capacity.

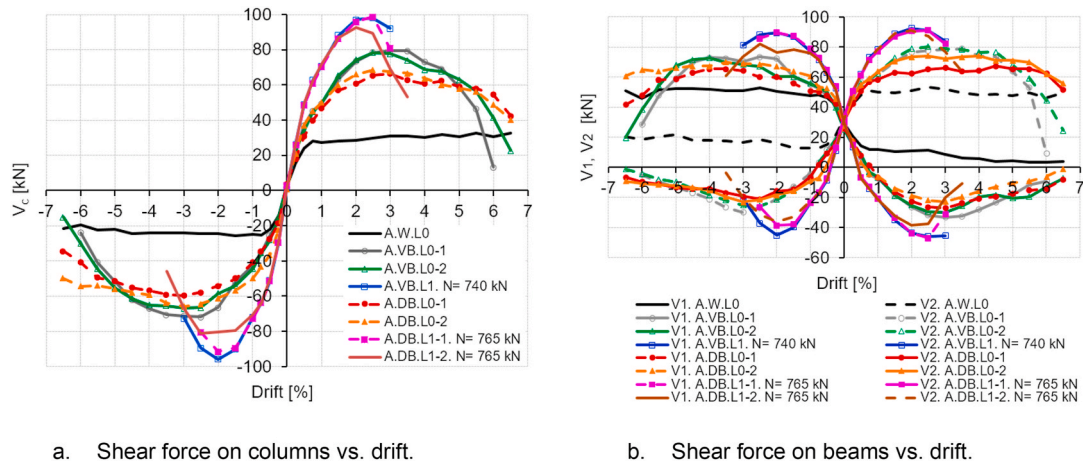
Fig. 9. Envelope forces vs. drift.

The envelopes of hysteretic curves are shown in Fig. 9.  $V_1$  and  $V_2$  are the loads on the beams end by the left-hand and right-hand actuator, respectively. As the gravity load on beams was 30 kN, the  $V_1$  and  $V_2$  values started from the drift ratio 0% value at the beginning of the test.

Fig. 9 shows that all the tested specimens achieved marked strength increments in relation to the reference specimen. When no axial load was applied to columns, the use of exterior vertical or diagonal bars increased strength by around 2.5-fold (2.58 for *A.VB.LO-1* and 2.48-fold for *A.VB.LO-2*) and 2.2-fold (2.15 for *A.DB.LO-1* and 2.29-fold for *A.DB.LO-2*), respectively. Vertical or diagonal bars configurations achieved similar strengths when the axial load was applied to the column. The incremented BCJ strength when the axial load was applied was about 1.3-fold in the specimens with vertical bars and 1.4-fold in the specimens with diagonal bars, compared to the situation in which no axial load was applied to strengthen specimens. Note that the results in Table 2 and Fig. 9 for the companion specimens (*A.VB.LO-1* and *A.VB.LO-2*; *A.DB.LO-1* and *A.DB.LO-2*; *A.DB.L1-1* and *A.DB.L1-2*) are similar for each test configuration, which confirms the repeatability of our test results.

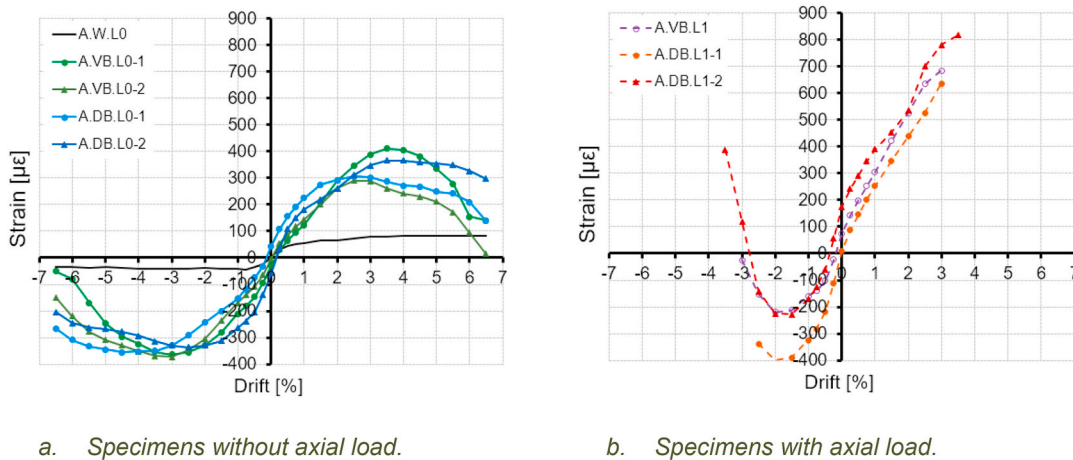
Fig. 12. Mean strain envelopes measured by the strain-gauges on steel angles (see Fig. 2).

Fig. 12 compares the strain at the steel angles of all the tested specimens. To better compare curves, and thanks to the symmetry of the specimens and loads applied to them, each curve was obtained by the mean value of the eight strain-gauges placed on steel angles (Fig. 2). This single curve per specimen was accomplished by computing the average of two curves (not plotted in Fig. 12). The first curve represents the average of the readings of strain gauges S1, S2, I1, I2 (steel angles compressed with a positive drift). The second curve represents the average of the readings of strain gauges S3, S4, I3, I4 (steel angles compressed with a negative drift). Bearing in mind that both curves represented the same phenomenon, but in opposite directions (symmetry vs. Y-axis), the sign of the second curve's drift was inverted to compute the average of both curves. Thus one curve in Fig. 12 represents the average behaviour of steel angles in tension and compression obtained by the eight strain gauges. A negative strain means tensile stresses.

High tension-compression symmetry was observed for the steel angles of those specimens without axial loads (LO - Fig. 12a). This figure depicts how the reference specimen (A.W.L0) angles presented a lower strain than in the other specimens because the steel cage was not colligated to the joint upon compression or tension if no external strengthening bars were added. In this case, tension or compression forces were transmitted to the steel cage only by the friction between angles and the column surface. With the specimens for which capitals were used (all the

specimens, except A.W.L0 - Fig. 12a), steel angles achieved a higher compression strain, which was even bigger when axial load was applied (L1 - Fig. 12b). With the specimens for which external bars were used (either vertical or diagonal), steel angles achieved a higher tension strain.

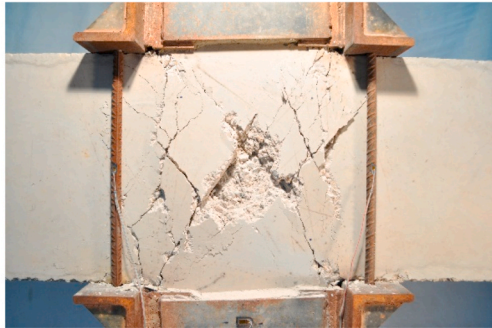
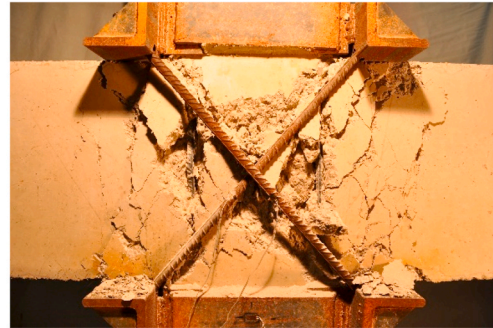
**Fig. 14.** Longitudinal strain of the eight steel angles (see Fig. 2) of specimens A.VB.L1 and A.DB.L1-2 under gravity load at the end of the first cycle for every drift ratio (a, b) and the damage state of the joints after first cycle for 3% drift ratio (c, d).

Fig. 14a and Fig. 14b show the strain of the steel angles of the specimens strengthened with exterior bars under the axial load applied to columns. The Y-axis (ordinate) represents the strain of the angles at

the end of the first cycle of the drift ratio indicated on the X-axis (abscissa); it is highlighted here that no horizontal load acted on the specimens at these positions. Despite the gravity load not changing, the strain of the angles increased considerably after some cycles. This was because when the concrete degradation at joint started to become significant (Fig. 14c and d), its axial strength sharply dropped and angles received the load that the joint could not, which prevented collapse. Almost the entire axial load is supported by the steel cage after the 3% drift ratio.

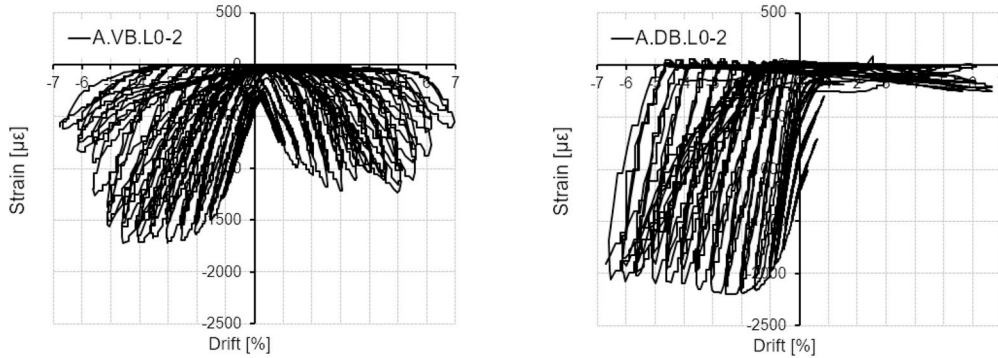
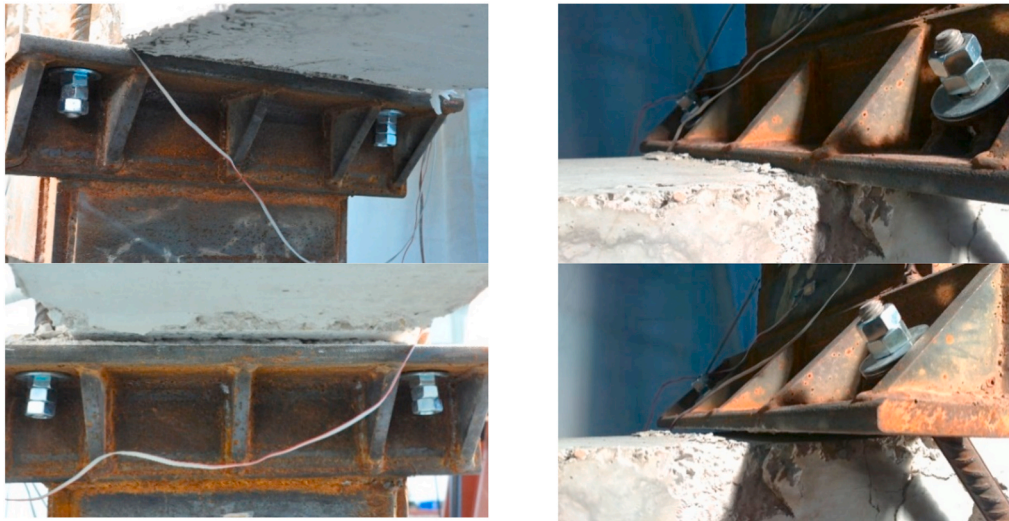
**Fig. 15.** Behaviour of vertical (A.VB.L0) and diagonal bars (A.DB.L0).

As described above, external bars allowed the capitals to contribute to column strength. External bars connected the steel cage through the joint, which enabled the continuity of column loads. Although the maximum strength of the specimens with vertical or diagonal bars was not that different, the behaviour of both external bars and the joint panel was.

The washers of nuts remained in contact with capitals regardless of movement being to one side or the other when vertical bars were used as bars were in tension. However, when employing diagonal bars, they did not work in one of the two movement directions. So a gap appeared

between the washer and the capital (Fig. 15c). The threaded part of bars at their ends was the system's weak part. As ends of bars had a smaller area than the remaining length, this was the part where the most marked deformation of bars concentrated, which reduced the cross-sectional area (necking) of external bars (Fig. 15d). Given the inclination of diagonal bars, these bars were subjected to more tension than vertical bars under the same horizontal load.

a. Deformation scheme of specimens.

b. Hysteretic loops of the strain on the vertical and diagonal external bars.

c. Contact and loss of contact of capitals in tension-compression reverse cycles.
