Preserving the heritage of world's monuments through Structural Health Monitoring – A case study: the Garisenda Tower

In this paper, we will focus on one part of the SHM system of the Torre della Garisenda located in Bologna, Italy, dedicated to the assessment of the strain at the

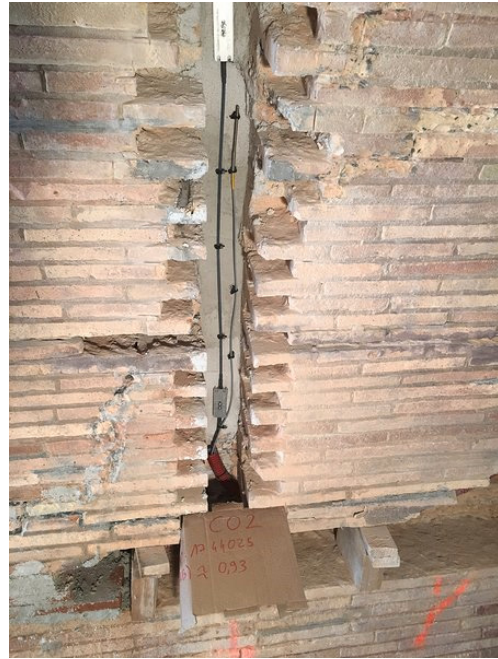
Figure 1. Optical Strand Strain sensor and temperature gauge integrated inside the cladding of the Pont de Pierre in Libourne, France. The picture is taken before completion of the cladding. ©OSMOS Group SA.

Ancient masonry bridges are also of great interest, especially when they are both of historical value and important traffic infrastructures. For example, a permanent SHM system has been set up since 2017 on the Pont de Pierre in Libourne, France, combining strain measurements under one of the arches and on the spandrel walls, with settlement and water level measurements (OSMOS Group SA, 2018). This system allows to assess the correlations between surface strain of the masonry and both settlements and water level, including a strong effect of the tides on the compression of the arches. Moreover, the threshold-triggered dynamic strain records are sensitive enough to assess the effect of heavy traffic on the keystone of the arch, and the continuous monitoring of strain on the spandrel walls gave anticipated signs of a potential crack opening, which eventually appeared visually on the wall. In this case, it is worth to notice that the Optical Strand strain sensors were integrated inside the cladding during rehabilitation works and are totally invisible, preserving the visual appearance of the construction (Figure 1).

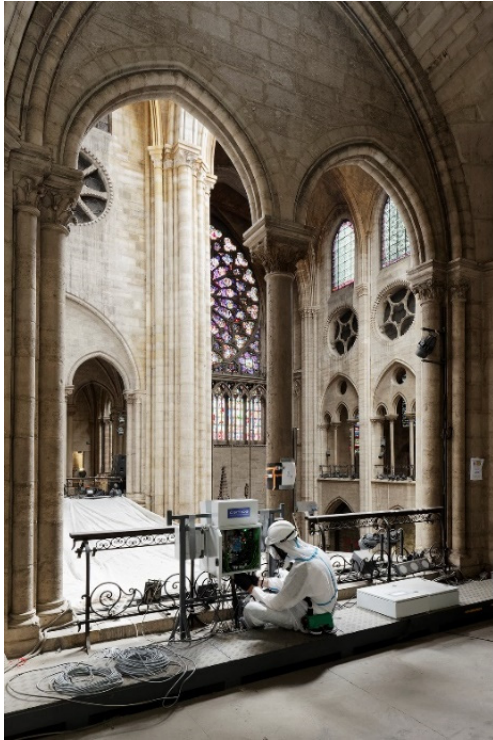
Figure 2. Set-up of the monitoring system of Notre-Dame Cathedral in Paris. ©OSMOS Group SA.

More recently, the continuous SHM of heritage buildings answered to a stringent necessity in the case of the fire which ravaged the Notre-Dame de Paris Cathedral on April 15, 2019 (Figure 2). Immediately after the disaster, the most critical parts of the damaged vaults have been instrumented with high-precision lasers to detect and anticipate any further movement. Then, up to more than 140 sensors have been in operation through the whole duration of the securing works, and furthermore for the assessment in view of the reconstruction. This complex system involves several different types of sensors, measurements and data analysis tools, including an immediate alert feature based on tilt and strain measurements on the damaged scaffolding of the spire during its dismantling until November 2020, a static monitoring of the deflection of the vaults with rows of tiltmeters, and OMA performed from numerous accelerometers on both the timber structures inside the two belfries and on the vaults and pillars of the nave (OSMOS Group SA, 2020).

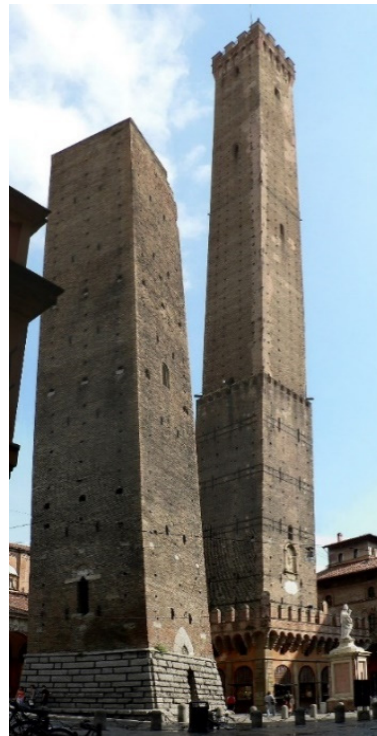
Figure 3. The two Towers: Garisenda (left) and Asinelli (right). The external side of the selenite basement of the Torre della Garisenda is clearly visible, as well as the entrance door.

The Torre della Garisenda (Figure 3), with a square base structure of 7 m on each side and built in the same way as abovementioned, stands out for its lower height of only 47 m. It is known for its steep slope, with an angle of 4° (3.22 m overhang). Originally about 60 m high, it was lowered by about 12 m due to the dangerous inclination caused by the poor mechanical and load-bearing capacity of the foundation soil in the mid-14th century.

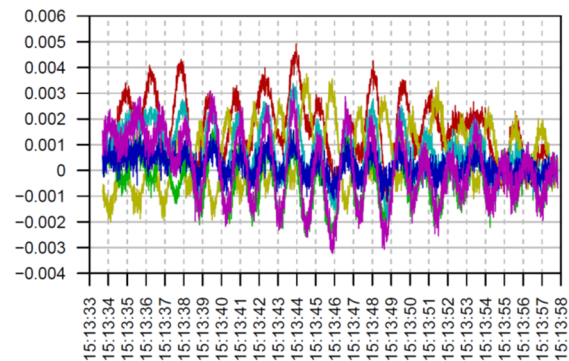
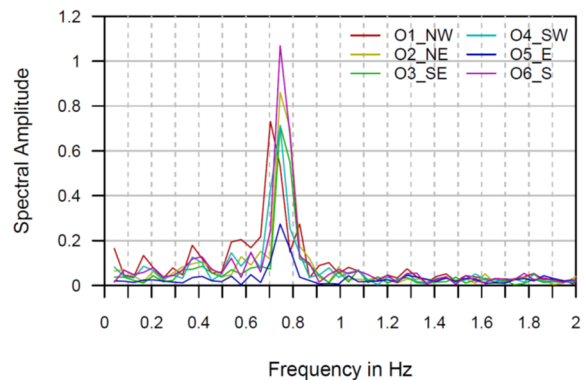
Figure 7. Deformation recording during 8/2/2019 wind event and corresponding frequency analysis.

August 2nd, 2019, at 15:13 UTC: Strong wind inducing vibrations with a frequency of 0.68 Hz. No remaining strain is noticed after these vibrations, from which we conclude they did not have any harmful consequence on the monitored parts of the structure. The amplitude of the strain at the base of the tower reaches 0.005 mm/m (Figure 7).
