Becker, V.; Schwamm, T.; Urschel, S.; Antonino-Daviu, J. (2021). Fault Detection of Circulation Pumps on the Basis of Motor Current Evaluation. IEEE Transactions on Industry Applications. 57(5):4617-4624. <https://doi.org/10.1109/TIA.2021.3085697>

Fault Detection of Circulation Pumps on the Basis of Motor Current Evaluation

Abstract — Motor current signature analysis (MCSA) for fault detection has found widespread application, especially for induction motors (IM). The basis of MCSA is the evaluation of a motor's current. This analysis is now also used for other motor types and can be used to detect faults of the coupled load. The purpose of this paper is to examine whether MCSA can be used to detect faults in a wet-rotor pump. A total of three faults are examined. The results show that, compared to a healthy pump, all faults could be detected. However, a detailed analysis of frequency components has to be carried out to differentiate the faults. A circulation pump with a maximum power consumption of 1.1 kW was used as the test item.

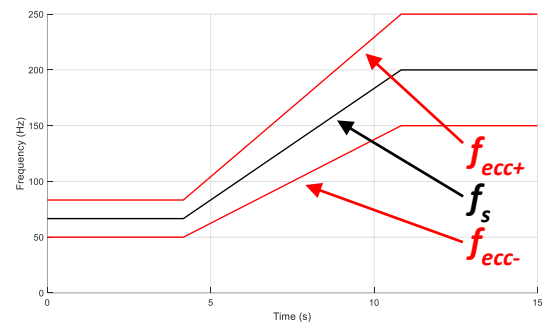
If the stator frequency is changed, the frequency component of the eccentricity also changes. This is of interest when considering start-up. The theoretical evolutions at the ramped start-up of the dynamic eccentricity components ($n_{ws}=1, n_d=1$) of an 8-pole PMSM are shown in Fig. 1. If there is dynamic eccentricity in a motor, the evaluation of the ATCSA should show an increased amplitude at the location of the red lines.

Fig. 1. Theoretical curves of the dynamic eccentricity components given by (1), for $n_{ws}=1, n_d=1$, for the start of an 8-pole PMSM ($n_{start}=1000$ rpm, $n_{end}=3000$ rpm)

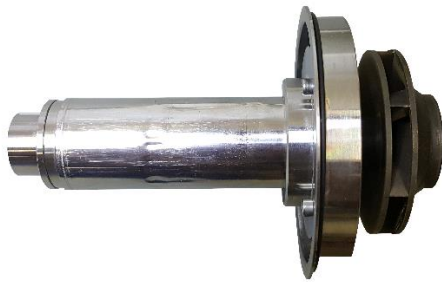
A circulation pump with a maximum power consumption of 1.1 kW and a nominal pipe size of DN 50 was tested. The functional principle is based on a wet-rotor pump driven by a PMSM. The motor is fed by an integrated inverter with a variable speed control of 1000 to 3000 rpm. Due to the high power of this pump, its field of application is mainly in heating systems of larger building complexes.

In the experiment, the rotor of the motor was equipped with eight permanent magnet excited poles. The stator winding was designed as a tooth coil winding with twelve slots. The impeller was designed as a radial impeller with seven blades. The shaft was supported by two journal bearings. A specially manufactured prototype was used as the can and split case (see Fig. 2). This allows the rotor to be removed from the can by loosening the screws. This is not possible with a standard version, as these spots are welded.

Fig. 2. The measured wet-rotor pump with a power of 1.1 kW.

The fault was provoked by grinding down a healthy journal bearing located in the metal housing (left side of Fig. 2) on the inside with the help of a lathe (see Fig. 5). This increased the inner diameter from 20 mm to 21 mm. The outer diameter of the journal bearing was 29 mm.

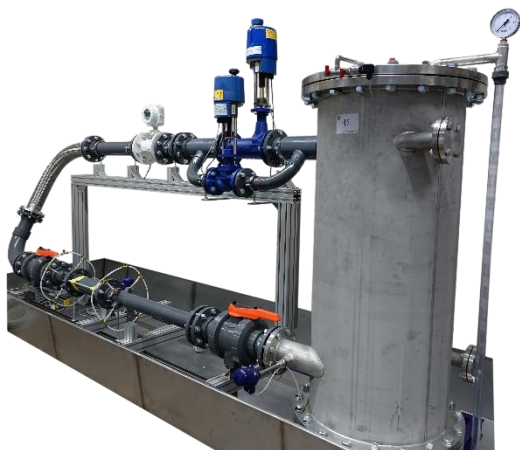
The measurements were carried out on a pump test bench (see Fig. 3). The test bench consisted of a piping system connected to a reservoir. Pressure (WIKA DPT-10) and flow sensors (ABB Watermaster FER100) were used to measure the hydraulic values. A data acquisition system recorded the values of the sensors and controlled the actuators.

Fig. 3. The pump test bench.

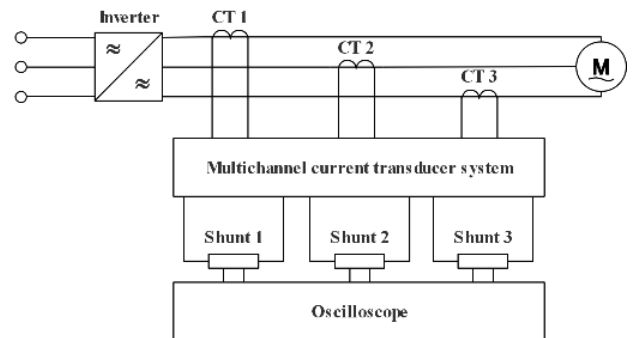
The measurement setup shown in Fig. 4 ensured high-precision recording of the current signature. The three-phase current from the inverter induced an equivalent voltage signal

in the zero flow current transducers (LEM IT 200-S), which were galvanically isolated from the power circuit. With the help of the Multichannel Current Transducer System (Signaltec MCTS), the supply of the current transducers was provided and their voltage signal was captured. The three galvanically isolated current channels and separate internal power supplies of the MCTS reduce both external and internal interference. The outgoing measuring signal was tapped via shunts (Yokogawa 19/SH5/BNC/0,05) and transmitted to the oscilloscope (Rhode & Schwarz RTE 1034). For each measurement, a sampling rate of 10 kHz with a running time of 60 s was set.

Fig. 4. Setup for precision measurement of the wet-rotor pump motor current.

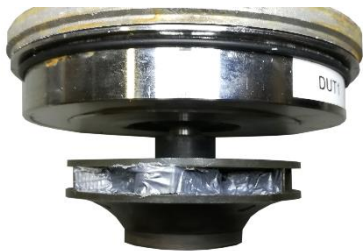
One type of faults that can occur in wet-rotor pumps **is** caused by contamination of the pumped medium. In this case, **the** channels of the impeller can become clogged. To test the effect of this fault on the measurement results, two of the seven channels **were** clogged with foam and **armor** tape (see Fig. 6). After the measurement, these spots **were** checked to see if the channels **were** still clogged.

Fig. 6. **Impeller** of the wet-rotor pump with two clogged channels.

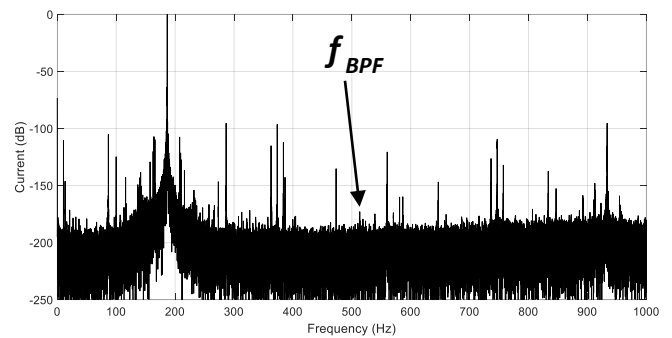
In order to get a reference for considering the faults, the measurement results of the healthy pump will be **considered first**. Fig. 7 shows the MCSA of the stator current of one phase of the PMSM, **while** Fig. 8 and Fig. 9 show the ATCSA of the same phase for start-ups from 1000 to 3000 rpm.

The fundamental component can be seen at a frequency of 186.6 Hz in Fig. 7. Furthermore, considering Fig. 7 and Fig. 8, an increased amplitude can be seen at every integer multiple of the stator frequency. What is noticeable in Fig. 9 are some speed-independent components, especially at the **100 Hz and 10 Hz** frequencies. A closer look at Fig. 8 reveals a component that starts at about 170 Hz and ends at 295 Hz, **meaning it** has a lower slope than all other components. These oscillations can be attributed to the design of the stator and the inverter operation. The component of the BPF of this configuration is at a frequency of 513.3 Hz (see equation 2) and is only weakly developed in the spectrum (-173 dB). If the frequency components around the stator frequency ($3/4$ and $5/4$ times f_s) of a dynamic eccentricity are considered, a slight characteristic is noticeable. The amplitude of f_{ecc-} is -139 dB and **that** of f_{ecc+} is -154 dB. This result is also consistent with the result of the ATCSA; see Fig. 9. Here, a slight increase of the amplitude of f_{ecc} is visible.

Fig. 7. MCSA of the wet-rotor pump in healthy condition at 2800 rpm.

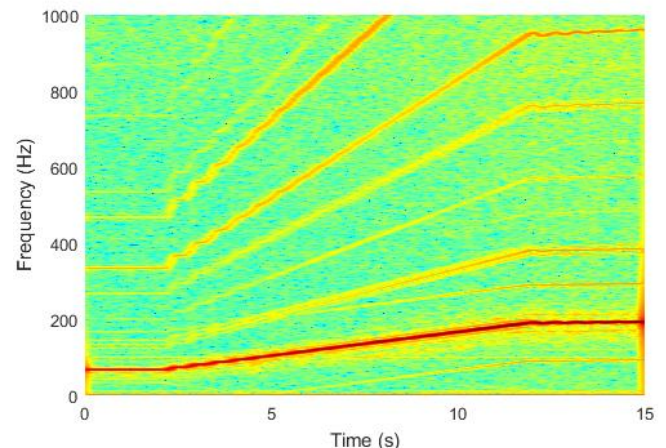
Fig. 8. ATCSA of the wet-rotor pump in healthy condition for a run-up from 1000 to 3000 rpm from 0-1000 Hz.

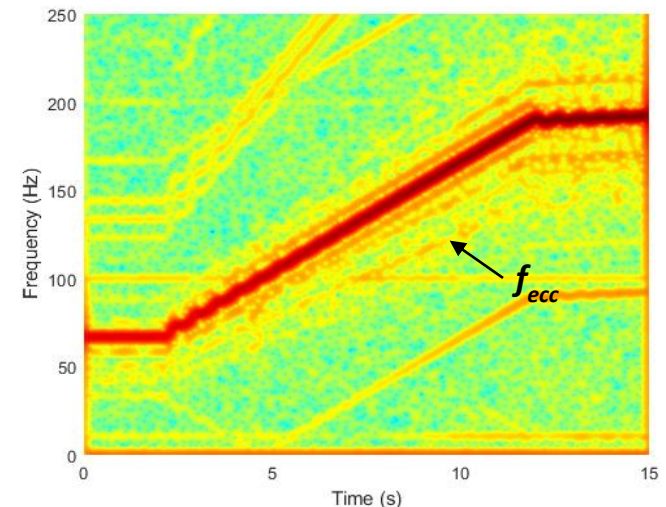
Fig. 9. ATCSA of the wet-rotor pump in healthy condition for a run-up from 1000 to 3000 rpm from 0-250 Hz.

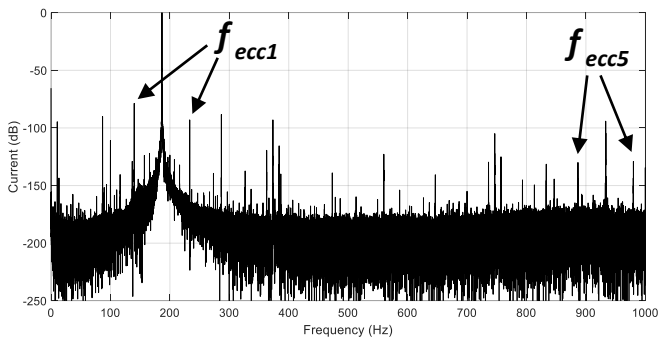
Fig. 10 **depicts** the MCSA and Fig. 11 the ATCSA of the pump with a worn **journal** bearing. Both figures show a significant amplitude of the sidebands around the stator frequency. Since the frequency components are at $3/4$ and $5/4$ times the stator frequency, they can be attributed to a dynamic eccentricity according to equation 1, for $n_{ws}=1$, $n_d=1$. Compared to the amplitude of the MCSA of the healthy pump, the component f_{ecc-} increases from -139 dB to -79 dB and f_{ecc+} **increases** from -154 dB to -93 dB. The ATCSA (Fig. 11) shows the typical color pattern for a motor with dynamic eccentricity, which is also shown in Fig. 1. **It can be observed** that this pattern only becomes visible **once** a certain **speed is reached**, about **half-way** through the run-up. What can also be

seen in Fig. 10 is an increase in the amplitude of the sidebands at the 5th harmonic ($w_s=5$). At 4.75 times of f_s (886.8 Hz), the amplitude increases from -185 dB to -130 dB, and at 5.25 times of f_s (980.2 Hz) from -193 dB to -129 dB compared to the healthy pump. These frequency components can be attributed to a dynamic eccentricity according to equation 1 ($w_s=5$, $n_d=1$). Due to the small absolute value of the amplitude, this frequency component is not visible in the ATCSA.

As described in chapter II. A, a static eccentricity should show an increase of amplitude at odd multiples of the fundamental components. At 3 times the basic frequency (560.1 Hz) as well as at 5 times (933.5 Hz), the amplitude remains about the same, compared to the healthy configuration (see Fig. 10).

Fig. 10. MCSA of the wet-rotor pump with a worn journal bearing at 2800 rpm.

These results are an indication that due to the worn journal bearing, the rotor no longer has any guidance and thus runs dynamically eccentrically.

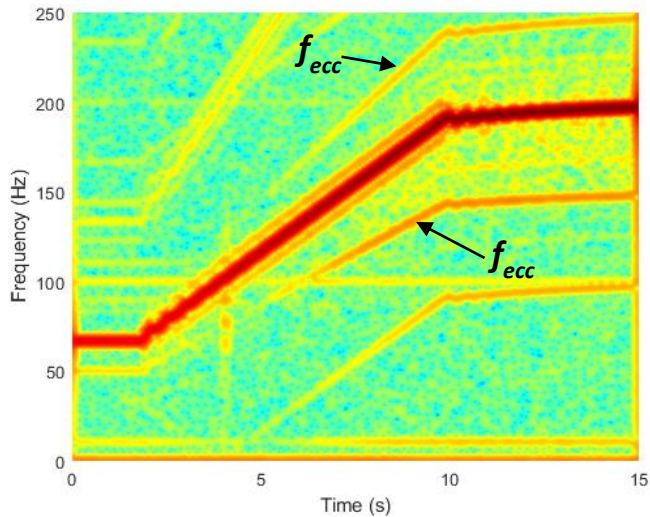
Fig. 11. ATCSA of the wet-rotor pump with worn journal bearings for a run-up from 1000 to 3000 rpm from 0-250 Hz.

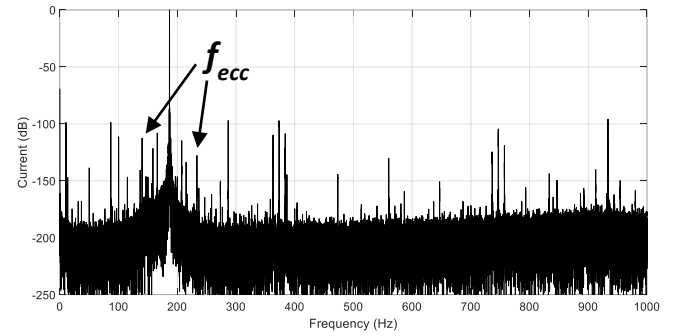
The MCSA and ATCSA results for the dry-running rotor are shown in Fig. 12 and Fig. 13, respectively. It can be seen from both analyses that the fault causes an increased amplitude of the dynamic eccentricity component. By comparing the MCSA of this fault (see Fig. 12) with the healthy configuration (see Fig. 7), the amplitude of f_{ecc-} increases from -139 dB to -113 dB and that of f_{ecc+} from -154 dB to -128 dB. The ATCSA (see Fig. 13) also shows the predicted pattern for dynamic eccentricity. Particularly notable is the f_{ecc} component, which is visible over the entire

time history. If the static eccentricity is considered (see equation (1), $n_d=0$), a slight reduction, from -121 dB to -130 dB, is noticeable at 3 times the stator frequency (560.1 Hz) compared to the healthy configuration. The amplitude of 5 times (933.5 Hz) the stator frequency remains the same in both configurations.

Fig. 12. MCSA of the wet-rotor pump with a dry-running rotor at 2800 rpm.

The results show that a slight dynamic eccentricity is caused by the dry-running rotor. This behavior can be explained by the fact that no lubricating film can form between the bearing and the shaft because there is no water in the rotor space. The gap between shaft and bearing is sufficient to cause a slight eccentricity.

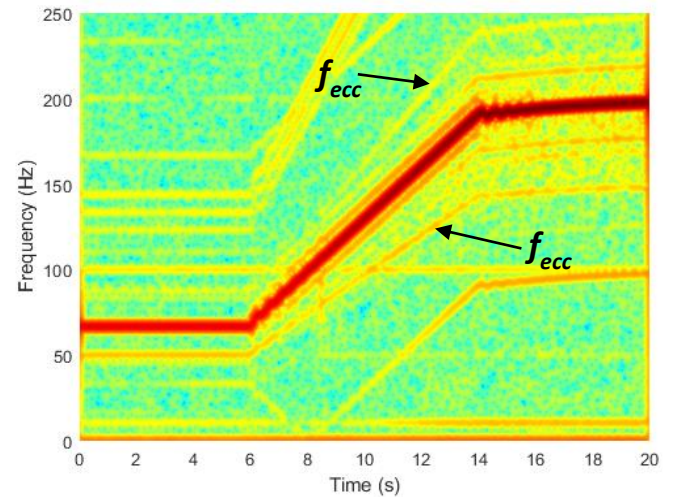
Fig. 13. ATCSA of the wet-rotor pump with a dry-running rotor for a run-up from 1000 to 3000 rpm from 0-250 Hz.

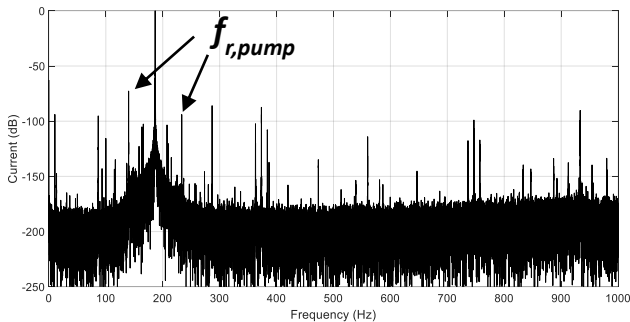
The MCSA and ATCSA results for the configuration with two clogged impeller channels are shown in Fig. 14 and Fig. 15, respectively. What is noticeable in both figures is the increase in amplitudes at the point of 3/4 and 5/4 times the stator frequency. In Fig. 15, the typical courses at these sideband frequencies are very noticeable. By comparing the MCSA of this fault (see Fig. 14) with the healthy configuration (see Fig. 7), the amplitude of the left sideband increases from -139 dB to -73 dB and that of the right sideband from -154 dB to -94 dB. Compared to the other two faults, these amplitudes are comparable to those of worn journal bearings. This fault is caused by the impeller and the frequency can be predicted using equation 3. What cannot be explained by equation 3, however, is the increase in the amplitudes of the sidebands around the 5th harmonic. This makes it difficult to distinguish this defect from a worn journal bearing. The clogging causes an imbalance, which is clearly visible in the stator current.

Since two of seven impeller channels cannot deliver hydraulic power, a look at the BPF makes sense. Compared to the healthy configuration, a slight increase of the BPF components at 513.3 Hz from -173 dB to -162 dB is observed. This increase is too small to conclude that a fault exists.

Fig. 14. MCSA of the wet-rotor pump with two clogged impeller channels at 2800 rpm.

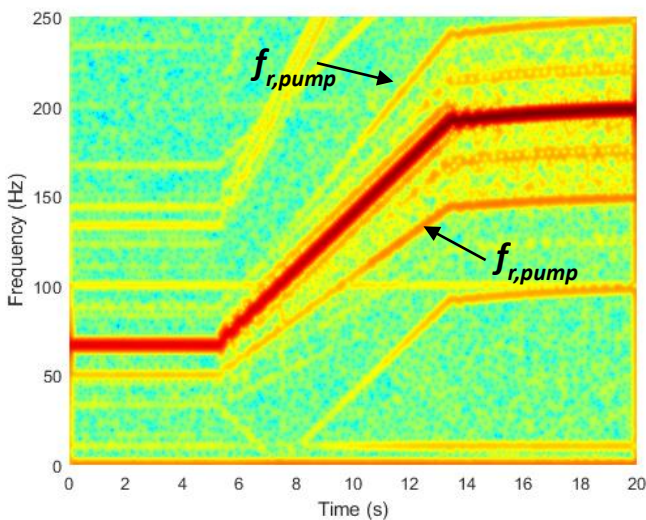
Fig. 15. ATCSA of the wet-rotor pump with two clogged impeller channels for a run-up from 1000 to 3000 rpm from 0-250 Hz.

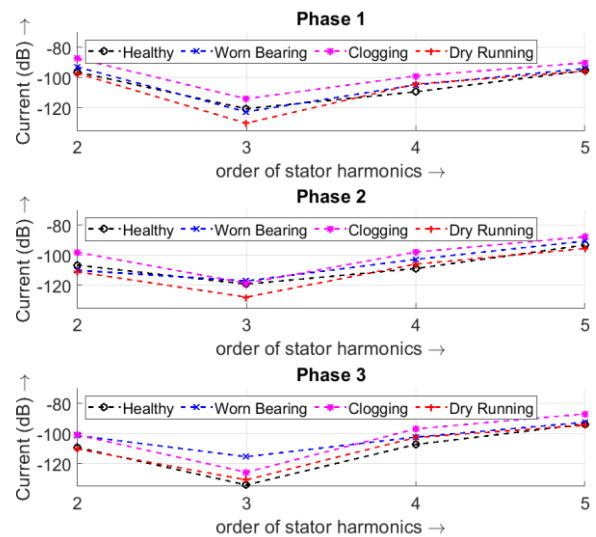
Since the BPF component is not influenced by the faults, the only possibility based on chapter II. are the static eccentricity components. Based on equation 1 ($n_d=0$ for static eccentricities), the frequencies influenced by a static eccentricity are multiples of the stator frequency. The result of the MCSA of the healthy variant (see Fig. 7) shows that at every multiple of the stator frequency, a peak of different height is visible. This is why in the following every multiple is considered, and not only the odd multiples as mentioned in equation 1. Fig. 16 shows the amplitudes of the 2nd, 3rd, 4th, and 5th harmonic for the three phases of all three faults and for the healthy variant. It can be seen that the differences among the amplitudes are small. To avoid drawing wrong conclusions, the courses for all three phases are shown.

It can be observed that the curves vary from phase to phase. For example, the peak at the 3rd harmonic in phase 3 is significantly higher than the amplitudes of the other variants. In phase 1, the variants Healthy and Clogging have higher

peaks. This shows that the analysis of a single phase could lead to false conclusions if the differences caused by a fault are small.

What is evident in all phases, however, is that due to the impeller clogging fault, the amplitudes at the 4th and 5th harmonics are the highest. In the place of the 4th harmonic, the amplitude is an average of 3.5 dB higher than the amplitude of the worn journal bearing fault and 4.5 dB higher than the amplitude of the dry-running fault. In the place of the 5th harmonic, the amplitude is an average of 4.1 dB higher than the amplitude of the worn journal bearing fault and 6.9 dB higher than the amplitude of the dry-running fault. The slightly higher differences and the higher absolute value of the 5th harmonic make it the best indicator for distinguishing the impeller clogging fault.

The amplitudes of the other variants are closer together. the amplitudes of the static eccentricity frequencies do not provide any added value for distinguishing the dry-running fault and the worn journal bearing fault from each other.

Fig. 16. Amplitudes of the harmonics of the stator current in MCSA for the three motor phases of all configurations
