## MULTISPECTRAL SENSORS IN COMBINATION WITH RECORDING TOOLS FOR CULTURAL HERITAGE DOCUMENTATION

Two issues are addressed here. First is the analysis and characterization of the weathering of the Djin Block No. 9 in order to assess the monument's condition, and second is testing the proposed approach of integrating visible, near-infrared, and thermal infrared imagery with terrestrial laser scanning.<sup>1</sup>

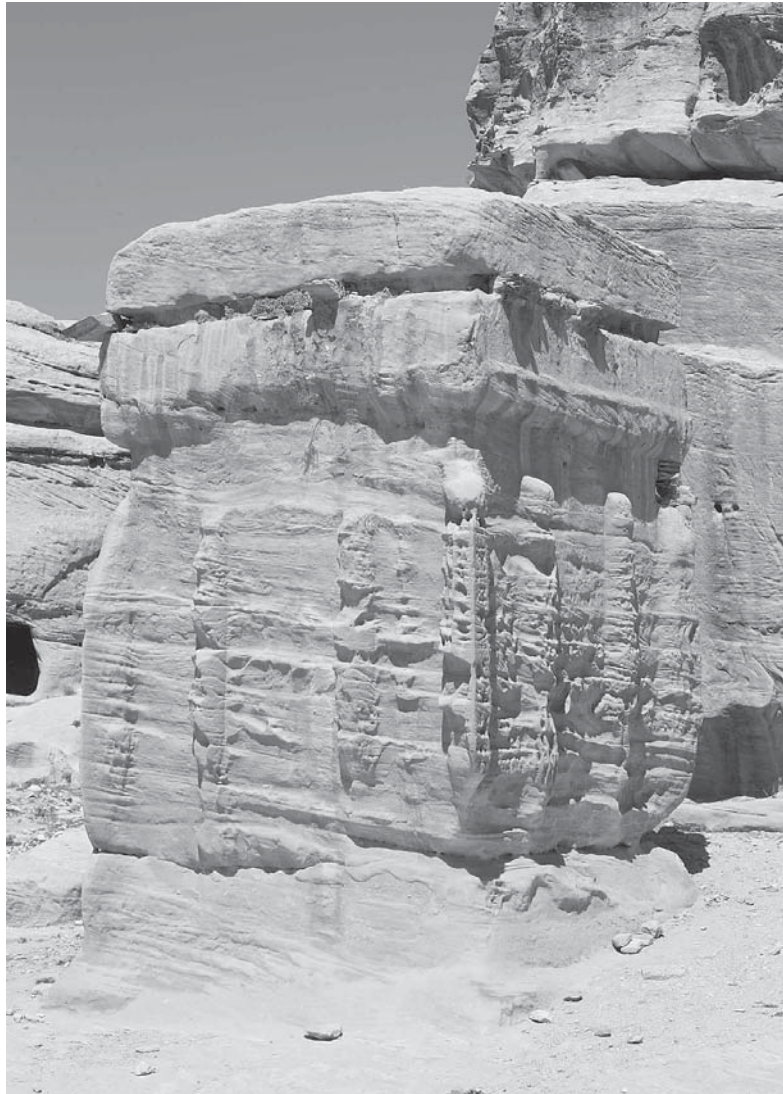
Figure 2. View of the Djin Block No. 9 from the southern and eastern sides depicting some of the fragments of the inset cornice in situ, 2010. (José Luis Lerma)

In this case study, the Nabataean Djin Block No. 9 (Fig. 2) is in the form of a temple. The block is 5.50 m × 5.50 m × 9.86 m (width, depth, height). The roof is flat and has a carved grave in its center (2 m by 0.6 m and 0.7 m in depth; Fig. 3). Its four sides are all similarly formed, consisting of four main units.<sup>6</sup> The top is a plain entablature unit with rectangular sides. Below it there is a deep rectangular groove in which stone insets were fixed with mortar. The row of inset stones forms a cornice running around the squared block. The row of stones that forms the cornice has a similar Hellenistic profile as is evidenced in most of the monuments in Petra. Each cornice stone has a sharp triangular front end section with a horizontal side pointing upward and a diagonal side facing downward. Below the groove another entablature follows, lying on top of a thin torus and a wider fascia. The latter curves inward into a thinner entablature, which constitutes the second unit. The third unit of the façade is highest in elevation and has two engaged semi-

The Djin Block No. 9 is heavily weathered on the southern side and to a lesser extent on the eastern side, with deteriorated lime mortar joints in which are contained two stone insets. The main weathering mechanisms are water flow down the main elevation, capillary rise at the base, and aeolian attack as confirmed by microscopic examination and XRF analysis.<sup>8</sup>

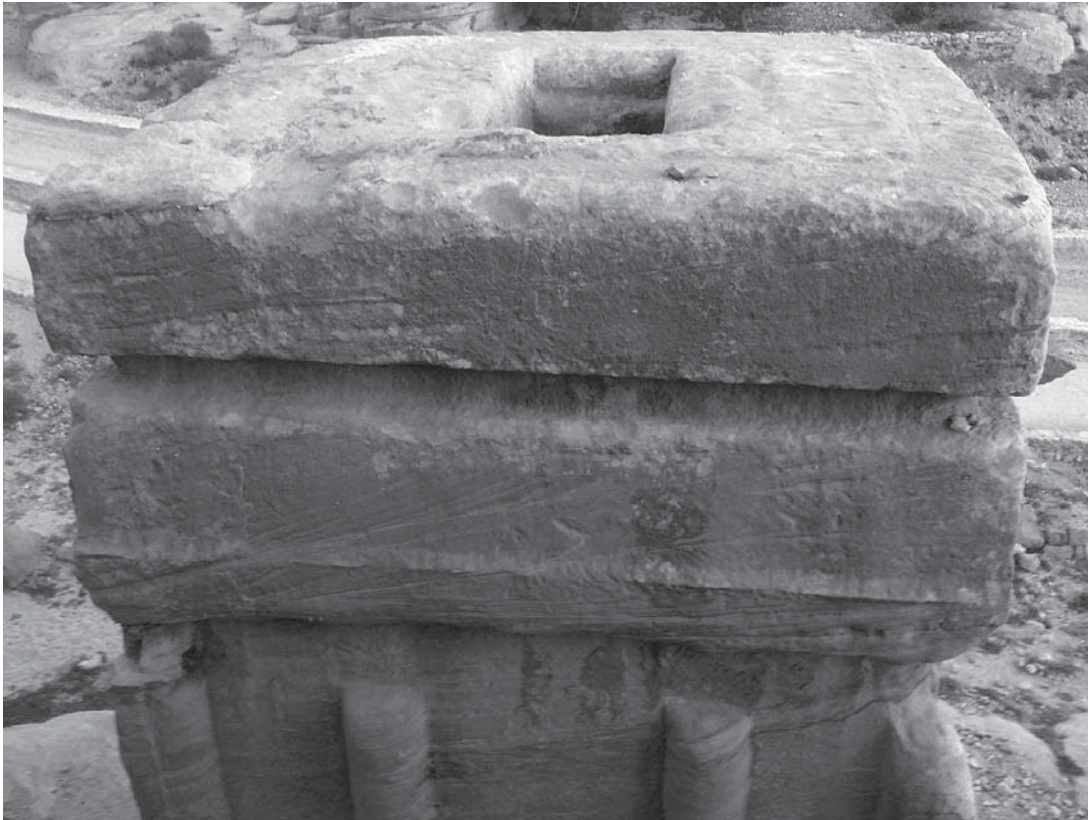
Figure 3. Top view of the Djin Block No. 9 from the northern side depicting the grave, 2010. (José Luis Lerma)

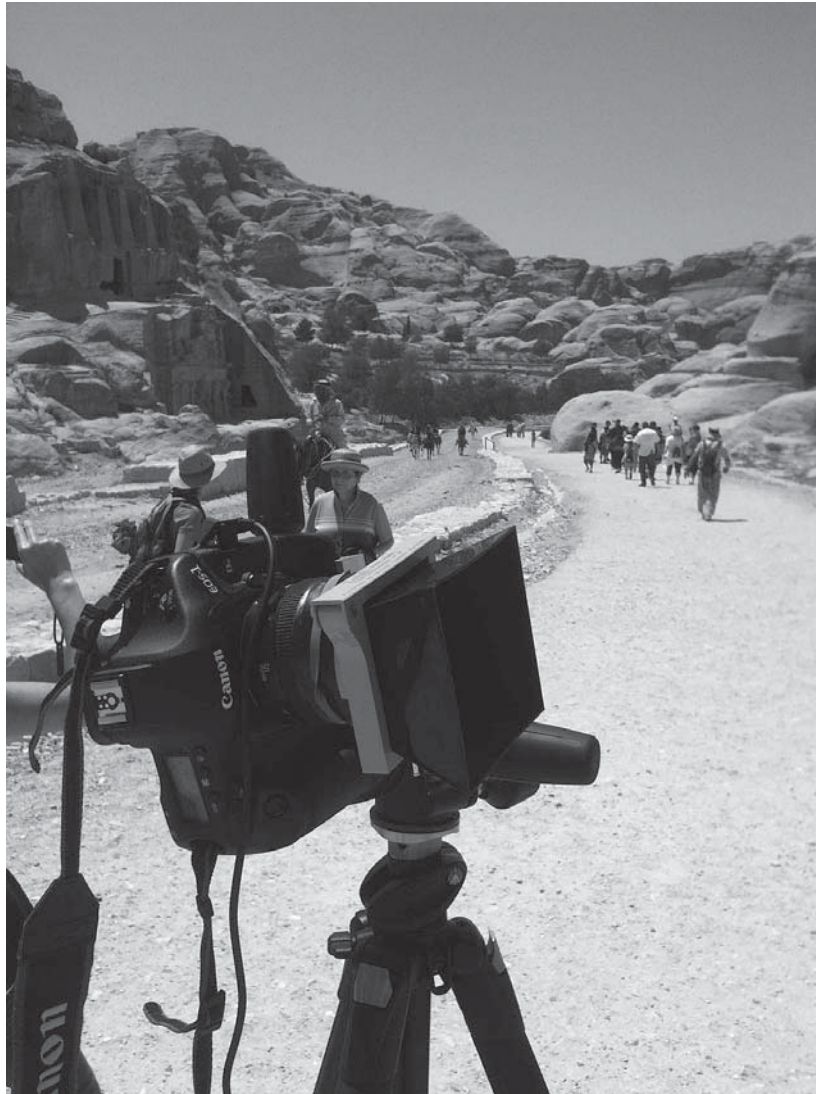
Figure 4. Acquisition of the near-infrared photography on site, 2010. (José Luis Lerma)

For the visible and near-infrared photography, a Canon 1 Ds Mark III digital camera was used. The acquisition of the near-infrared photography required filters to block all the UV and visible radiation. Herein, a low-cost gelatin filter, the Kodak Wratten 87,<sup>12</sup> was used in front of the camera (Fig. 4).

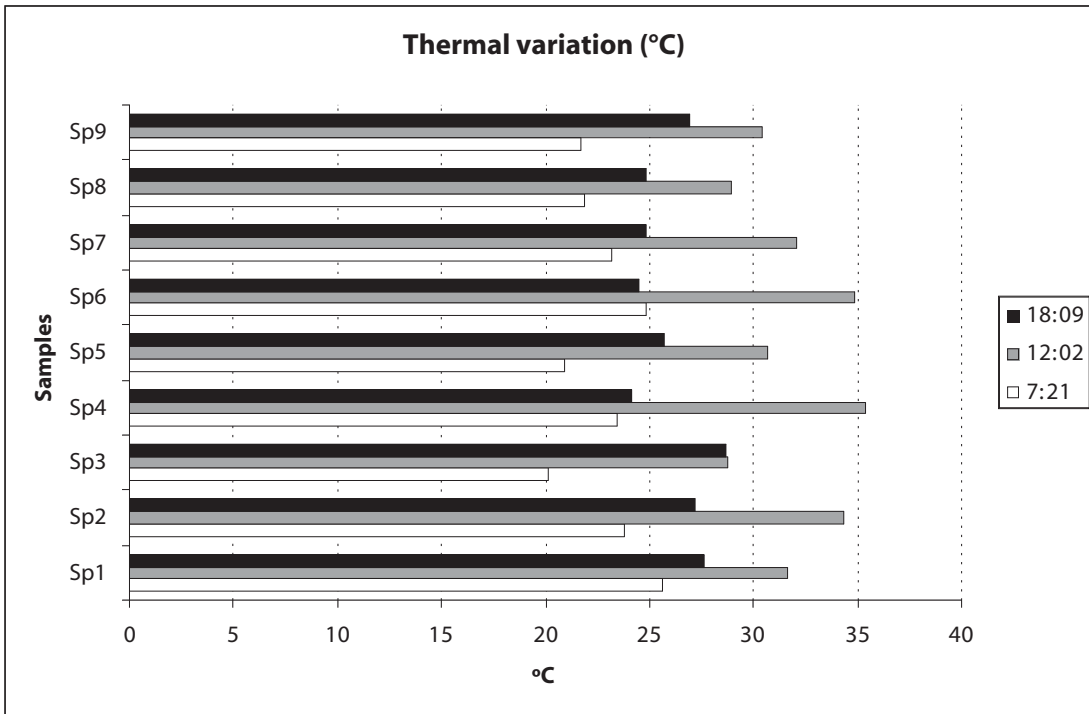
Table 1. Thermal variation of the Southern side at nine sampled areas in April 29, 2009.

The acquisition of the thermal infrared (TIR) images required several shots to get as much thermal difference as possible over the day. For that purpose, the same side was shot at three different times: early in the morning (around 7:30), midday, and during the afternoon (around 18:00). Nine samples were tracked carefully after rectifying the set of imagery and selecting the same features. In this way it was possible to check the thermal variation of the monument on a specific side (Table 1). Figure 6 depicts the thermal image taken during the afternoon with the nine samples overlaid.

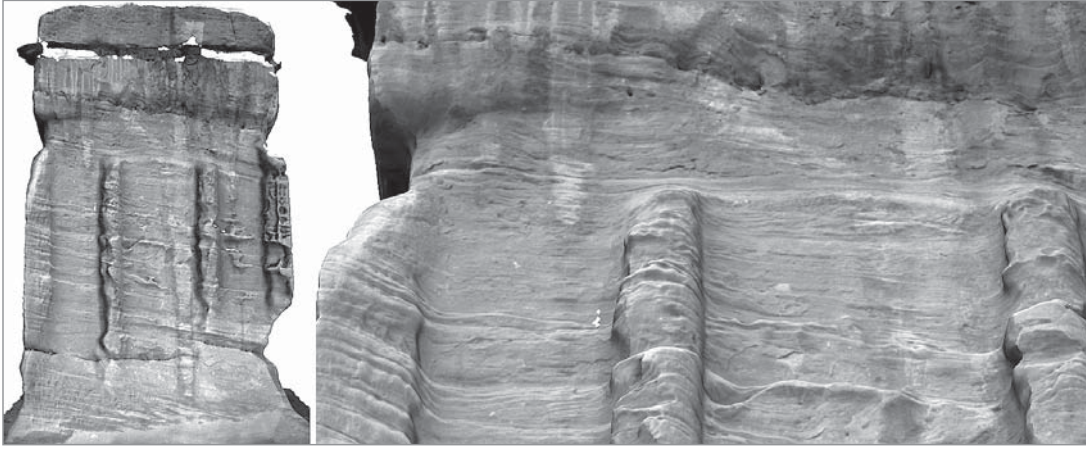
Figure 9. General view and detail of a photorealistic 3D model of the southern elevation, 2010. (GIFLE)

The level of detail of the 3D model derived from the terrestrial laser scanner can be highly enriched with texture from a digital camera following several photogrammetric steps,<sup>13</sup> even with images taken with noncalibrated cameras.<sup>14</sup> Figure 9 shows the results of draping the visible image (shown at top left in Fig. 5) onto the mesh displayed in Figure 8. Furthermore, draping is independent of the spectral band of the image. The results achieved after draping the visible and thermal imagery onto the digital surface models for the eastern side of the Djin Block is presented in “Integration of 3D Laser Scanning, Photogrammetry and Thermography to Record Architectural Monuments.”<sup>15</sup>
