SZCZECIN PEDESTRIAN ZONES SURVEY

PATHOLOGIES AND CAUSES RESEARCH
INTERVENTION PROJECT

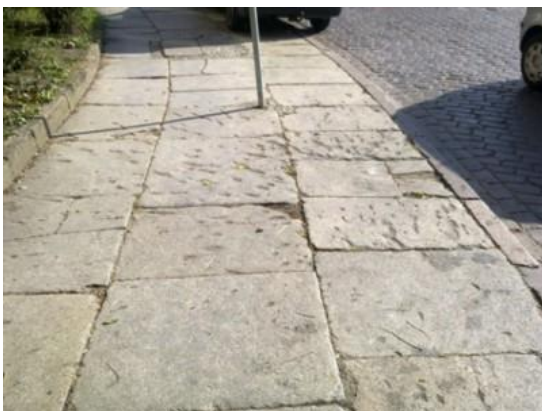
Signals in Szczecin's sidewalks of artillery firing succeeding in Second World War. [3]

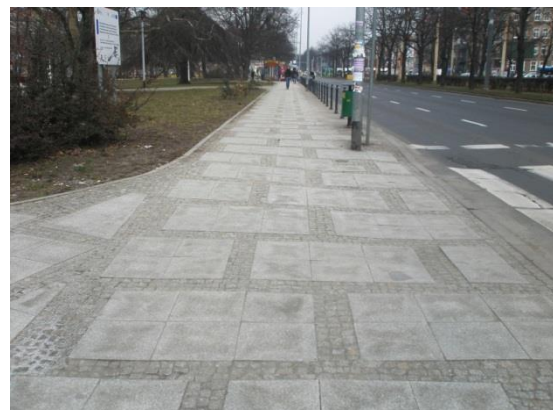
In some areas of Szczecin, it has been carried out the replacement of the old pavement by their poor condition. The replacement has been made with existing pavement, which mimics the layout of the old big blocks of granite, with smaller pieces and appropriate for climate cycles present in the city.

Replaced pavement in Szczecin' sidewalks. [3]

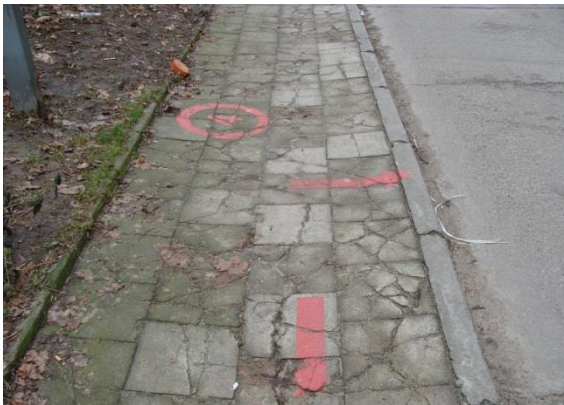
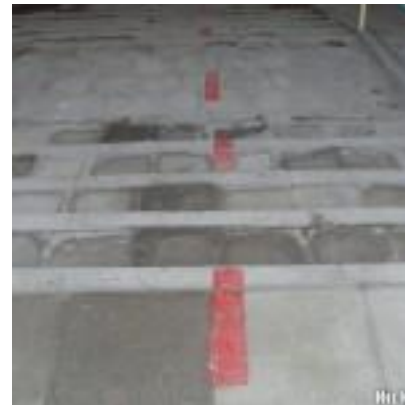
On the Szczecin's pavement it's possible to see also a red dashed line on them, it's called "red walk", a route of 7 kilometers, which connects all the important sightseeing to see in the city, in total forty-two. All attractions are marked by a number on the pavement and at each of them there is a sign explaining some details about the sight. The red line starts and ends at the Główny Railway Station. There are some maps that include the red line and an illustrated view of the city as well as additional information on the sites included in the red line tourist route some information about the history of the attractions.

Red line in Szczecin's sidewalks. [3]

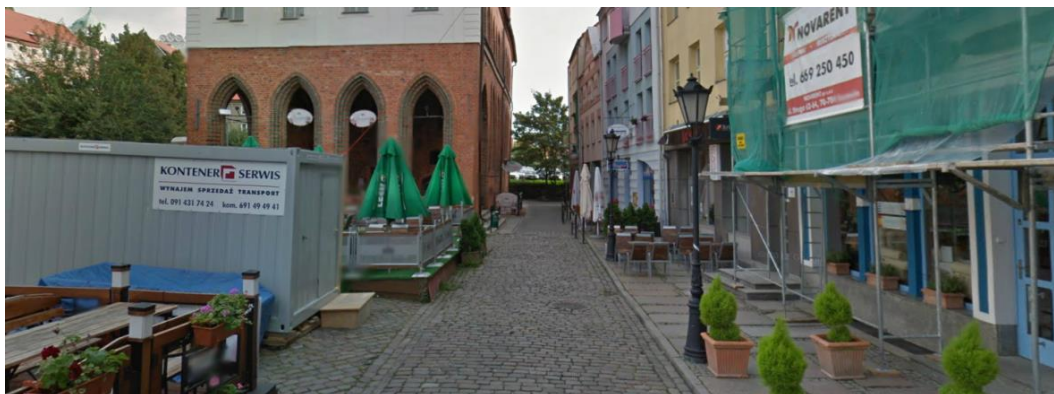
One of the oldest pavements of the city is the cobblestone of Rynek Sienny square. Today it's a pedestrian square in the Old City, but some time ago was open like a park vehicles until it was closed to preserve the cobblestone because its antiquity.

Rynek Sienny square. [4]

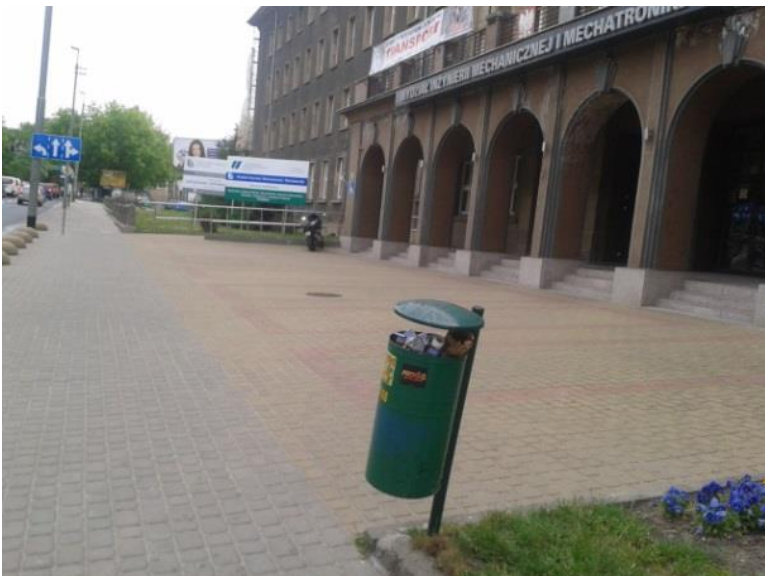
There are also, along the street, numerous university schools, which access has been renewed due to high pedestrian traffic during school days.

Pavement renewed in access to the faculty of Mechanical Engineering [3]

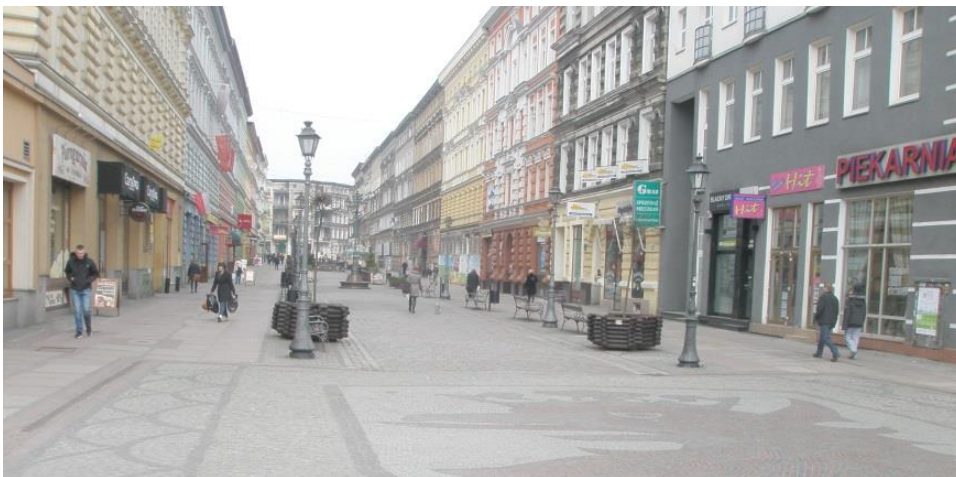
The pavement of this street was renovated in 2000, when the street was designated as pedestrian. For its execution were reused some of the pieces existed before the intervention. Has no sidewalks, all street pavement is level to facilitate access to existing commercial premises in the area.

Bogusława Street [3]

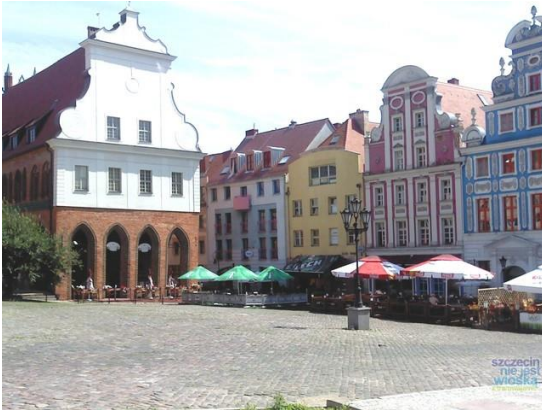
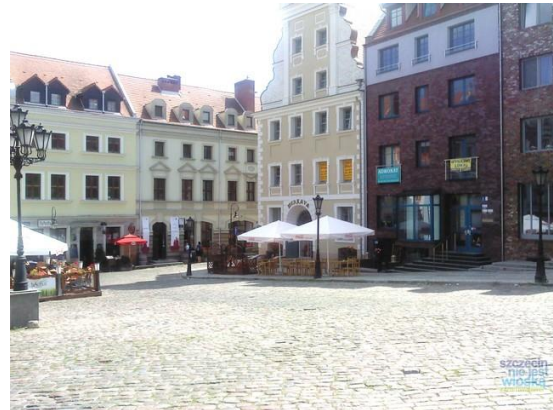
It preserves the original pavement of the square, while the sidewalks of the square were rebuilt to allow good access to all the existing businesses.

Images of Rynek Sienny [3]

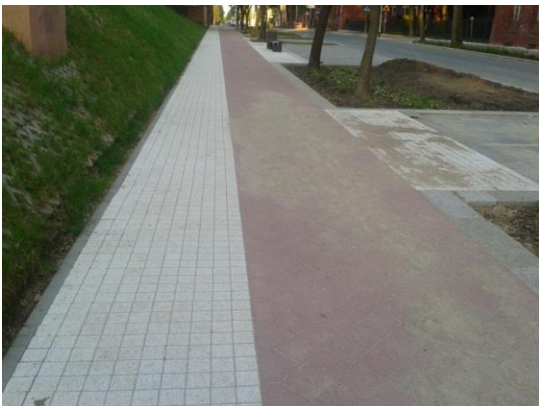
The pavements in this street has been recently renovated, expanding the width of them to improve pedestrian circulation because the ancient was in bad shape and its width was insufficient.

Renovated sidewalk Sowinskiego Street [3]

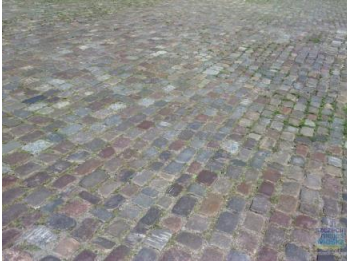
| PHOTO | DESCRIPTION | LOCATION |
|---|--|--|
| | Cobblestone of colored granite and basalt, resistant to the inclemencies of the time, to the abrasive agents, to the passage of time and to the impacts. The size is variable, between 25-28 cm of length and 13,5-15 cm of width. | According to the map of 3.1. Alieja Piastow 3 Ulica Bugoslawa 16 Ulica Rynek Sienny 18 |

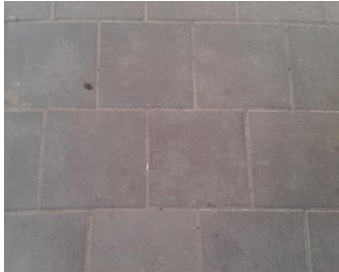
| PHOTO | DESCRIPTION | LOCATION |
|---|--|--|
| | It is done of concrete B20 or B50 with additives to do it more plastic. Great capacity of load. The size is 35,5x35,5 cm. | According to the map of 3.1. Alieja Piastow 4 Alieja Piastow 6 Alieja Piastow 7 Alieja Piastow 8 Alieja Piastow 12 Alieja Piastow 13 |

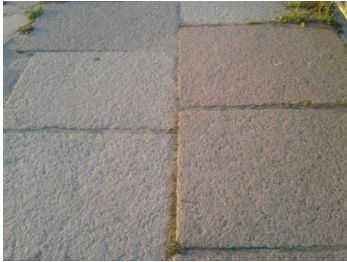
| PHOTO | DESCRIPTION | LOCATION |
|---|--|--|
| | Slabs of granite and gneis, it is the pavement that characterizes Szczecin's sidewalks. Of great size and variable, between 109-125 cm of length and 65-119 cm of width. | According to the map of 3.1. Alieja Piastow 6 Alieja Piastow 8 Alieja Piastow 11 Alieja Piastow 12 Alieja Piastow 13 Ulica Bugoslawa 16 Ulica Rynek Sienny 17 |

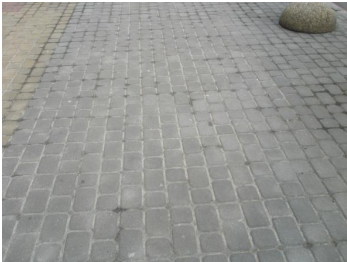
| PHOTO | DESCRIPTION | LOCATION |
|---|--|--|
| | Cobblestone of concrete B20 or B50 with additives to do it more plastic. Great capacity of load. The size is 21x10 cm. | According to the map of 3.1. Alieja Piastow 9 |

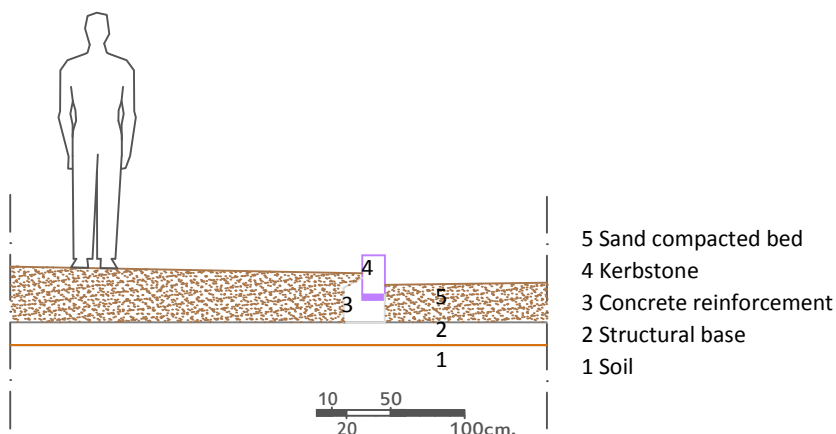
Once the sand is extended, it will undergo a compaction process with vibrating plates or stompers of vibrating rollers. Furthermore, in order to be compact, the sand must not contain too much moisture.

Compaction [2]

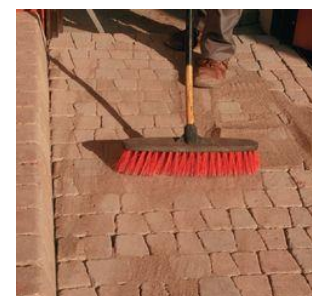
Sand sweep [2]

Grouting sand is done with fine and dry sand. This grouting is done by sweep of the granular material on the paved surface to penetrate sufficiently. The remaining sand is also removed by sweeping. In the case of prefabricated concrete tiles the joints are performed with sand and mortar.

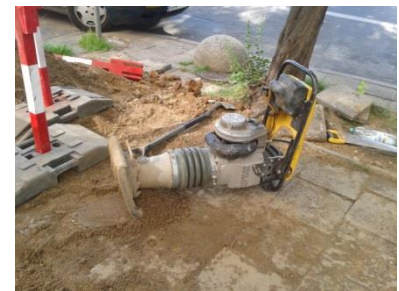
Vibrating coated [1]

After completing the grout with sand, the pavement should be vibrated by vibrating coated neoprene plates or vibrating roller compactors. It is sometimes necessary to place a blanket of felt above the pavement in order to absorb shocks. Once compacted pavement and removed the excess sand is convenient to water the pavement to facilitate bonding of the aggregate.

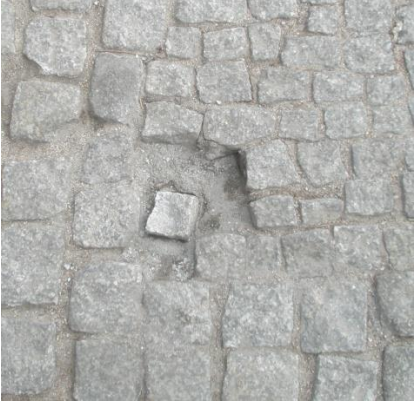
| PASO | PHATOLOGY | PHOTO |
|---|---|--|
| <p>Step 1: Execution of the base and support of adherence by means of a bed of sand.</p> | <p>The bed of sand like base is necessary in order that the pieces remain in his place once placed. If there is not placed a bed of sufficient sand it is very easy that the pieces lose his correct position, even they go out of the studding and get lost. In case of mistakes in the thicknesses of the base of support, will appear differential seats and the cause will be the break of the land.</p> | |

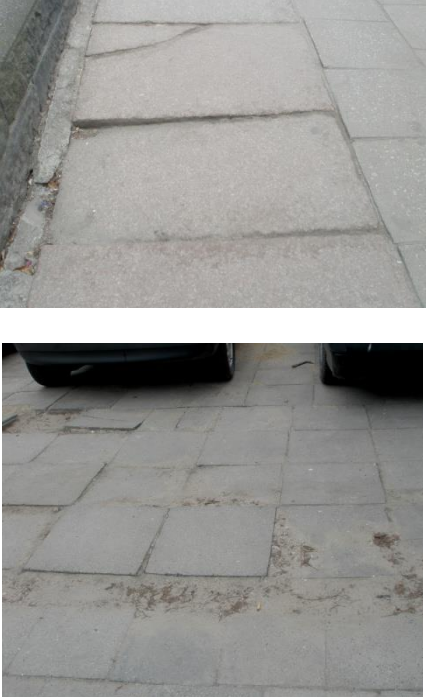
| PASO | PHATOLOGY | PHOTO |
|---|---|--|
| <p>Step 2: Compaction of the bed of sand.</p> | <p>It is necessary to fulfill a compacted good one making her leveled and with a thickness of between 3 - 5 cm. If we do not compact the bed of sand or not compacted correctly the consequences are: presence of drops in the pieces, since on not having been the base compacted once enters load or the pavement is trodden the bed of sand is compacted heterogeneously; unequal sunk of pieces, a piece they enter load more than other this is sunk more, giving place to the staggered pavement.</p> | |

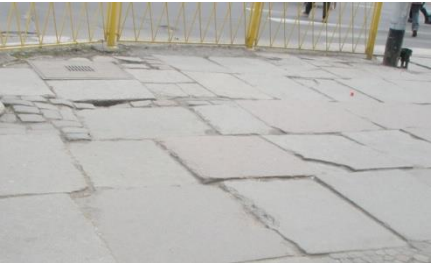
| PASO | PHATOLOGY | PHOTO |
|---|---|--|
| <p>Step 3: Placement of the pavement.</p> | <p>In this phase there must be made rigorous controls of leveling of the pieces and correct any observed mistake. If the pavement of the sidewalk is not realized correctly it will be unbalanced.</p> | |

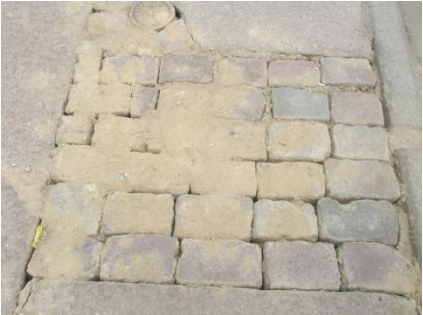
| PASO | PHATOLOGY | PHOTO |
|---|--|--|
| <p>Step 4: Sand sweep to grouting.</p> | <p>The sand is swept over the pieces to achieve that it penetrates in the joints if this step is not realized correctly by the sufficient sand for the joints easily the pieces go out of his position and / or the inclemencies of the time and other factors can act more aggressively on the pavement. If the joints has little thickness provokes that in the process of expansion of the materials exposed to high temperatures, they hit and create fissures and cracks.</p> | |

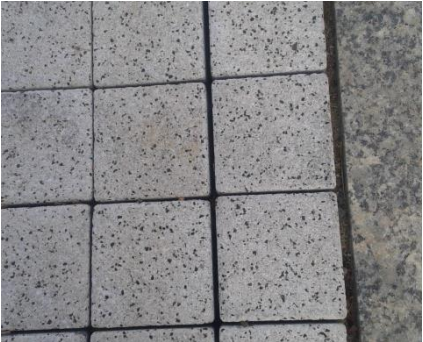
| PASO | PHATOLOGY | PHOTO |
|---|--|--|
| <p>Step 5: Vibrated of pavement.</p> | <p>The vibration on the pavement is realized in order that the sand placed in the previous step penetrates between the joints and is compacted. If the sand is not vibrated it is not compacted and easily the pavement remains without the material of the joints and the inclemencies of the time with other factors can act aggressively on the pavement.</p> | |

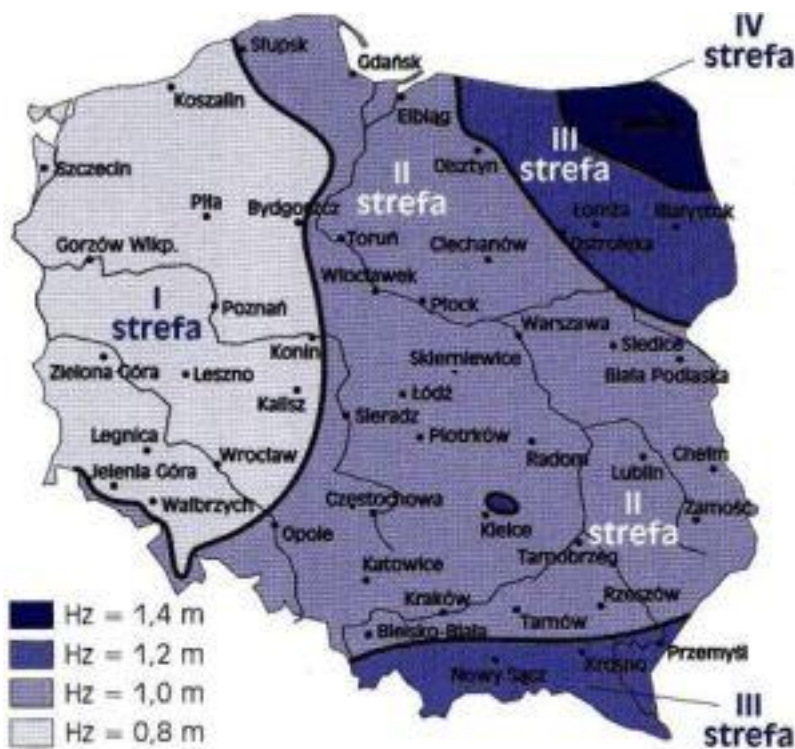
Poland divided in zones depending its depth of frost [5]

Due to these low temperatures also present in Poland during the colder winter months, there is zoning, according to the depth range of frost under the ground. This determines, in our case, the depth at which drains should be executed as they are drivers of water, and we must prevent it from freezing inside. According to this division, Szczecin is located in zone I, the lowest area in frosts of the country where the minimum depth to which you have to install the drains is 0.8 meters.

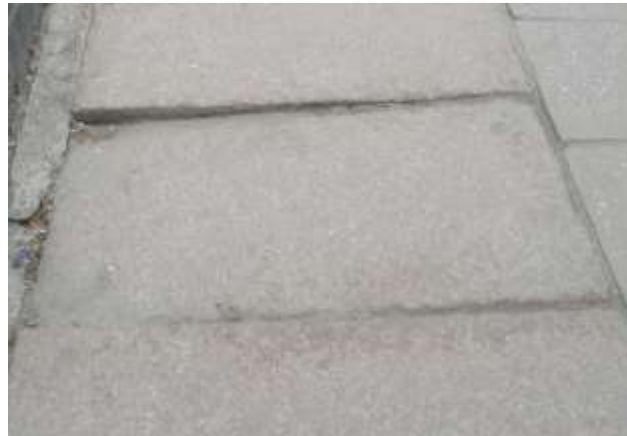
1. Tiles have sinking, decreased pavement surface, causing a slope in the pavement. Dirt accumulates in the joint with sinking.

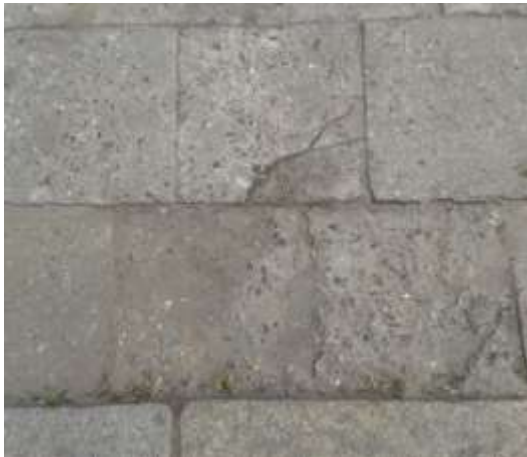
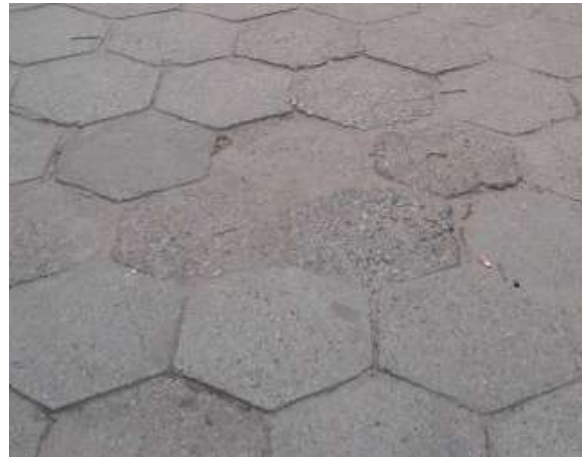
1. The tiles show an advanced state of erosion and disintegration of the pavement surface, causing a loss of its original volume and shape.
2. White spots are observed on the surface of the pavement, these spots are efflorescence.

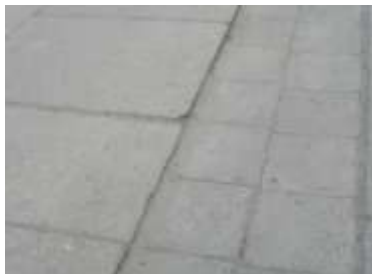
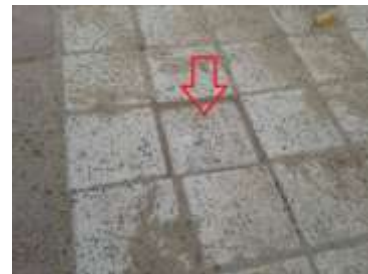
Aleja Piastow and Ulicia J. Sowinskiego

1. The tiles are staggered with respect to the slabs of granite and gneiss, appearing, a decrease or grade than two pavement surfaces separated by a joint.
2. Little joint thickness and sealing material is eroded. In times of rain or snow water remains stagnant, with no possibility of escape, and penetrates into joints and in the porous material like concrete being able to drag soluble salts and being able to cause efflorescence, disintegration of the material, dampness or damaged sealing joints.
3. Dampness stains are seen on the finish, in addition of surface deposits, due to the accumulation over time of different materials can be soot, feces, smoke or any other type of biological organism.
4. Disintegration, erosion and weathering abrasion of the pavement surface, causing the loss of fine material.
5. Breakage corners of some parts of the pavement.

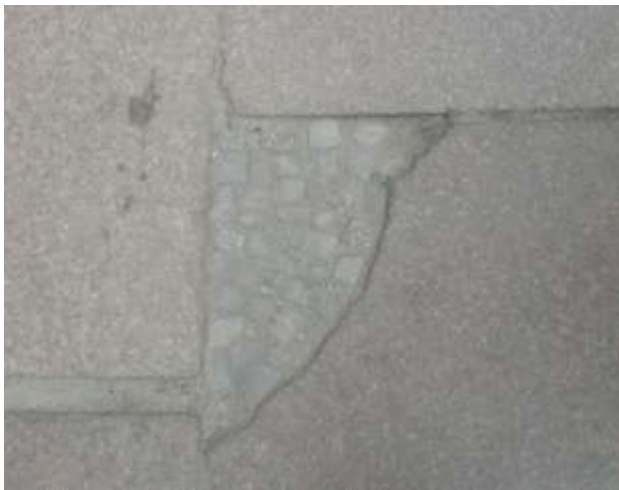
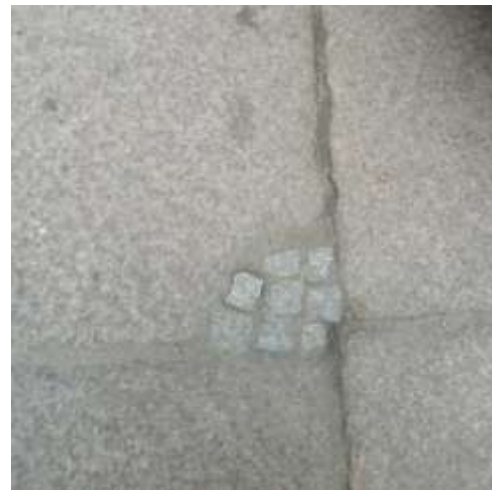
1. Break in the corner of granite slab, it intersects a transverse joint with a longitudinal joint.
2. Placing different types of pieces like broken piece solution. The consequence of this is that the pieces do not fit positioned properly in the hollow and they have other joints separation, the smaller angle corners are left without finishing material, employing the sealing material as a finish.

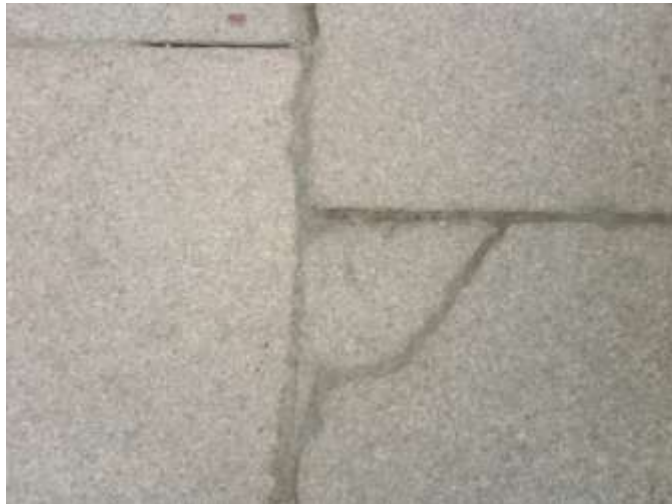
1. Break in the corner of granite slab, it intersects a transverse joint with a longitudinal joint.
2. Joints with small thickness and little sealing material, even in some case the sealing material has been completely eroded to disappear.
3. Dampness stains on sealing material.
4. Disintegration, erosion and abrasion wear of the road surface, causing loss of its original volume and exterior finish.
5. Aging patina, discoloration patinas and black patinas or dirt.

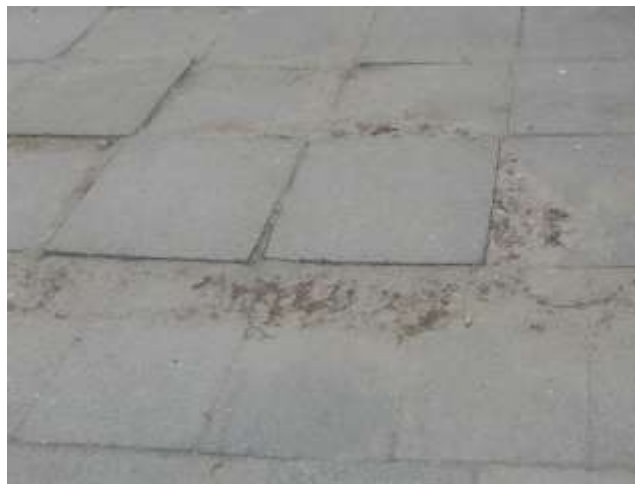
1. Tile rising concrete tiles, there is the material of the gripping layer, or sand bed overhanging the sides of the raised parts.
2. Joints with small thickness and little sealing material, and sealing material are eroded.
3. Disintegration, erosion and abrasion wear of the road surface, causing loss of its original volume and exterior finish.
4. Accumulation of dirt on the pavement. Dirt is mixed with the fixing material, which has left his position.

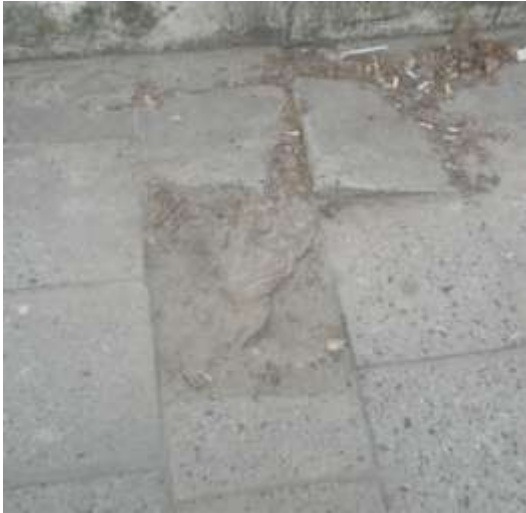
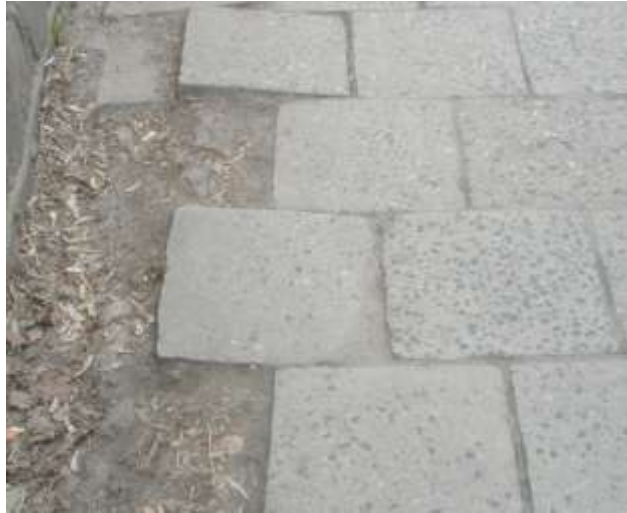
1. Raised and broken tiles, and even seen many holes where there were tiles that now are removed.
2. Different gasket thickness, there is no uniformity of joints, as well as erosion of the sealing material. In times of rain or snow water remains stagnant, with no possibility of escape, and into joints and in porous materials such as concrete, and can drag soluble salts and may cause efflorescence, disintegration of the material, dampness or damaged seal joints.
3. Dampness stains on sealing material.
4. Disintegration, erosion and abrasion wear of the road surface, causing loss of its original volume and exterior finish and eroded tile edges.

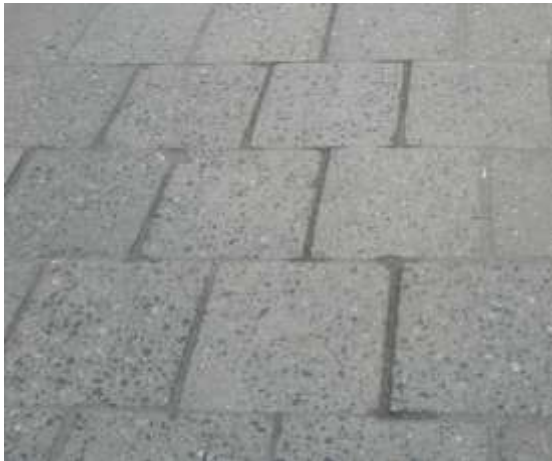
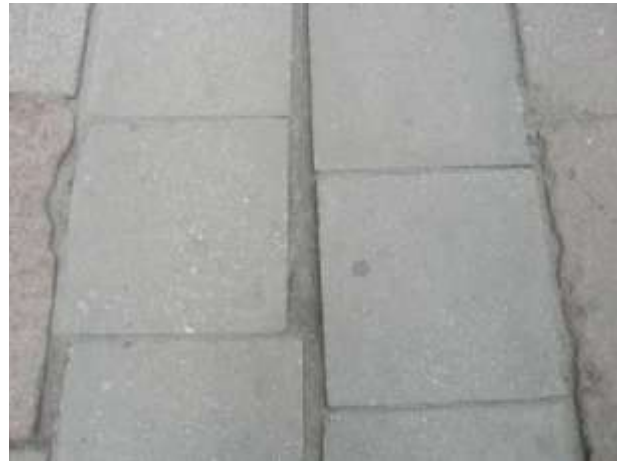
1. Different gasket thickness, there is no uniformity of joints, as well as erosion of the sealing material.
2. Dampness stains on sealing material.
3. Disintegration, erosion and abrasion wear of the road surface, causing loss of its original volume and exterior finish and eroded tile edges.
4. Wear was observed on corners and edges of granite slabs in picture 2.

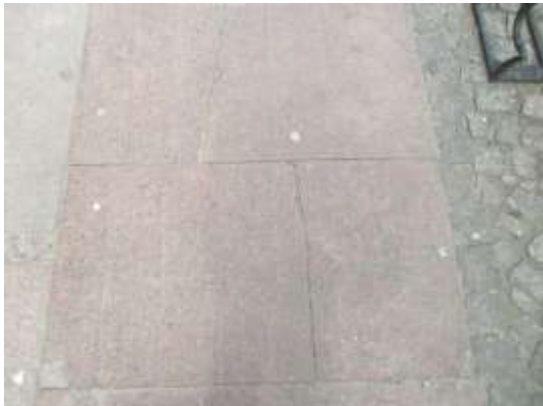
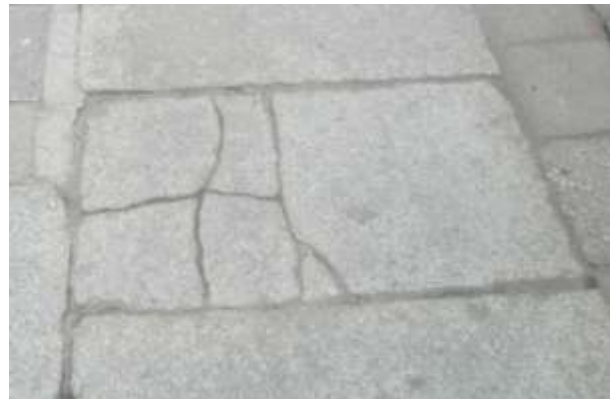
1. Cracks are observed on the surface of the tiles. The picture 1 shows transverse break, which subdivide the slab in two. In picture 2 there is a mesh type and transverse break.
2. Small thickness is observed, and little sealing material between joints in photo 1.
3. Aging and discoloration patinas are observed.
4. In photograph 2 dampness stains are observed on the finished surface, as well as surface deposits, due to the accumulation over time of different materials can be soot droppings or any other type of biological organism.
5. Disintegration, erosion and abrasion wear of the road surface, causing loss of its original volume and exterior finish and eroded tile edges.

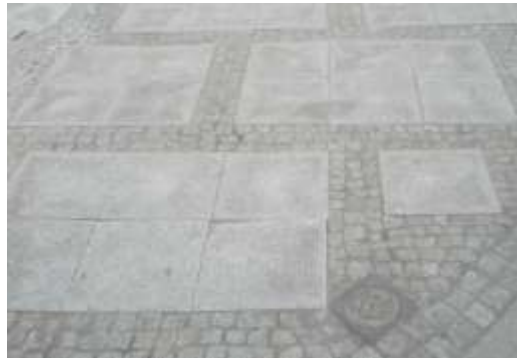
1. See spots of dampness on the finish and the joints, as well as surface deposits, due to the accumulation over time of different materials can be soot droppings or any other type of biological organism. See spots of dampness on the finish and the joints, as well as surface deposits, due to the accumulation over time of different materials can be soot droppings or any other type of biological organism.
2. Are observed granite stones with differential settlement, causing steps or potholes. Being small sized stones the gap generated is almost negligible when you are walking on the pavement, but is perceptible to the naked eye.
3. Disintegration, erosion and abrasion wear of the road surface, causing loss of its original volume and exterior finish and eroded tile edges.

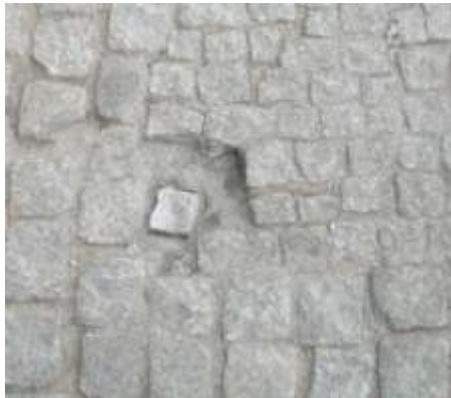
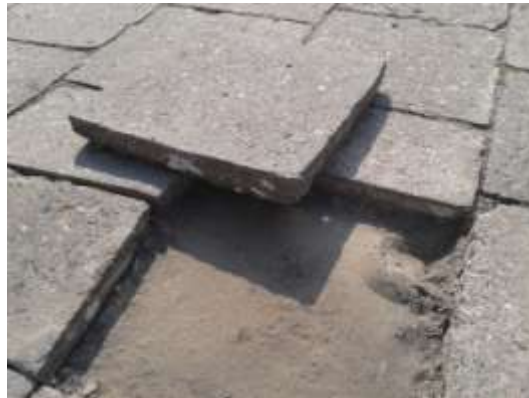
1. The picture 1 shows that some of the granite stones that formed the pavement have disappeared, leaving the fixing material or sand bed to the weathering, facilitating erosion and adjacent parts undergo a change position.
2. The concrete tile on picture 2 shows internal efflorescence, whitish stains.
3. Different gasket thickness, there is no uniformity of joints, as well as erosion of the sealing material.
4. Disintegration, erosion and abrasion wear of the road surface, causing loss of its original volume and exterior finish and eroded tile edges.

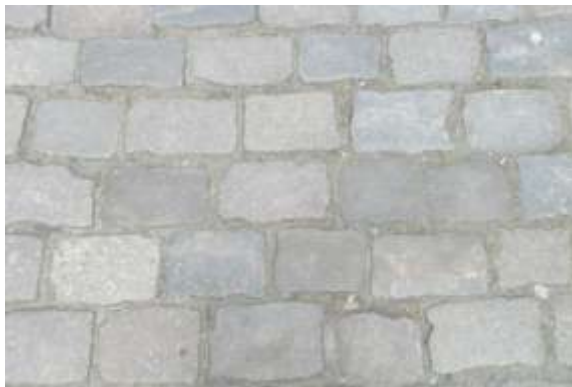
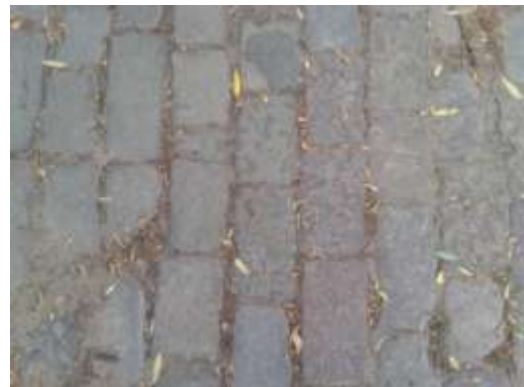
1. The cobblestones have an erosion and abrasion of the surface layer.
2. Aging and discoloration patinas are observed.
3. Dampness stains are seen on the finish, as well as surface deposits, due to the accumulation over time of different materials can be soot droppings or any other type of biological organism.

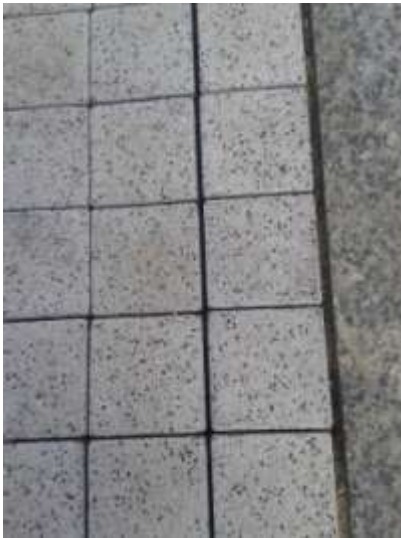
1. This pavement is just finished and is possible to see that there is not sealing material on the joints of the concrete pieces with granite finished.
2. The thickness of the joints of the pieces is insufficient in many cases.

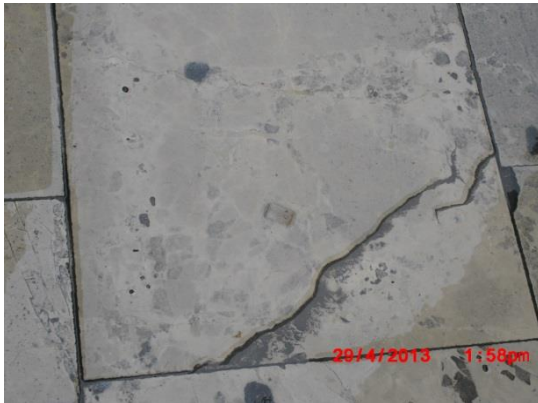
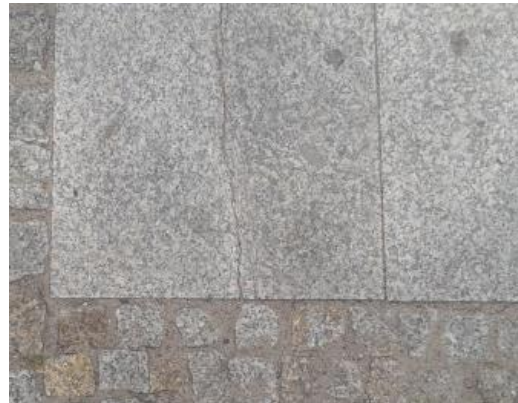
Fissures by climatic causes: Valencia (picture 1), Szczecin (picture 2) [1]

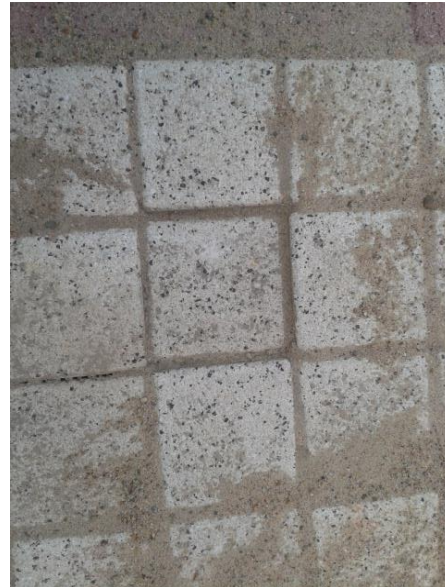
The surface finish of the pavement, is different in Valencia usually performed a polished finish of the pieces and it is usual in Szczecin a rough finish in order to prevent slipperiness of the pieces during periods of snow. This superficial finishing pavement makes it prone to the accumulation of water and dirt on the surface.

Joint execution difference: Valencia (picture 1) with mortar joints, Szczecin (picture 2) with sand joints. [1]

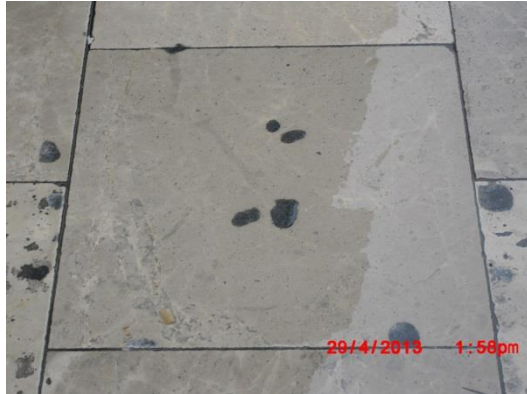
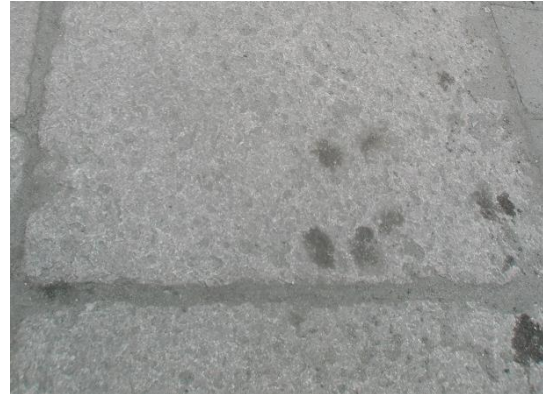
Necessary maintenance operations are not carried out as the replacement of grouting material, which also causes the appearance of many lesions.

Presence of surface deposits over the pavement:Valencia (picture 1), Szczecin (picture 2) [1]

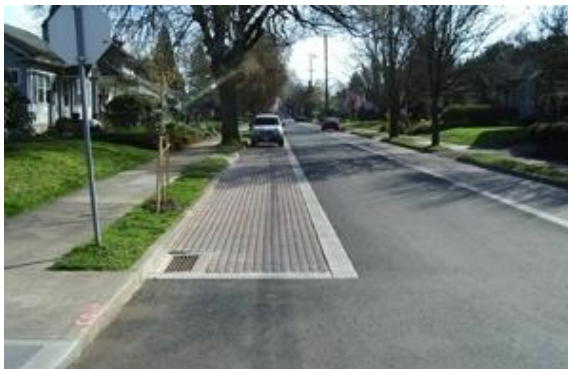
Permeable pavement in residential zone [1]

The permeable pavement is a surface where filtered and / or storing the rainwater that falls. Permeable pavements can be constructed from permeable concrete, porous asphalt, permeable pavers, and other materials. These floors are especially profitable where floods or ice is a problem.

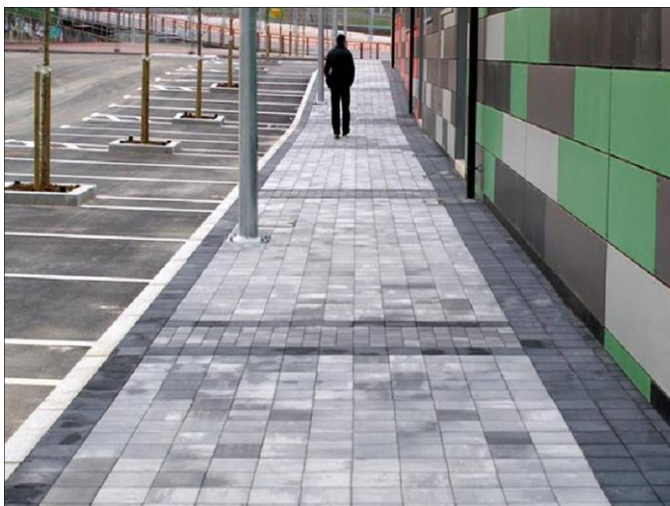
Ecogranic placed on sidewalk [2]

A prefabricated pavement concrete with two layers. One layer base and an active surface layer, causing the acceleration of a chemical reaction called photocatalysis, responsible for the degradation of air pollutants. It offers a wide variety of formats, sizes and colors, as any other pavement. But with a peculiarity of incorporating a catalyst capable of transforming the pollutant emissions from the atmosphere in the environment-friendly products. In this way, the pavement using solar energy as a source of activation of the catalytic process and its effect remains unchanged throughout his life.

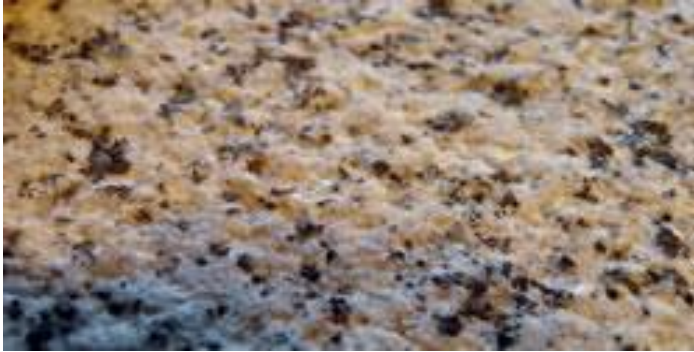
Bush hammered finish granite surface [5]

To provide a homogeneous rough surface, is made hammered, hitting the rock surface repeatedly with a hammer Bujard, previously shaped with uniformly distributed small craters. It is an ancient form of surface treatment of all stone materials for exterior coatings.

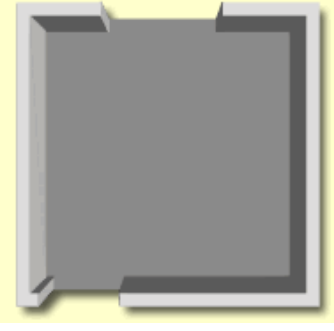
| Step | Picture |
|---|--|
| <p>We will clean the surface of the ground, to avoid having any sharp objects that may damage the insulating sheet or the heating cable.</p> | |

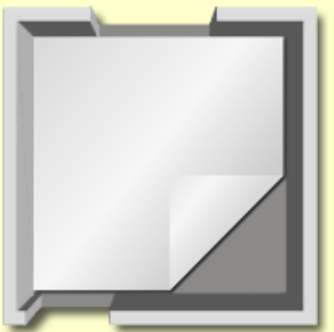
| Step | Picture |
|---|--|
| <p>Placing the insulating sheet covering the total surface area, to avoid unnecessary heat loss. If it is necessary we will put sheets pieces, where it was not possible to put whole sheets.</p> | |

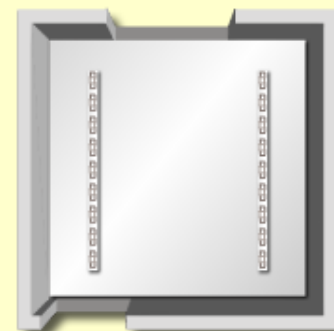
| Step | Picture |
|---|--|
| <p>Place the spacer guides at 1 or 1.5 m of distance. We will fix the guide above the insulation.</p> | |

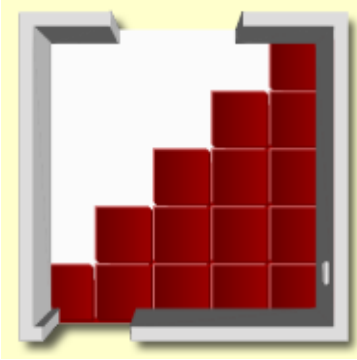
| Step | Picture |
|---|--|
| <p>We will cover the installation with a sand bed. Then place the tiles and put sand for the joints.</p> | |

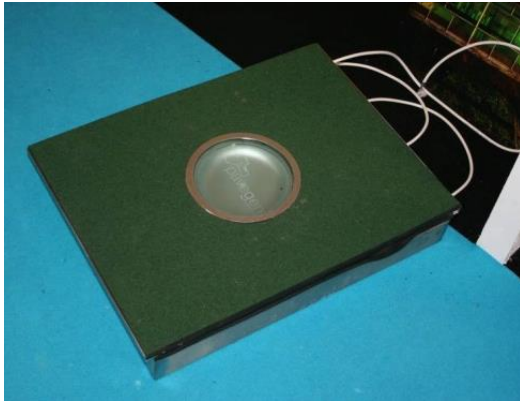
Pavegen tile [6]

Marketed by Pavegen tiles have a size of 45 x 60 centimeters and are made with materials that respect the environment. The upper part is resolved with recycled rubber car tires. Internal mechanism components are made of recycled aluminum.

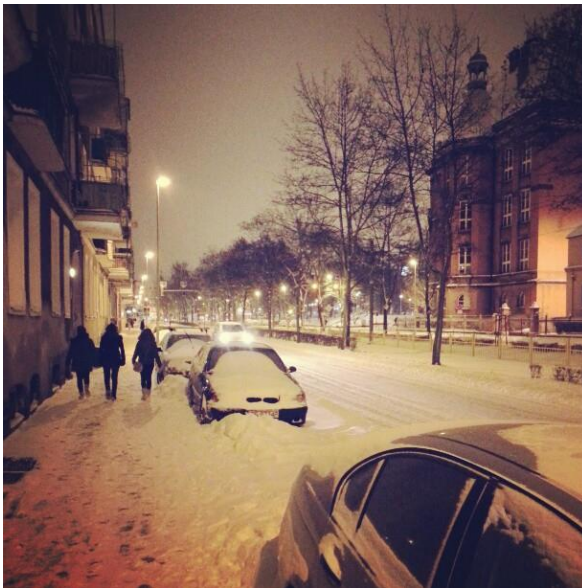
Sidewalks from Piastow Street full of snow [7]

Water in Szczecin comes as rain, snow or hail. The main problem for walking on the streets in winter is the snow presence on the sidewalks. One of the maintenance work carried out on the sidewalks is remove the snow by salt or by shovel. As we know, the salt is a harmful substance that acts aggressively on the pavement material, with water, especially.
