Final Degree Project:

**Bremerhaven's
Christus-Kirchengemeinde
restoration.**

by
Castellar Barres, Javier

2013

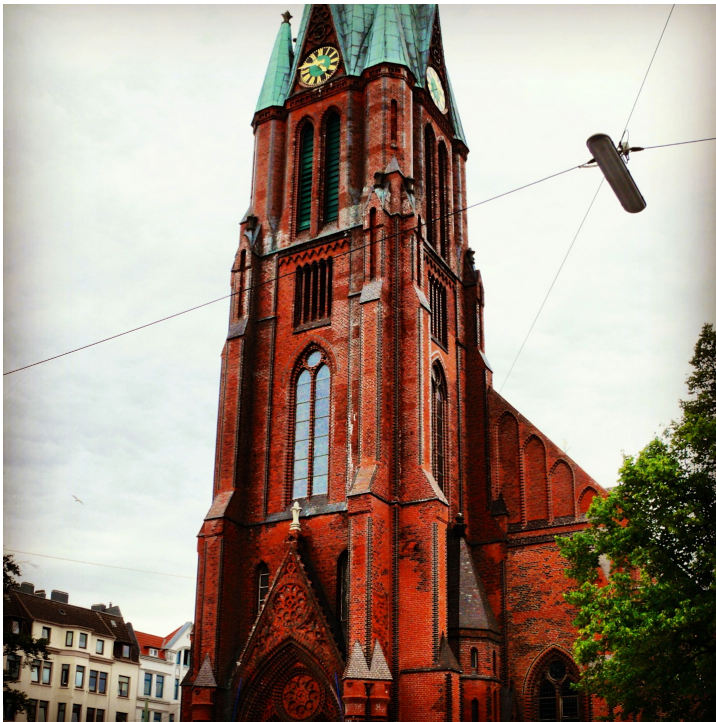
Pic 3.1.2.1 Churchs tower

Three years were need by them to finish building the church. That's why in November 14th of 1875 the inauguration of the church toke place. However two years later, they saw problems with the mortar used in some parts of the construction was not good enough to withstand loads, so it can produce an overthrow. After the demolition and reconstruction of the tower the building was ended in 1880.

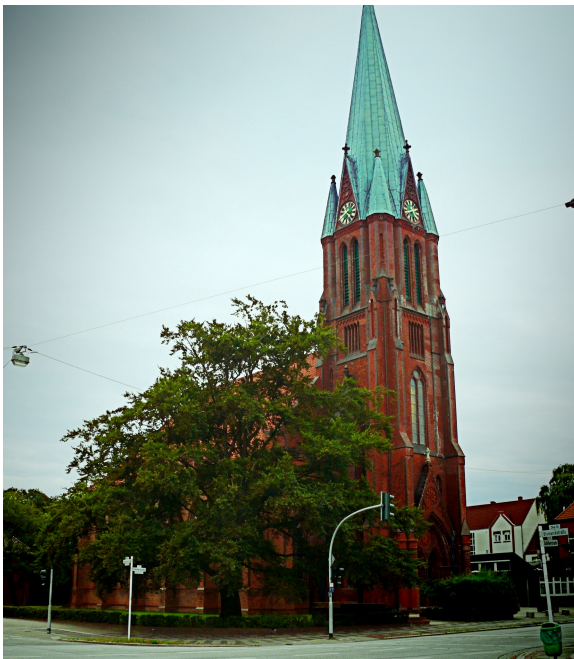
Pic 3.1.2.1 Bremerhavens church

Regarding the size of the building, 29 meters are the length and 18 meters the width. Bricks are the materials used to build the exterior walls. Buttresses situated

between the gothic windows, which are part of the breast wall, help it. These buttresses are as tall as the windows. The shape of the top of them draws the same line as the roof, following the shape of the strength line and trying to make the water running easily. Although on top of each buttress the normal bricks are replaced by another type of bricks with a waterproof cover.

There is one of the buttresses on each side of the church, which is bigger than the others. This one is supporting the tower. An orthogonal topping closes this squared section tower. It is more or less 60m high divided by five floors. The tower is over the principal facade being part of the main entrance. In each floor we can see an outgoing line which denotes where the floor structure.

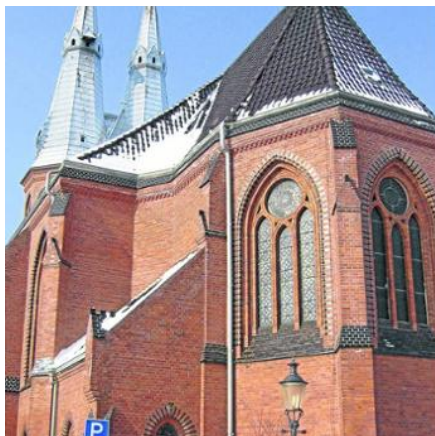
As we can see, the church is also affected by the low temperatures, and is also built with enameled bricks.

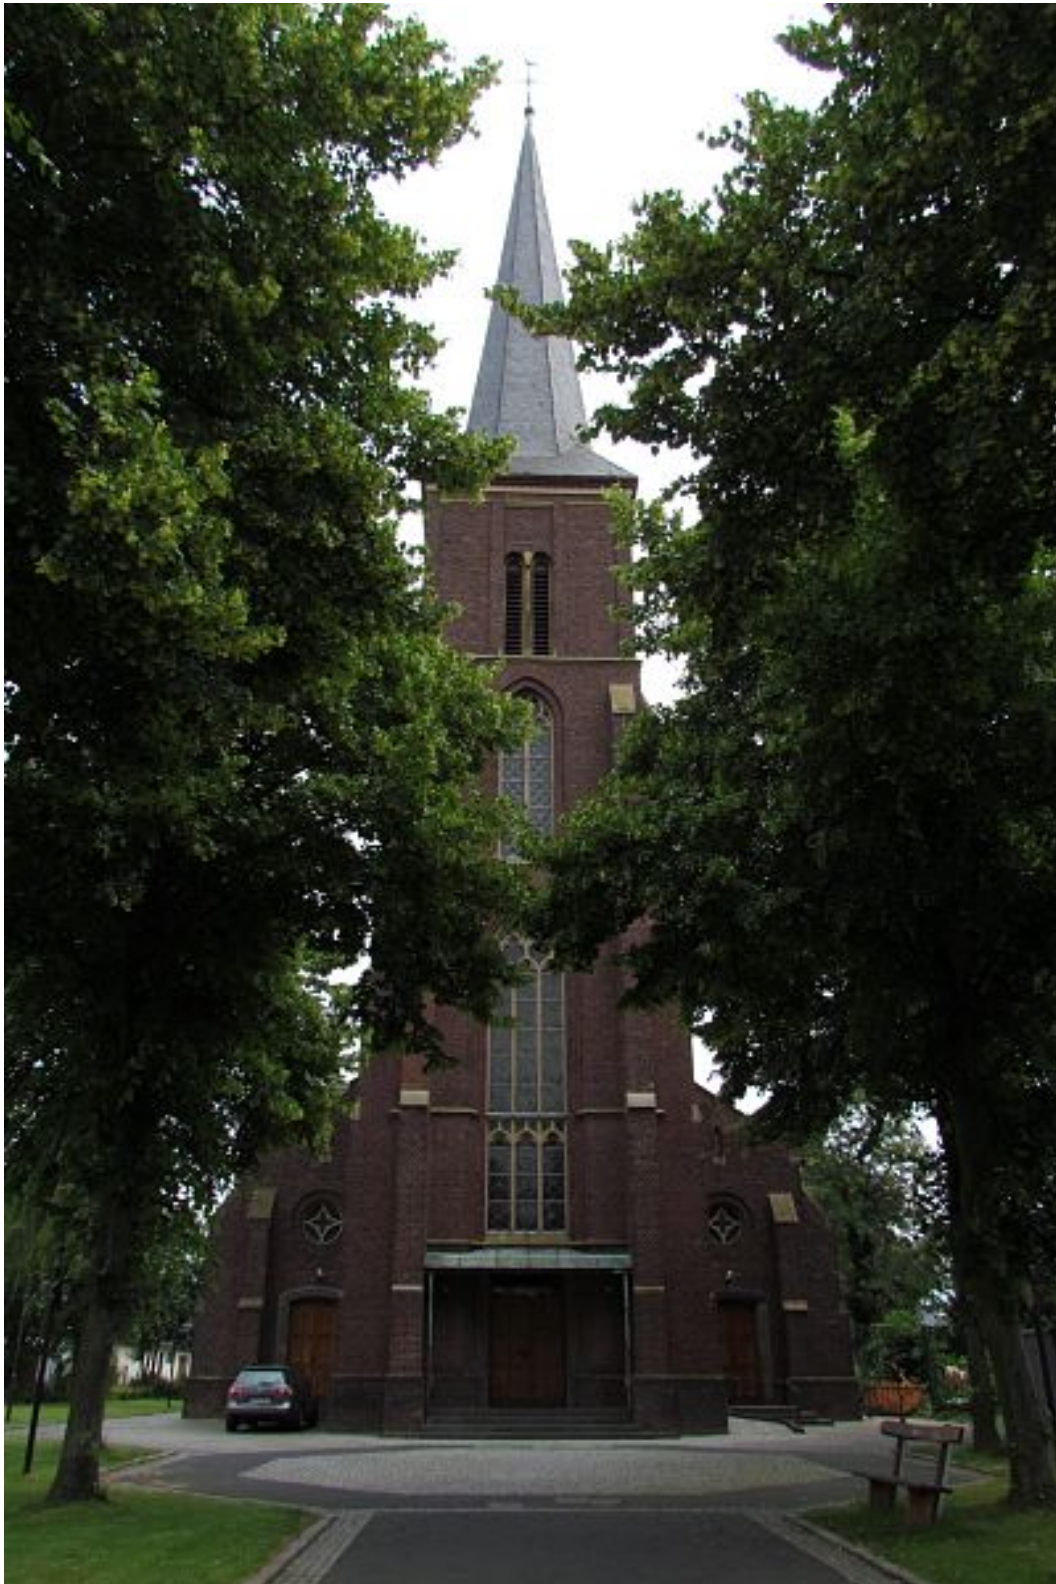
Pic. 3.1.4.3 Pfarrkirche St. Dionysius, Hochstraße, 27 (Kloneinbroich)

This church was restored because it had problems with bricks.

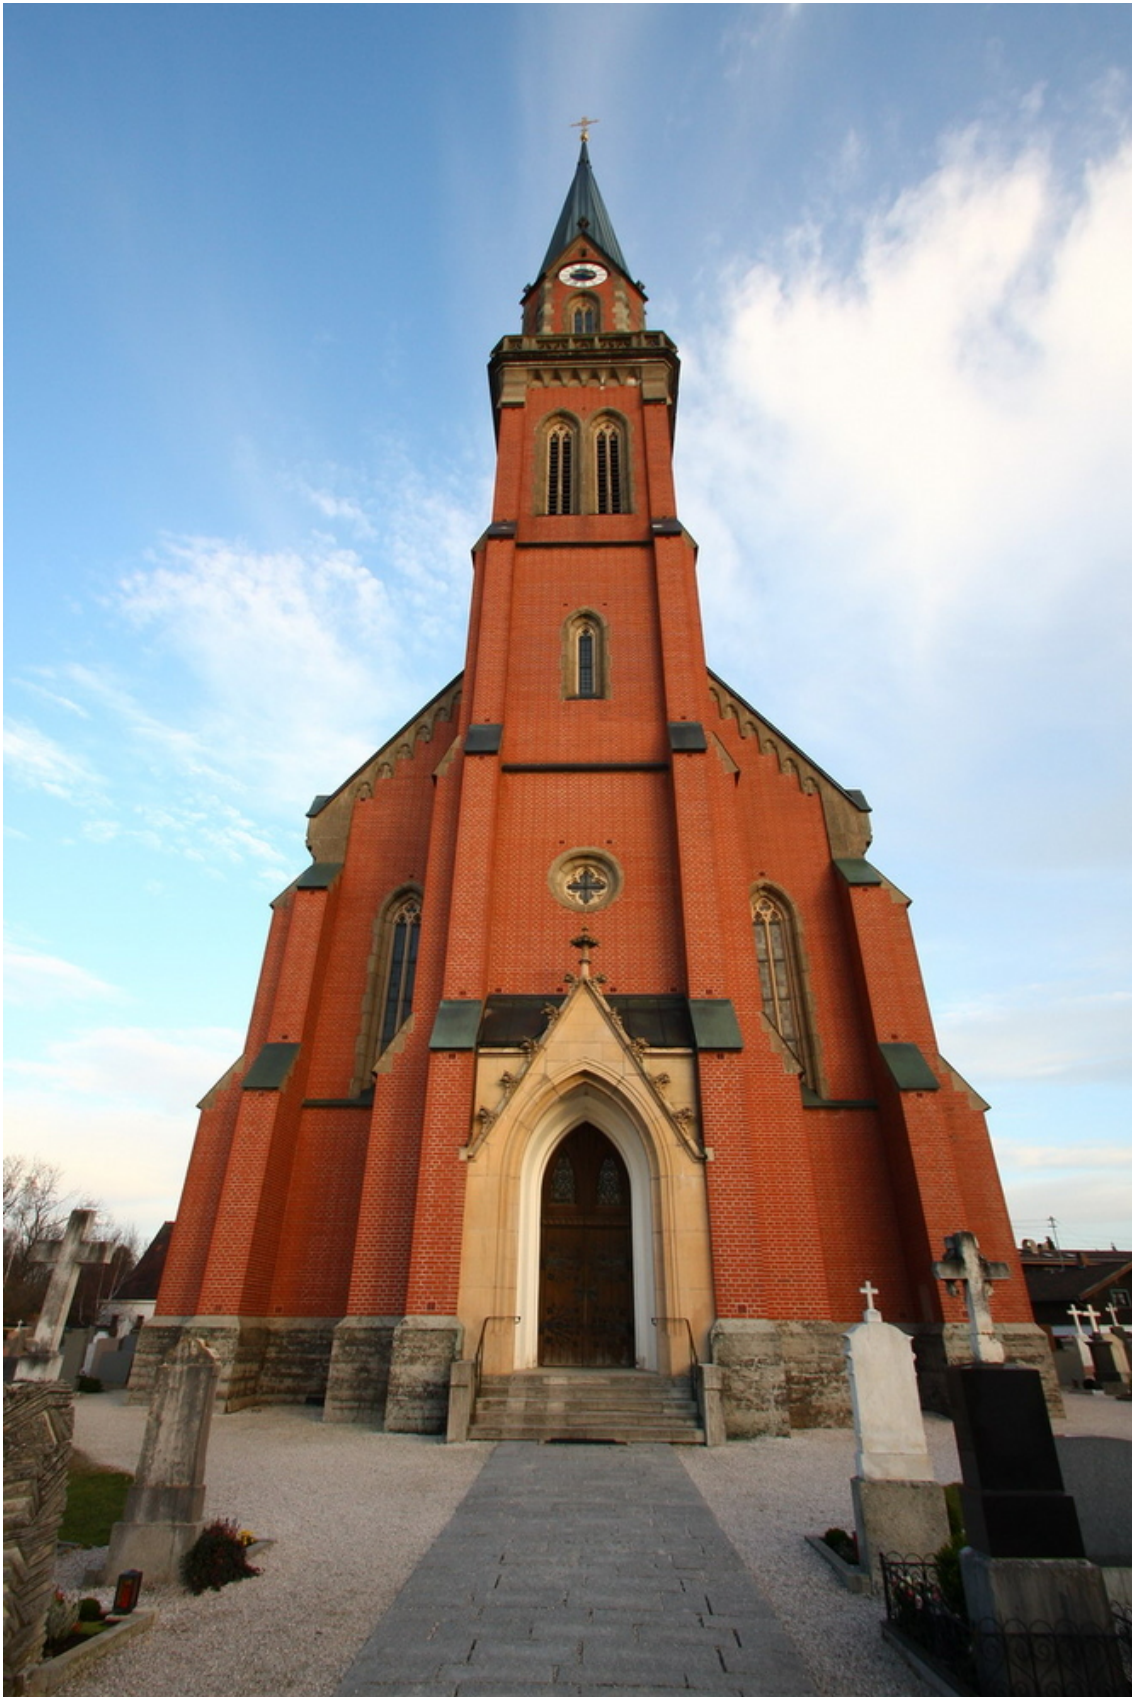
Pic. 3.1.4.4 Pfarrkirche St. Nikolaus in Übersee

In this last church we can appreciate that an impermeable plaque covers the top of buttresses, over a part of concrete.

That makes us think about the possibility of a change of material during a restoration. Maybe painted bricks, which didn't make their work properly and were changed by this final solution.

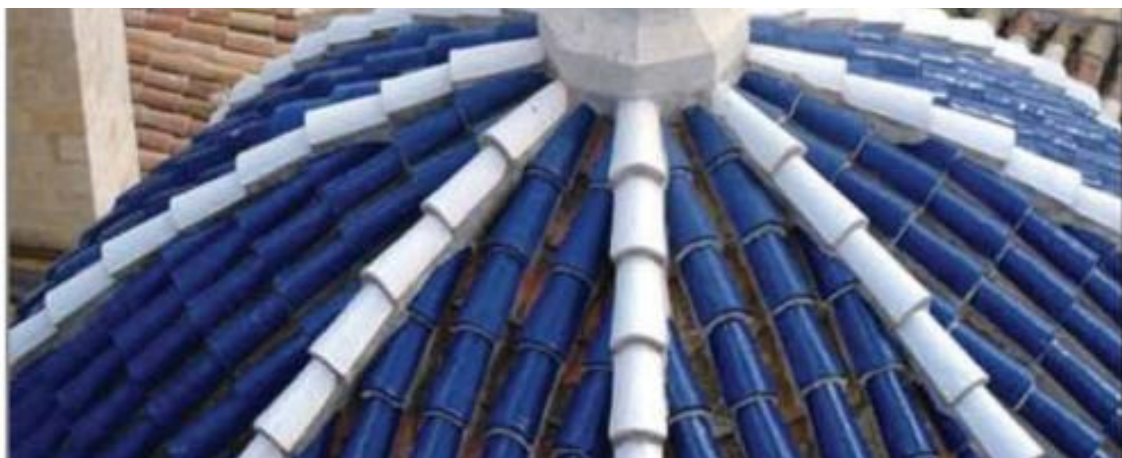
Pic. 3.1.4.5 Blue smelted tiles over dome.

Anyway, it's impossible to compare these tiles with the bricks we are studying. First of all, in Valencia there is no problem with frozen water. Moreover the tiles are part of the cover the building, so they solve the permeability by overlap. This makes more difficult for water to go through the mortar.

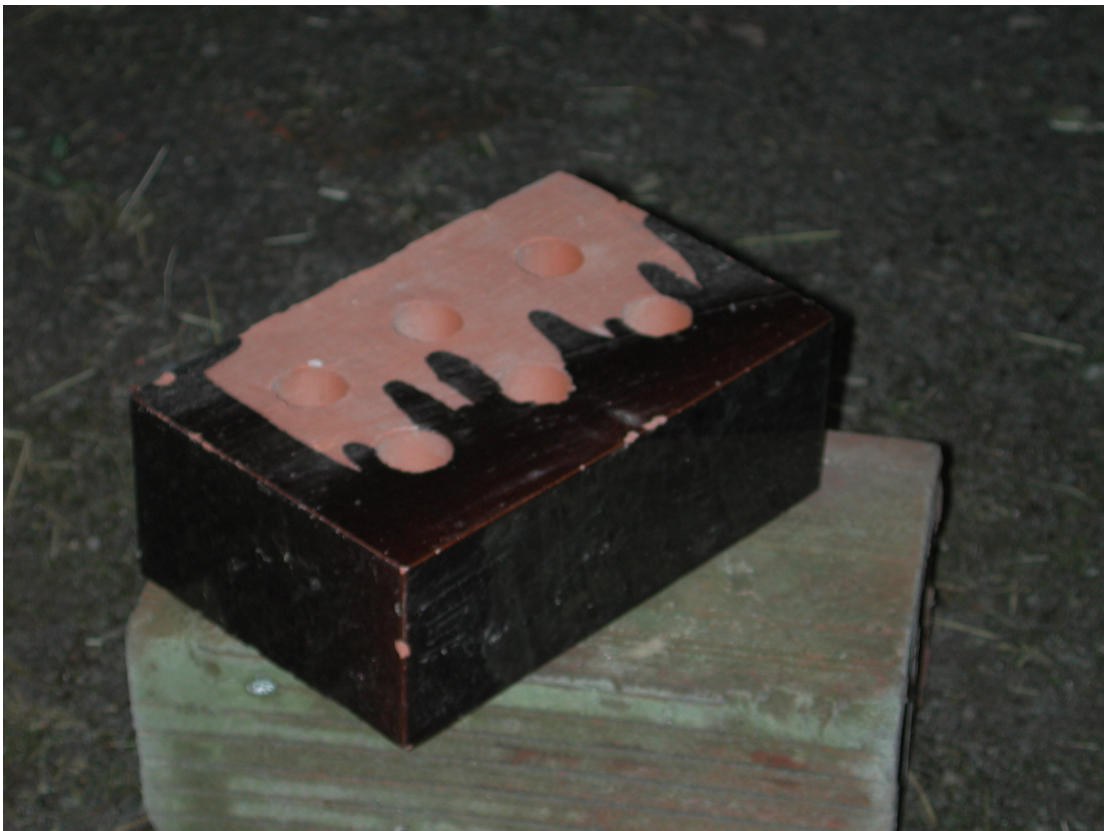
Pic. 3.2.1.1. Smelted brick.

One of these problems is the one of which affects to the top of the buttresses. The buttresses were built with bricks, as all the façade. The ones on the top and on the sides are covered by a special impermeable paint in their visible surface. This paint is also over the not seen surface, as the next picture XXX shows.

The paint diverts water from the rain and humidity but also doesn't let the mortar paste properly in the surface in charged to receive it. That makes little holes between the mortar and the brick.

The next mortar to be used needs to be a special mixture, containing special kind of glue, which keeps bricks together even in the part of this paint. This won't let water come between them, so it won't cause any damage again.

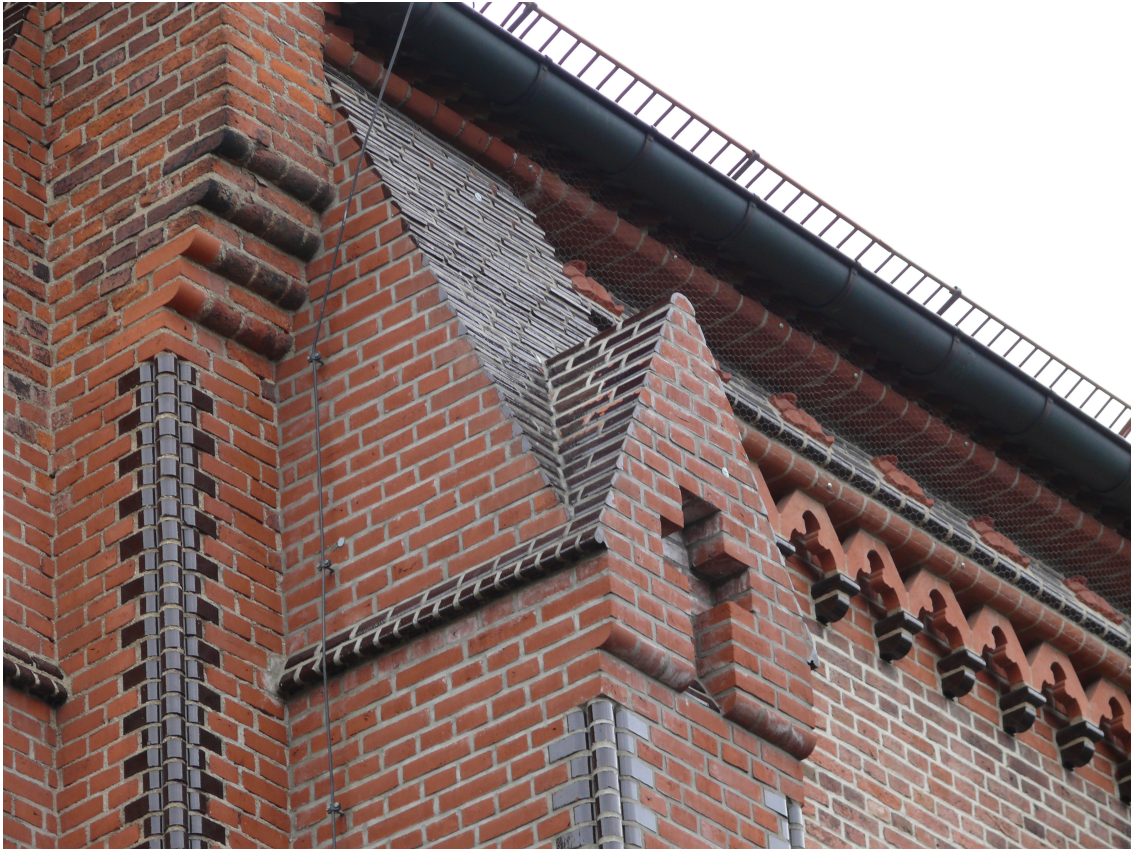
Pic. 3.2.1.2. Top of the buttress.

Because of this, water can come inside the already named holes and stay there after the rain. So when the temperature comes down, below zero degrees, this water becomes ice and increase it volume making the bricks not to stay in their place.

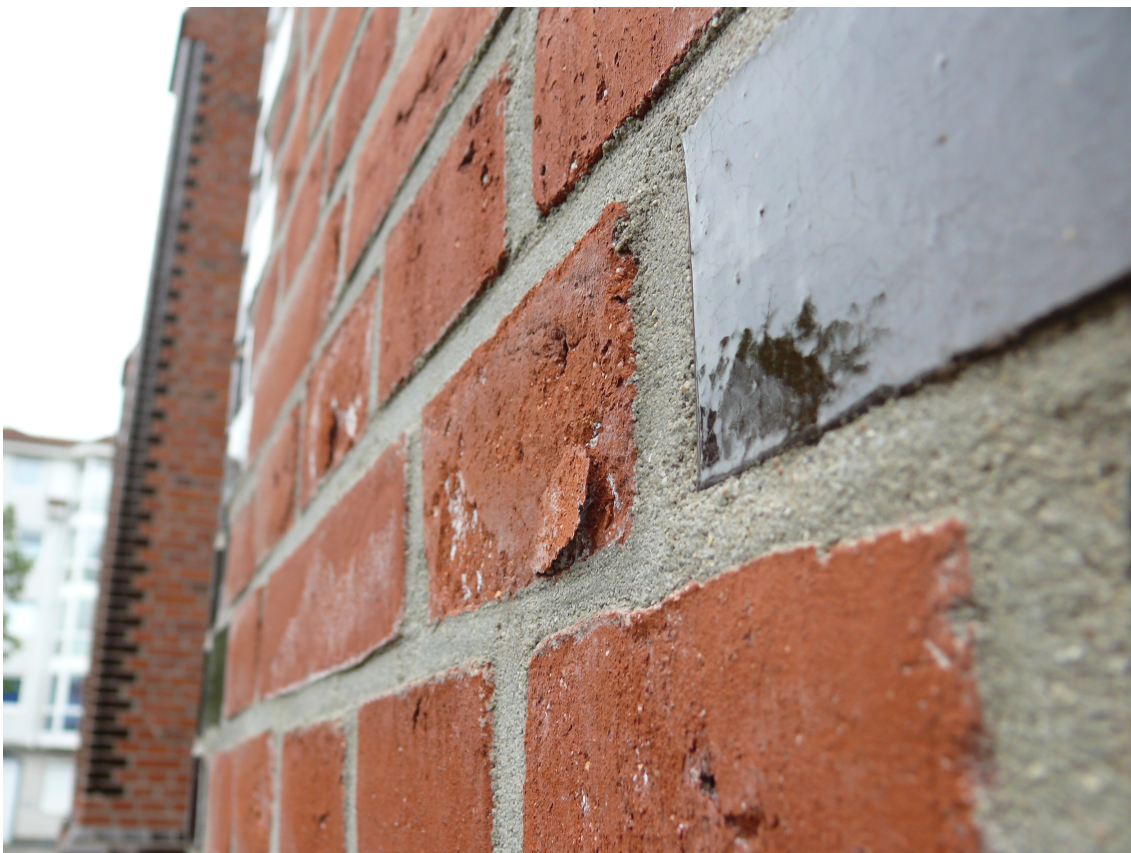
Pic. 3.2.1.4. Spalling brick.

Besides, there are some bricks with out this impermeable paint that are damaged. This is probably caused by also the freezing of water, which is inside the internal pores, and comes from the rain.

Therefore, maybe a preventive idea would be to avoid the entrance of water in the pores.

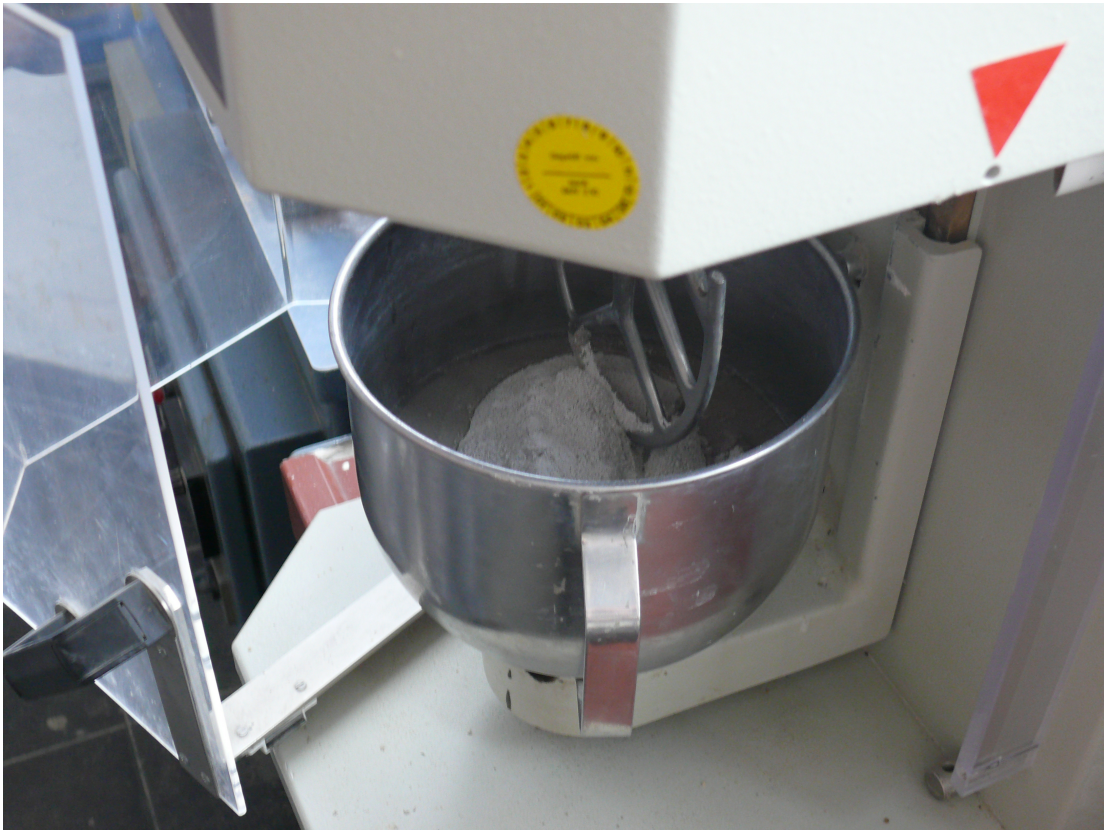
Pic. 3.3.1.1. Mortar mixer.

The maximum mass of mortar we can do is three kg. So all the mixes were made of tree kg, counting the water and the cement together. Once we get the required amount, we put it inside a metallic recipient, wen all the ingredients are in the container we start mixing during 30 seconds, then we stop the machine and with a spoon we take the parts of the fund, we put the container again in the mixing machine during 90 more seconds. Now we have the mixt ready.

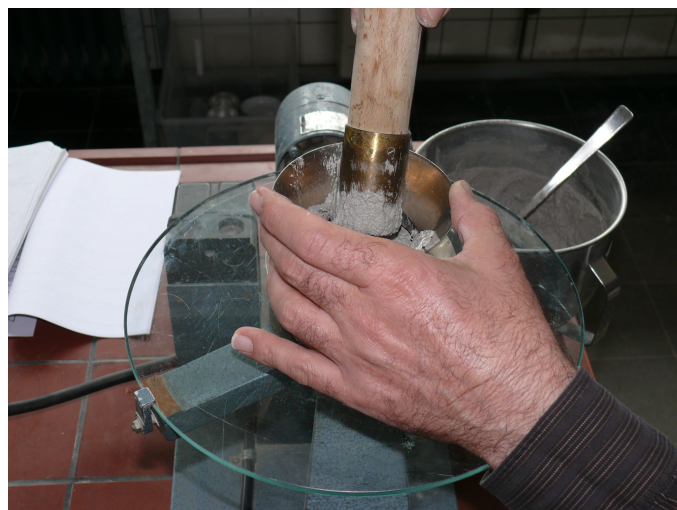
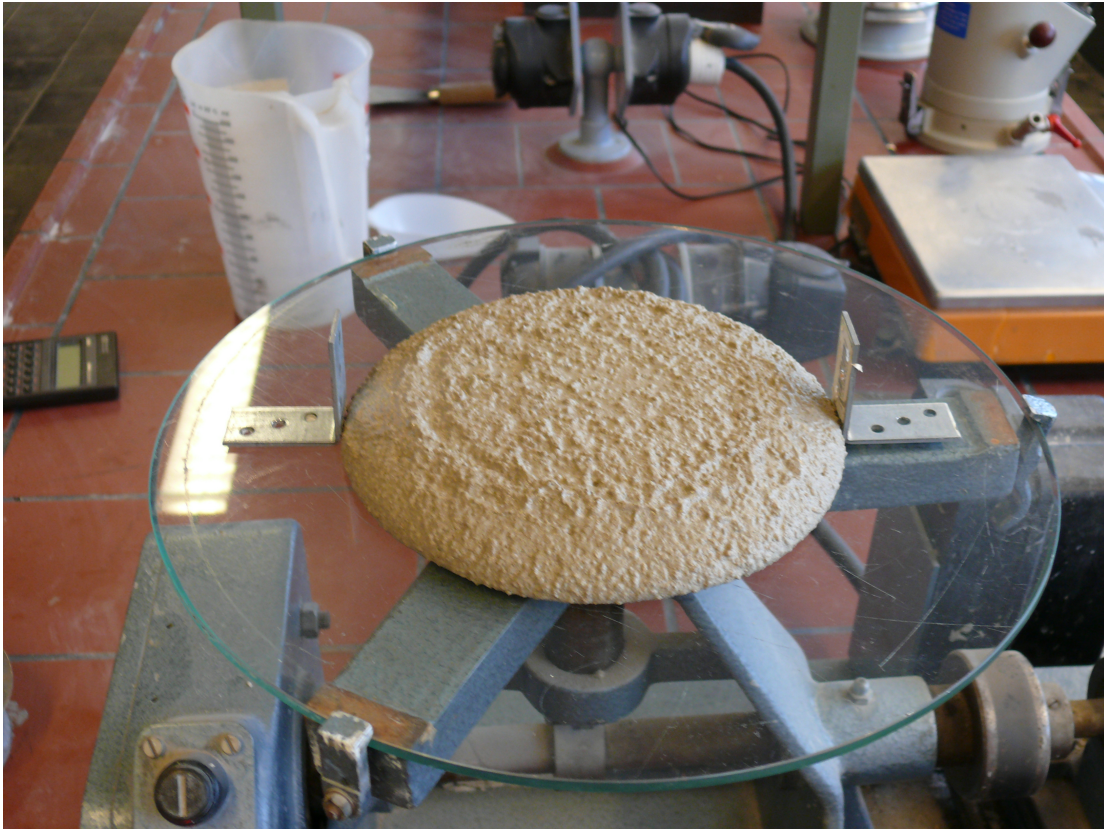
Pic. 3.3.1.2. Flow table.

To prove that the mash has the correct consistence, we try it in the flow table. Attending to the *European standard EN 1015-03*, which explains how to get the value from the flow table, we need to place the metallic mold in the middle of the table, we introduce the mixt in the mold in two times, after each time its required to compact the paste hitting it with the pounder. During the fill up it's required to hang the mold hardly with the hand.

After we fill up, it's needed to take away the excess of mortar a ruler, after more or less 15 seconds, we take off the mold in a vertical way. Then we turn on the flow table and it will yield 15 shakes.

Once we get the formed mortar cookie, we will measure the diameter of it, the diameter needs to be more or less 15 cm long.

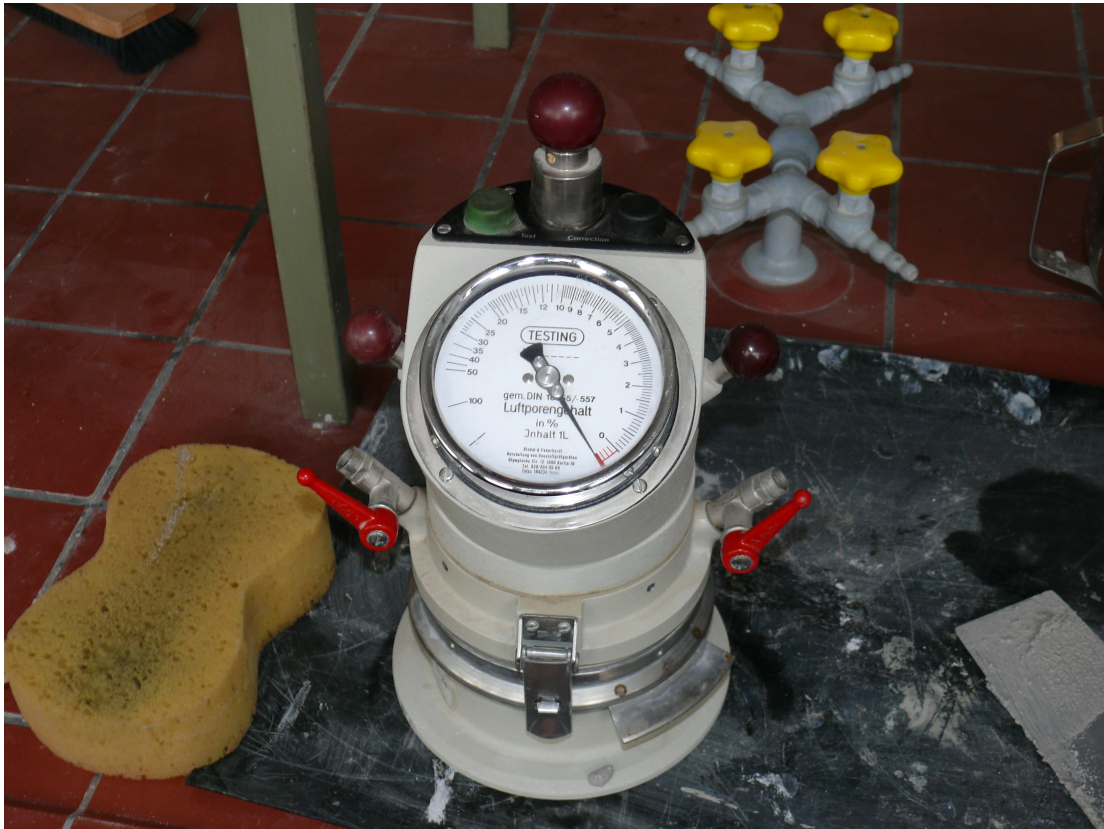
Pic. 3.3.1.4. Porosimeter.

When we have the mix and after it's proofed that it has the proper consistence, we use the porosimeter of mortar to measure the quantity of air inside the mix. Before the test, we need to calibrate the tester with water. After the calibration, we test the mortar getting the percentage of air. This process is specified on the *European standard EN 1015-7*.

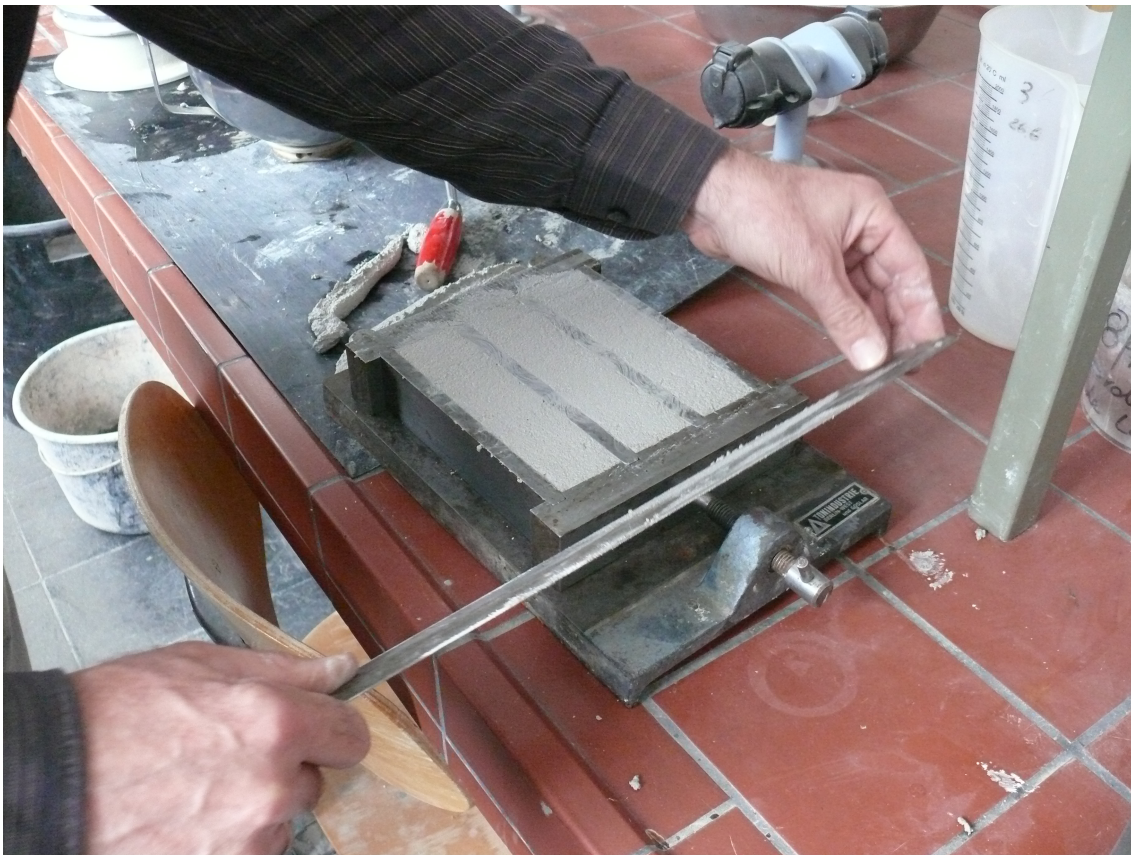
Pic. 3.3.1.4. Triple prismatic shape.

Now we need to make the mortar specimens by introducing the mix inside a triple prismatic shape. Again we need to introduce the mix in two times, after each we need to shake hardly the shape to take away all the bubbles. When it's full, we need to take away the excess of mortar with a ruler. Once we finish, we need to write down the date, and introduce it in the special camera.

After two days we can take off the shape and leave the prismatic forms alone inside the chamber for one week. After being inside the camera, we will leave them at atmospheric temperature until they are 28 days old. Then we will be able to test them.

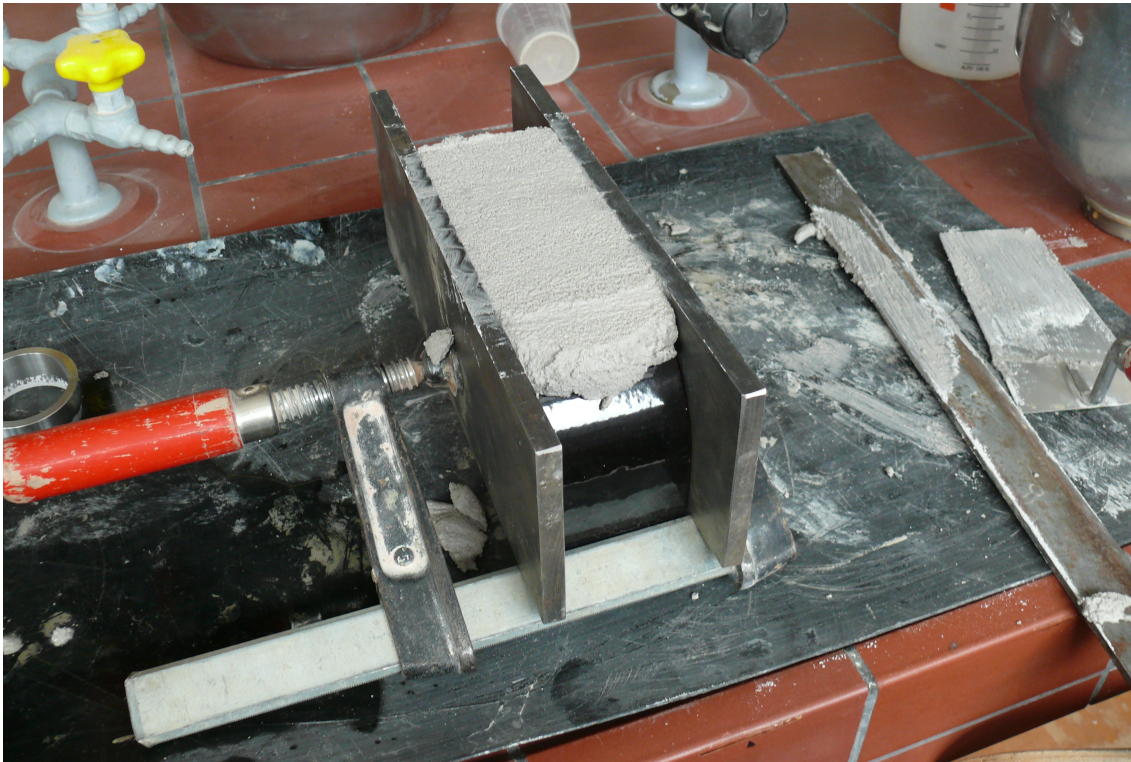
Pic. 3.3.1.5. Preparing the brick.

To prepare it, first we need to put in the correct place the formwork, so we can add one-centimeter dick mortar over the brick, then wait for a couple of minutes until the mix is enough dry to insert a conical ring, with the characteristics named on the *European standard EN 1015-12*.

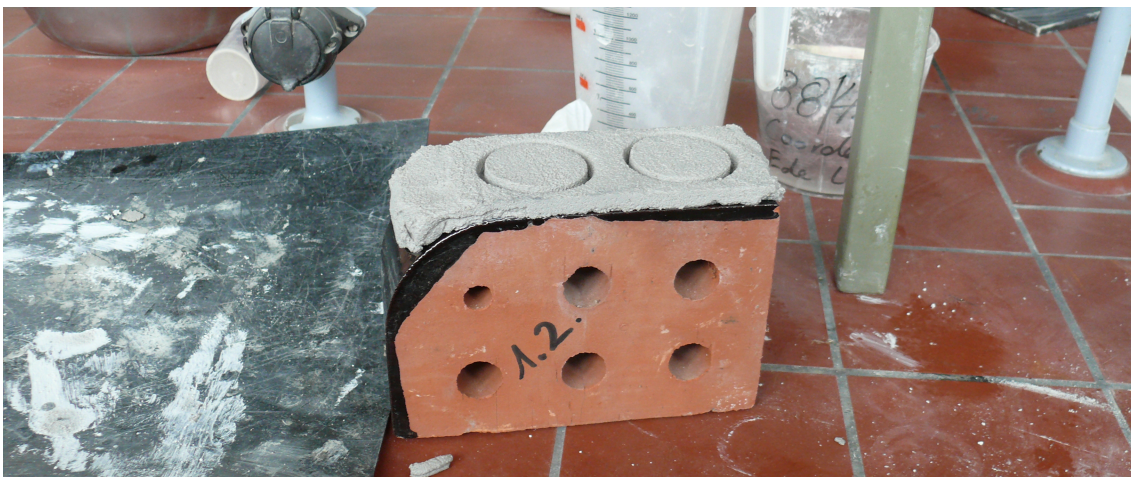
Pic. 3.3.1.6. Prepared brick.

When the hole is done and staying, then we can put the brick in the same chamber as the prismatic specimens. After one week we will take the bricks out of the chamber and put them in a place with atmospheric temperature. At day 28 after the day they were made is time to use them for test.

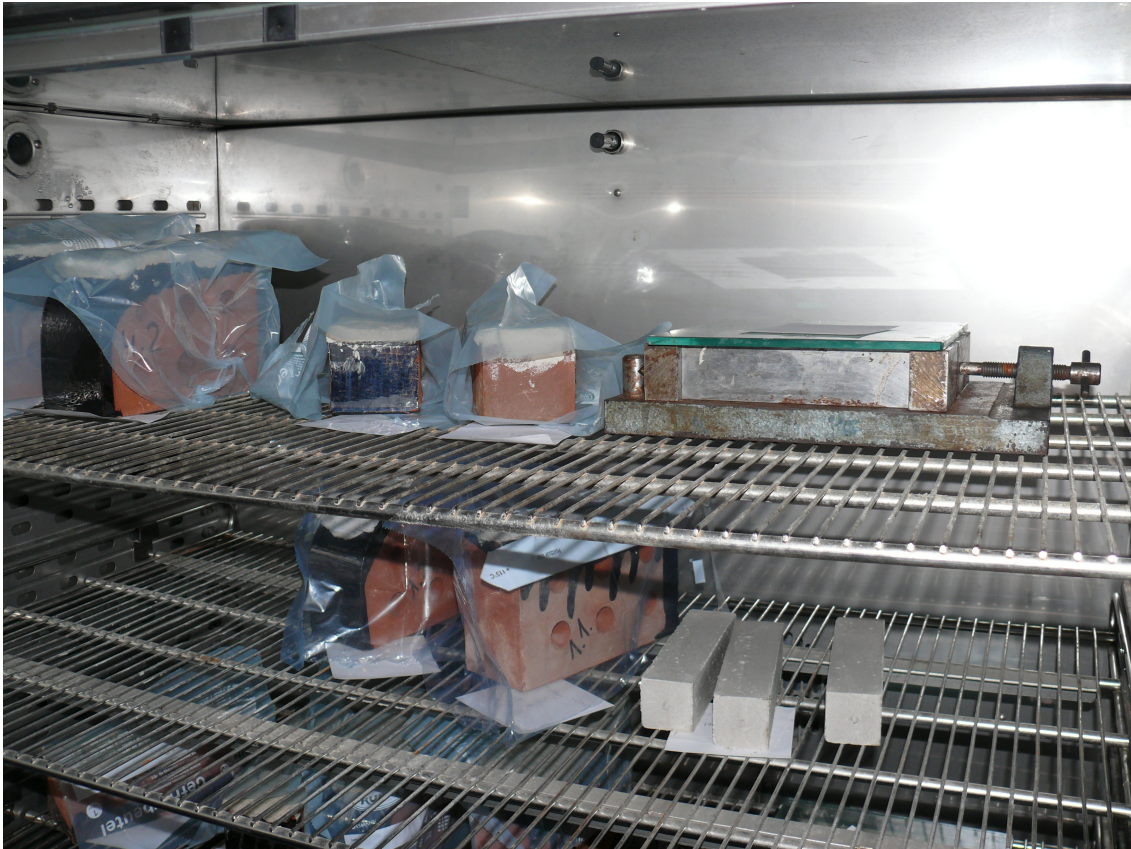
Pic. 3.3.1.7. Chamber

The chamber where are this last two types of specimens, will be at 20^a and with a relative humidity of 65%.

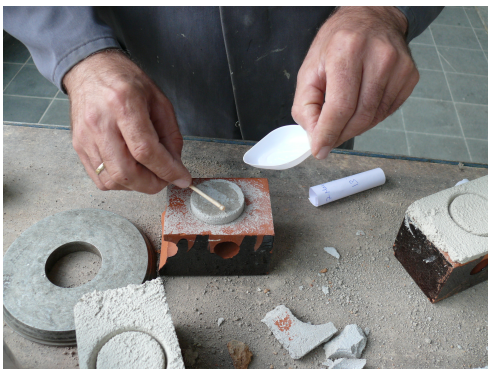
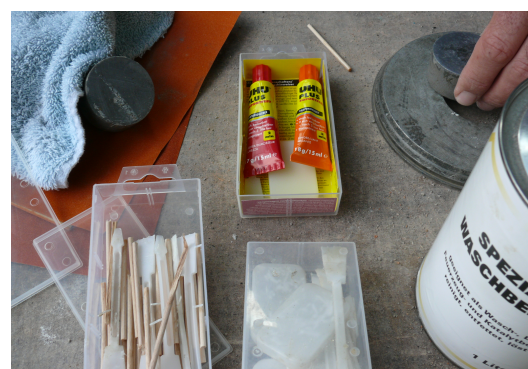
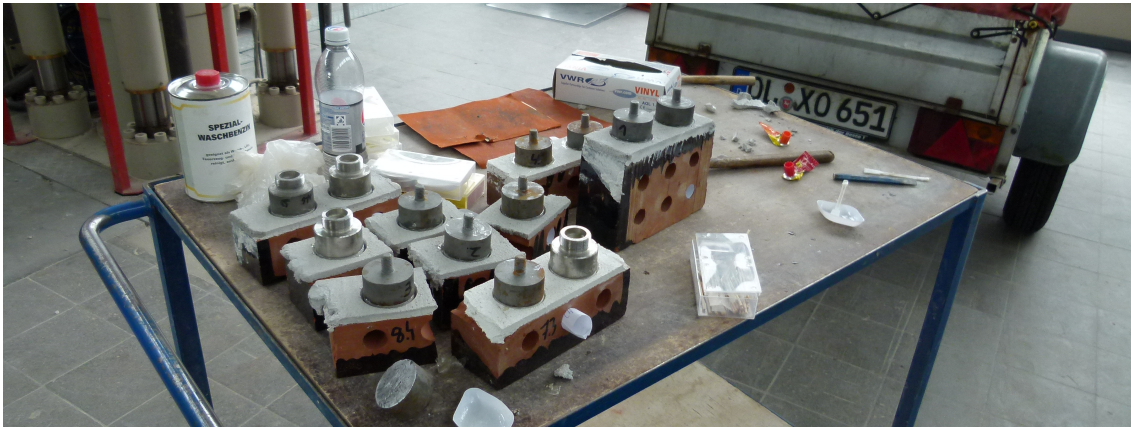
Pic. 3.3.1.8, 9 and 10 pasting the specimens.

Before the traction test, we need to paste the mortar to a special stainless steel pieces with hard glue, which paste it in less than one hour. These pieces are 50 mm of diameter and 10mm high, with an attachment mechanism to hold it with the traction machine.

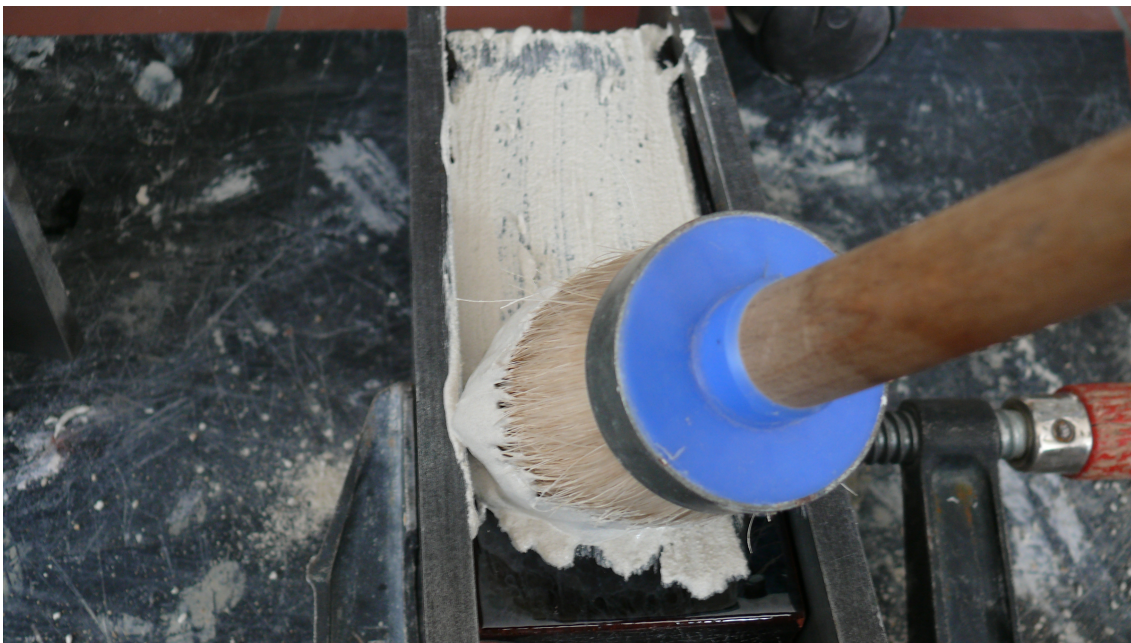
Pic. 3.3.1.11 Painting the surface with glue mortar.

There are two cases where, between the mortar and the brick, we need to extend a glue cement layer. For this glue cement we will need a more fluid mix, 20 cm in the flow table. The method used to mix it is the same one as the others but it need to be mixed twice with five minutes of difference between each time. When we get the mortar and the glue, we extend the glue with a brush making a slim layer. Immediately after, we put the mortar over it.

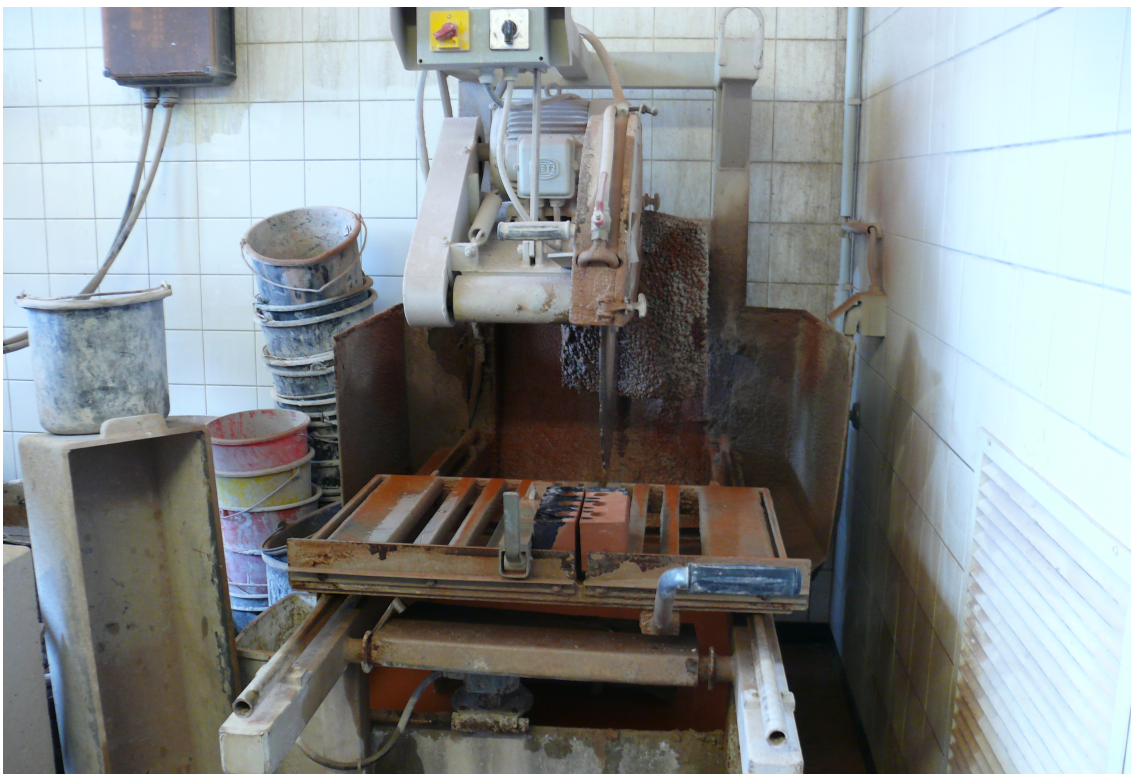
Pic. 3.3.2.1 Cutting bricks

For the compression testing, the machine needs to be in contact with the entire surface of the brick. That's why we need to treat the bricks and make their surface flat, so results will be as best as possible. Also the bricks had an irregular shape. We need to know the volume of them in order to calculate the compression strength per squared millimeter. There were not enough rectangular pieces for the test, so we took bricks with one corner rounded. Also it was needed to prove some bricks picked directly from the buttresses, these bricks were unstuck. The last ones had a trapezoidal section. In order to make them rectangular and flat, we used a buzz saw by cutting and abrading the bricks.

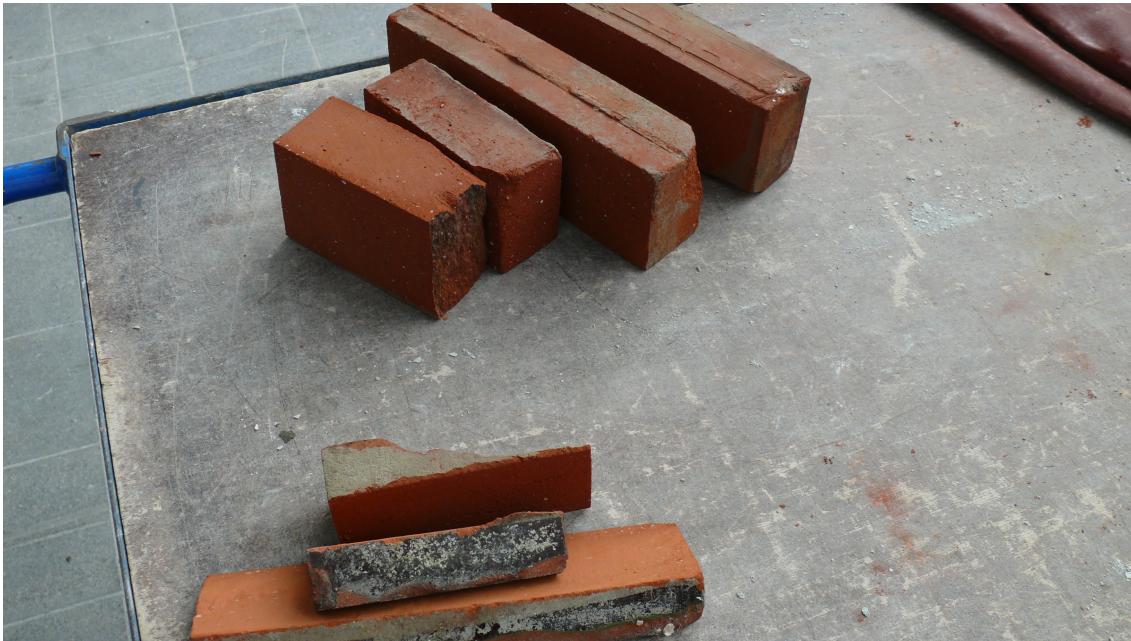
Pic. 3.3.2.2 Bricks from the church.

Once we get the appropriate shape, is time to remove all the wetness they can have inside the internal pores. This is impossible just leaving the pieces in the open air, because the water of inside the internal pores will never disappear. That's why it's needed to leave the bricks inside an oven for 24 hours at 105 degrees. After this time when the bricks are dry and cold, is time to measure and weigh them.

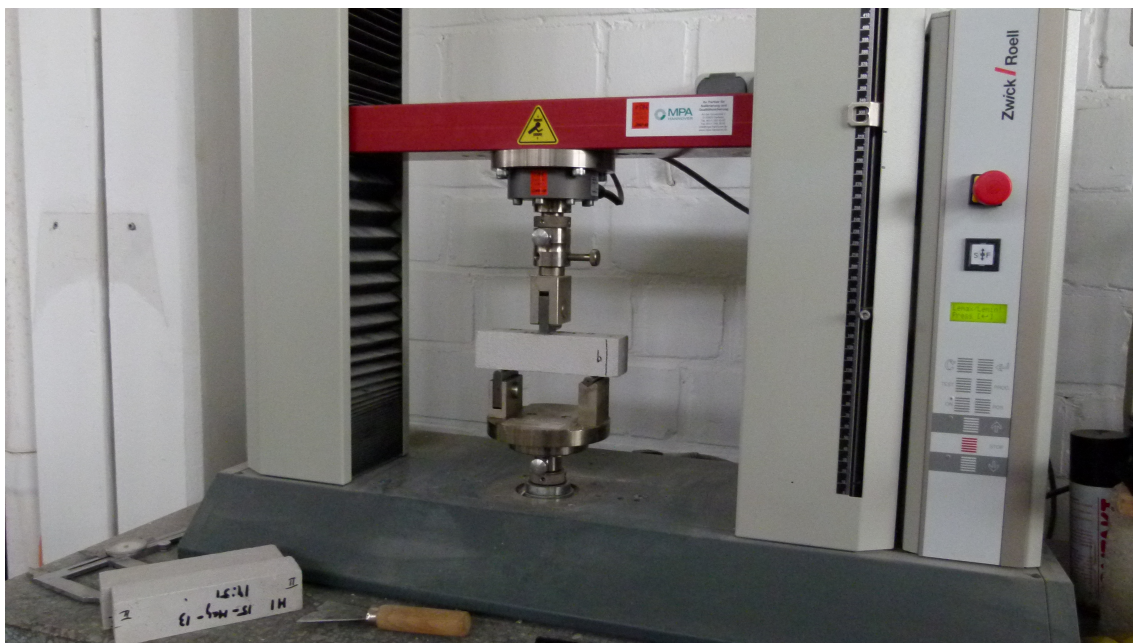
Pic. 3.3.3.1 Bending machine.

We need to know the bending tensile strength of the different mortars we made. In order to get the wanted results, we need to use a bending device formed by two cylindrical rollers, over where specimens rest. These two rollers are separated 100 millimeters. Also it has another cylindrical roller, which applies the strength. This one is situated in the middle of the other two, but this one is on the top.

To introduce the specimen between the rollers, the surface, which was uncovered when they were inside the formwork, can't touch them.

The strength is applied, increasing it in a gradual way in order to break the specimens in between 30 and 90 seconds.
