Alija, S.; Torrijo Echarri, FJ.; Quinta Ferreira, M. (2013). Geological engineering problems associated with tunnel construction in karst rockmasses: The case of Gavarres tunnel (Spain). *Engineering Geology*. 157:103-111. doi:10.1016/j.enggeo.2013.02.010.

Title: Geological engineering problems associated to tunnel construction in karst rock masses: The case of Gavarres tunnel (Spain)

Keywords: Tunneling in karst, karstified rock masses, retrospective analysis, Gavarres tunnel, NATM

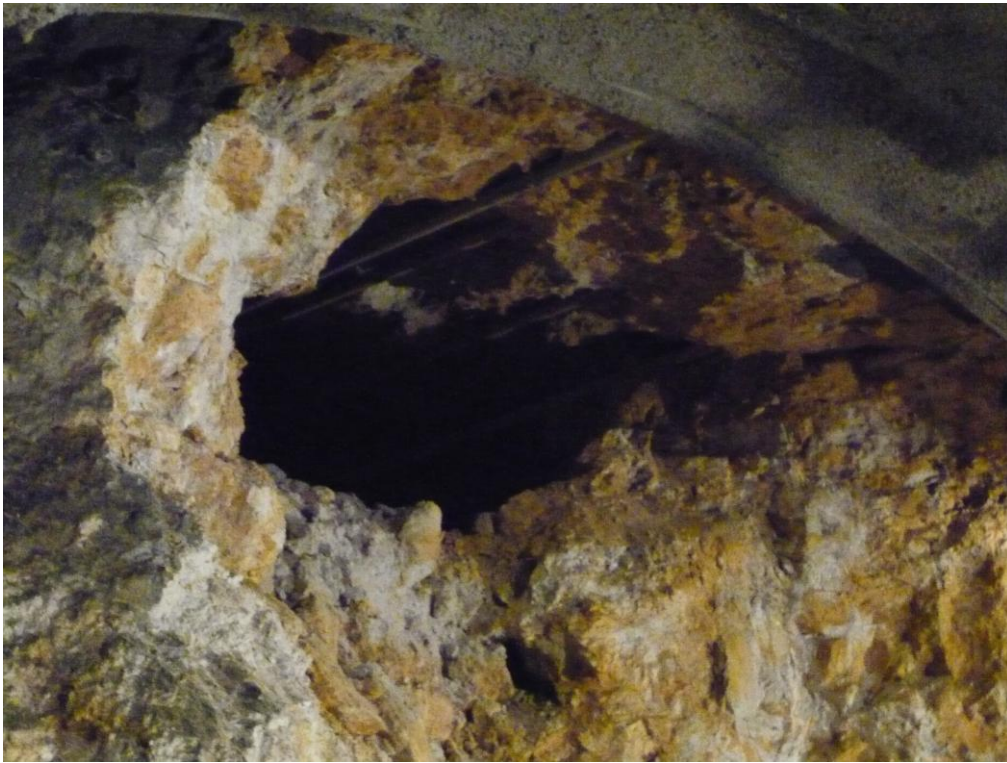
Figure 5
[Click here to download Figure: Figure 5.docx](#)

249 Due to the increase in the number and size of the instabilities it was decided to
250 increase the number of the bolts and to raise their length from 4 m to 6 m,
251 overlapping 3 m. Despite this reinforcement, masses of clay and limestone blocks were
252 still able to strip out the bolts (Fig. 5) requiring the improvement of the support
253 solution.

255 Fig 5. View of an instability with a distorted light umbrella in zone 2 (section 70).
