Durability of repair mortars used in restoration of a Sardinian coastal tower: assessment after ten years

Abstract

This study reports the results of investigations on conservation conditions of an ancient tower, called Torre del Pozzo, located in the S-W coast of Sardinia, restored about ten years ago. The tower suffers from serious problems related to vulnerability of building materials, particularly limestone and sandstones and aerial lime mortar with poor physical-mechanical properties. Over the centuries the materials were subjected to aggressive actions (wind corrosion and salt crystallization) causing an intense erosion of the walls with consequent partial collapse of the structure. About ten years ago a restoration involved the mortars and only the replacement and integration of ashlar deteriorated. After about 10 years from this intervention, some inspections have been carried out in order to assess the effectiveness of the intervention and the state of preservation of the tower. This paper focuses on analyses and tests carried out to assess condition and durability of the repair mortars.

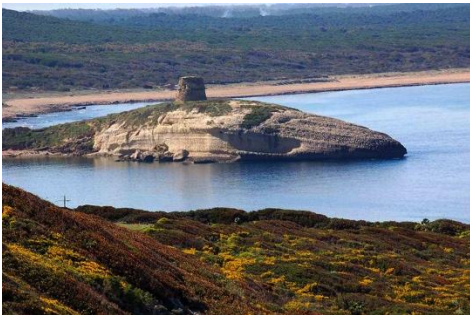
The Torre del Pozzo is situated on a promontory at 19 m above sea level, in the SW coast of Sardinia. It is architecture with a circular base diameter of about 15 m and a height of 11 m. Torre del Pozzo is located in the village of the same name, part of the coastal villages of Cuglieri, in the northern part of the Sinis Peninsula. It is located on a rock panoramic (the Whale), surrounded by a shallow and slightly sloping to the sea (Fig. 1).

Fig. 1- Torre del Pozzo at present
