## UNDERSTANDING SPANISH TIMBER JACK ARCH FLOORS, EXAMPLES OF ASSESSMENT AND CONSERVATION ISSUES

Jack arch floor, timber, grading, on-site assessment, UNI 11119, Valencian Community.

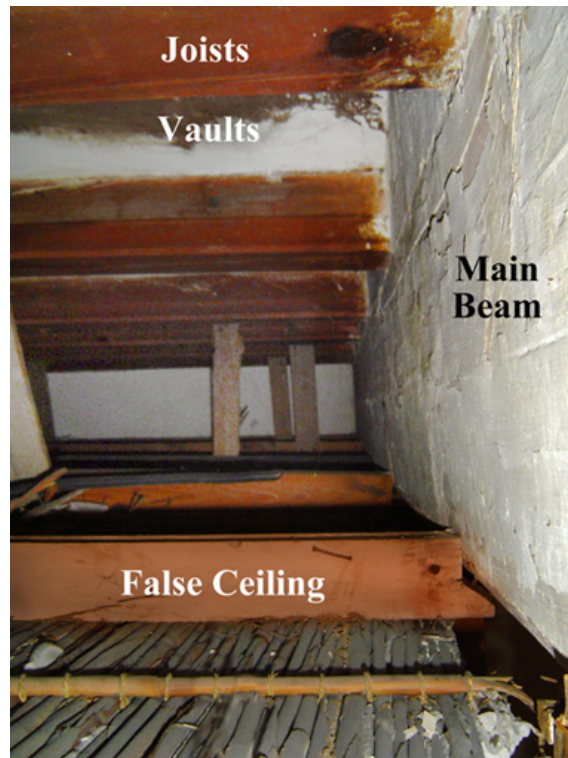
Decorated with moldings or not, sometimes, the structures remain hidden behind false ceilings by design or due to a change in fashion (Figure 5). These false ceilings are made of a plaster finishing and panels of reeds tied together and nailed to the joists or to a hanging timber frame. Nowadays, after some restorations, these joists are frequently brought to light.

Figure 5.  
Hanged false ceiling structure made with timber frames, reeds panels and a plaster finishing underneath, School of Theology, Valencia, built around 1829-1853

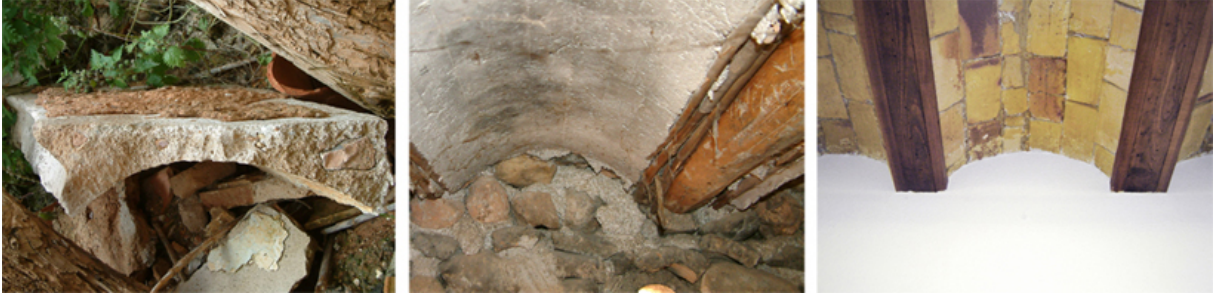
Figure 7.

Examples of vaults: portion of a dismantled plaster conglomerate vault, pieces of bricks are visible in the section (ruins north-east of Requena, Valencia), plaster conglomerate vault with a group of reeds along the impost of the vault (homestead near Cofrentes, Valencia), jack arch floor with masonry vault and composed joists (House of the Vallier family, Valencia, building started in 1883)

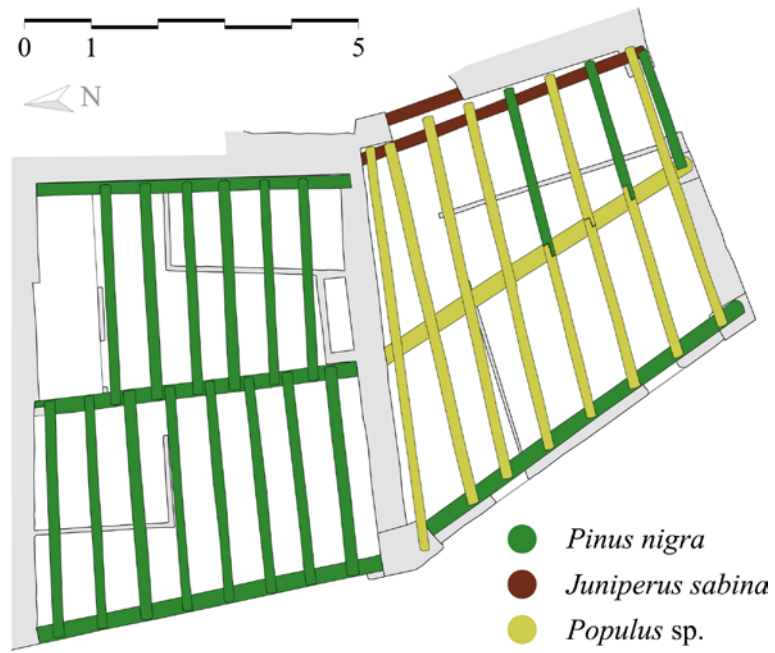
The different features of the three species are not entirely exploited in the structural configuration of the building; this means that there is not a clear relationship between the structural function of a member and its species. However, one peculiarity is that the *Juniperus sabina* elements are usually used as lintels and main beams and almost never as secondary joist (Figure 17).

Figure 17.  
Plan of the species of wood used in the vernacular building in Sesga (Ademuz, Valencia)
