2 Wind turbine tower collapse due to flange failure: FEM 3 and DOE analyses

9 ABSTRACT

96 In October 2008, two months after being out into operation, one of the *Abuela de Santa Ana* wind
97 turbine towers collapsed due to a catastrophic failure in the lower flange fixed to the foundations. An
98 on-site inspection of the damage was made the following day.

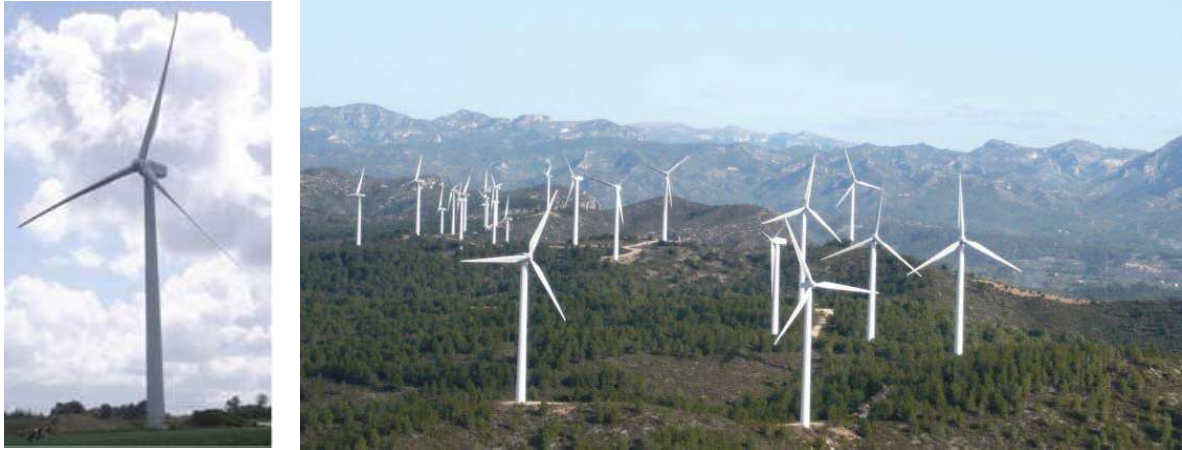
Fig. 1. General view of the Abuela de Santa Ana wind farm and one of the towers

75 The *Abuela de Santa Ana* onshore wind farm is located near the town of Pozo Llorente in the province
76 of Albacete (Spain). It consists of 25 GE Energy 1.5sle Model 1.5KW wind turbines, **the diameter of**
77 **the rotor is 77m and the height of the tower** varies between 61.4m and 85m. It is operational at the
78 present time under the control of the ACS Company at a nominal power of 37.500 kW. Its geographic
79 coordinates are 39° 4' 36.5" latitude and -1° 30' 23.5" longitude. A view of the wind farm with a close-up
80 of a tower can be seen in Fig. 1.

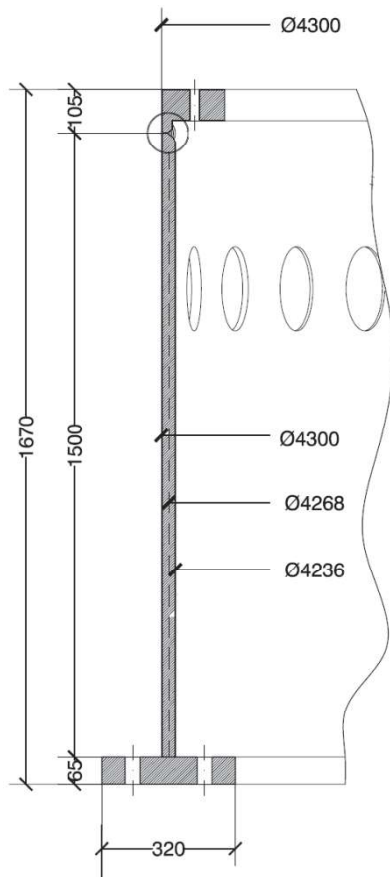
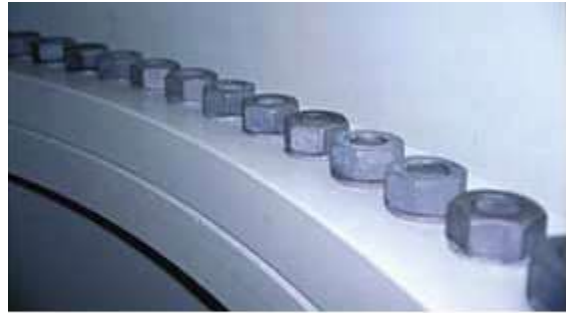
Fig. 2. Details of the tower/foundation connection. a) Detail of lower flange and foundation; b) Detail of flange and bolts. Source: [16]

82 The turbine towers are composed of different steel tubes and the flange is fixed to the lower tube and is
83 embedded in the foundations (see Fig.2). The tower tubes are bolted together and are required to
84 maintain the necessary stiffness to support the turbine nacelles fixed to the top of the tower.

85 The flange is placed in the lower part of the tower. The flange is a steel tube 1.67 m long and 4.3 m
86 diameter. It consists of the following components (see Fig. 2):

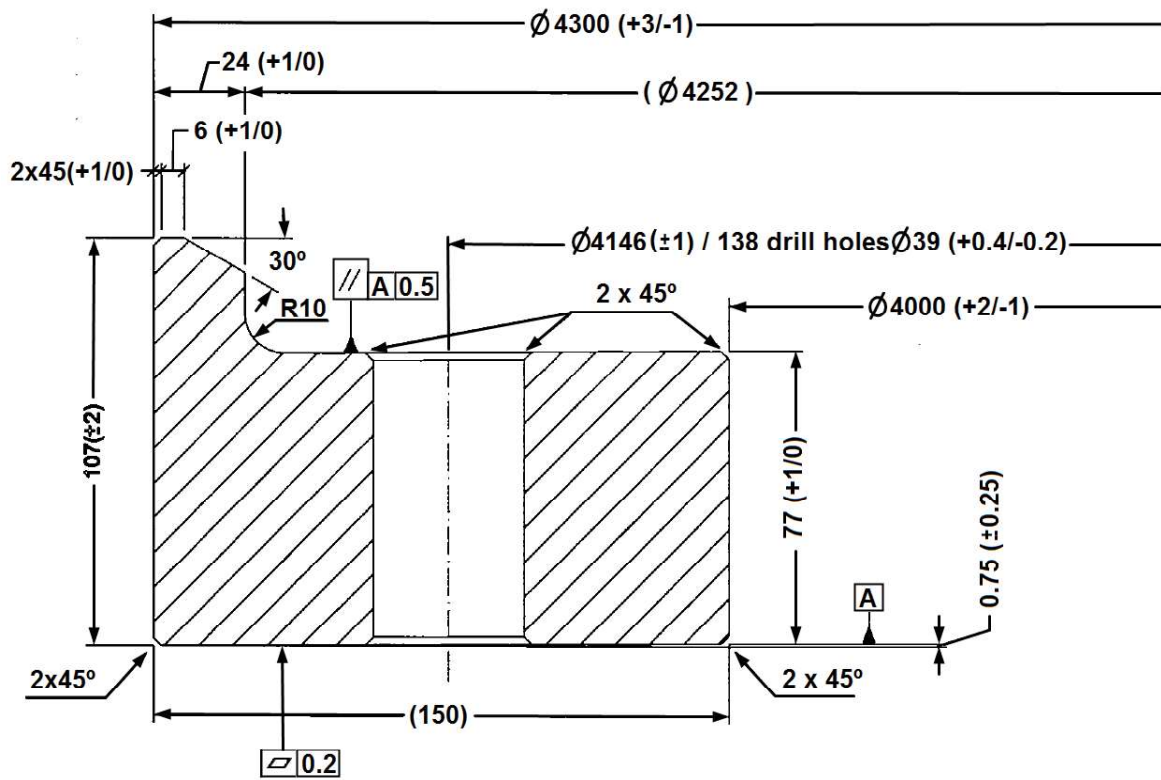
Fig. 8. Geometry of flange section

156 The flange dimensions are as follows: 4.3 m. external diameter, 0.107 m. maximum thickness, and 0.15
157 m. in width, with 138 drill holes of 0.039 m. in diameter. The section geometry and tolerances are given
158 in Fig. 8.

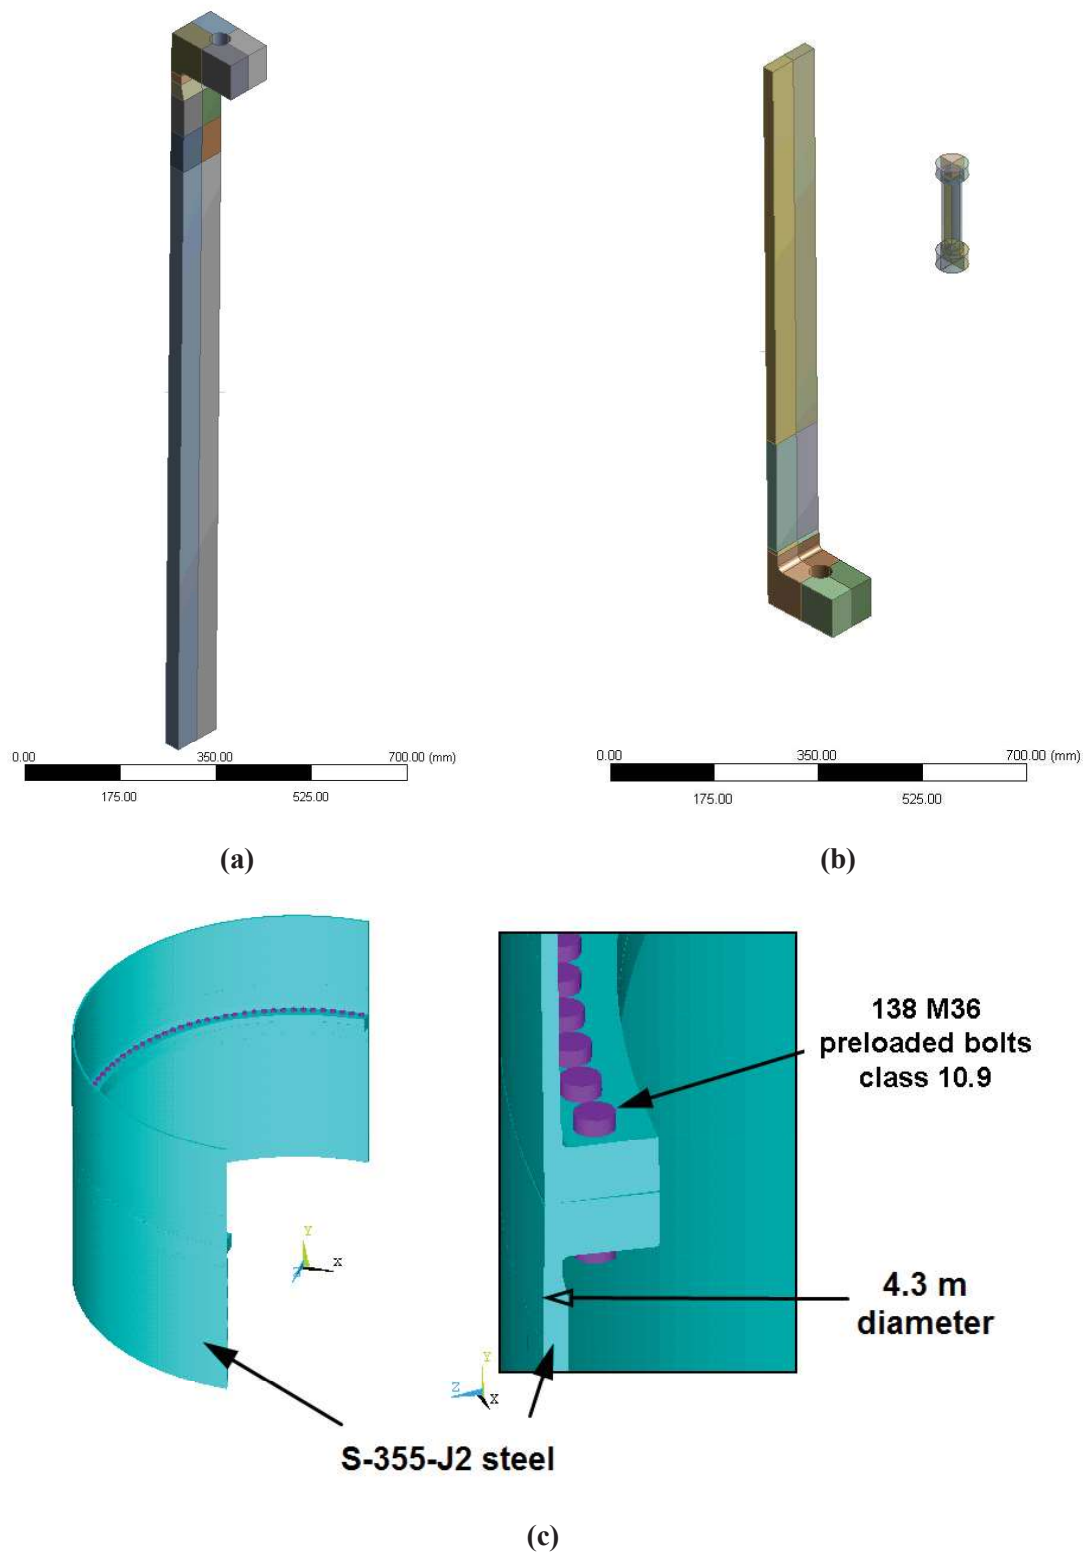
Fig. 10. Geometric model: a) Lower flange; b) Upper flange and bolt; c) Complete (symmetry) model.

203 The geometrical model studied consisted of the lower flange, the upper flange and a bolt joining both
204 parts, to which symmetry conditions were applied in order to reduce the computational cost of the
205 models. Details of the model geometry can be seen in Fig. 10.

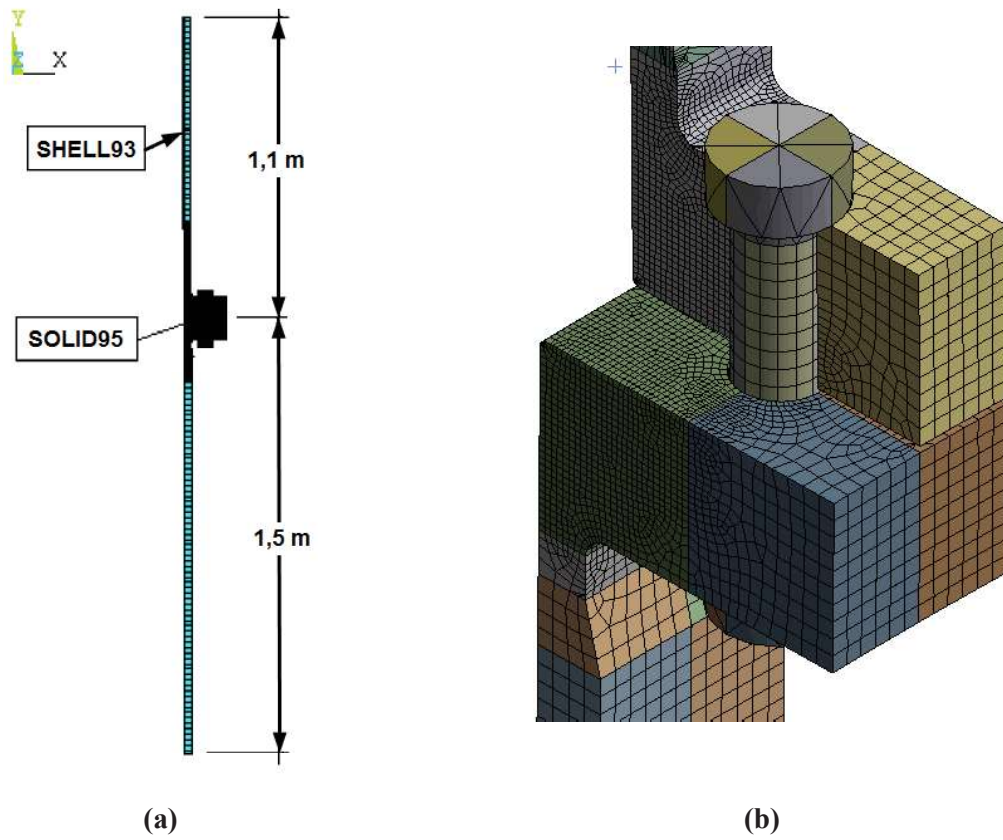
Fig. 11. Finite elements mesh: a) General view; b) Detail of the mesh in the bolt

210 SOLID95 type finite elements were used for the flange and SHELL93 for the steel tube at a distance
211 from the joint (see Fig.11a). These elements are suitable for modelling curved zones and complex
212 geometries, as in the case under study [25–27].

219 The mesh size was minimum 0.0013 m and maximum 0.27 m, with a total of 266.194 nodes and 71.117
220 elements. As can be seen in Figure 11b, certain zones of the geometry were modelled with a very fine
221 finite elements mesh due to the curves and transitions between the elements.

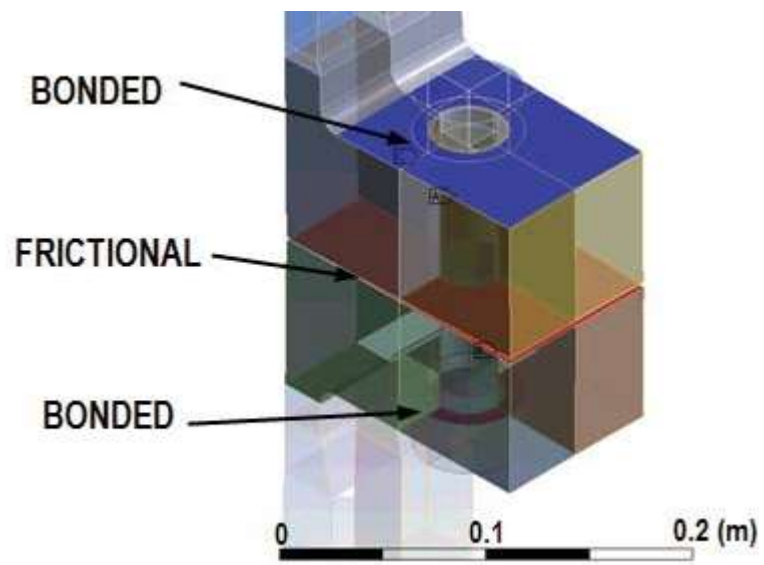
Fig. 12. Contacts in model

226 The model was completed with the configuration of the contact between elements and the application
227 of boundary conditions, which consisted of frictional contact between the flanges surfaces and bonded
228 contact between the bolt head and the upper flange surfaces and for the nut with the lower flange
229 surfaces (see Fig.12). The friction coefficient considered was 0.1, adopting an Augmented Lagrangian
230 formulation [30].

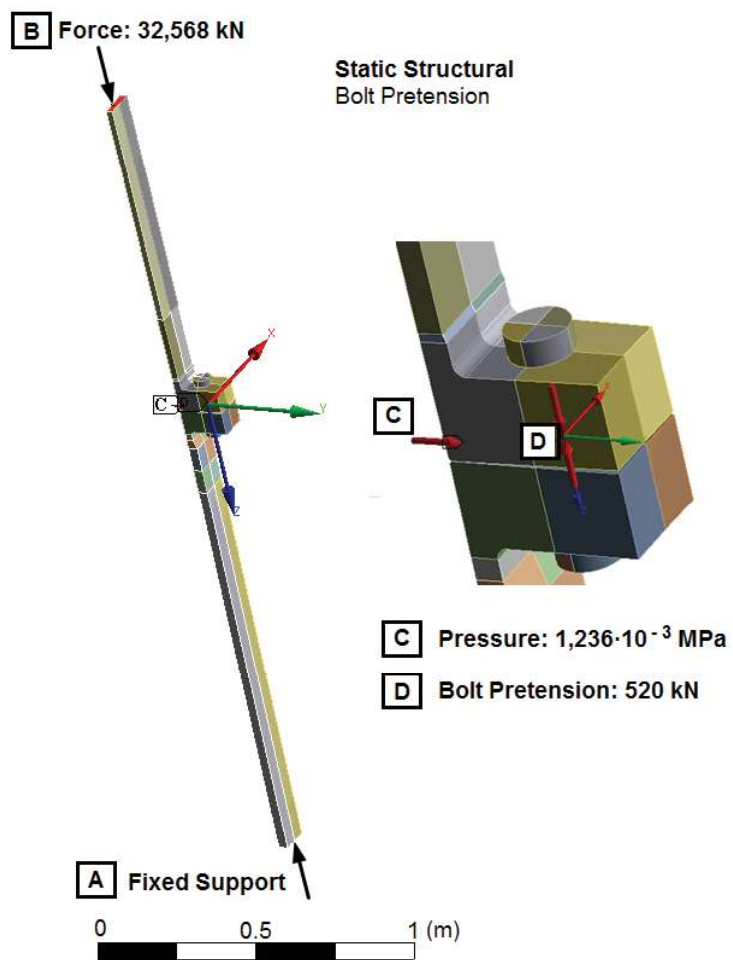
Fig. 13. Boundary conditions used on a section of the flange

237 To begin with, use was made of the flange symmetry to simplify the model and represent the actual
238 continuity of the tower shell and flanges. In this way, only a 1/138th sector of the flange was simulated
239 and symmetry conditions were applied (see Fig. 13). Secondly, a restriction was applied on the

240 displacements at the lower end of the foundation steel tube (A in Fig. 13). Thirdly, a load was applied
 241 on the upper end of the joint (B in Fig. 13) representing the vertical load exerted on the foundation by
 242 the structure and its various components. Additionally, other loads present in the structure were applied,
 243 whose values were provided by the manufacturer of the tower (C and D in Fig. 13). The loads applied
 244 on the model and their values (see Fig. 13) were as follows:

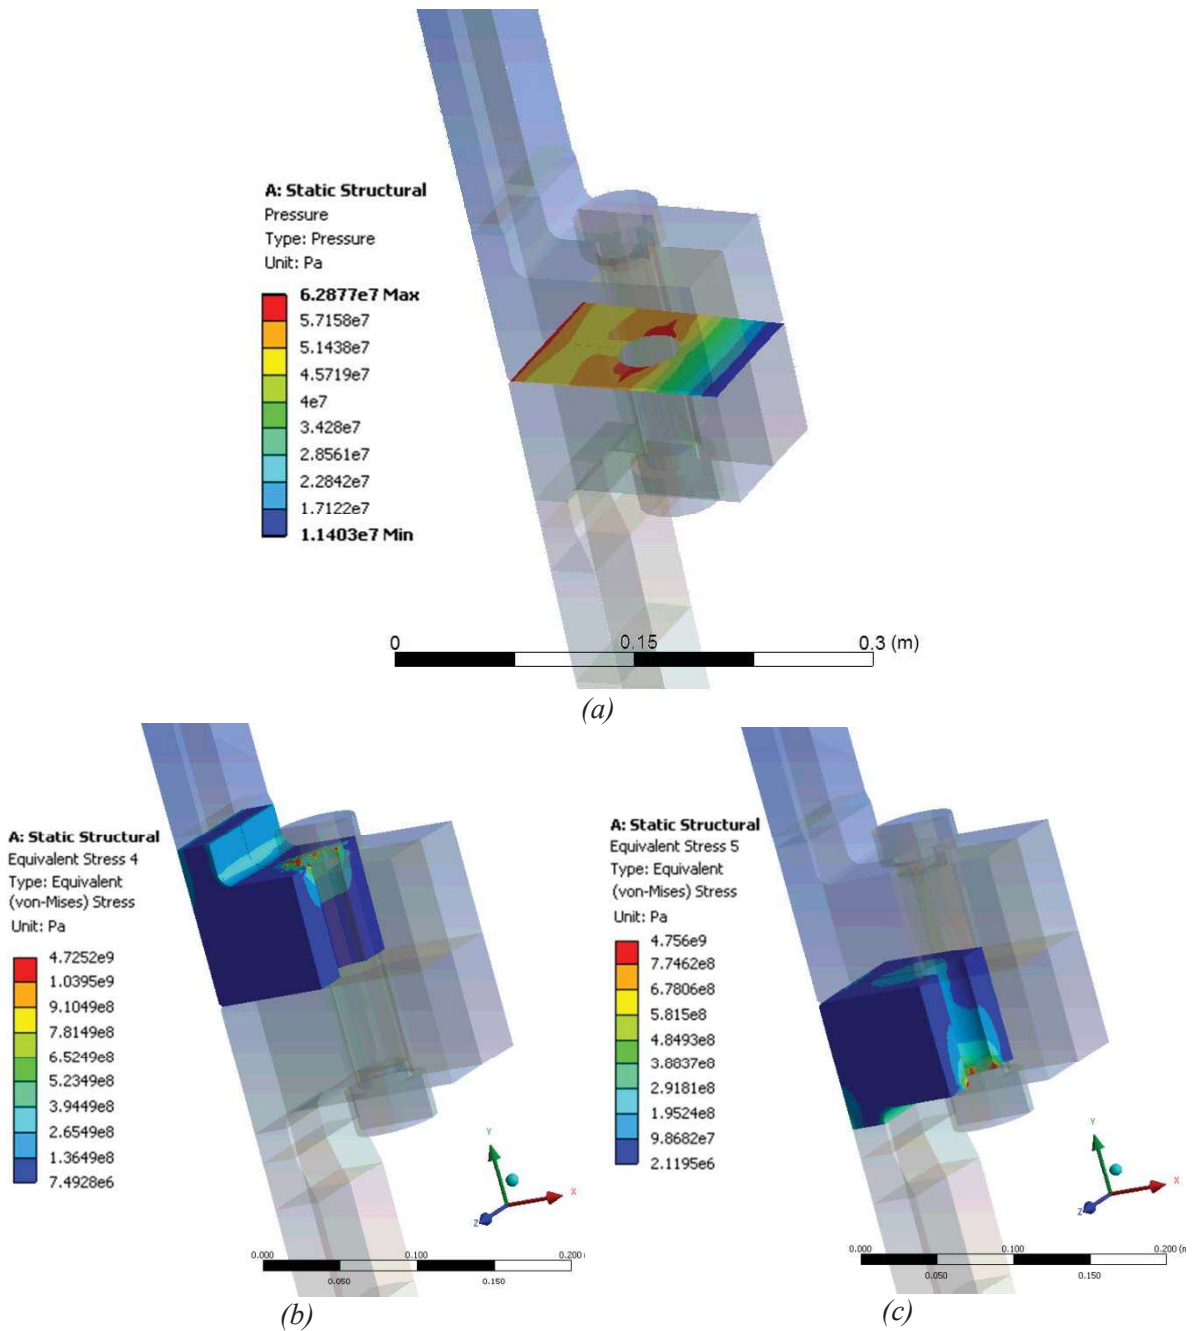
Fig. 15. Results of the FE model and DOE analysis: a) Contact stress between upper and lower flanges (in Pa); b) Von Mises stress in upper flange (in Pa); c) Von Mises stress in lower flange (in Pa)

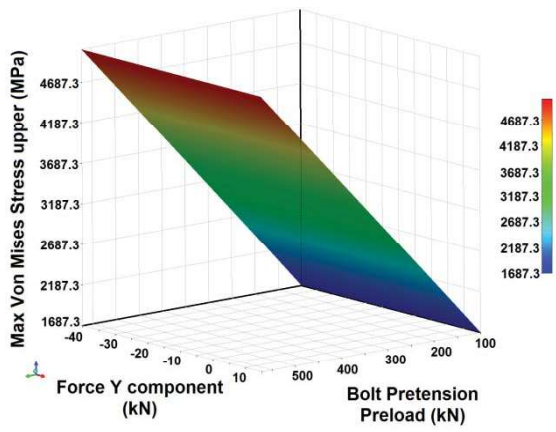
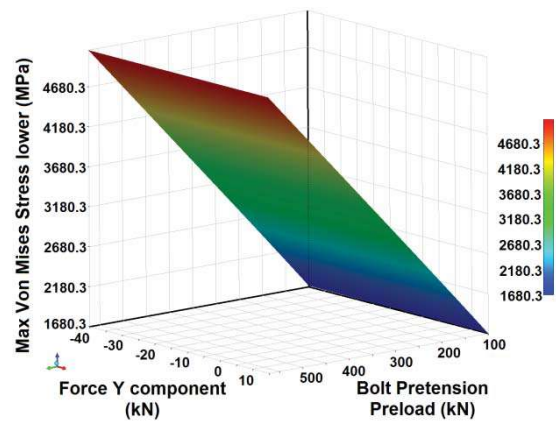
Fig. 17. DOE analysis: External part of the flange (upper and lower part. a) Bolt pretension vs Force Y in upper part of the flange; b) Bolt pretension vs Force Y in lower part of the flange

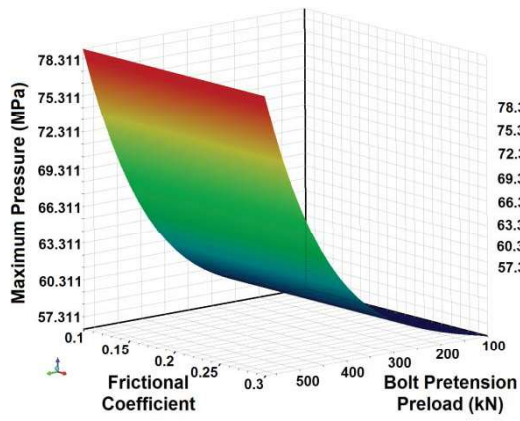
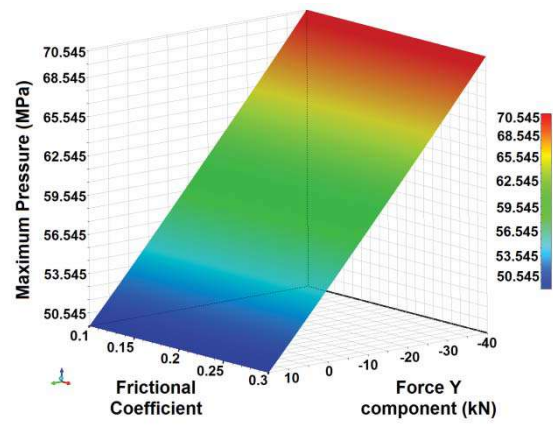
Fig. 18. DOE analysis: maximum pressure in contact between the flanges: a) Contact friction vs Bolt pretension; b) Contact friction vs Force Y.
