MORE COMPREHENSION, MORE PROTECTION: NON-DESTRUCTIVE TECHNIQUES IN THE SURVEY OF THE FORMER S. SALVATORE HOSPITAL IN L'AQUILA, ITALY

*Mariangela De Vita**, *Giulia Massari***, *Pierluigi De Berardinis***, *Luis Palmero Iglesias****

Abstract

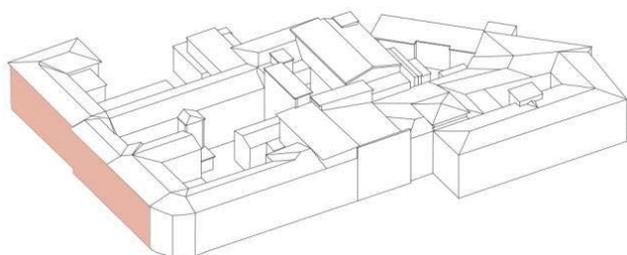
Fig. 7: Thermographic scanning mode on south façade

Taking the elevation with the highlighted south façade as an example (figures 6 and 7), it is possible to understand the used methodology. The façade was analysed at 10:00 a.m. in passive mode, detecting the energy emitted under stationary operating conditions, which is when the element is in thermal equilibrium.

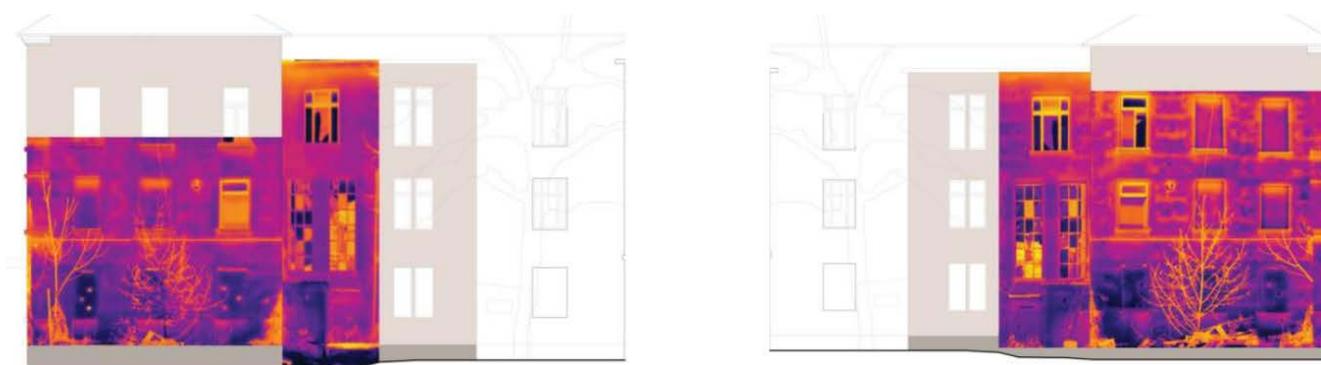
Fig. 13: North façade -time: 11:00 and 15:00

In the figure 11 it is possible to see the reconstruction of the south façade analysed in passive mode and in the figure 12 the reconstruction of the south façade analysed in active mode. The reconstruction of the north and west façades is shown in the figures 13 and 14.

With the thermographic tests, through the prospectus reconstruction, it was possible both to find anomalies in the building and to verify the data of which there was not absolute certainty. One of the problems detected was the capillary ascent, highlighted in the façades analysed through passive mode. The examination of the masonry texture was interesting, which was instead highlighted in the façades analysed in active mode. The historical sources of the building had provided information on the type of wall texture, composed by striped masonry of stones

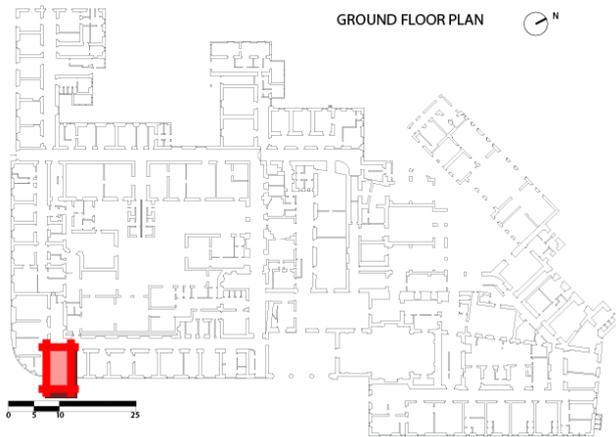
Fig. 15: In red: position of the room analysed

The room indicated in the figure 15 was chosen for its orientation, as it has a wall facing East - protected by a building cloth cover that avoids direct sunlight - for its small size and for being the only room on this front that does not have concrete pillars, which would have been thermal bridges. The room has an area of 18 m², a volume of 60 m³ and an external wall with a thickness of 0.70 m.

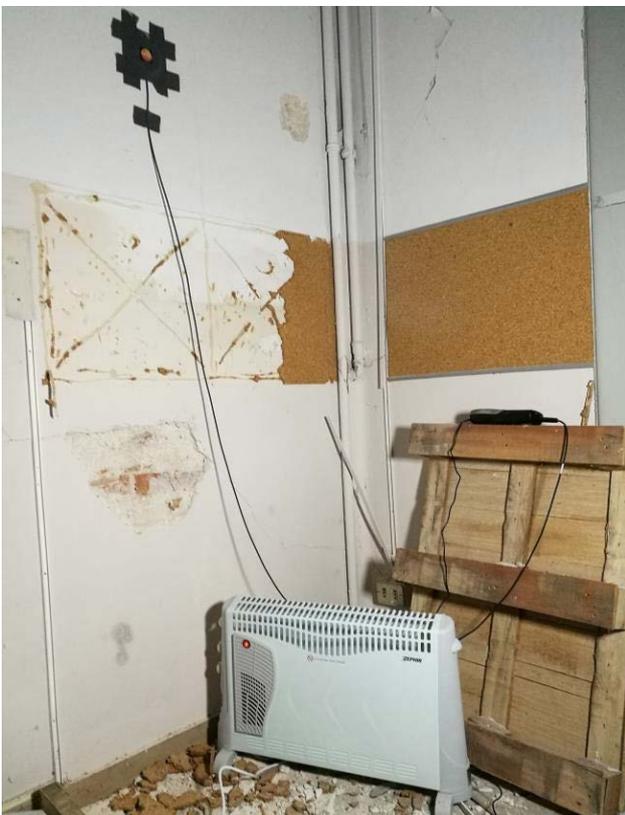
Fig. 16: The plate on the inner side of the masonry to analyse

The instrument was positioned on January 23 2019. The thermofluximeter plate was fixed - in the point previously checked by the thermocamera - using an adhesive tape and making sure that the logo was not covered to avoid insulating the sensor, as shown in figure 16. On the outside, the probe was fixed in correspondence with the thermofluximeter plate and set to send the data every 10 seconds. In figure 17 it can be seen how the probe was fixed to the scaffold that supports the building cloth cover. The instrument, once connected to the thermofluximeter plate, was activated. The monitoring was set in the automatic mode, with a measurement frequency of every ten minutes which adds up to a total number of 430 measurements during 72 hours.
