Material weathering and structural damage in historic adobe constructions in Spain: preliminary results of a quantitative approach.

This article presents the study of the main phenomena of material weathering and structural damage that affect traditional architecture built in adobe, analysing the damage found in 553 case studies, representative of different technical varieties of adobe construction in Spain. The analysis methodology proposed in this text made it possible to quantify and identify the risks of damage appearing, establishing its impact and identifying its main mechanisms and causes. At the same time, the behaviour of adobe construction systems was further studied, observing how specific modifications in technique can promote or hinder deterioration and establishing the probable causes of the different responses to these phenomena.

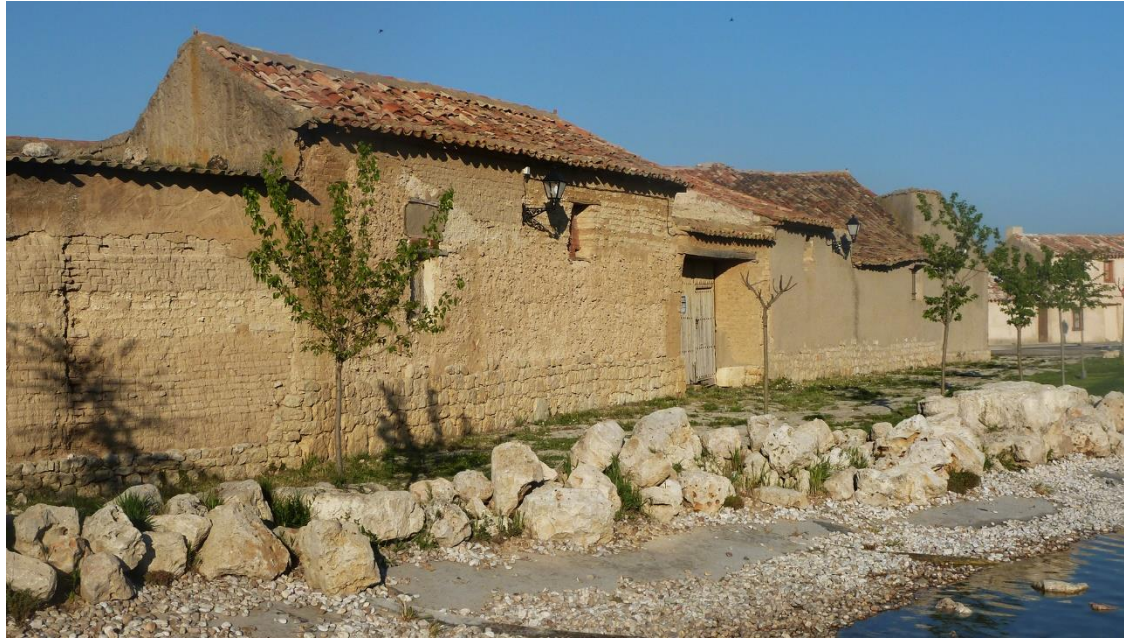
Regardless of the organization of the blocks, mudbrick walls can also be erected in combination with structural elements (such as buttresses, wall plates or wooden frames) or be reinforced with insertions in the fabric or the joints (shards, flat stones, reeds, etc.)⁴ to make the most of available raw materials and to adapt the building to the geographic and climatic conditions of the location⁵ (Fig. 1).

Figure 1. Adobe constructions in Uruña, Valladolid.

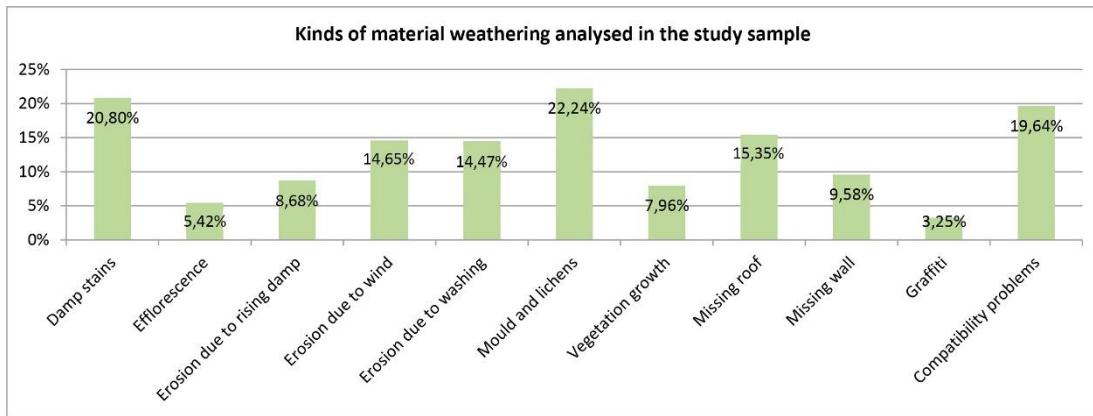
In the course of this study, 11 kinds of material weathering were analysed in detail (Fig. 5). Material weathering of any kind appeared in 12.81% of cases, with mould and lichen as the most common phenomena (22.24%) and graffiti as the least frequent (3.25%).

Figure 5. Kinds of material weathering analysed in the study sample.

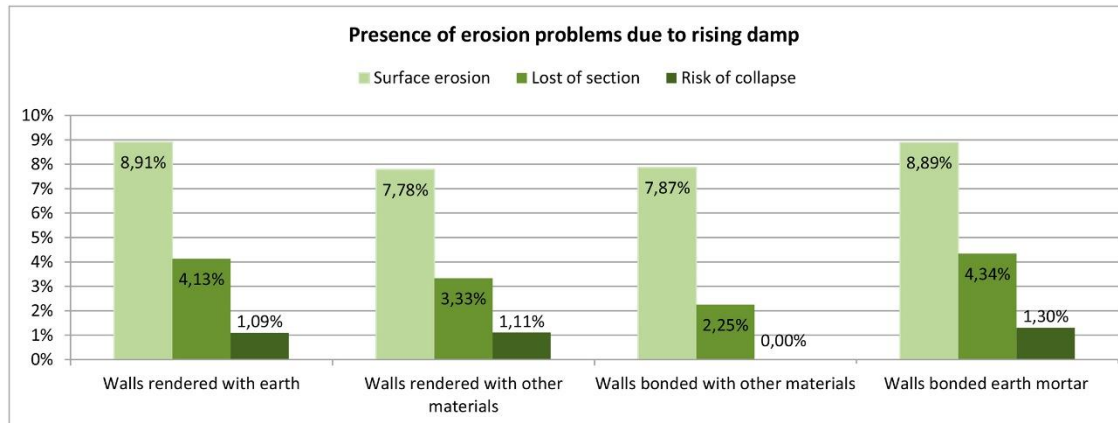
In adobe walls attached with earthen mortars, loss of volume due to rising damp was almost twice (4.31%) as frequent as in case studies where lime or gypsum bond the wall (2.25%) (Fig. 8). However, buildings using these elements show a similar amount of surface detachment problems that those not using them. Thus, it seems reasonable to conclude that although mortars with added binders do not prevent wall surfaces from becoming detached, they do slow down this process, reducing the risk to building stability.

Figure 8. Presence of erosion problems due to rising damp.

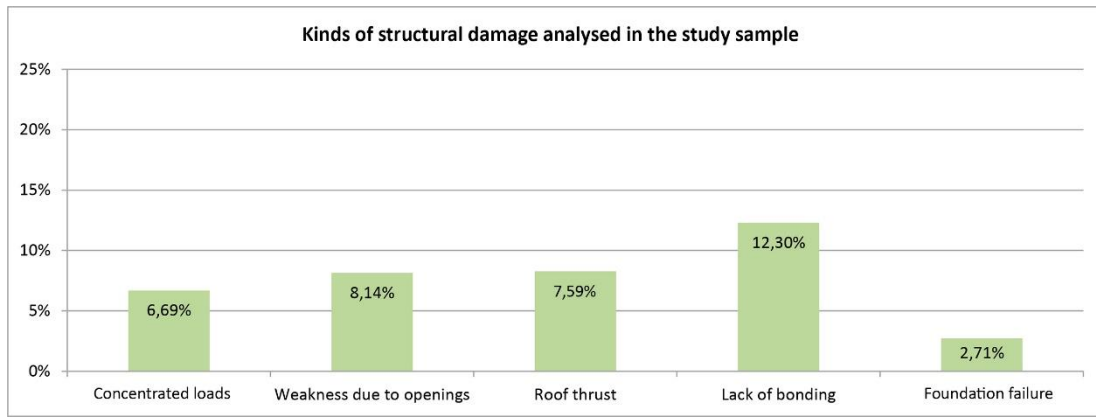
Five different types of structural damage, appearing in 7.48% of cases on average, were analysed in detail (Fig. 13). The most common were the cracks due to lack of interlocking

Figure 13. Kinds of structural damage analysed in the study sample.
