A Case Study of a Large Unstable Mass Stabilization: “El Portalet” Pass at the Central Spanish Pyrenees

Abstract: This case study presents the engineering approach conducted for stabilizing a landslide that occurred at “El Portalet” Pass in the Central Spanish Pyrenees activated due to the construction of a parking lot. Unlike common slope stabilization cases, measures projected here were aimed at slowing and controlling the landslide, and not completely stopping the movement. This decision was taken due to the slow movement of the landslide and the large unstable mass involved. The degree of success of the stabilization measures was assessed by stability analyses and data obtained from different geotechnical investigations and satellite survey techniques such as GB-SAR and DinSAR conducted by different authors in the area under study. The water table was found to be a critical factor in the landslide’s stability, and the tendency of the unstable slope for null movement (total stability) was related to the water table lowering process, which needs more than 10 years to occur due to regional and climatic issues. Results showed a good performance of the stabilization measures to con

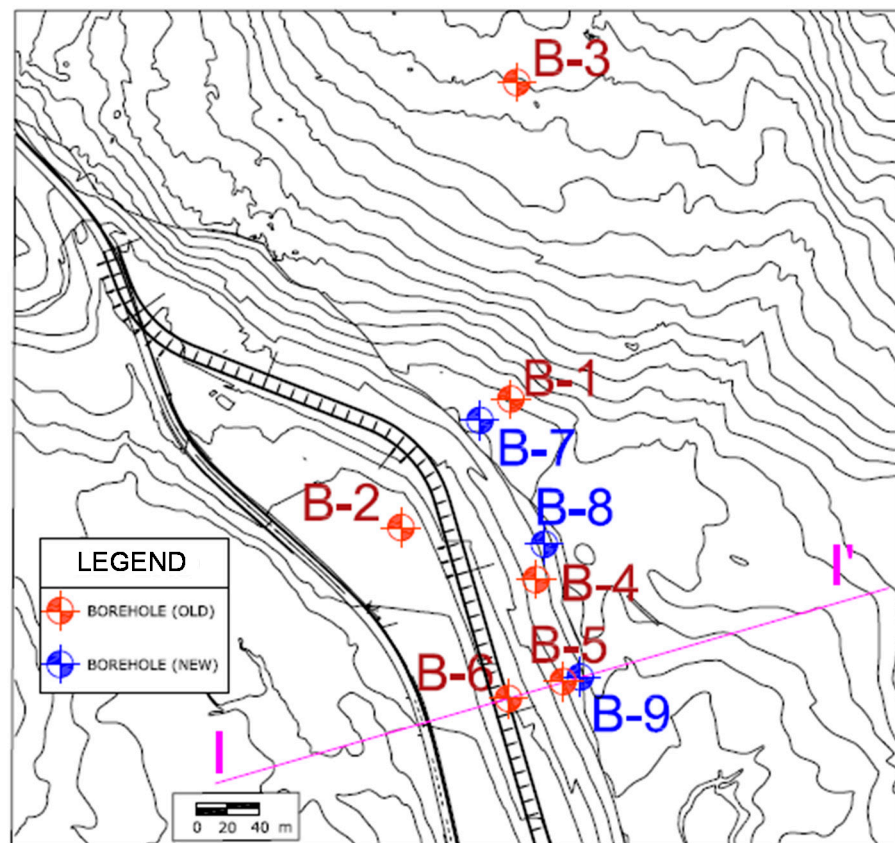
Previous geological–geotechnical investigations [15] conducted in 2005 consisted of six boreholes (location is shown in Figure 2) with depths between 24 m and 40 m. Standard Penetration Tests (SPT) were performed on each borehole when crossing soils and very weathered rocks, with a frequency of about 3 m. Disturbed and undisturbed samples were extracted from each level identified. Laboratory tests conducted on such samples included general identification tests (e.g., grain size, Atterberg limits, unit weight) and mechanical tests (uniaxial compression strength on rocks and direct CD shear tests and triaxial CU tests on soils).

Figure 2. Location of the boreholes performed in the previous study [15] (“old” boreholes, conducted in 2005, reprinted with permission from ref. [15], Copyright Year 2005, Copyright Owner’s F.J. Torrijo) and the new geotechnical investigation (“new” boreholes, conducted in 2016); profile I-I’ relates to Figure 5.
