## Repair grants for historic farm buildings in Dartmoor National Park

Nils White<sup>1</sup>

**Topic:** T4.1. Conservation and restoration projects of vernacular architecture

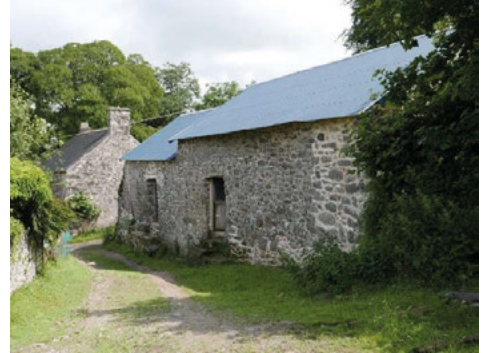
Fig. 5. Pizwell barns (north side) following repairs (Source: White, 2021).

The buildings had suffered from the twentieth century build-up of rubble and earth spoil against their south wall. This had exacerbated water penetration, washing out pointing and bedding mortar and loosening the masonry. Furthermore, both the south and west walls had been further damaged by the roots of adjacent ash trees. A full-height vertical crack in the NW corner had been made worse by attempted repairs using Portland cement. The corrugated iron roof was rusty and let in water, and door lintels were rotten, or had been replaced with slender angle irons.

extent of damage caused by tree root penetration. In the event, part of the west gable had to be rebuilt. As at Beckhams, stainless steel Helibars were used to tie old masonry to new. Another modern intervention was the placing of a root barrier membrane between the wall and earth to help prevent root penetration from reoccurring.

The extent of repointing was greater than had been originally specified due to water damage on the south and west walls; even so, it was only carried out where absolutely necessary. As at Beckhams, Full mortar analysis was carried out and matching material specified.

The corrugated iron roof was replaced and new seasoned oak lintels put in place. As there are no gutters or downpipes, a French drain was installed along the south wall to divert water away from the building.

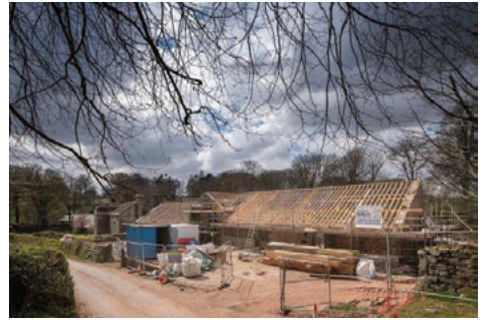
Fig. 11. Great Cator Barn during work (Source: Copyright Historic England Archive, Davies, 2021).

Each project has thrown up its own challenges, whether these were technical, philosophical, or around owner expectations. However, in all of them, repair specifications were informed by a good understanding of the buildings' original construction. For example, on sites where analysis revealed that 'hot lime' or subsoil based bedding mortars were used, this same technique was successfully replicated.
