Restoration of the stained glass windows of the British Cemetery of Valencia

Carmen Burguete Gil¹

Topic: T4.1. Conservation and restoration projects of vernacular architecture.

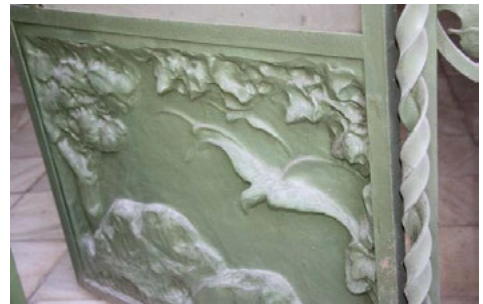
Fig. 2. Detail from the chapel door. British Cemetery, Valencia (Source: Burguete, 2017).

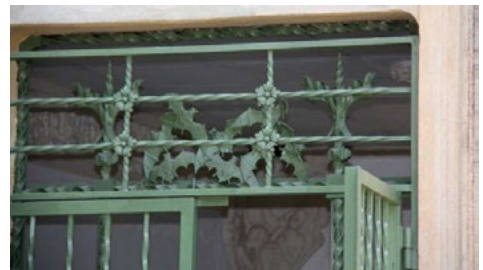
Fig. 3. Detail from the chapel door. British Cemetery, Valencia (Source: Burguete 2017).

Despite being located inside the cemetery, protected from vandalism, the stained glass windows showed cracks and the loss of part of their design. These panels displayed a serious deterioration of the lead, with around 10% missing. It also presented damage mainly through the passage of time (dirt, discolouration).
