RURAL ARCHITECTURE. REHABILITATION AND PUTTING IN VALUE. MOYA

Emma Barelles-Vicente

Department of Architectural Constructions, Universidad Politecnica de Valencia, Spain.
ebarelle@arq.upv.es

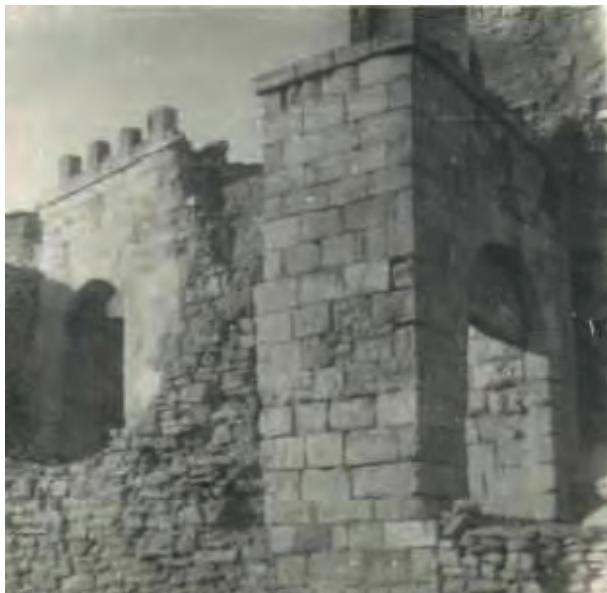
Fig. 6. Image of the gate of the Villa, 20s. (Source: Mata, M.P.).

The construction of these two portals was after the construction of the wall, hence the evident difficulty of interlocking between different materials, which, with the deficient sealing in the upper part or coronation, offers us the two more negative aspects of its current state; but pointing out that the response of each of the covers to the problem pointed out has been different depending on what was initially pointed out: situation and orientation.

The lack of lock between the semicircular arch (north façade) and the lowered arch of the south façade are those that have considerably influenced the damage produced.

The two sheets (north and south) of the arches contained a masonry fill with a defective upper finish that allowed continuous wetting of this fill over the years, which has been generating strong lateral thrusts and also dead weight on the arches.

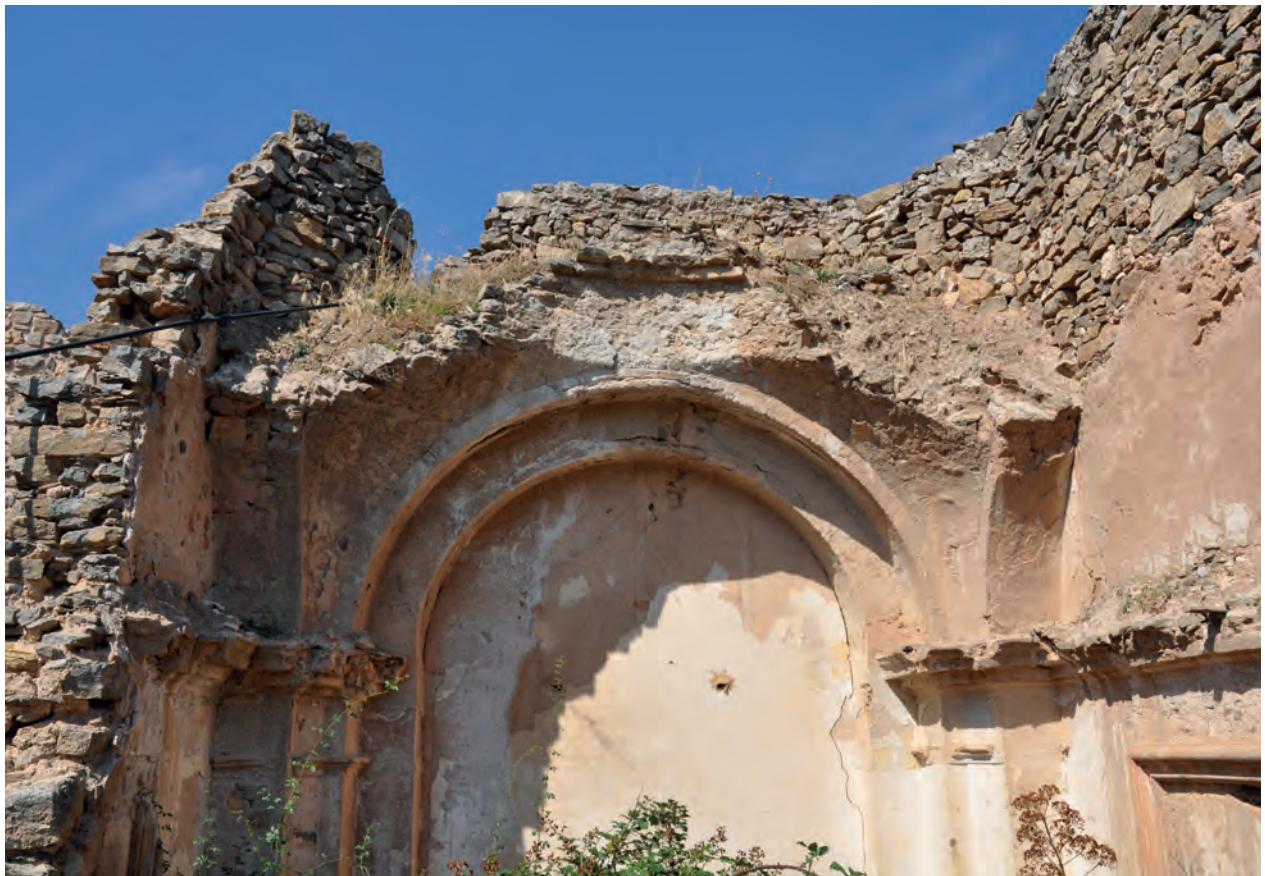
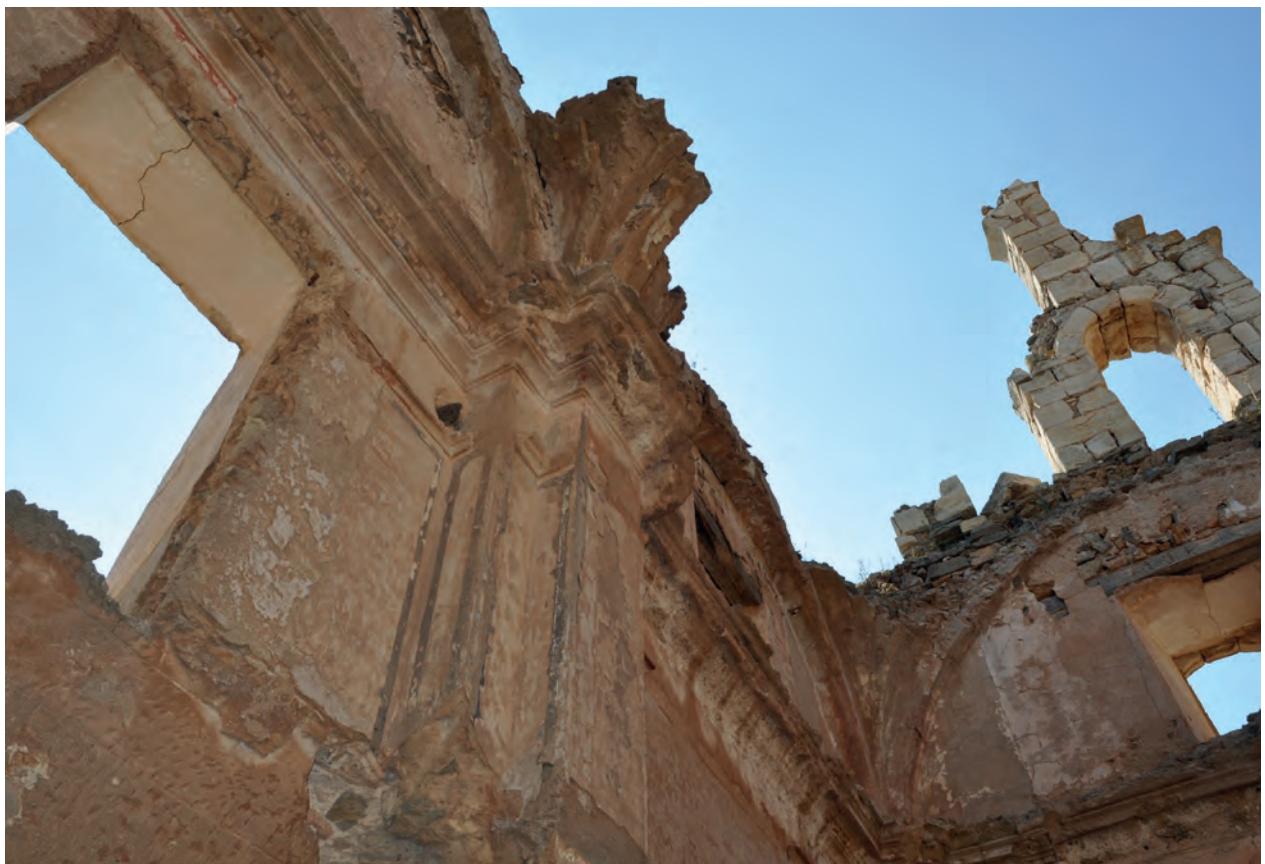
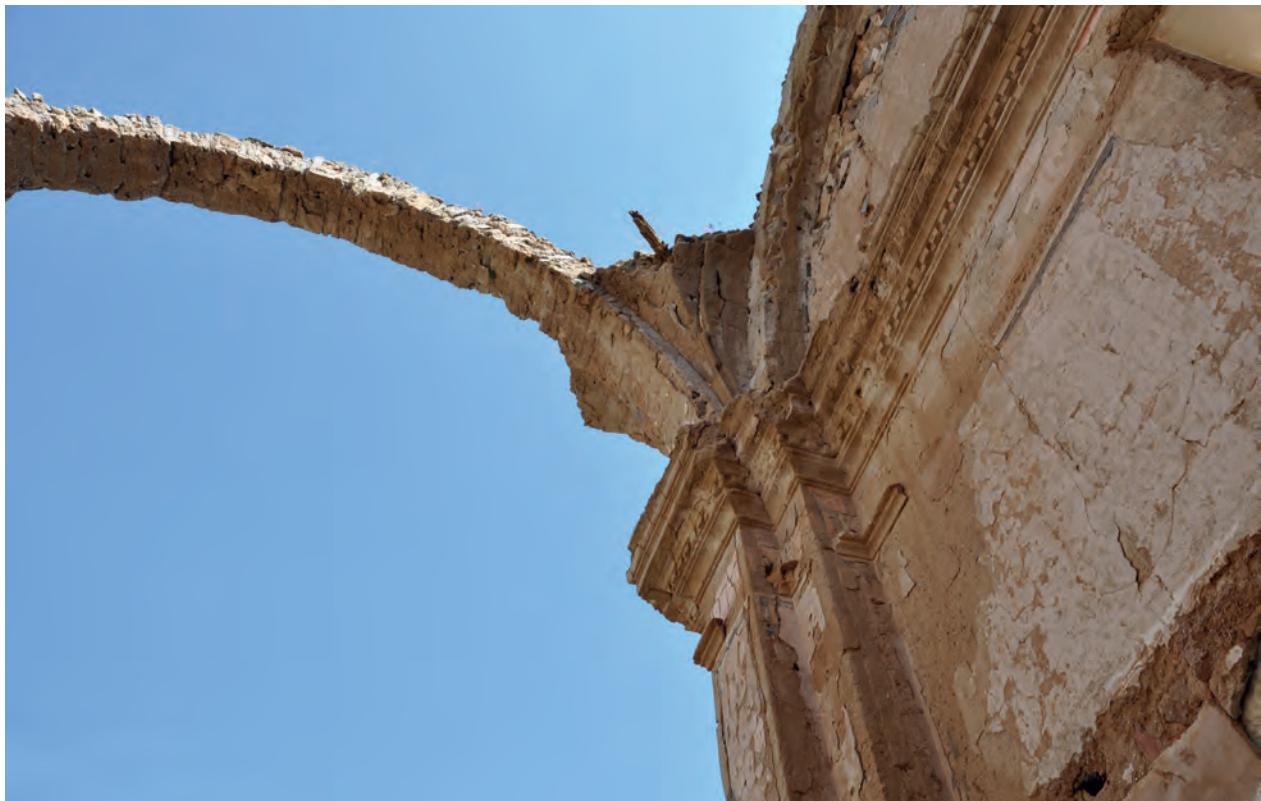
In 1927, it suffered a devastating fire during the 42nd septenary, but it was immediately restored. It is because of the bombings that occurred during the civil war that the building is in this state. Once the roof and some of the enclosing walls of the building have been lost, the rest of the elements that make up the Church suffer continuous deterioration caused by external aggressive agents, such as rain, wind, sun, snow, throughout all this time. and the continued looting of reusable materials by the neighbors.

The lesions found in the building are summarized as follows: humidity by capillarity, loss of interior lining, loss of decorative paintings inside, breakage of interior moldings, dirt on ornamentation, fissures and cracks in lining, loss of section in walls, landslides in different elements, loss of verticality in elements and loss of mortar in ashlar or masonry joints (Barelles & Gimenez 2015).

Within the possibilities of intervention and focusing on the case study of the Church of San Bartolomé, whose level of deterioration is considerable, we have opted for preserving by carrying out the necessary operations on the property, guaranteeing its survival against environmental incidents. and the passage of time. In this way, it is committed to consolidating the structural elements, providing them with greater consistency and solidity, in order to avoid the imminent collapse of some of its parts. Always through the use of materials and techniques compatible with those existing in the building (Gómez de Terreros & Pérez-Prat 2018).
