# Analysis of the failure and remedial measures taken after the collapse of a historical bell

This paper describes the collapse analysis of the historical *El Jaume* bell, cast in 1429, one of the bells in the Cathedral of Valencia's *Micalet* bell tower (Spain). In 1992 the yoke was completely restored and given a new steel axis. The failure occurred when the bells were being rung on Christmas Day 2014, fortunately without any casualties. After several field visits to assess the damage and failure “in situ”, a diagnosis was made of the causes of the failure. The diagnosis was the result of (1) a detailed visual inspection, (2) a metallographic and fractographic analysis of the fractured steel axis, (3) a fatigue damage analysis by finite element modelling software and (4) an estimation of the bell's remaining fatigue life cycle using Whöler S-N curves. In view of the results obtained it was concluded that the fatigue life cycle should have been reached between 300,000 and 400,000 cycles, while the failure occurred at 346,500 cycles. Although these elements are usually designed to not fail during its life, they can sometimes suffer cracks during cyclic ringing. One of the main cau

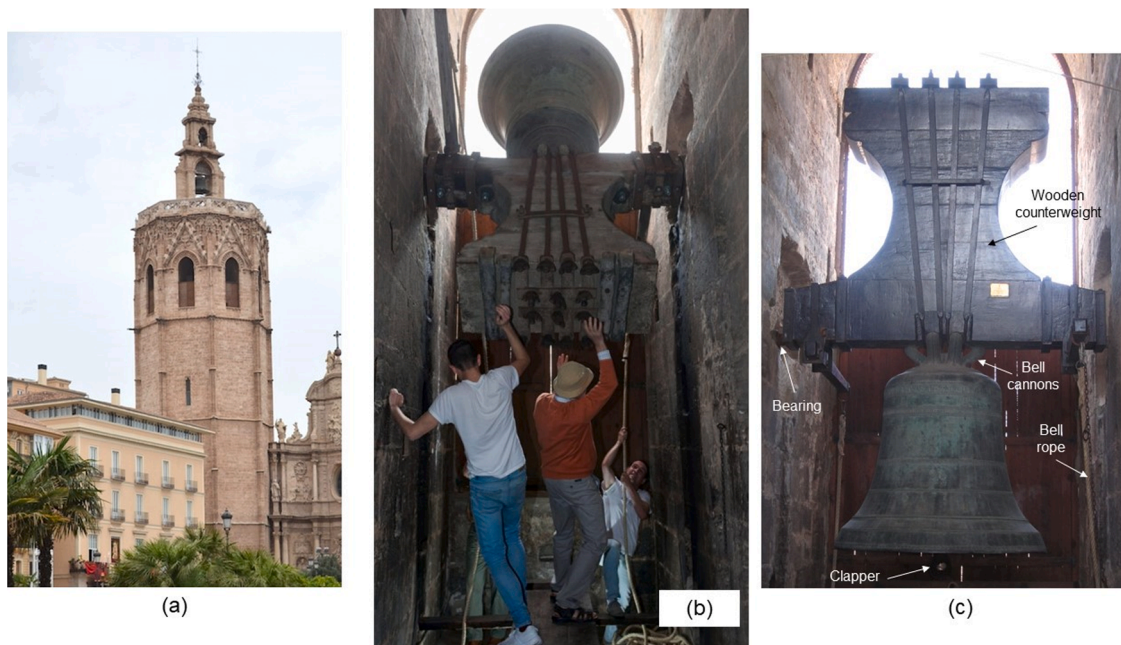
Fig. 1. (a)- *El Micalet* bell tower. (b)- Bell ringers ringing the bell manually (c)- *El Jaume* bell.

On Christmas Day 2014 *El Jaume* bell (Fig. 1c) suddenly collapsed when being rung manually. Due to the bell's famous reputation the news was reported in the national and international media.

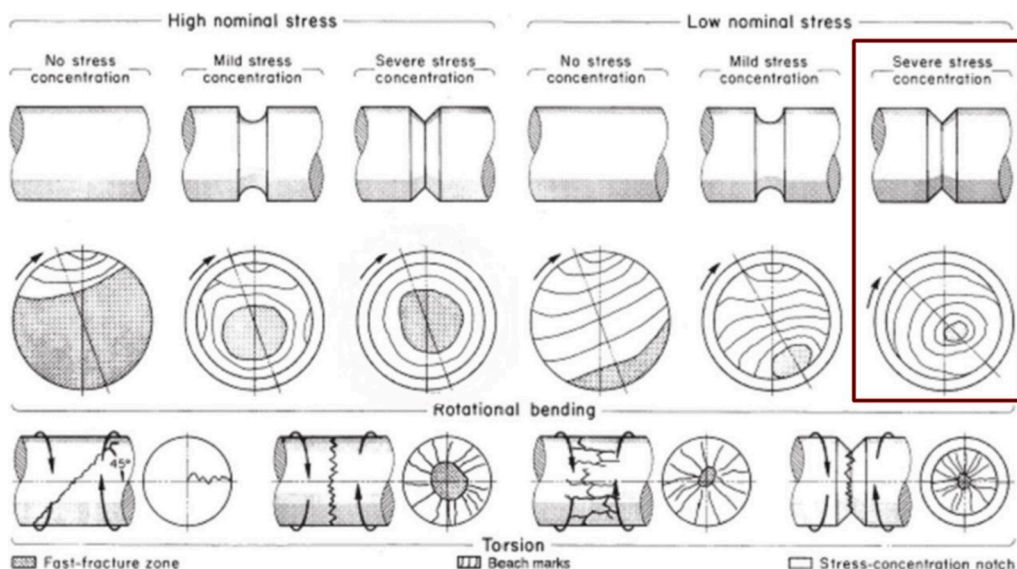
According to [30], this type of failure is typical of a shaft subjected to tension-compression stresses derived from positive-negative bending under low stresses – the bell goes through relatively few revolutions compared to an industrial machinery - but with severe stress concentrations (Fig. 4). Presence of ratchets is another characteristic feature of fatigue failures in rotating bending shafts (Fig. 3).

Fig. 4. Schematics of fatigue fracture surfaces from ASM Metals Handbook [30]. Obtained from [31].

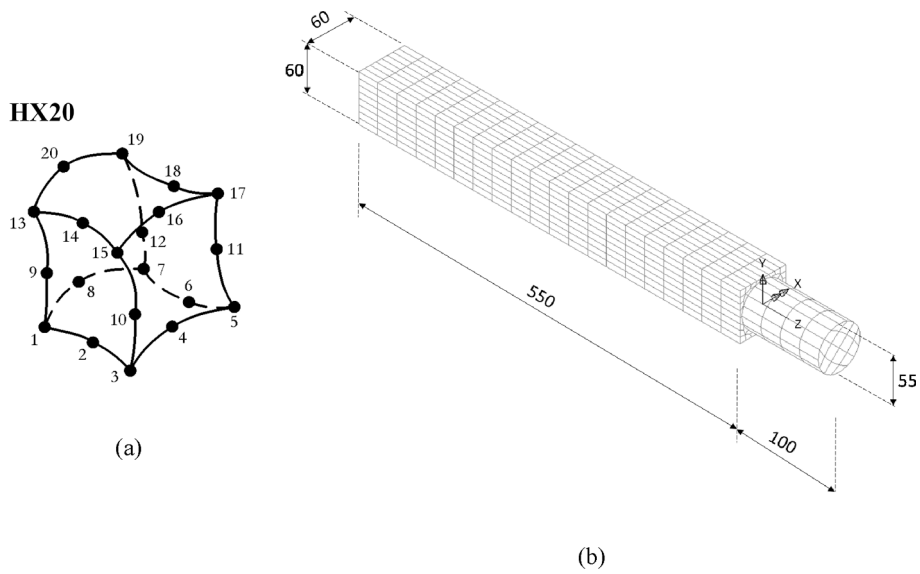
The numerical study was carried out with Lusas software [39]. Steel gudgeon was modelled with hexahedra 3D HX20 solid elements (Fig. 7a). Each of these elements had 20 nodes, each node with three degrees of freedom (Translation along X, Y, Z). For material properties, a conventional steel has been used with a Young's Modulus of 210000 MPa, a Poisson's ratio of 0.3 and a mass density of  $7.8 \cdot 10^{-9} \text{N/mm}^3$ . All the model elements had linear elastic behaviour. The model (Fig. 7b) has a total number of 1344 finite elements.

Fig. 7. (a)- Hexaetra 3D HX20 element. (b)- Finite element model of the steel axis (mm).

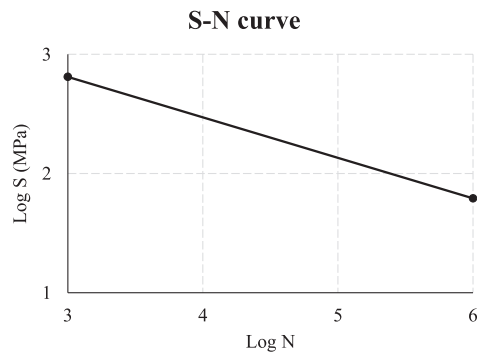
Fig. 8. S-N curve used in a numerical fatigue simulation.

To carry out fatigue analysis using Lusas [39], service conditions and material properties must be defined, i.e. a S-N curve (stress-number of cycles) and fatigue loading spectrum. The fatigue loading spectrum defines the loading sequence in terms of the number of cycles of each load case that are to be applied to the structure. To obtain an estimate of the number of cycles that cause a damage value of 1, the fatigue loading spectrum will be varied until identifying the areas in which the damage value is equal to 1. The SN curve contain the variation in stress values with the number of cycles to failure and are defined on a Log-Log scale. Fig. 8 shows the SN curve used in this analysis. The procedure to obtain it, will be detailed in the following section.

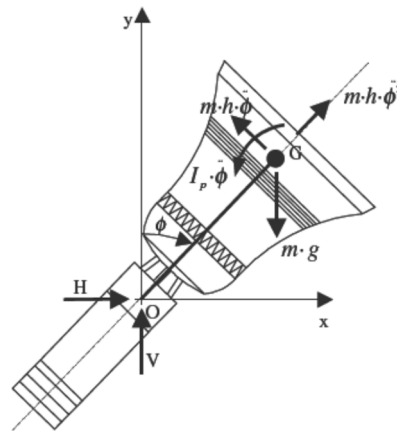
However, as the bell was swinging at an approximate rate of 35 rpm there was a cyclical inversion of tension-compression loading caused by the variation of positive-negative bending generating inertial forces  $H$ ,  $V$  (Fig. 11) that were transmitted directly to the gudgeon, which in turn transmitted them to the tower through the bearings (Fig. 11). The value of these inertial forces depended on the position of the bell's centre of gravity and its rpm. [4] calculated these results adopting maximum values of dynamic amplification of 1.5 for the vertical and 0.4 for the horizontal load, both referring to the bell's self-weight. Taking this into account, the von Mises stress amplitude applied to this critical section due to bending and shear dynamically amplified by the swinging bell was estimated to be around 139 MPa.

Fig. 11. Simplified bell model obtained from [4].

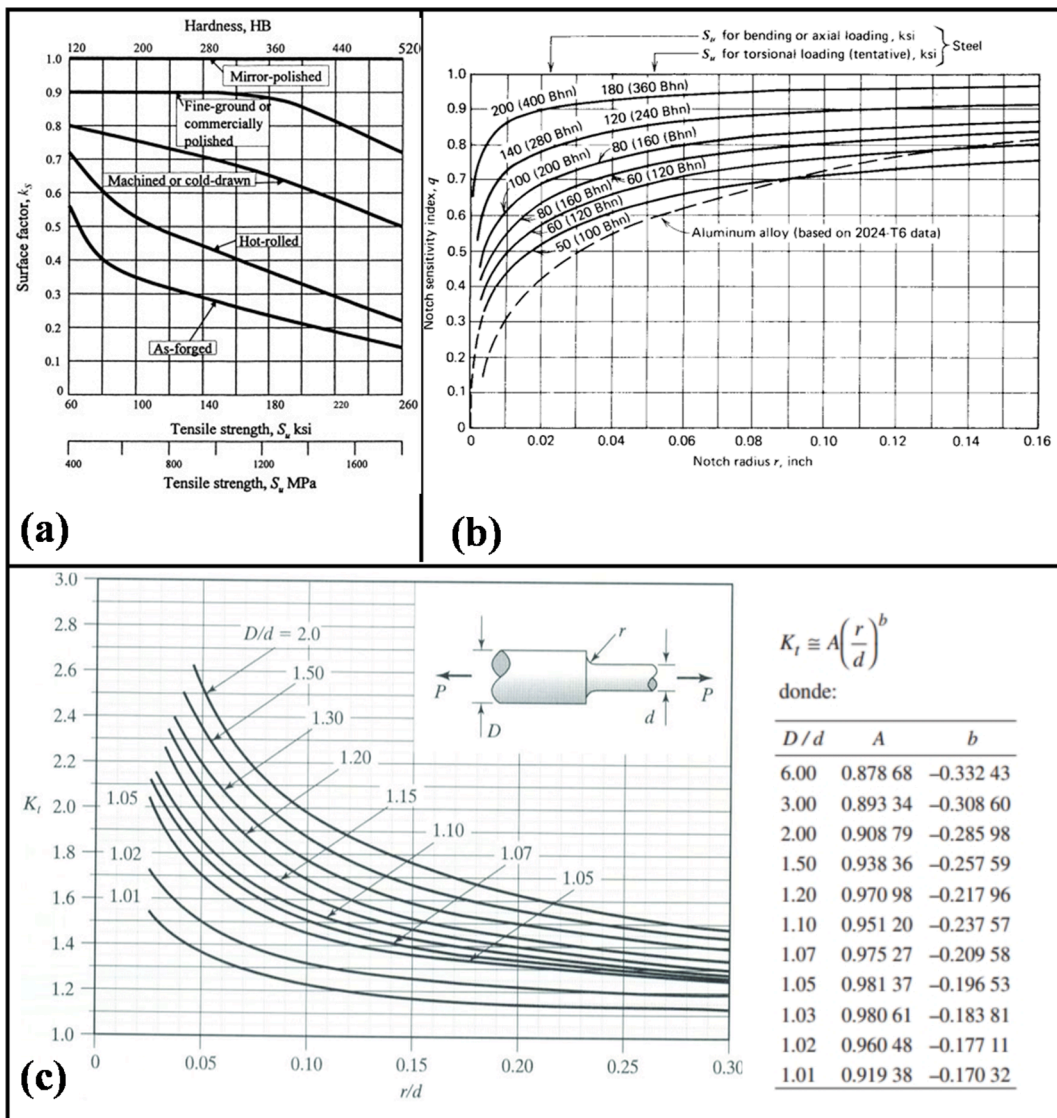
Fig. 12. Sensitivity factors to obtain fatigue stress. (a) Surface factors for various finishes on steel. [41,43] (b) Fatigue notch sensitivity curves for bending and axial loads, torsion [41,42] (c) Evaluation of the stress concentrator coefficient on a shaft subjected to bending [24].

fatigue crack initiation. Referring to the results published in [24,41], the surface roughness factor of 0.9 (Fig. 12a) can be obtained.

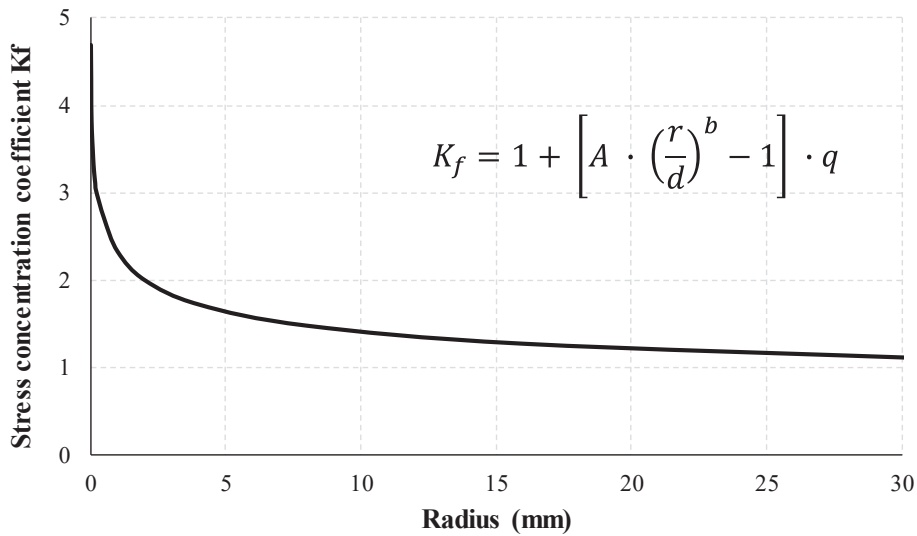
Fig. 13. Evolution of notch coefficient as a function transition radius.
