## THE REFURBISHING OF THE BROTHERHOOD HOUSE AT SANTA LUCIA'S HERMITAGE

TITULACIÓN:  
GRADO EN ARQUITECTURA TÉCNICA

ESTUDIANTE:  
ELENA SERRA GARCÍA

FECHA DE PRESENTACIÓN:  
JULIO 2013

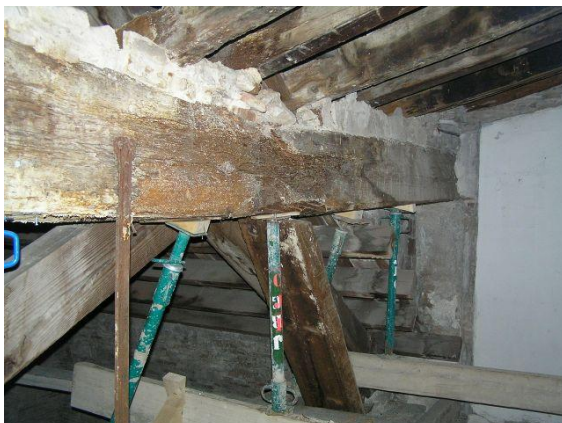
Picture 134. Former wood beam struted <sup>(44)</sup>

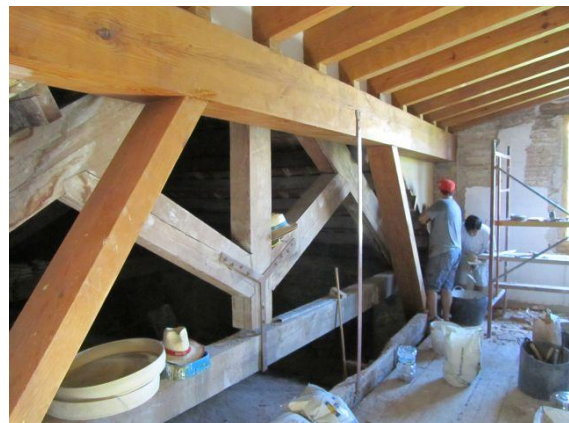
Picture 135. New wood beam <sup>(45)</sup>

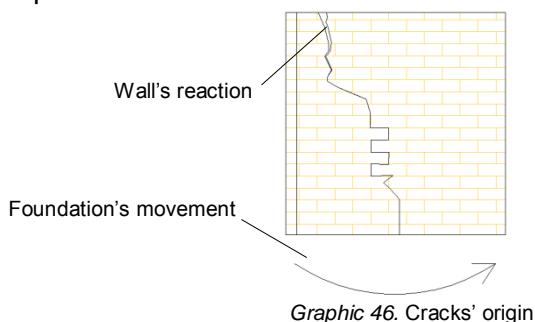
Graphic 46. Cracks' origin

**Pathology definition:** as it can be appreciated, the crack increases their thickness just as it ascends, this is to say, it diminishes its section in the lowest part. It can be also seen how the crack starts very close to the pillar and moves away in a diagonal sense when it descends. This is due to a building movement in the opposite direction.

On knowing a water line crosses the Hermitage underground, it is very possible that the building settlement comes from the foundations, because they may have been affected by the waterline.

In the pictures it can be observed how the cracks have originated a lack of joints between the bricks. Furthermore, the appearance of the cracks has also cause the loosening of the covering material around the area.

The lesion long term consequences depend on the cracks state: if they are still alive, it would be necessary to reinforce the foundations in order not to aggravate the situation; if the crack isn't alive, there wouldn't be an important incidence

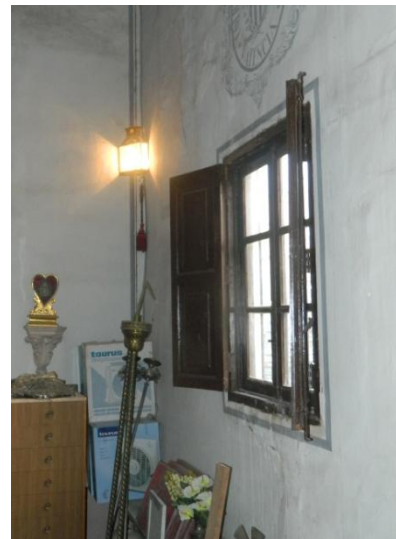
Picture 146. Interior window sight

**Pathology definition:** as it can be observed in the pictures, the cracks just appear under the window in vertical sense. Therefore, as there are no more cracks in the whole window outline, it can be suspected that the vertical cracks are caused by the dampness, which may have filtered by the windowsill.

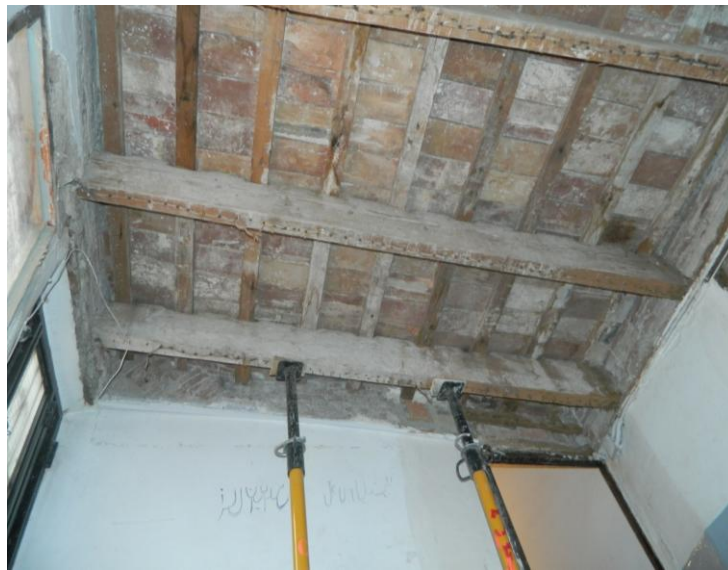
Picture 147. Wood beam strutted

**Location:** floor structure located over the stairs to access to the first floor from the ground floor.

**Pathology definition:** as it can be seen in the pictures, the wood joists have experienced a clear reduction of flexural strength, because after being repaired, it's still necessary to strut one of them. This may be caused because the wood beams section wasn't the appropriate one for supporting the weigh over them. Besides, they have suffered a weakness after the dampness filtration, because over the wood floor structure is placed a shed roof. There would be recommendable to check the woods heads as well, in order to study their state.

This pathology may cause in long term the structural framework collapse if the beams don't get fixed.

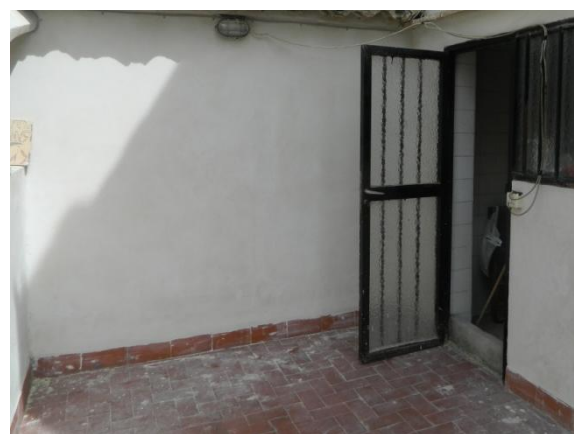
Picture 152. Passable plain roof where the filtration is produced

**Pathology definition:** as it can be seen in the pictures, the room has severe problems because of the filtration dampness. This filtration has been produced through the passable plain roof located over the room. In order to determinate the causes if the filtration, it would be necessary to make a roof study.

At long term, the dampness may cause healthiness and durability problems (painting bubbles, loosening of mortar fillings and even structural damages) in the constructive elements.

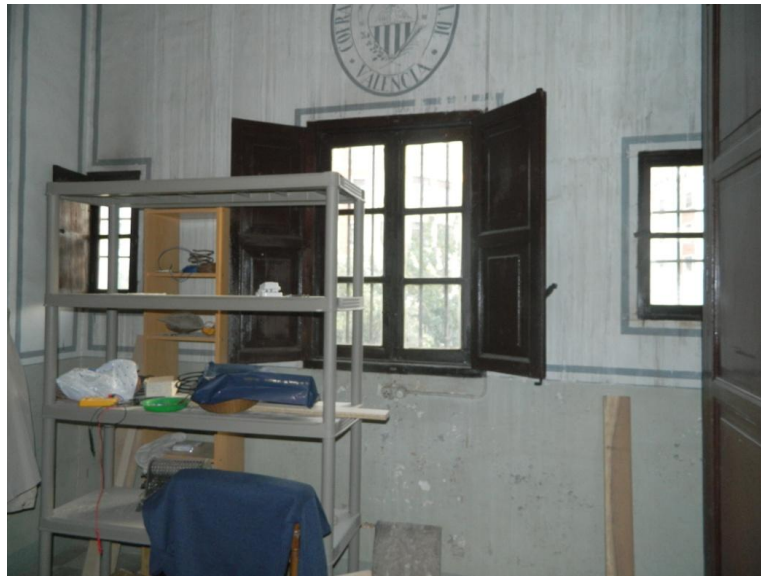
Picture 153. Vertical surface cleanings

**Location:** vertical surface of the *Former Meeting Room*, in the second floor of the Hermitage House. .

Although apparently this lesion may not seem very prejudicial, sometimes, when the water speed is very slow it can be associated to concretions or calcareous deposits.

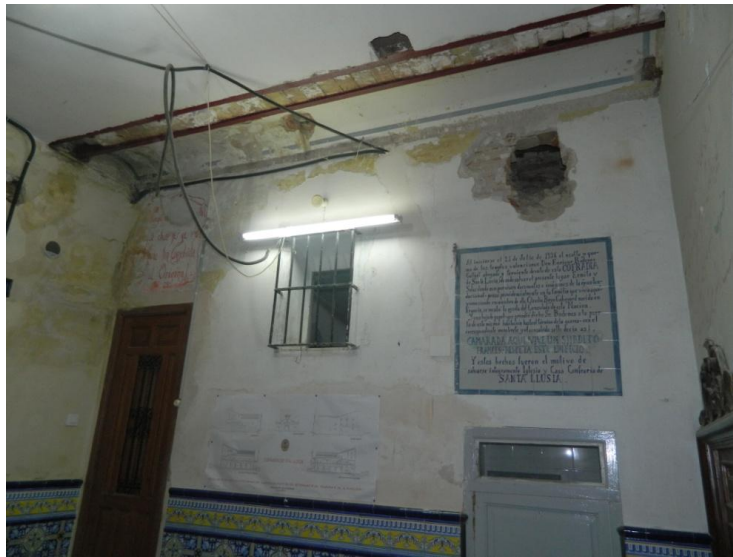
Picture 156. Inappropriate elements and mutilations

**Location:** room whose access is placed on the lateral right door of the main façade.

On the other hand, there're also appreciated mutilations in the brick wall and the ceiling, where a violent pull up of the material has been produced. These wrongful mutilations are a cause of the omission of the modern techniques to make exploration test, such as the boroscope.

In the case of the brick wall, the mutilation has also provoked a loosening of the covering material around the hole.

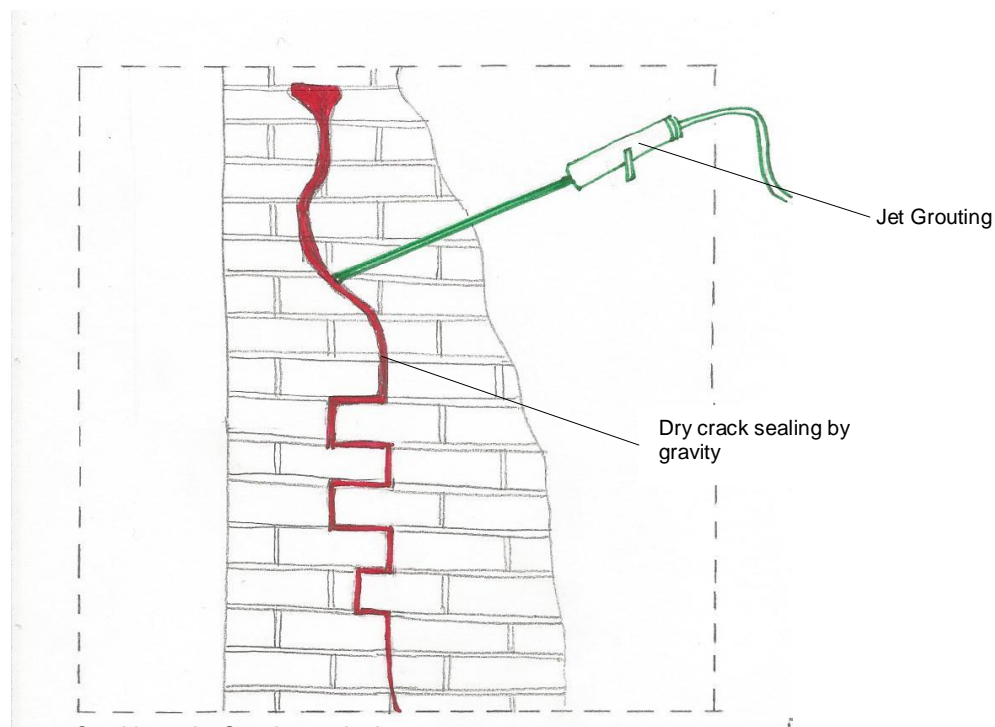
Graphic 49. Jet Grouting method

**Intervention proposal:** The testers that were positioned have proved no expansion of the crack width over time..Therefore it can be concluded that the soil and foundations are properly settled down, and they are not affecting the structural elements.

So the intervention will be reduced to a cracks sealing task, filling them by applying the same natural mortars as the existing ones (rigid sealing) by gravity with the *Jet Grouting* method

**Intervention:** the affected areas in the entire thickness of the crack will be cleaned by applying compress air and pressuring water. Previously, there will be made the corresponding X-lightning diffraction essays, as well as other laboratory essays that will determine the existent mortar and paste's physical and chemical properties. Finally, the surface will be painted using the same color tones as the rest of the corridor has.

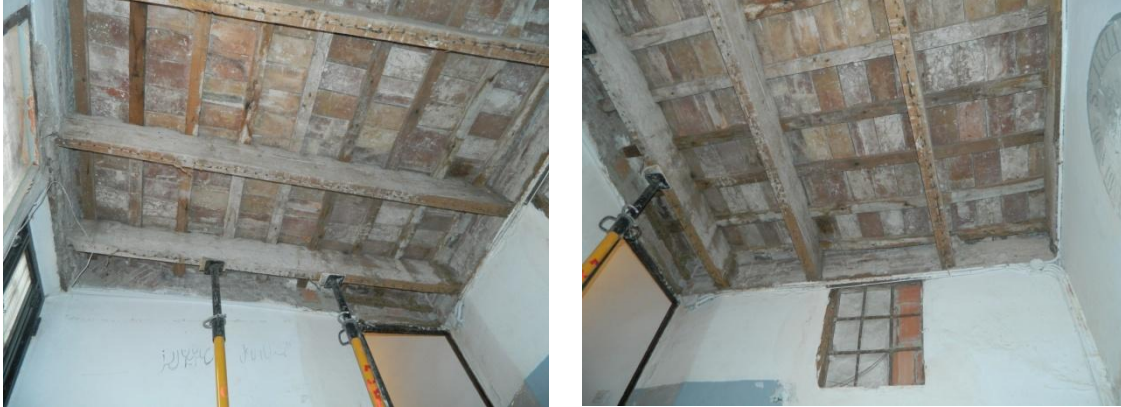
Picture 157 and 158. Different views from the floor structure.

The first element to be fixed is the floor structure which covers de Access to the first floor. This element is composed by three wood beams fixed into the solid brick wall. After checking with a punch the drive length in order to verify the wood's state, the conclusion to arrive is the following one: the beams have lost a great part of their structural strength and show some rotting signs in their heads-ends.

First of all, the floor below ought to be strutted in the working area. The replacement beam will be a laminate wood beam with the dimensions 250x20x10 cm. Once this new beam is in the working place, the supporting area of the changing beam will have to be strutted as well, by putting a shoring up board in the ceiling. The changing beam will have also three supports: one in the center and two in the opposite sides.

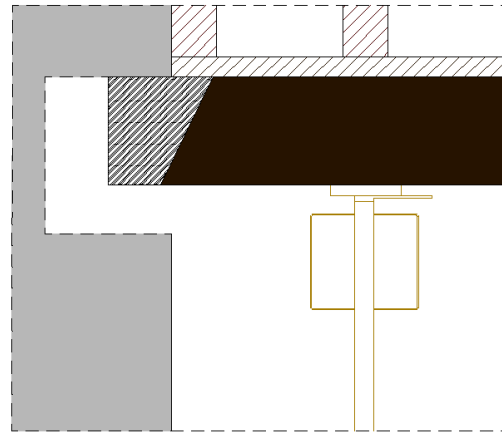
Graphic 65. Rotten beam head to be cut

First of all, the two opposite sides of the beam will have to be strutted, having in mind they are placed over the stairs. The next step will be the saw of the rotten part. Previously, it will have necessary to perforate the wall enough so it can be possible to work comfortably.

Right after, in the cut side are introduces some fiberglass ribs with epoxy resins, forming from 25° to 30° with the horizontal plan.

The following step is the elaboration of a formwork in the beam in order to be able to spill lately the epoxy resins with silica sand load, which will proportion the new beam head with dark brown color, simulating the wood.
