PREVIOUS STUDY AND REHABILITATION OF A BUILDING

Jennifer Aroca Alarcón

June 2013

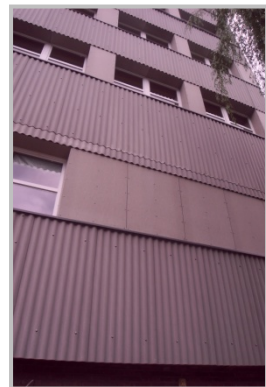
Photography 1

- Enclosure finished with fibre corrugated plates: large part of the façade is made with this kind. It is comprised of Aerated concrete block 24 cm, 10cm mineral wool, fiber cement plates 125 x 250 x 0,6 cm on wood slats with cross section 5 x 6cm. and protective varnish finish

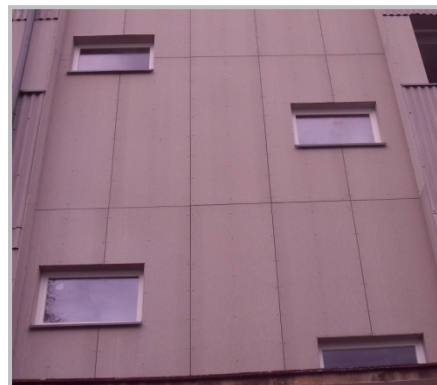
Photography 2

- Enclosure finish with smooth plates bolted: Part of the facade and the facade of the staircase is made with this type. The layers that comprise this kind is the same as above constructive solution but the finish is solved with smooth panels.

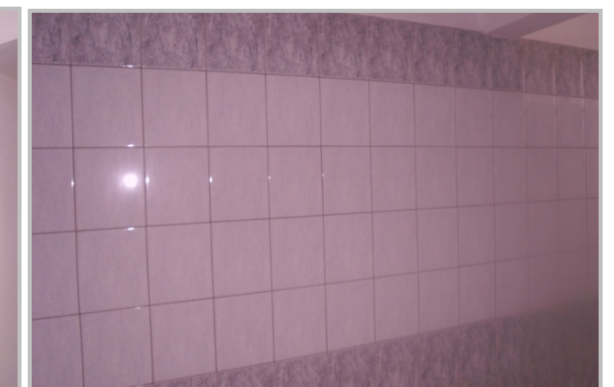
Photography 7. Ceramic tiles of a wetland

Partitions of wetlands are solved in the same way but with ceramic tiles finish (*Photography 7*)

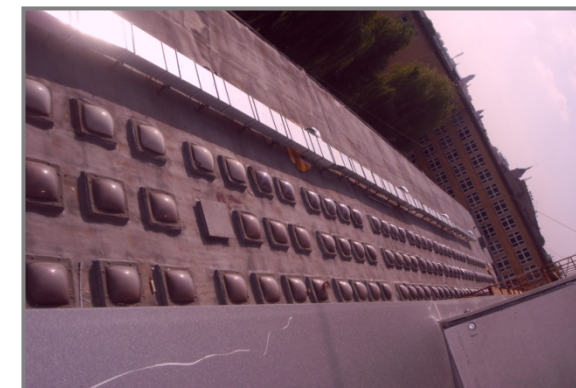
Photography 9. Photo of second floor

It is a sloping roof. Water evacuation is solved by a hidden gutter that runs the entire length (the longer side) of the deck. (Photography 9)

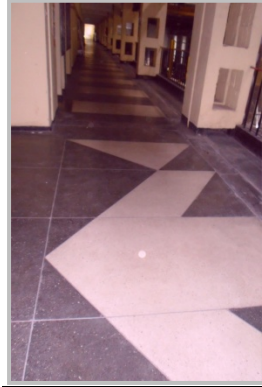
Photography 10.
Photo corridor of
first floor

The majority of the pavement in this building is terrazzo. (concrete mixture with marble grits). This pavement gets executed in situ. The advantage

is that It can be made on site and it doesn't have a factory preset shape. It Can be adapted to any area. (Photography 9)

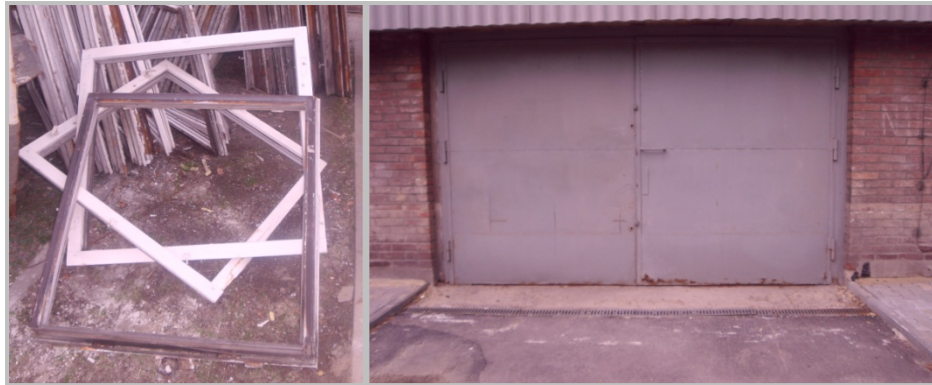
- Outdoor: The windows are mostly wood, except for the stairwell, that are large single glazed steel windows. Photography 20
The doors in technology areas and garage are of stainless. Photography 21

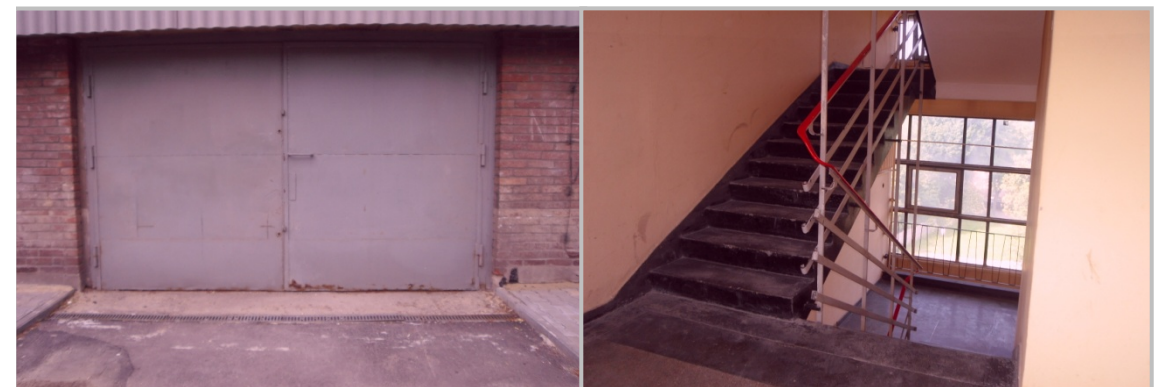
Photography 28. North elevation

Photography 29. Interior stairs.

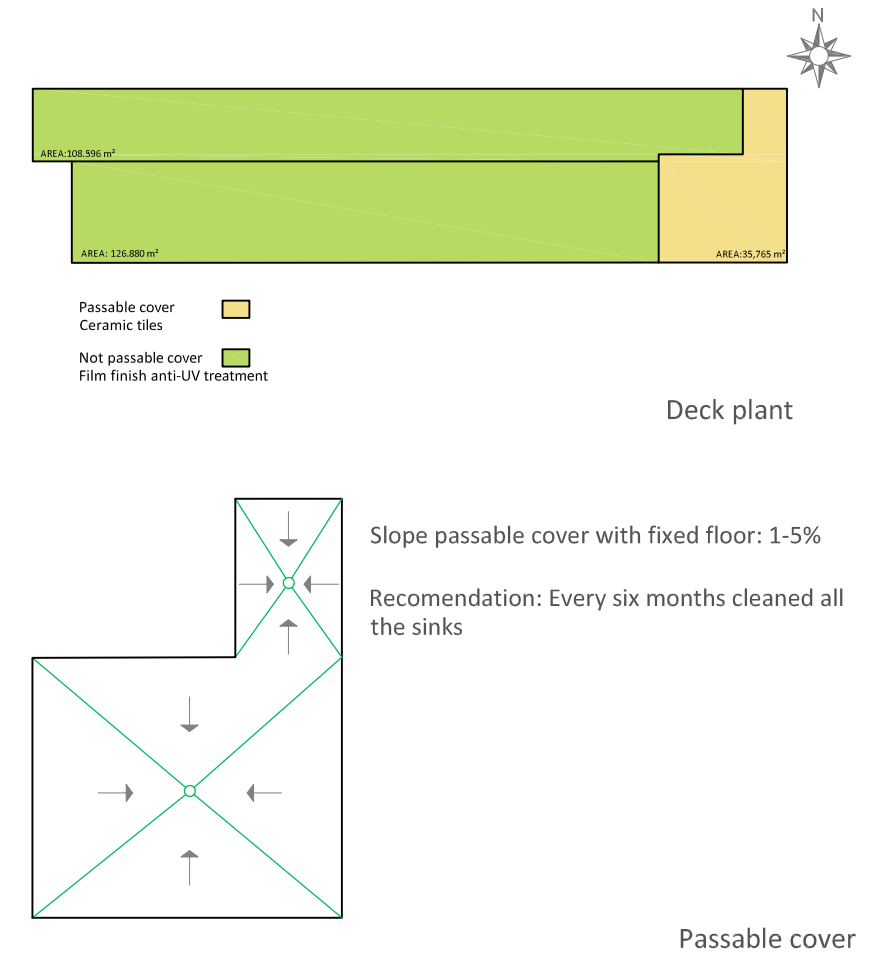
Passable cover

DESCRIPTION: Humidity in two different areas on the top floor of the building. Heating in the deck, It doesn't comply with thermal conditions

Increasing the thickness of polyurethane insulation 10cm $U = 0,23 \text{ W / m}^2 \text{ K}$

- Remove layers from the deck to reach the wrought
- Rerunning all the layers (detail 1) placing another sump.

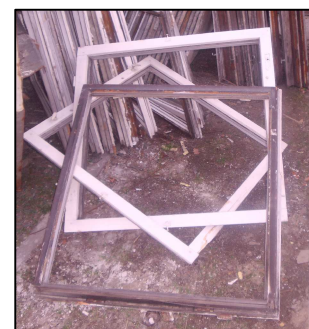
DESCRIPTION: Most of window frames is deteriorated. The window fittings are rusted. The windows of the staircase are made of steel and are oxidized.

Because of the weather ,they are continuously exposed to rain, snow ..

Change affected window frames and replace PVC windows and change the window sill too.

By aesthetics of the building and to avoid future problems with window frames, recommended to change all the woodwork of the building

The windows will be of PVC material and soundproofing of 40 dB

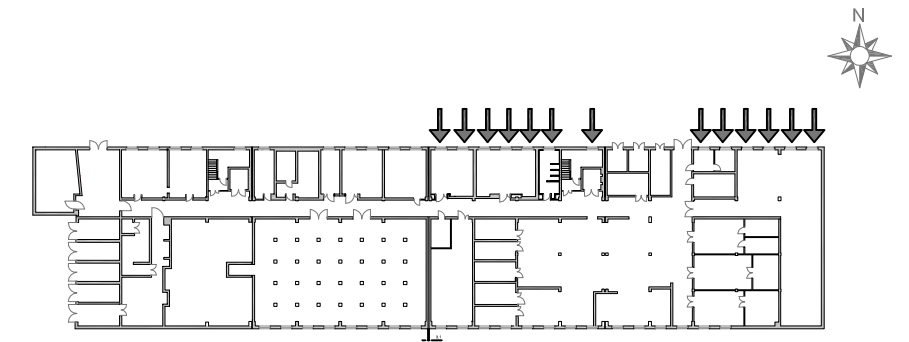
basement

➔ Rusty windows

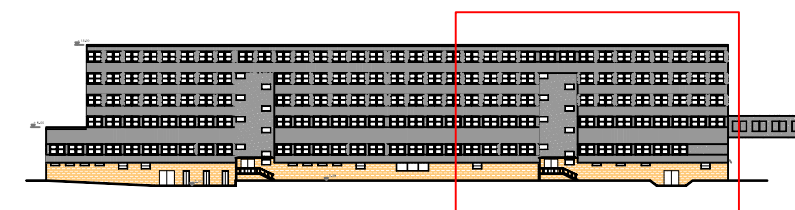
North

DESCRIPTION: Damp in most of the facade of the building, at the bottom. observed deterioration of elements, efflorescences and coatings

- Very porous wall material
- Too much water in the subsoil because of ground water table
- Saturation field rainwater
- Water facilities breakage or deteriorated (pathology 4)

1. The steps to intervene successfully on this pathology are:
 - Remove of the whole coating by chopping the entire affected area.
 - Clean all the support by sandblasting.
 - Be placed on electro-osmosis system by pulses of resonance.
 - Coat the entire surface with a special mortar microporous
 - Take the initial state of the facade.

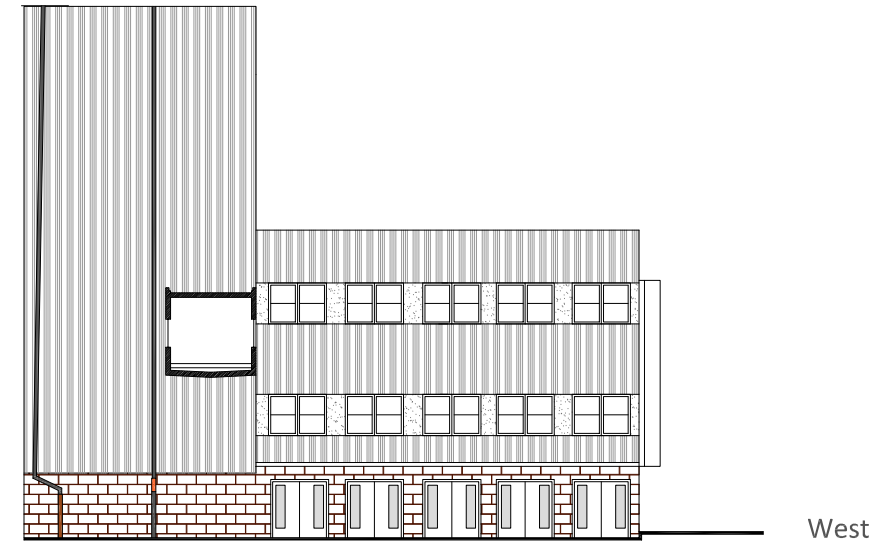
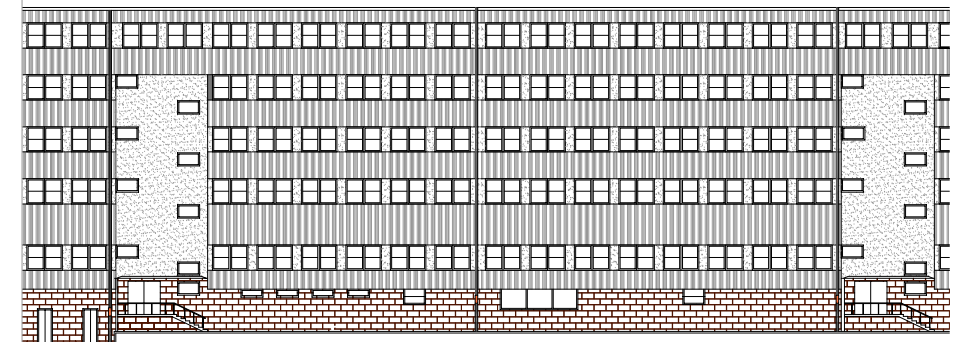
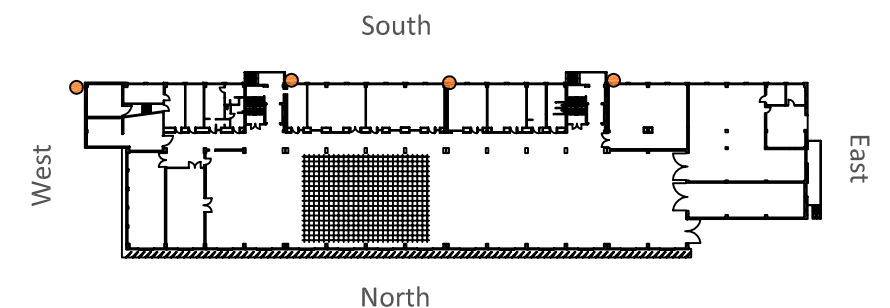
● Situation of pipes

Change all downpipes and replace the entire system

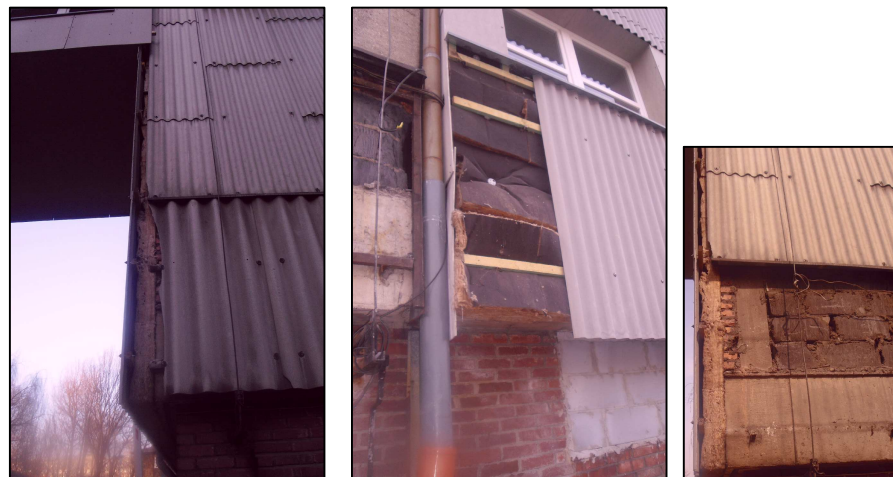
DESCRIPTION: With step the years cement fibre corrugated plates have been deteriorated, leaving the interior discovered. Also all the facade does not comply with the thermal conditions. Global warming.

Given that the facade finished with fibre corrugated plates and with smooth plates bolted does not meet regulations regarding thermal transmittance and is generally in very poor condition. The recommendation would be to change the entire facade increased insulation rockwool and complying with:

Regulation: $U = 0,30 \text{ W / m}^2$

Increasing the thickness of rockwool 14cm $U = 0,29 \text{ W / m}^2 \text{ K}$

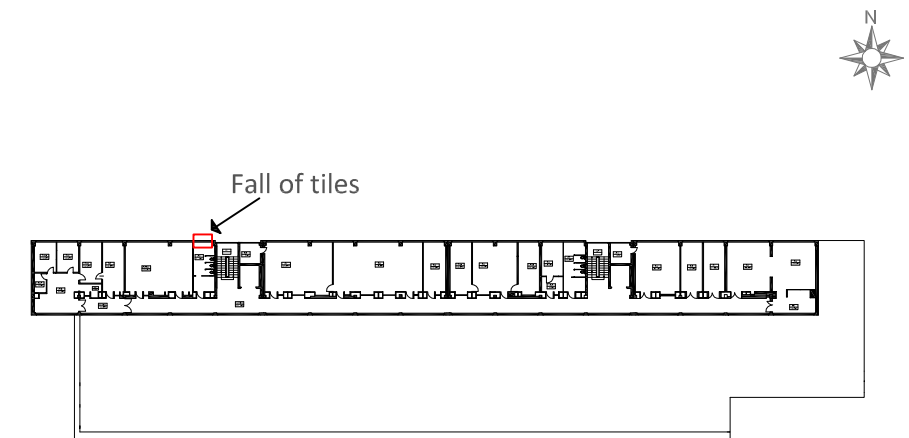
DESCRIPTION: Some tiles have fallen and others are bulging. The pathology is in a wet area of the building

- Moisture
- Poor quality plaster
- Tile placement without prior wetting
- Insufficient plaster layer
- Exposure to high temperatures because there are close to a radiator

1. The steps to intervene successfully on this pathology are:
 - Removing the tiles bulging
 - Remove the layer of plaster
 - Clean the surface
 - Applying plaster of good quality
 - Placement the tiles wetting

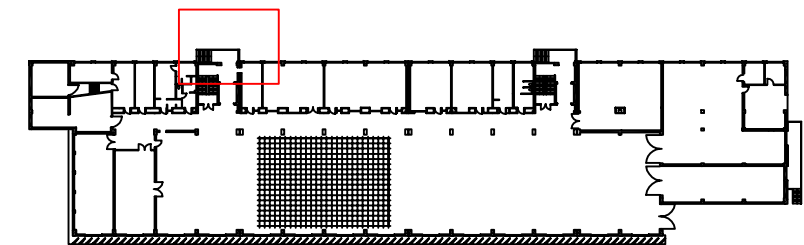
DESCRIPTION: Stairs deteriorated by weatherproof. Observe detachment of concrete remaining sight and rusty armour

- Missing armor coating
- Lack of maintenance of concrete
- Corrosion of reinforcements
- Concrete surface without treatment. Observed pilling and oxidized armor in sight
- Abruption of concrete (coating)
- Insufficient vibrated concrete which has produced voids and detachments
- Elevated foot traffic
- Impact on the steps
- Use low strength concrete.

1. The steps to intervene successfully on this pathology are:

- 1- Substrate preparation: for the corrosion steel, clean it with sandblasted
 - 2- Corrosion protection for exposed reinforcement: it comes to apply a dry mortan, comprising high-grade cement, aggregate plus additives, mixed with water. It provides durable protection against corrosion
 - 3- Application of bonding layer: The cementitious Sopro Repadur mortar bonding layer
 - 4- Ensures good adhesion : Apply cementitious, fibre-reinforced. The repair mortar is applied wet-on-wet to the slurry in 1 to 5cm thick coat.
 - 5- Final surface finishing: Sopro Repadur 5 fine PCC concrete filler is used to fill pores and blowholes and to prepare substrate for paint systems or other coatings. The filler may be applied in coats up to 5 mm thick.
- Following post the whole staircase formwork
 - Return to be concreted the areas where lost concrete section

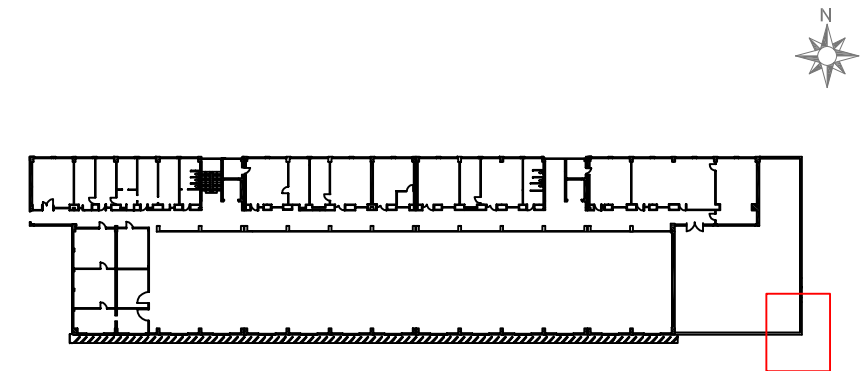
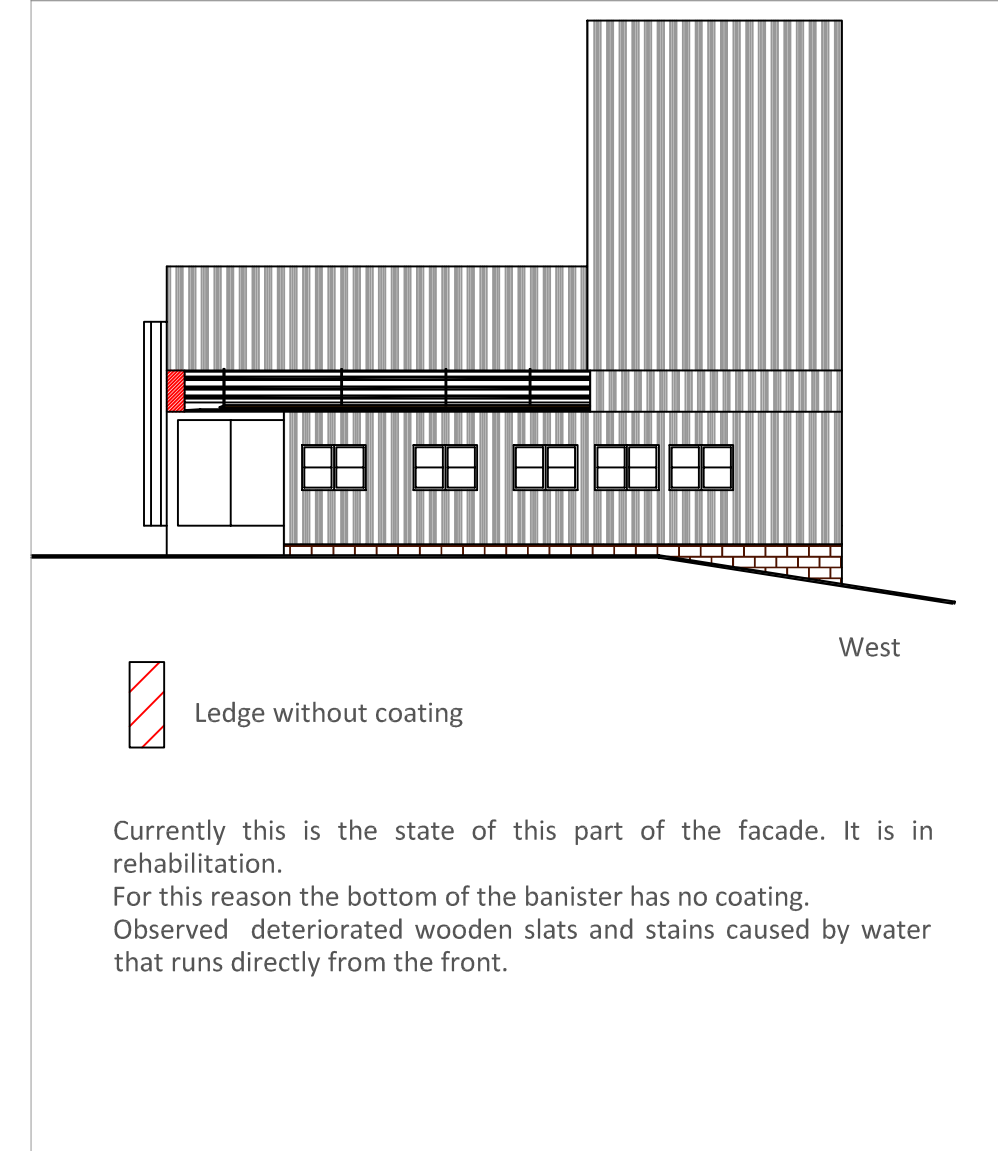
DESCRIPTION: Part of the facade without a coating (cement fibre corrugated plates) . Railings in disrepair, it doesn't comply safety conditions. It is made with painted wood and steel. The steel has oxidized some parts. Cover water flows directly by the facade causing leaks

- Probably the cement fibre corrugated plates has been withdrawn for safety reasons (perhaps was loose)
- On the other hand, the cover hasn't vertical height and don't formed ledge so for this reason the water falls directly from the front facade and producing by filtration humidities

1. The steps to intervene successfully on this pathology are:
 - Remove cement fibre corrugated plates affected and the rockwool.
- * According with the intervention performed in the pathology 5

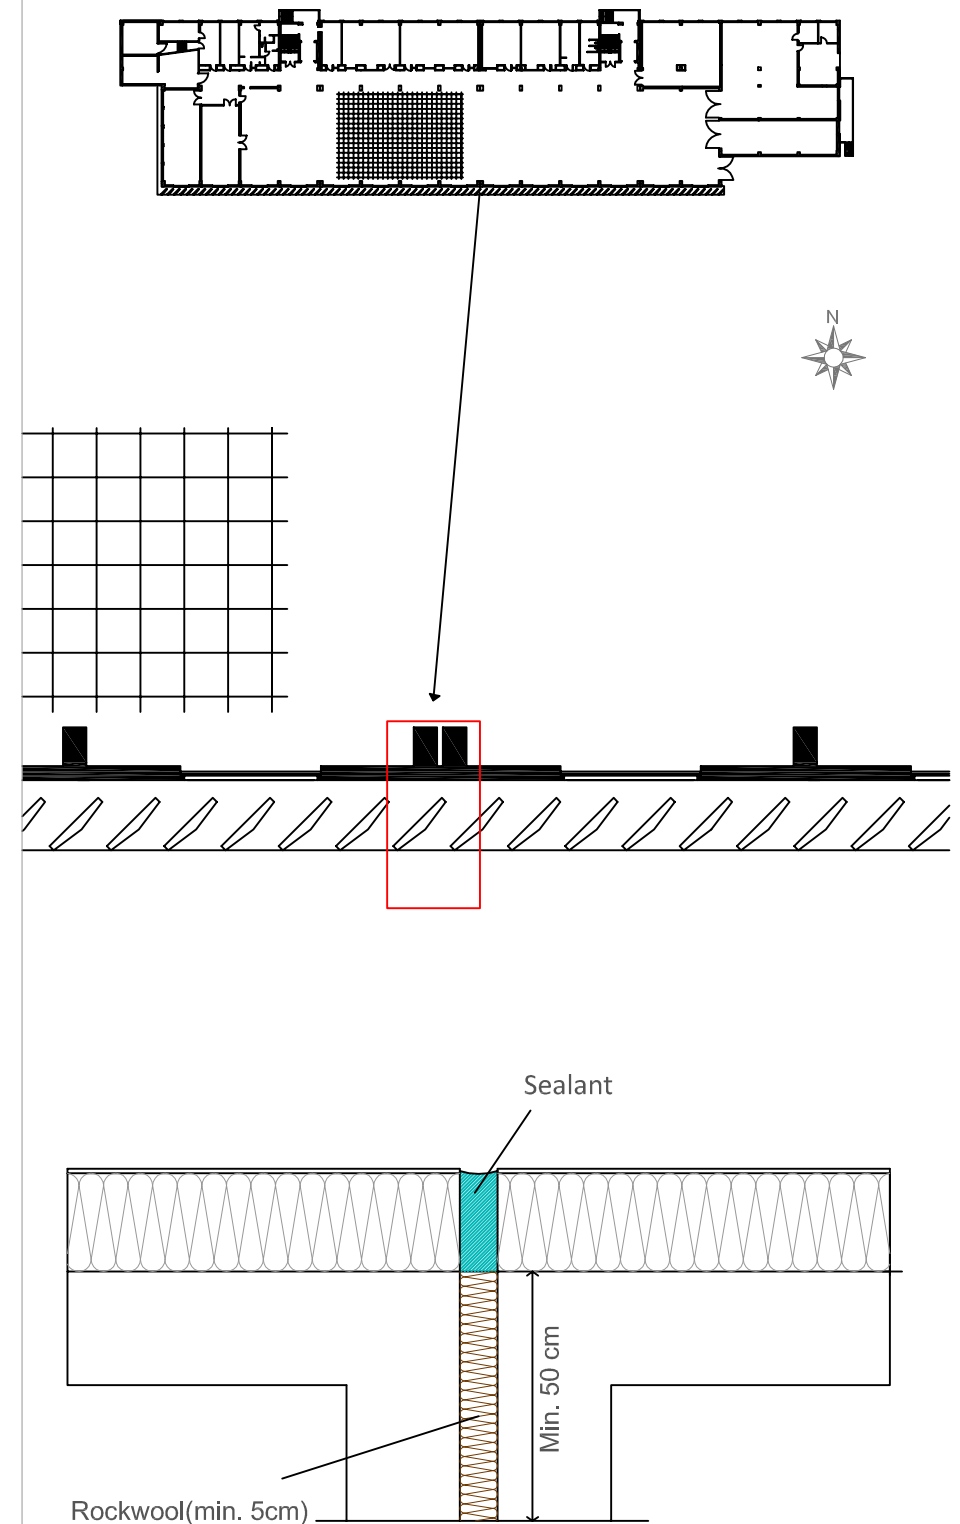
DESCRIPTION: Expansion joint is dirty and has moisture around. The mineral wool also is not constant along its length. It hasn't sealant, so air and moisture can enter into the joint.

The expansion joint aims to absorb the movements of expansion or contraction due to temperature variations. It should be sealed with elastic fillers that are resistant to mechanical damage and chemical products. It must be impermeable and resistant to atmospheric agents.

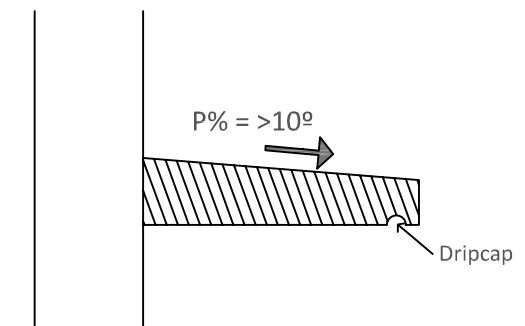
South

DESCRIPTION: Concrete facade outgoing where there are water stains, chipping, concrete disintegrations even formation of mold on the surface.

- Water stagnates resulting moisture and oxidation.
- No dripcap at the bottom, which causes the water to run directly by the slab
- Concrete surface without treatment. Observed pilling
- Insufficient vibrated concrete which has produced voids and detachments
- Lack of maintenance of concrete
- Slope insufficient outward which causes the water is stagnant

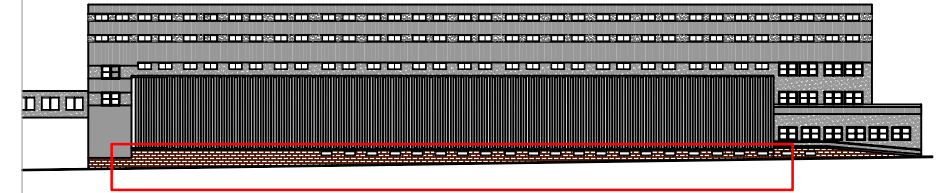
DESCRIPTION: Poor choice of water drainage method. placing a sink for landscaped deck with holes to evacuate water from the perforations in the sump. But when it rains the water is not drained properly and remains in the ground causing it to be wet. That moisture passes into producing more moisture facade.

1. The steps to intervene successfully on this pathology are:
 - Remove all lands that are observed.
 - Change the drainage method.
 - Place a water collection gutter in the middle of the street with a slope to evacuate the water and it doesn't touch the front of the building

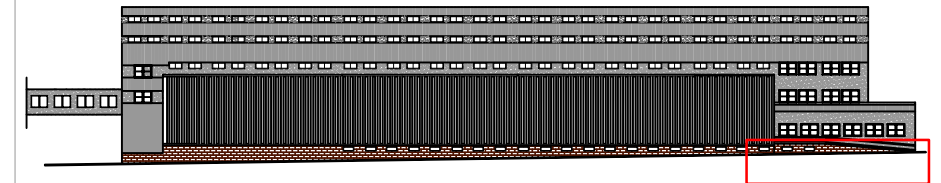
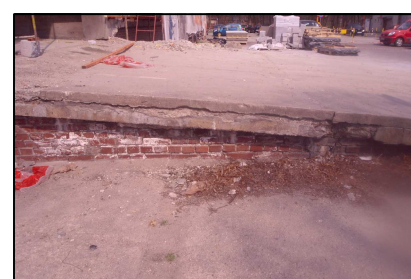
DESCRIPTION: There are lack of uniformity in rolling layer and there is a layer slip. It can be observed rust problems, disaggregation of concrete and efflorescences

- The surface wear is produced by mechanical action due to foot traffic, ordinary vehicles, commercial vehicles and the water that carries suspended particles. Observed disaggregation of the concrete
- Small differential settlement
- Lack of maintenance of concrete
- Concrete surface without treatment. Observed pilling and oxidized armor in sight
- Abruption of concrete (coating)
- Insufficient vibrated concrete which has produced voids and detachments
- Use low strength concrete.

The steps to intervene successfully on this pathology are similar to the intervention of the pathology 7:

- 1- Substrate preparation: for the corrosion steel, clean it with sandblasted
 - 2- Corrosion protection for exposed reinforcement: it comes to apply a dry mortar, comprising high-grade cement, aggregate plus additives, mixed with water. It provides durable protection against corrosion

- 3- Application of bonding layer: The cementitious Sopro Repadur mortar bonding layer
 - 4- Ensures good adhesion : Apply cementitious, fibre-reinforced. The repair mortar is applied wet-on-wet to the slurry in 1 to 5cm thick coat.

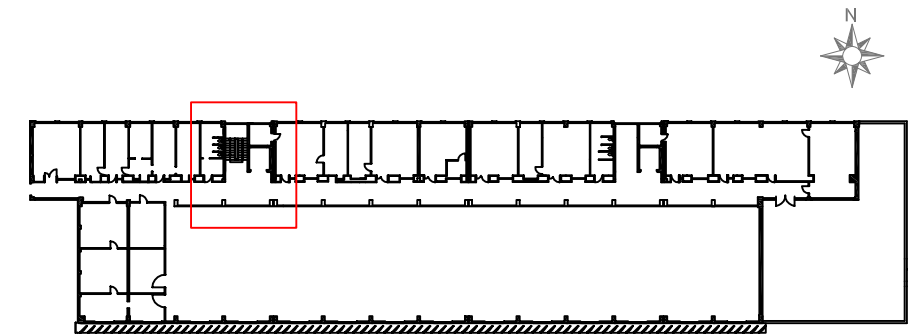
First Floor

DESCRIPTION: Observed fissures and cracks in different directions of the pavement. Terrazzo is positioned "in site" It isn't made up of tiles of a given size. They are unspecified dimensions plates with joints therebetween

- Absence of dosing mortar 1:6 that makes sharing mortar in order to distribute pressures and level the ground
- Joints insufficient or excessive plate dimensions
- Weakness of the flooring material.
- Errors in adherence with the support.
- Insufficient flexural strength of the tiles (not to be less than 150kp/cm²)
- Lack of continuity and strength of the layer.
- Uneven distribution layer.
- Mechanical erosions produced by the friction of use, since the pavement is in an area of passage and very busy.
- Linear cracks caused by tensile stresses to shrink the pavement.

At the moment is not very serious pathologies, but if the cracks increase the best solution would be the removal of all the affected flooring and replace it by taking various precautions:

- Lift the entire affected and corresponding pavement layers up to the slab.
- Resume all layers.
- Placement Print impact resistant
- Placing concrete leveling for surface leveling.
- 2cm of crushed sand.
- Mortar cement terrazzo gripping.
- Placement terrazzo pavement, paying extreme care to the execution of the joints. The marble floor has to be special for high traffic.

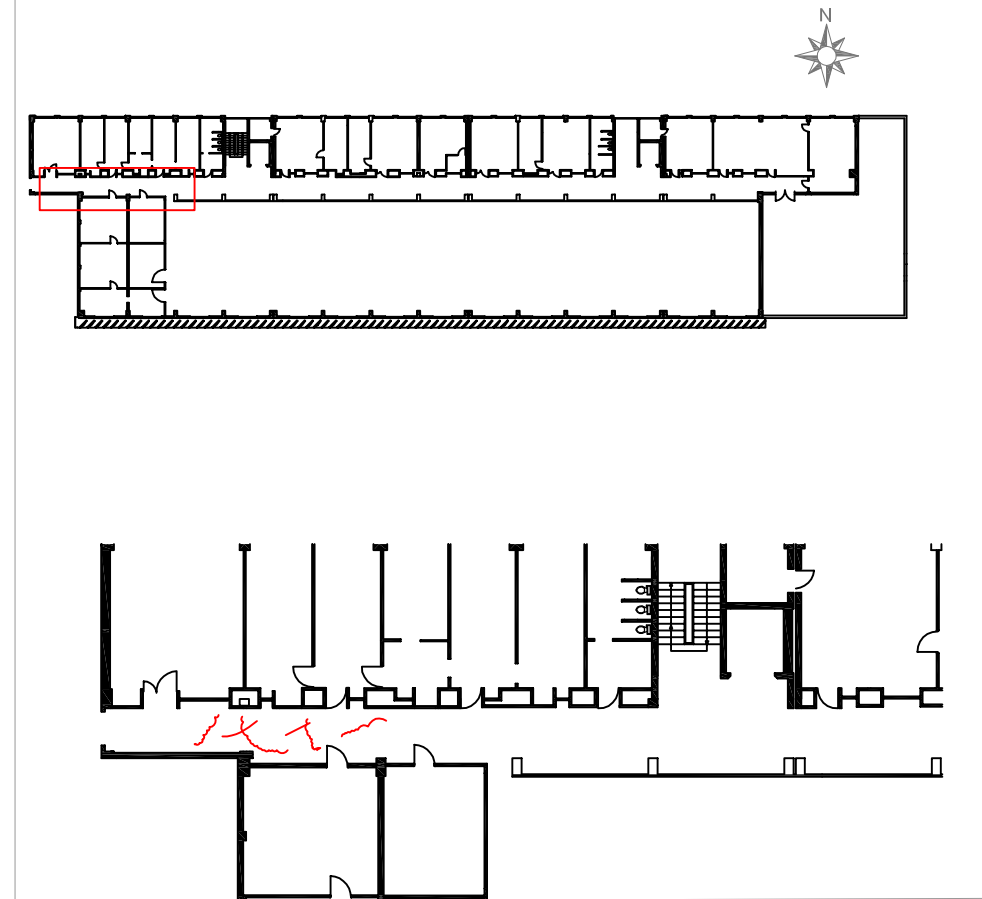
DESCRIPTION: Outer wall made of brick 7. Insufficient wall thickness and the anchoring of the banister has perforated the brick and leaving a completely portion of a brick

- Placement of a brick thick inadequate

1. The steps to intervene successfully on this pathology are:
 - Withdraw the banister and one of this option:
 - 1- Perform the anchoring banister in a different way and repair the broken brick
 - 2- Increase the width of the wall. realizing it again with thicker brick

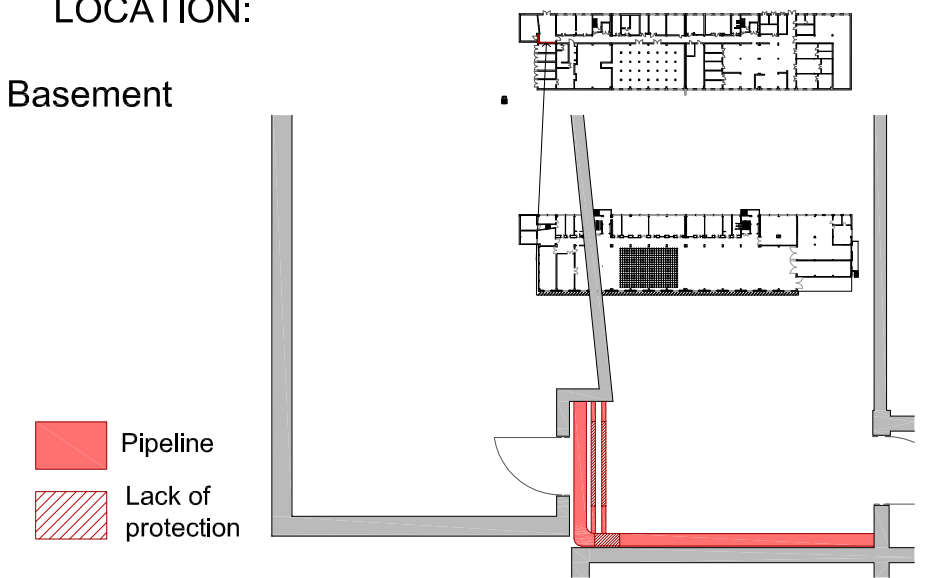
Basement

DESCRIPTION: On the ground floor partitions where it runs the facilities, moisture and stains are observed on the wall. The tubes that protect installations are damaged and broken. Even ducts there are sections that haven't protection. The installations clamps are rusted. On the fourth floor It can be observed a similar problem as the pipe is exposed unprotected one hand.

- Indoor humidity
- Leaks in water pipes
- Lack of care and maintenance
- protection tubes are unsuitable materials

1. The steps to intervene successfully on this pathology are:
 - Check the operation of the facilities is correct by testing, to see that the stains don't come from a leak.
 - Remove the damaged parts, as well as protection tubes and clamps rusted
 - Cleaning the surface of the wall
 - Replacing tubes pipes protection of a suitable material must be insulating.
