Serrano Cruz, JR.; Tormos Martínez, BV.; Gargar, KL.; Bouffaud, F. (2013). Study of the Effects on Turbocharger Performance Generated by the Presence of Foreign Objects at the Compressor Intake. *Experimental Techniques*. 37(2):30-40. doi:10.1111/j.1747-1567.2011.00795.x.

# Study of the effects on Turbocharger performance generated by the presence of foreign objects at the compressor intake

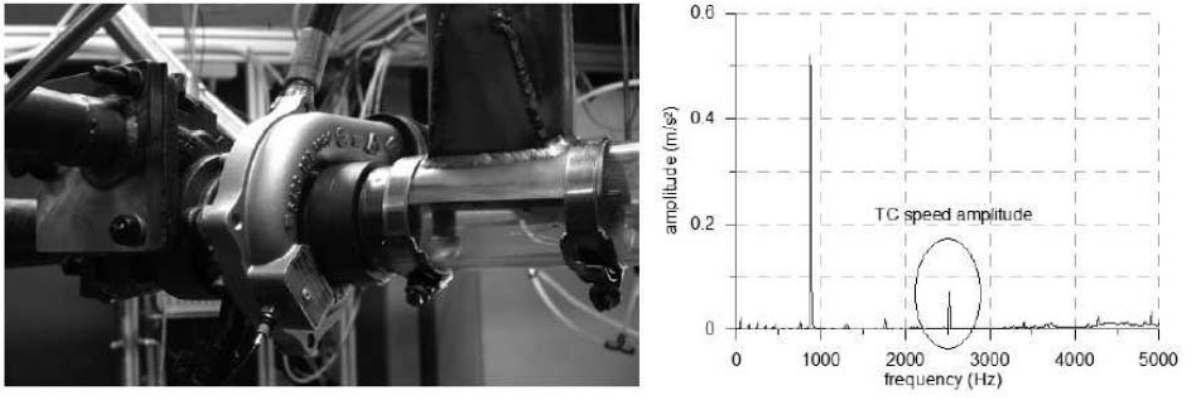
Figure 3

In order to carry on a vibration analysis and detect incipient damages that may not be evaluated through the thermodynamics measurements, an accelerometer and a data acquisition system had been added to the bench. The accelerometer, Brüel & Kjaer type 4384 (SN:1909599), was axially mounted on the compressor side of the turbocharger. Accelerometer is 200 g in weight and its sensitivity is 3pC/g in the range of 1 to 16.6 kHz. The signal from the sensor was transferred to a conditioning amplifier and then recorded at a sampling frequency of 50 kHz using a data acquisition system. As previously mentioned, the vibration analysis is not presented in this paper. Although there are other options to measure turbocharger speed <sup>12</sup>, the accelerometer signal has been used to assess the turbocharger speed for this case. The location of the accelerometer can be observed on the figure 3.

**Figure 3.** Left: location of the piezo-electric accelerometer and right: example of frequency graph showing the turbocharger speed.

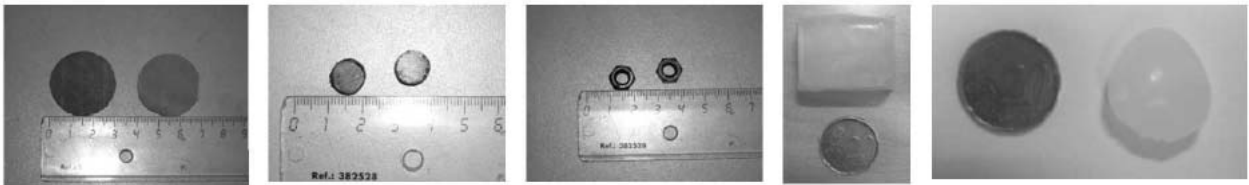
Figure 4

An image of the different objects used in this study can be observed on figure 4.

**Figure 4.** Picture of the objects and size used to hit the compressor wheel. From left to right: (a) paper, (b) plastic, (c) nuts, (d) ice cube and (e) ice sphere.
