**FINAL
PROJECT
2013-2014**

**“THERMAL COMFORT IN A
HISTORIC BUILDING IN FRANEKER”**

**Jesús Pizá Martín
409481 Group 59**

Graduation Placement at NoorderRuimte

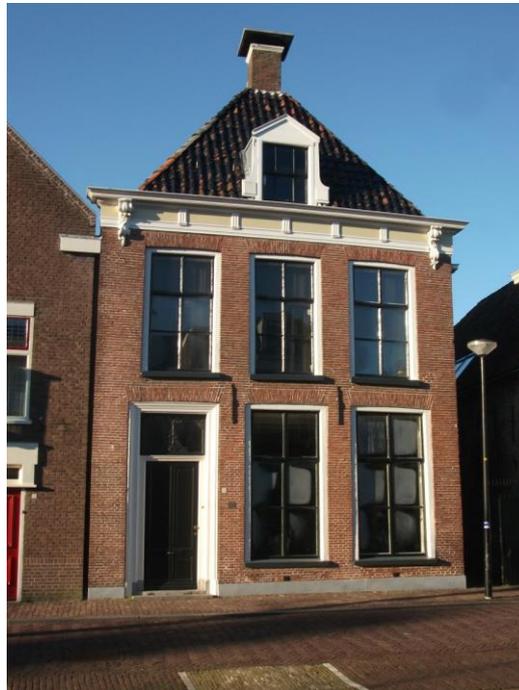
Image 4.3.1- Main facade of the building

On the facade, the first two floors of the building are made with a wall of solid red stone bricks with light grey mortar and large windows that cover much of the surface of the facade. These old windows, as it is possible to see, have traces of surface condensation. The difference of temperature between the inside and the outside of the building is producing the condensation partition on many of the window, mainly on the South facade (the closest to the canal).

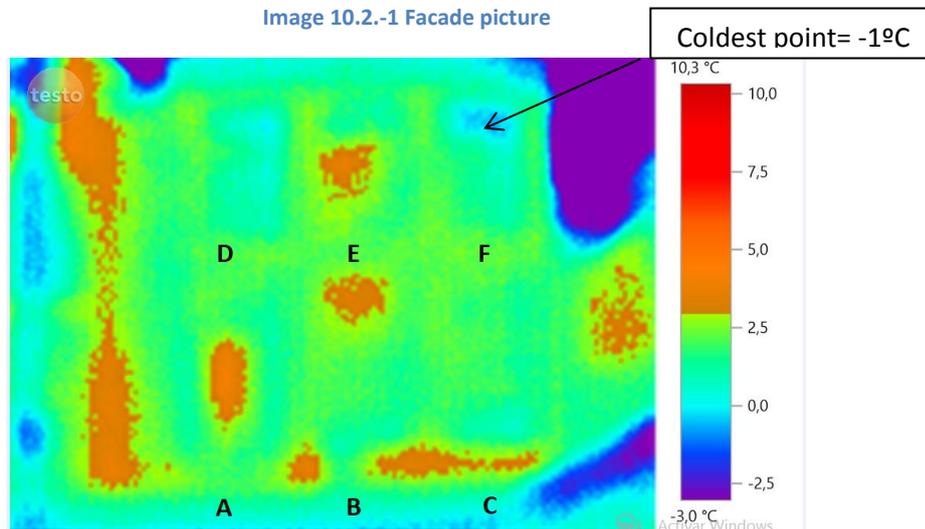
Image 10.2.-2- Thermal picture main facade

The blue areas represent the coldest parts on the building facade, while the orange ones represent where the building is warmer and losing heat. The difference of temperature between the warmest point and the coldest at the facade surface as we can see in the thermal scale of the picture 10.2-2 is around 7°C being the coldest point closes to -2.5°C at the window F and 5°C at any heat losses that we can see in orange colour like the heat from the window E.

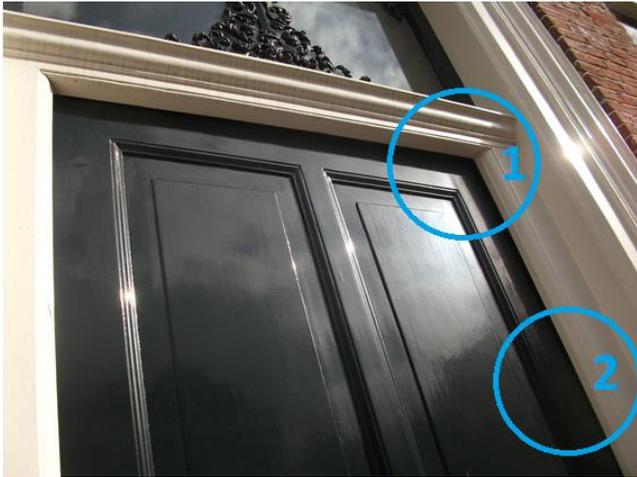
We will start analysing the gap on the main door of the building, in the A zone of the thermal picture.

At the image we can see that there are heat losses on the share of the door, but not at the top of the door glass where that extra glass layer mentioned before had been installed. This proves that it somehow prevents the air leaks at this part of the house.

Image 10.2.1. Main door

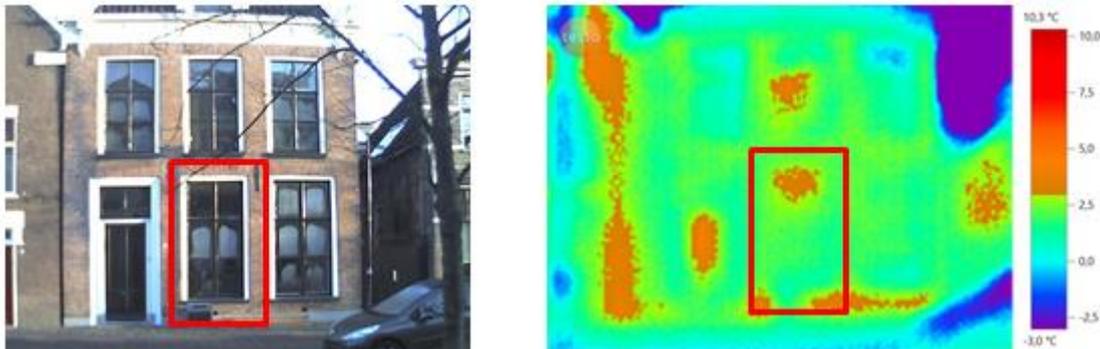
Imagen 10.2.2-1 Thermal picture window B

We can see that at the superior part of the window the thermal camera has detected heat losses but not at the lowest part. This area matches the only part of the window that has not condensations.

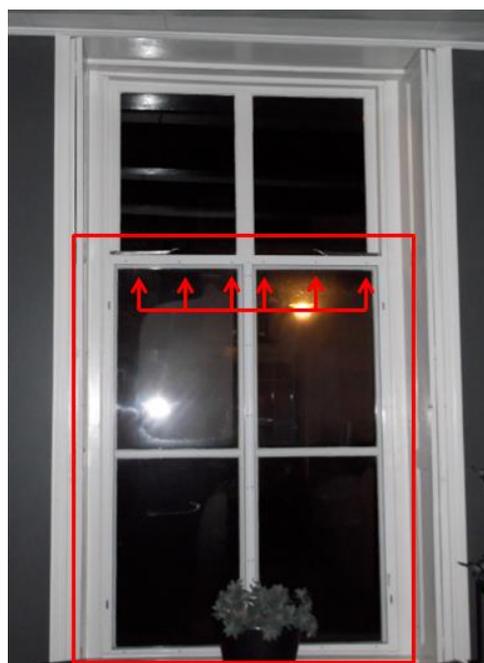
That extra glass layer was fixed on the old frame of the window but in this case (window B) it was only installed at the low part of the window, not on the highest because as this part is the only opening system of the ground floor of the main facade.

Image 10.2.2-2 Extra glass layer

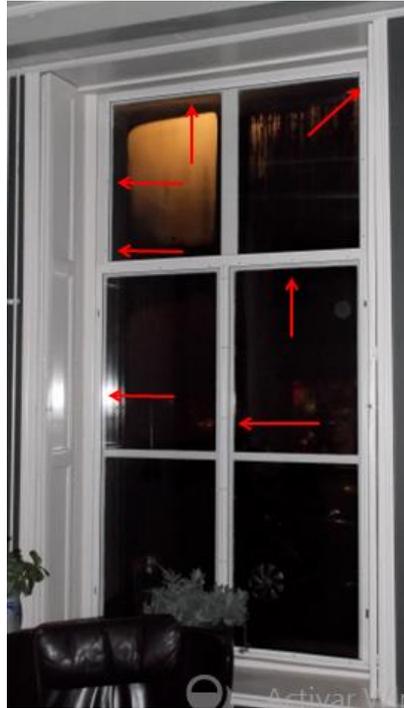
On this window, there is not a system that permits the possible opening of the window as at the window B. For that reason, at the last restoration the same extra glass layer was installed but in all the surface of the window creating a bigger amount of condensation on it now. This amount of condensation is much bigger at the highest part, as the hot air tends to go up creating a bigger temperature difference and creating more condensations, as we can see in pictures 10.2.2-4 and 10.2.2-5.

Image 10.2.2-4 Window C without opening system

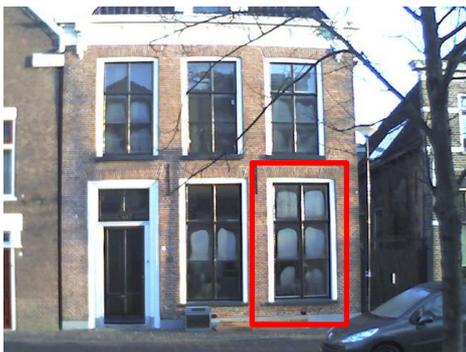
Image 10.2.2-5- Window C full of condensations

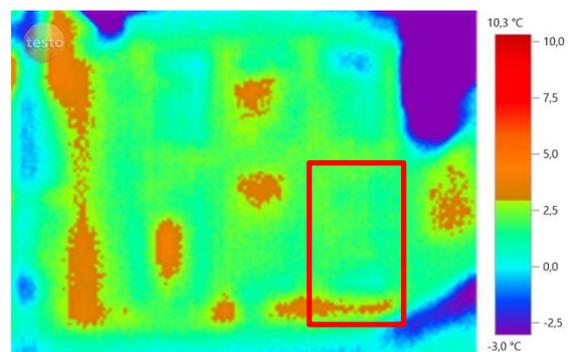
Image 10.2.2-6- Thermal picture window C

That is the reason why we cannot see heat losses with the thermal camera (10.2.2-6), as it detects only the heat losses at the surface of the objects, and the exterior glass (the older one) is cold, and the extra glass layer is warmer in the interior part.

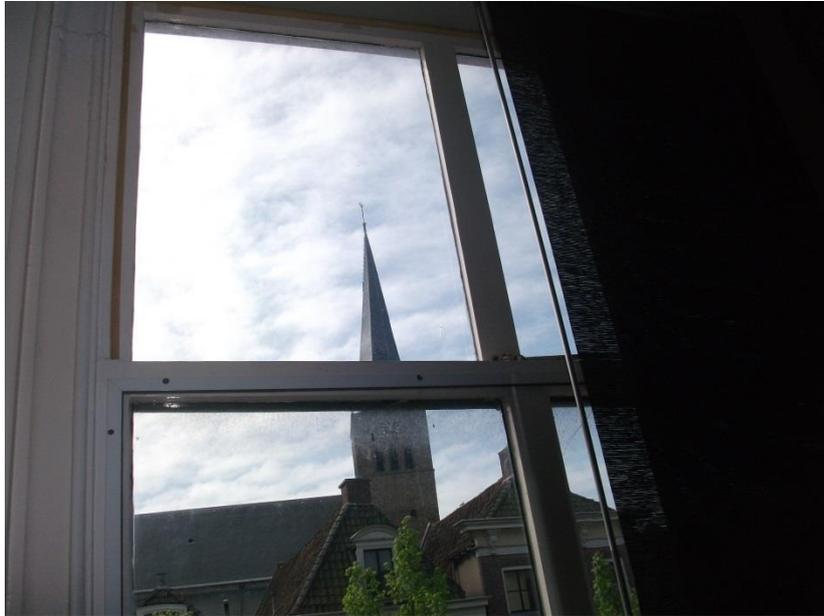
This case is very similar than the window B. The extra glass was installed on all the window less on the highest part like we can see at the picture below.

Image 10.2.3-1 Extra glass layer, on the low part of the window

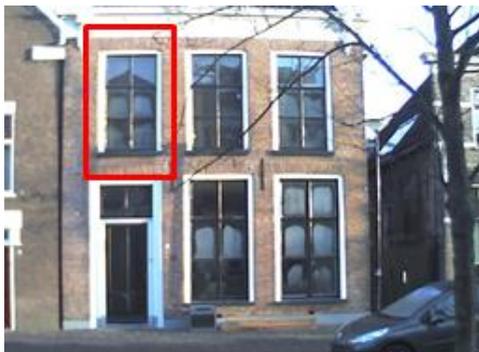
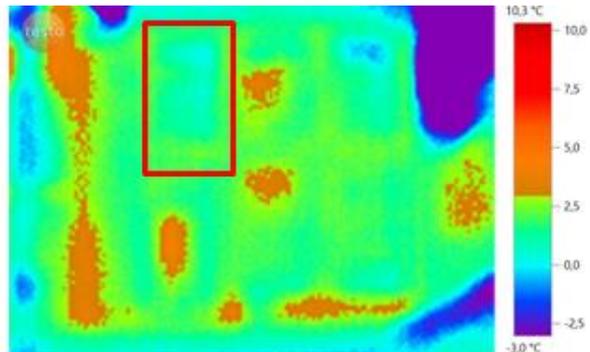
In this room and as we can see at the plane number 10 of the Annex 1, there is a system to open the window, and if the thermal camera does not detect heat losses (picture 10.2.3-2) on this part, it could mean two different things: firstly, that the opening closes well because there are not heat losses at the thermal picture, secondly that the extra layer continues accumulating vapour in the air chamber producing condensations on the old glass.

Image 10.1.4.-2 No heat losses shows on the window D

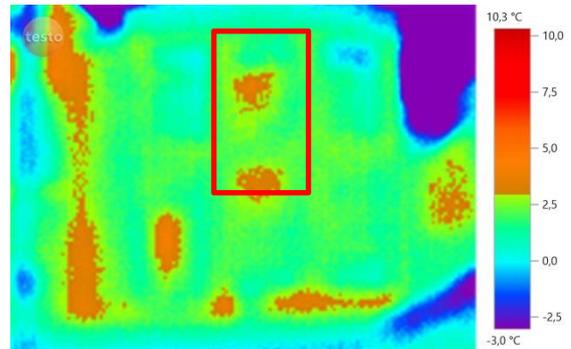
It is the unique window in all the building that does not have condensations in the whole window. Moreover, we can see the heat losses that the window has in almost all the surface at the picture 10.2.4-2.

Image 10.2.4-2 Heat losses window E

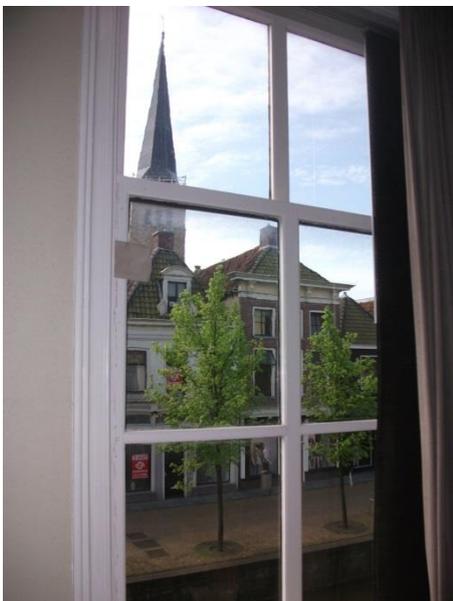
Because this window is the only one that has a different opening system called “guillotine” and it does not have the extra glass layer on any part of the window as we can see at the pictures 10.2.4-3 and 10.2.4-4 below.

Image 10.2.4-3 window E

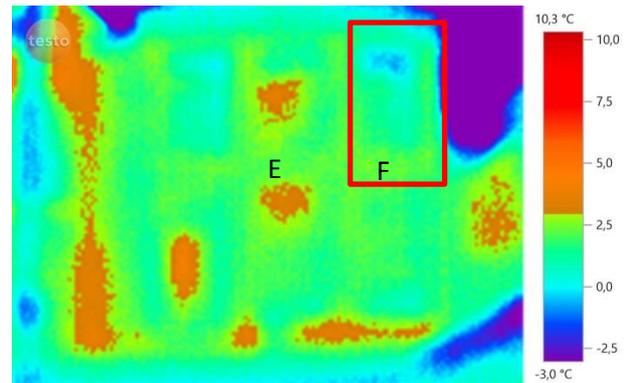
Image 10.2.4-5 No apparition of heat losses on window F

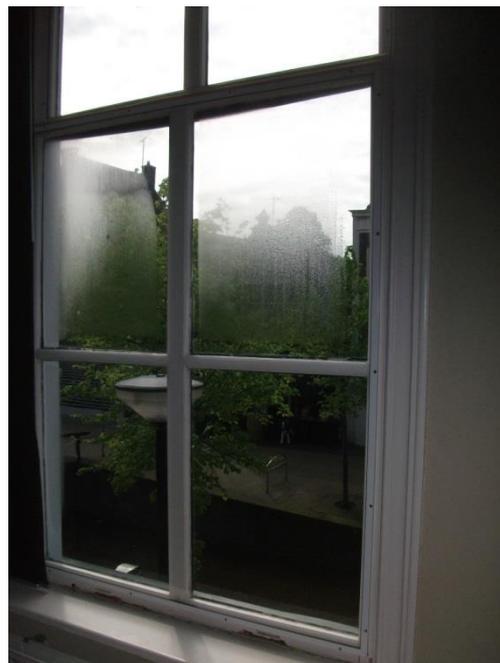
Image 10.2.4-6 Condensation on the window.

As we can see at the picture 10.2.4-6, on that window there is a continuous small amount of condensation.

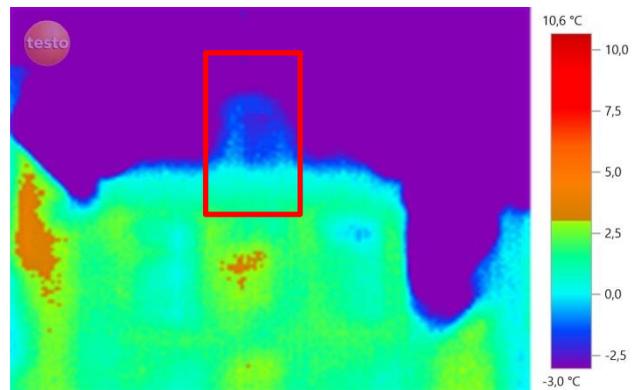
Image 10.2.5-3 Thermal picture of the window G

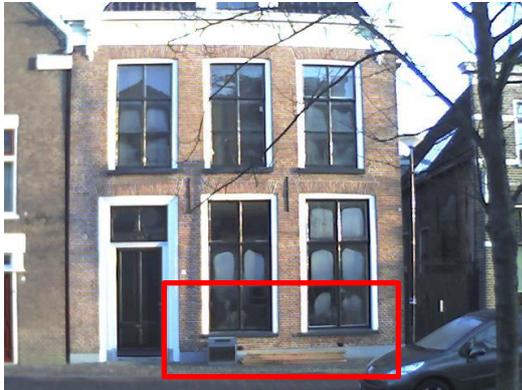
At the facade, there is other part where we can find heat losses. It is at the lowest part of the facade, just below the windows of the ground floor.

Image 10.2.6-1 Lowest part of the building

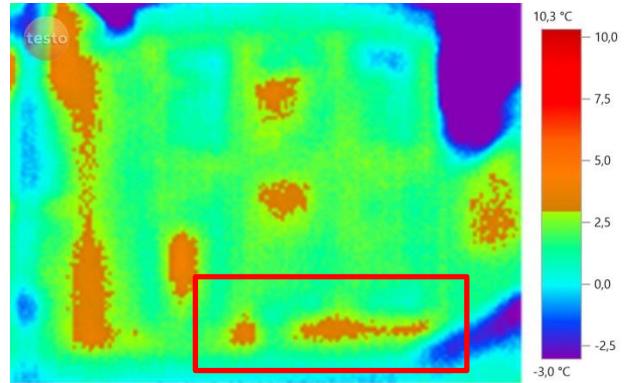
Image 10.2.6-7 Heat losses lowest part of the building

Why the building is losing heat in that part?

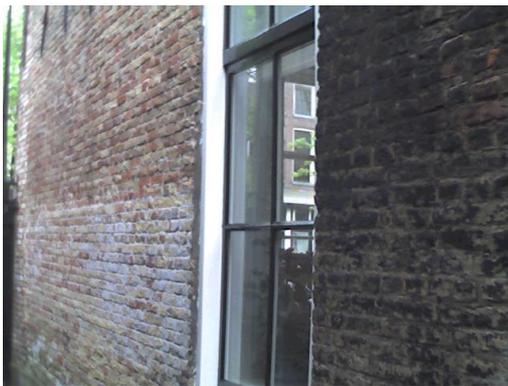
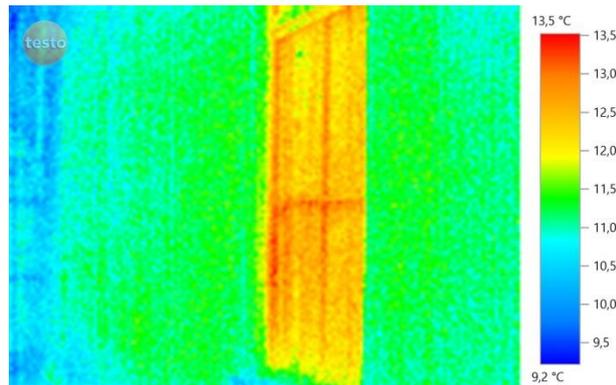
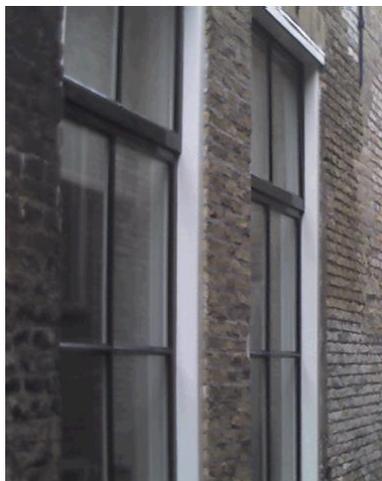
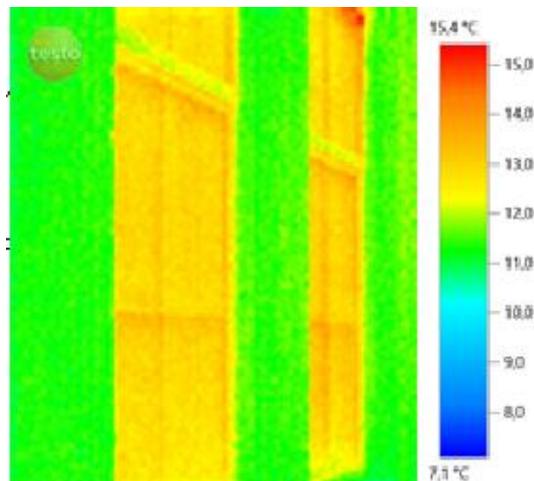
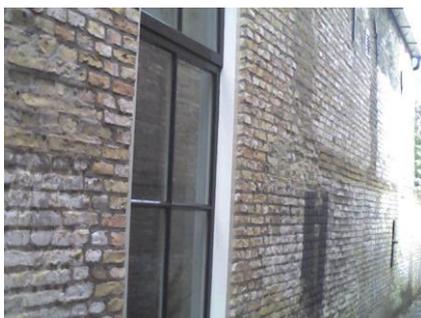
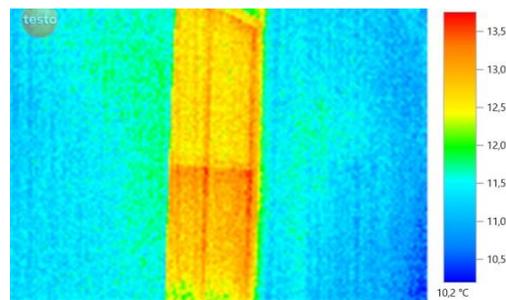
Imagen 10.3.1 -1 Window O

Imagen 10.3.1-2 Thermal picture window O

Imagen 10.3.1 -3 Windows P and Q

Imagen 10.3.1-4 Thermal picture window P and Q

Imagen 10.3.1 -5 Window R (TV Room)

Imagen 10.3.1-6 Thermal picture window R (TV Room)

In general terms, the windows are warm because their thermal resistance is not big. There is not big difference of temperatures than in the other pictures from the main façade and that means that there are not air leaks in this part.

In these windows, it is not like in the main facade, where the difference of temperatures at the same windows could be up to 5°C. The no existence of an opening system in these windows favours the non-presence of air leaks because the windows have less joints and the extra glass layer covers all the surface of the window.

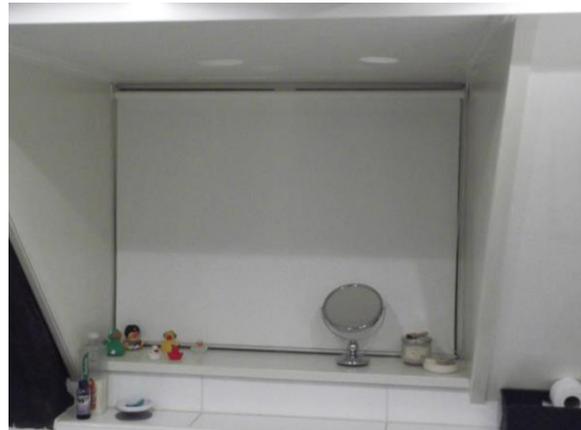
The window S corresponds with the bathroom from the first floor as we can see at the picture below. The window is covered by a curtain but it has an opening system and glass are made with simple glassing, like in all the windows of the building except for window T that has double glassing.

Image 10.3.2.-1 Window S first floor (simple glassing)

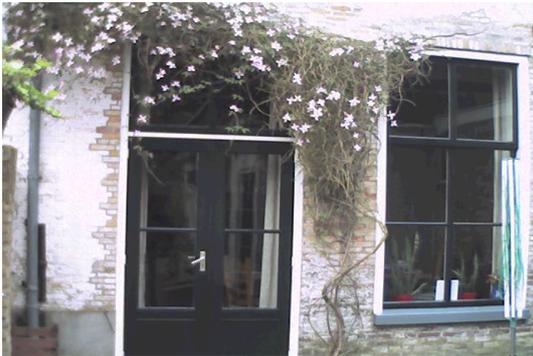
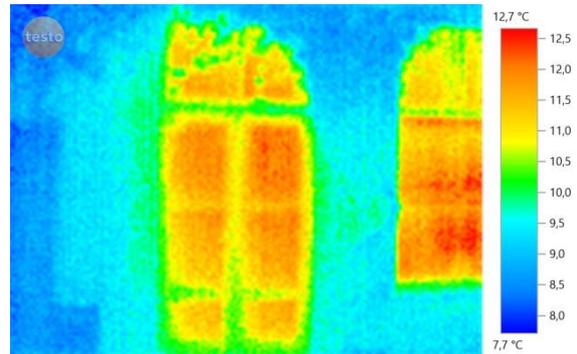
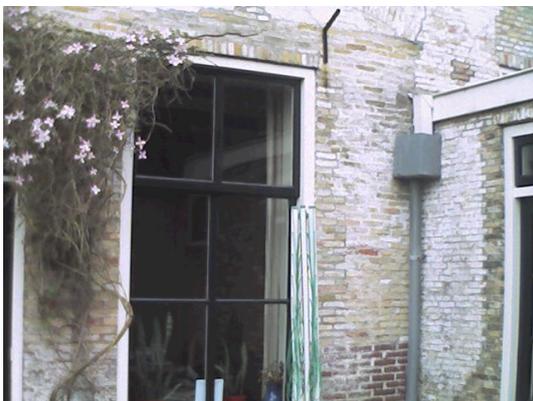
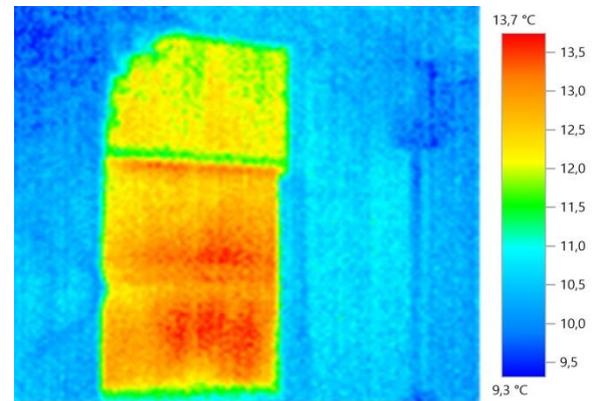
Imagen 10.4.1-1 Door H (Kitchen)

Imagen 10.4.1-2 Thermal picture kitchen

Imagen 10.4.1-3 window J (kitchen)

Imagen 10.4.1-4 thermal picture window J

As we can check at the thermal pictures and like at the other windows from others facades there are heat losses by conduction but there are not air leaks. The door of the kitchen closes properly because there are not temperature differences (if we check the thermal scale from the picture 10.4.1-4 there is a difference of colour but the difference of temperature is only 1°C).

We will have to improve the thermal resistance of these as there are a lot of heat losses by conduction through the window glassing in all the windows of the building.

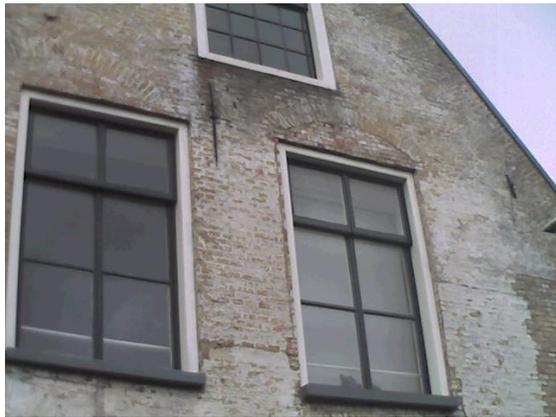
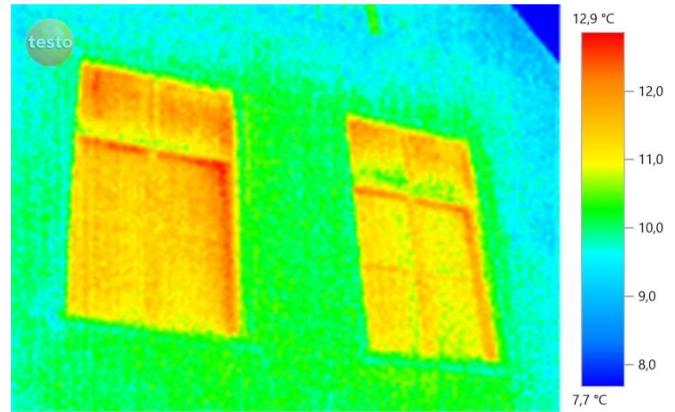
Imagen 10.4.2-1 Windows L and K (Bedrooms)

Imagen 10.4.2-2 Thermal picture windows L,K

At the first floor, the situation is the same than on the ground floor of the North facade. The main way why the house is losing heat on this part is that it does not have an extra glass layer on the old window. Therefore, to reduce the energy losses it will be necessary to improve the thermal resistance of the glazing.

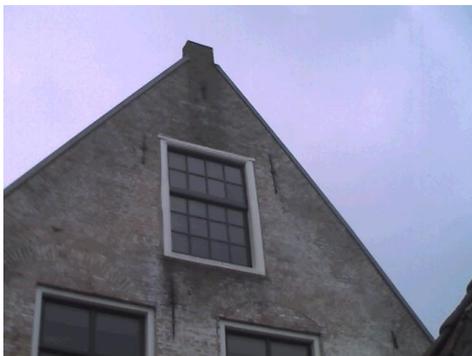
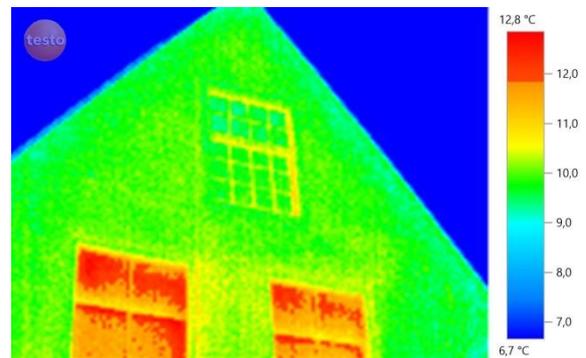
Imagen 10.4.3-1 Attic

Imagen 10.4.3-2 Thermal picture Attic

The attic, as we can see at the pictures 10.4.3-1 and 10.4.3-2 the temperature of the wall and of the glass is the same given that, in that specific part of the building there are not any radiator inside. It will not be necessary to do changes there if it is an unused and cold space.

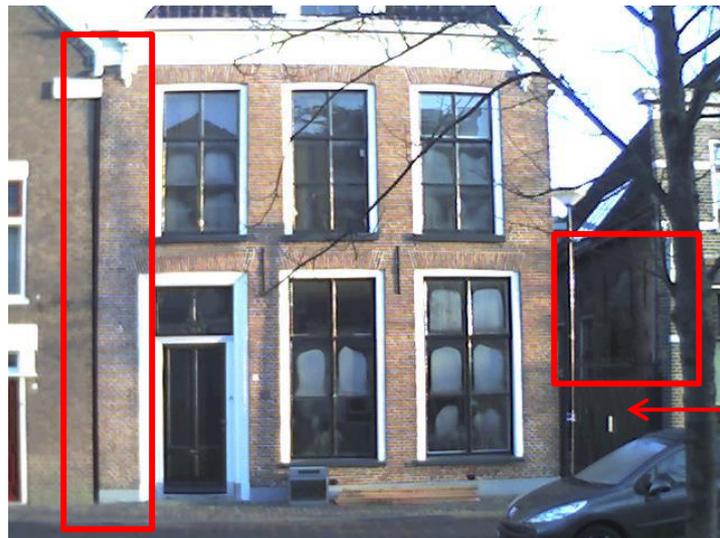
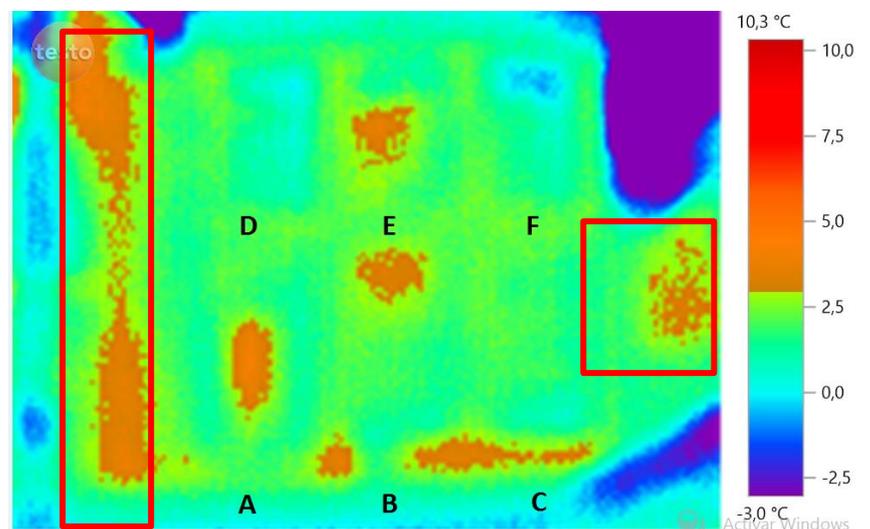
Image 10.5.1-1

We can see at the thermal pictures of the main facade that the temperatures of the corridor and of the small space between the two buildings at the left part of the house is higher than at the main facade.

At the left part (there is a space between the 2 facades), the inexistent ventilation produces an increment of the temperatures in that small space. It is the first example of the higher temperatures at the 2 side parts of the house, when the ventilation is lower.

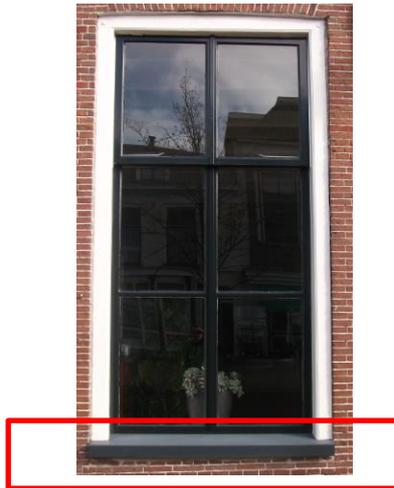
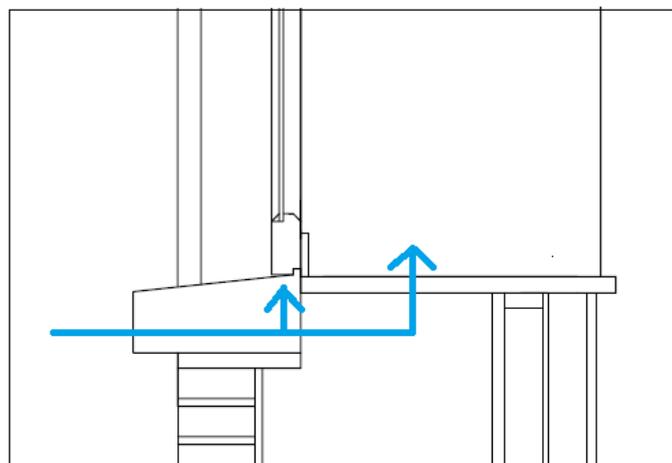
The second one that could produce the condensations are the thermal bridges that are at the stone sill of the windows.

All windows are supporting on a stone sill where there is a bigger thermal transmission than at the exterior wooden frame of the window (painted in white colour).

Image 10.5.2-1 Stone sill at the lowest part of the window

Image 10.5.2-2 Thermal bridge in the detail of the window.

That thermal bridge is bigger if the exterior temperatures are higher so the thermal bridge is bigger too at the main façade than at the side wall of the house.

It is clear that is not allowed renew the stone sills of the windows being that we would be modifying the historic values of the façade. If we want to improve the thermal resistance of the windows, which is the principal way in which the building is losing heat, we would have to firstly remove the extra glass layer of the windows, because it is the reason of the condensations and secondly improve the thermal resistance of the window.

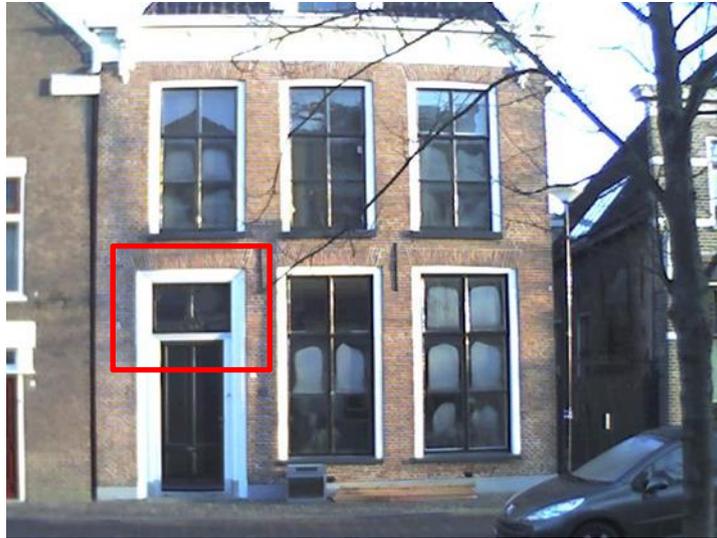
That would explain why there is only one window at the main façade that does not have condensations, even having extra glass layer without opening system. It does not have a stone sill being supported on the wooden frame, but it could be the glassing of the highest part of the main door.

Image 10.5.2-3 Window A. Without condensations at the coldest part of the year

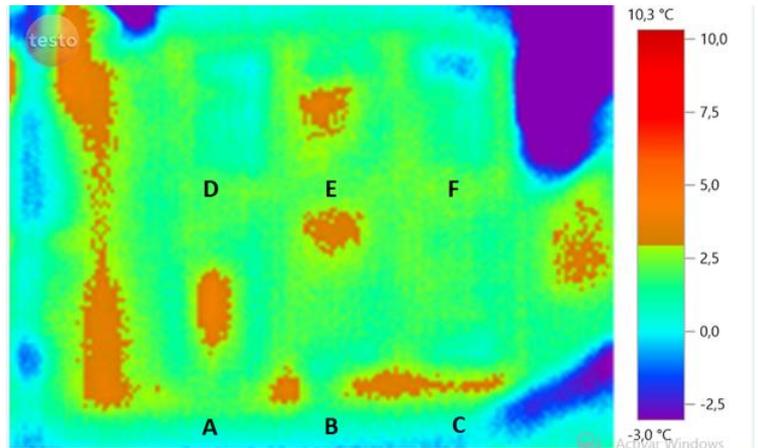
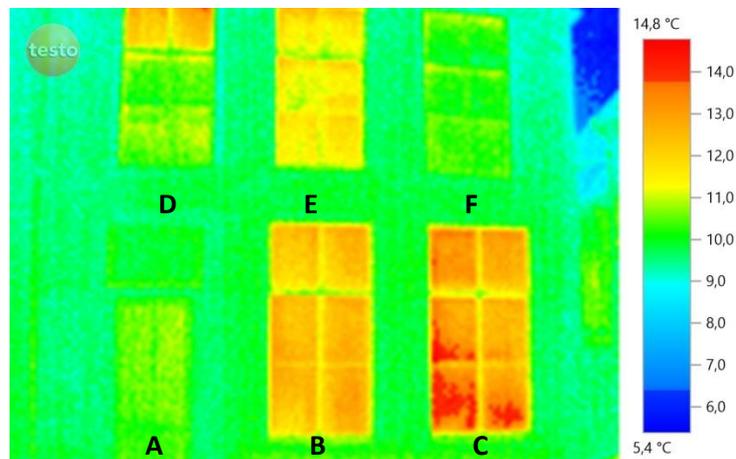
Imagen 10.6-2 Thermal picture token during winter with the extra glass layer installed on all the windows less the E.

Imagen 10.6-3 Thermal picture- token without extra glass at the windows B,C and E.

We can compare in picture 10.6.-3 the differences between the windows B-C (without extra glass now) and the window F, which still has the extra glass. Being able to compare the difference between the windows with the extra glass and the windows without, we found a difference of around 3-4°C.

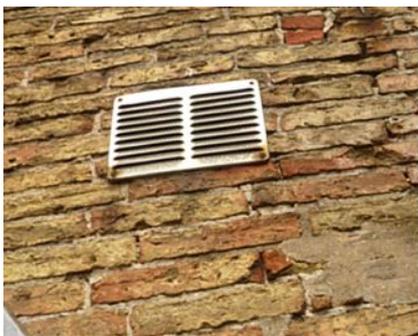
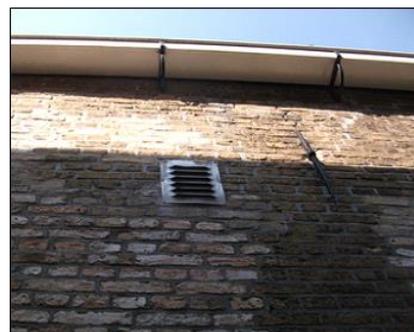
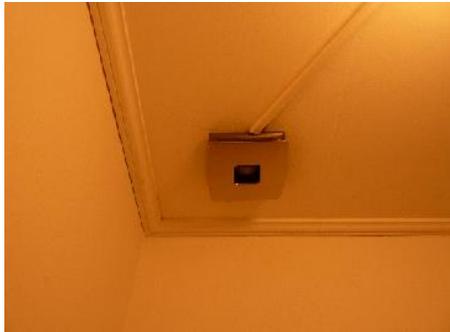
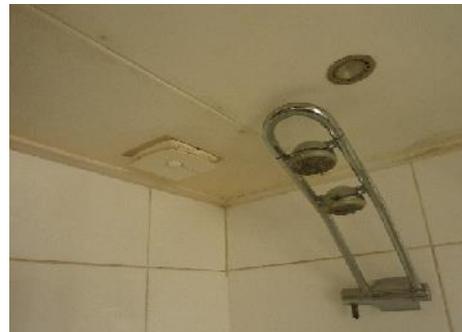
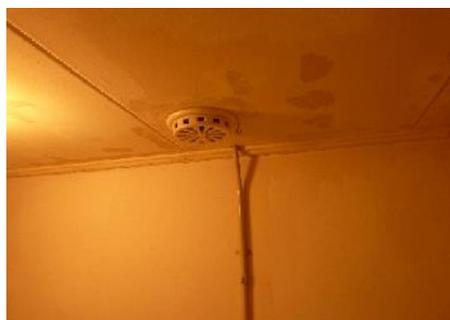
Image 12.2-1 Metal grill of the dryer (left facade)

Image 12.2-2 Metal grill from the of the kitchen hood

Image 12.2-3 Fan of the W.C. of the ground floor (Room 10)

Image 12.2-4 Fan of the bathroom first floor (room 17)

Image 12.2-5 Fan of the washing machine room from the first floor (room 14)

If there is condensation in the building, that means that the ventilation is insufficient because the existing fans are not working properly, are broken or they do not have enough power to ventilate the house in a correct manner.

To solve this problem, there will be necessary the installation of new fans and a new ventilation unit to permit the ejection out of the house of the interior air. The entrance of new air will continue being like now, by infiltrations.

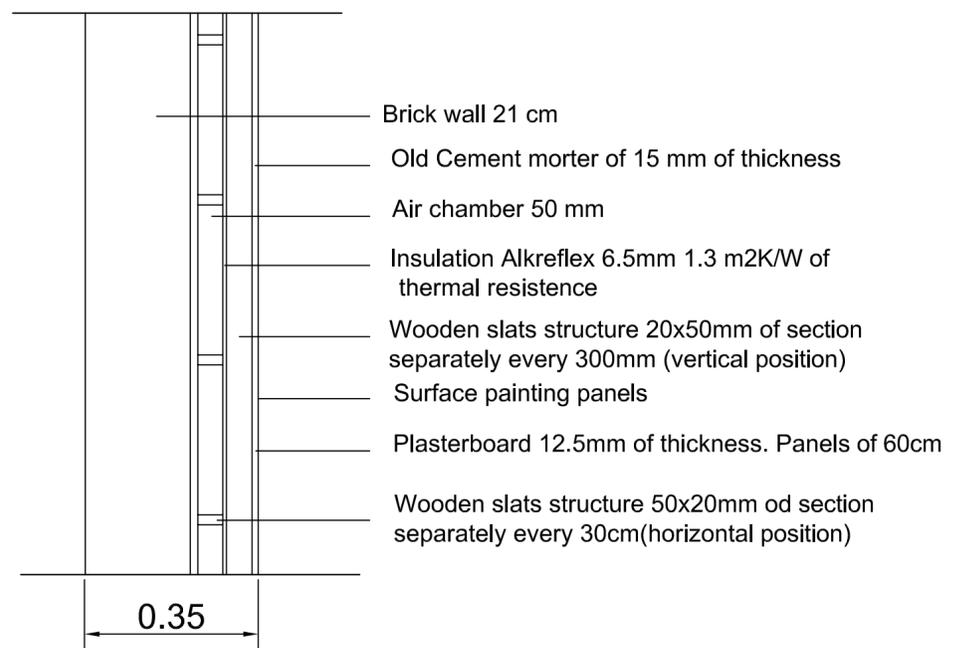
WALL N°2
SIDE AND BACK FACADE SCALE 1:10

In the bathroom from the first floor (room 17) , moreover to the the wall number 2, there is an extra layer of tiling. At the kitchen from the ground floor (room 7) there is not this layer being the walls as most of the house like the wall N°1.
