Grid structures in Wenchuan Earthquake

Abstract

Keywords: grid structure; Wenchuan earthquake; earthquake resistance

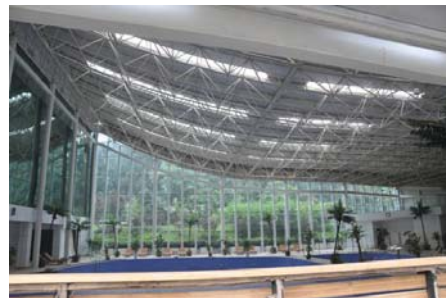
Figure 2-b: internal space

Fig. 2-a~g show a damaged grid shell in Dujiangyan. We can find some members close to supporters are buckled under pressure or yielded under tension. The earthquake resistance intensity of Dujiangyan is 7 and so earthquake effects can be ignored in this city according to stipulations of Chinese code. But in Wenchuan earthquake, the earthquake intensity

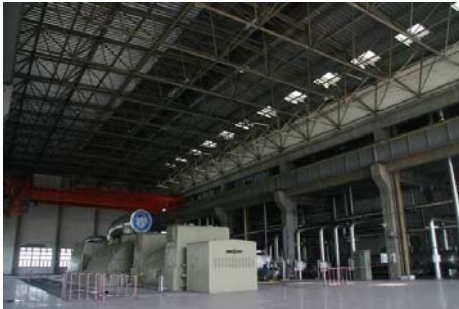
Figure 4-b the intact sector

Figure 4-a~c show the damages to a grid shell of a factory in Jiangyou city. The factory spans 28 meters, with 12 meters of column spacing, and has two stories. The first floor is constructed by reinforced concrete slabs; the roof is the combination of lattice shell and concrete slabs. The shell has a skylight shelf along the longitudinal direction. The shell and the lower concrete structures were divided, along the longitudinal direction, into two sectors by the seismic joint: one sector collapsed, the other was only with some small damages. The reason is there is a big hole by side of the constructional joint at the collapsed sector.
