# Investigation and Monitoring of Sinkhole Subsidence and Collapse: Additional Data on the Case Study in Alcalá de Ebro (Zaragoza, Spain)

**Abstract:** Alcalá de Ebro is located 35 km northwest of the city of Zaragoza, on the right bank of the Ebro River at the outlet of a ravine (Juan Gastón) towards the river, with a catchment area of more than 230 km<sup>2</sup>. Over time, urbanisation and agricultural development have eliminated the last stretch of the drainage channel, and these water inputs have been channelled underground, filtering through the ground. This section of the Ebro Valley rests on a marly tertiary substratum, which promotes dissolution-subbing processes that can lead to sinkholes. The ground tends to sink gradually or suddenly collapse. Many studies have been carried out to understand not only the origin of the phenomenon but also its geometry and the area affected by it in the town of Alcalá de Ebro. In this sense, it has been possible to model an area around the main access road, where numerous collapsing sinkholes have been found, blocking the road and affecting houses. It also affects the embankment that protects the town from the floods of the river Ebro.

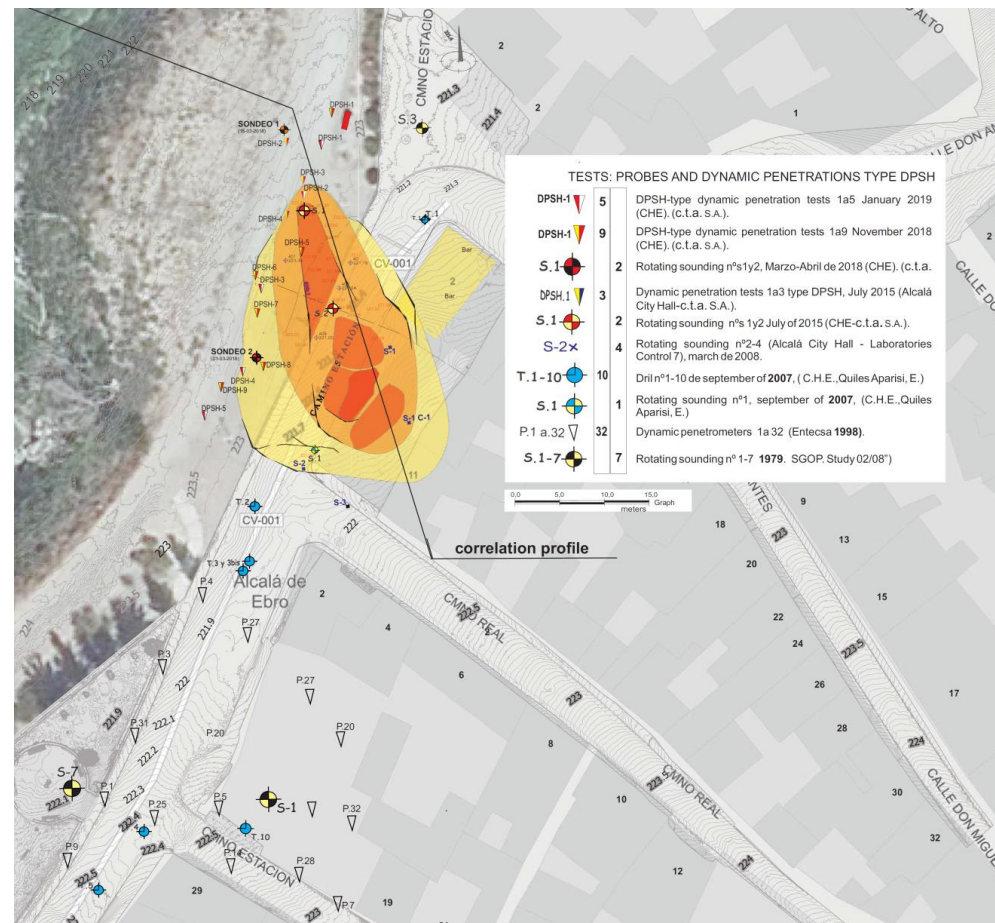
**Figure 3.** Location of the geotechnical investigation works carried out. The areas marked in red indicate sinkholes that occurred in the last 17 years. The areas in orange and yellow indicate the contour zones affected by cracks in pavements and buildings, which show evident signs of subsidence. The correlation profile is shown in Figure 9, modified with permission from [2].

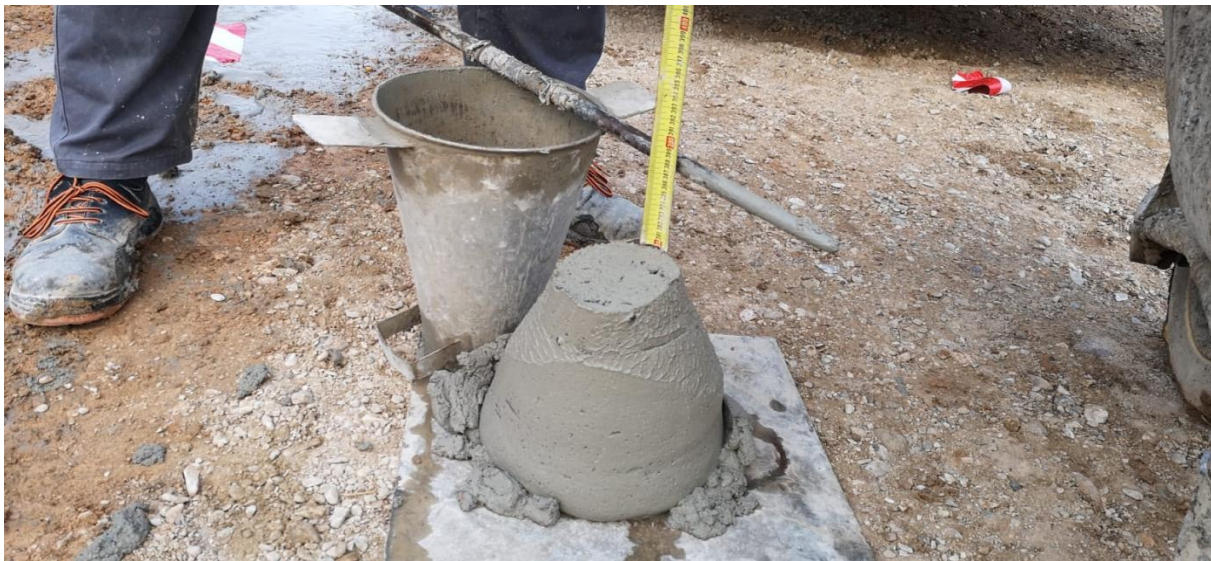
The characteristics of the mortar were rigorously checked using the European Standard: EN 12350-2:2019—Testing fresh concrete. Part 2: Slump test [9]. Specifically, its dosage is to control its density and viscosity, with the intention that it remain in the environment of the application itself, creating semi-columnar structures (Figure 7).

**Figure 7.** Control of the consistency of the mortar L.M. of Column no. 24. The Abrams cone gives values between 8 and 12 cm. The location of this column is shown in Figure 5.

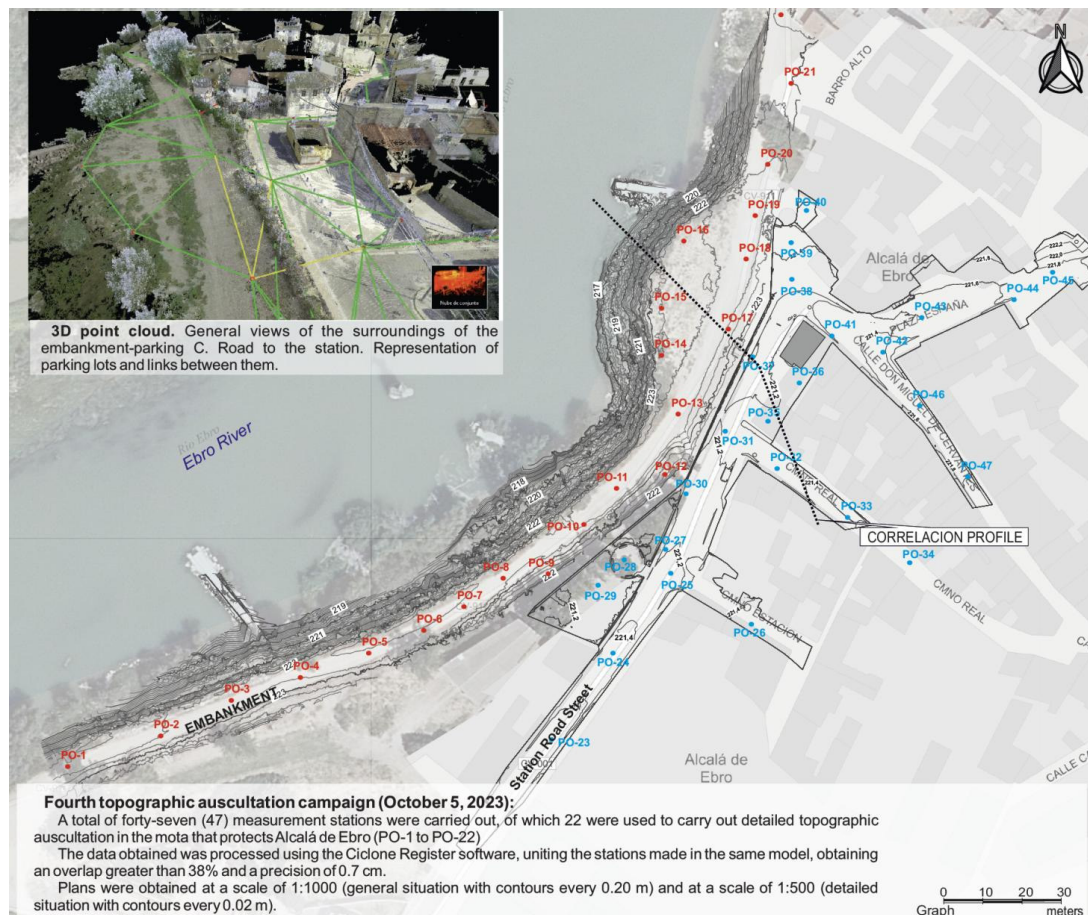
**Figure 10.** Measuring stations used for topographical auscultation: 24 at the embankment (red colour) and 27 in the village (blue colour). The result of the precision was achieved in September 2024. The correlation profile is shown in Figure 7.

A total of 51 stations (Figure 10) have been made for this campaign (24 September 2024), between the town (27 stations) and embankment (24 stations). In this case, a total overlap of 47% and a set error of 0.7 cm were achieved.
