## Masonry Walls Restoration and Urban Regeneration in the Clock Tower of Monóvar (Alicante, Spain)

V. Fernández-Mora<sup>1,\*</sup>, E. Moya Soriano<sup>2</sup>, C. Boigues<sup>3</sup>

### Abstract

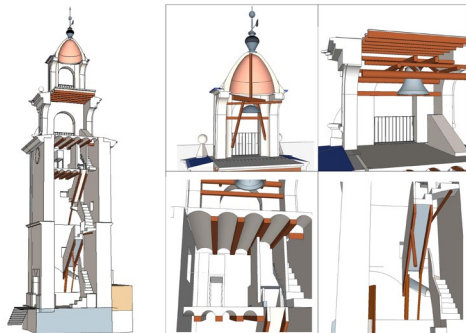
Fig. 4 – *Current stairs and interior of the clock tower.*

Over the centuries, several modifications altered the original structure. When the mechanical clock system was added, it was necessary to demolish the original stairs and build the one visible today. It also seems that this affected several windows, closing them (Fig. 4).
